IAEA-TECDOC-1637

***Corrosion of Research
Reactor Aluminium Clad
Spent Fuel in Water***

INTERNATIONAL ATOMIC ENERGY AGENCY
VIENNA, 2009

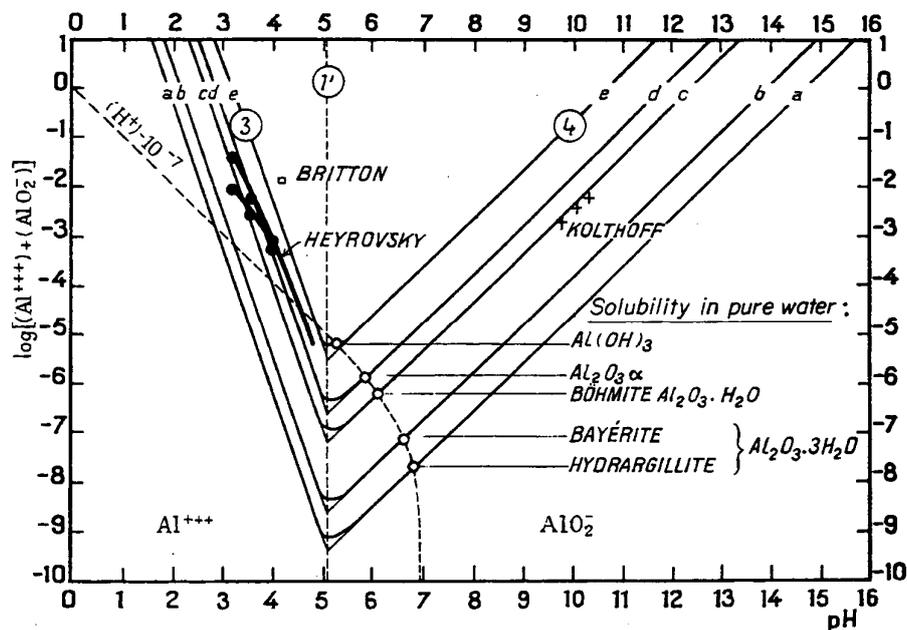
FIG. 1. Solubility of aluminium oxides in water [5].

Depending on the conditions (mainly humidity and temperature) various kinds of aluminium oxides may be formed, from the anhydrous alumina (Al_2O_3) to the successively more hydrated bohemite ($\text{Al}_2\text{O}_3 \cdot \text{H}_2\text{O}$), Bayerite and Hydrargyllite (two crystalline forms of $\text{Al}_2\text{O}_3 \cdot 3\text{H}_2\text{O}$) [5]. $\text{Al}(\text{OH})_3$ (aluminium hydroxide) can also form. All these compounds are soluble in water, depending on the pH. The minimum solubility (maximum stability) is attained at $\text{pH}=5.1$, as seen in Fig. 1.

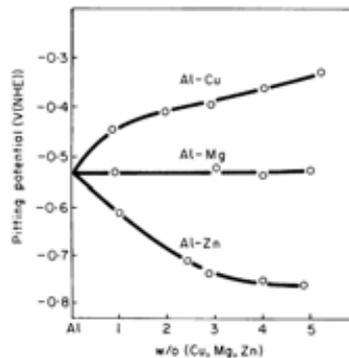
FIG. 2. Effect of different alloying elements on Al pitting potential in chlorides [6], [7].

Pitting potential increases when ion concentration decreases, tending to infinite in pure water (no pitting possible). Any reaction which alters the acidity in the interior of pits will tend to affect E_p , influencing pitting susceptibility. That is why the addition of alloying elements to aluminium may produce different results, as depicted in Fig. 2.

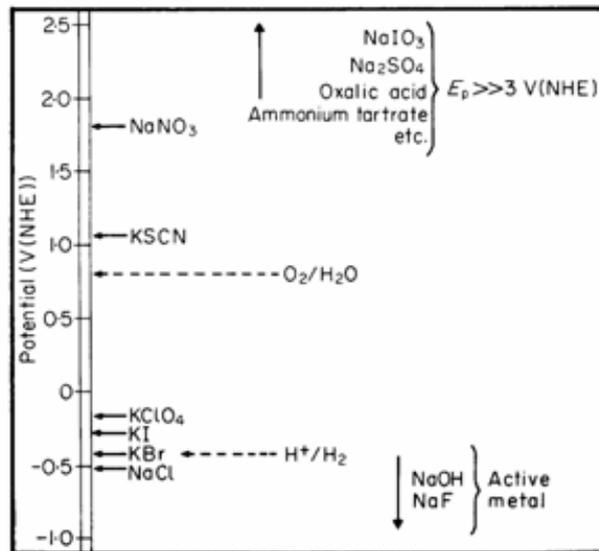
FIG. 3. Pure Al E_p values in solutions of various anions [8].

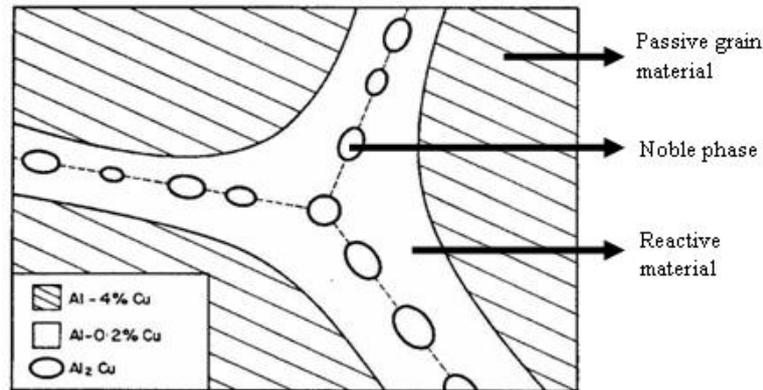
FIG. 4. Second phase precipitation in Al-Cu alloys [9].

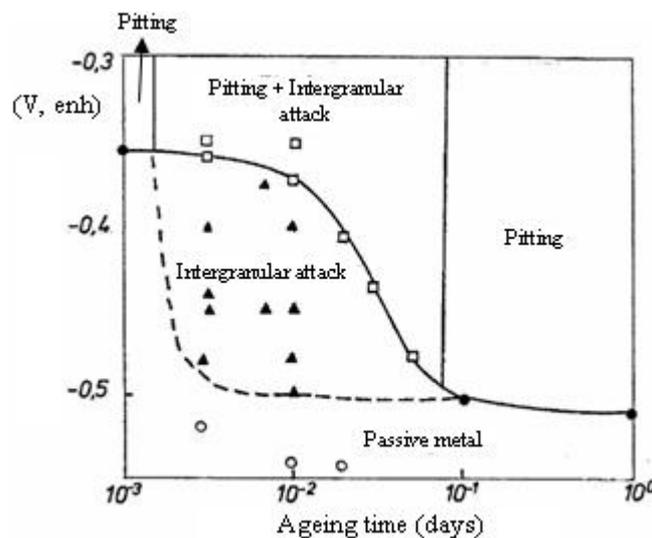
FIG. 5. Effect of ageing time in corrosion susceptibility of Al-Cu alloys in NaCl solutions [9].

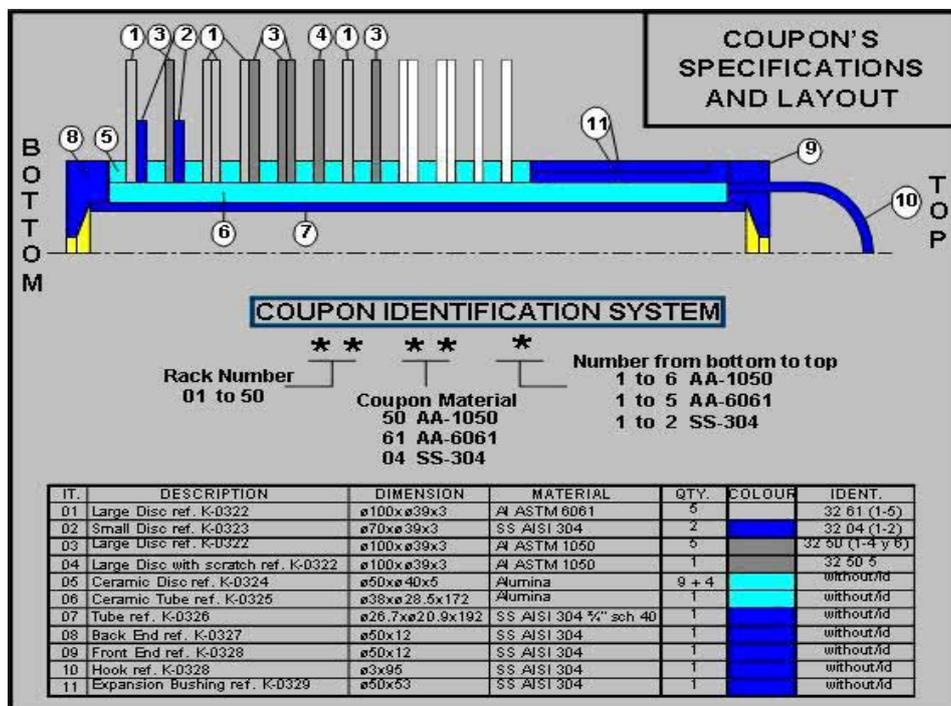
FIG. 6. Schematic representation of a test rack used in the regional project.

The coupons were manufactured from a common source, to permit a better comparison between results in different sites. For the CRP they were machined from a cast rod produced by a Hungarian company under contract with the Atomic Energy Research Institute (AEKI-KFKI) of Hungary. This had been previously used to cut discs for the IAEA CRP on Aluminium Corrosion Phase I. For the regional project all the coupons were fabricated in Brazil. As one of the findings of CRP Phase I was that pitting morphology seems to depend on the manufacturing history, these new batch of coupons were cut from a rolled plate, rather than from a cast rod, to have a metallic structure similar to that of nuclear fuel plates. Later on, for the last part of both the CRP and the regional project, discs cut from extruded (Ex) and rolled (R) plates were also included in those racks used to test the behaviour of the vertical oriented coupons.

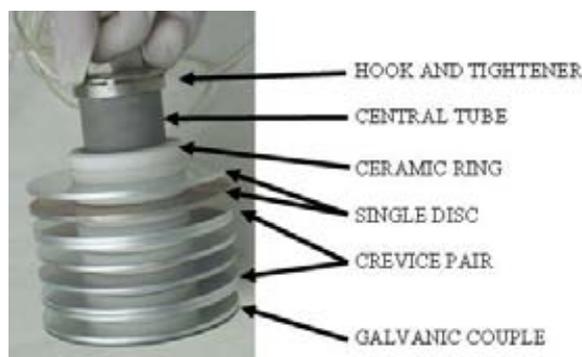
FIG. 7. Example of test rack.

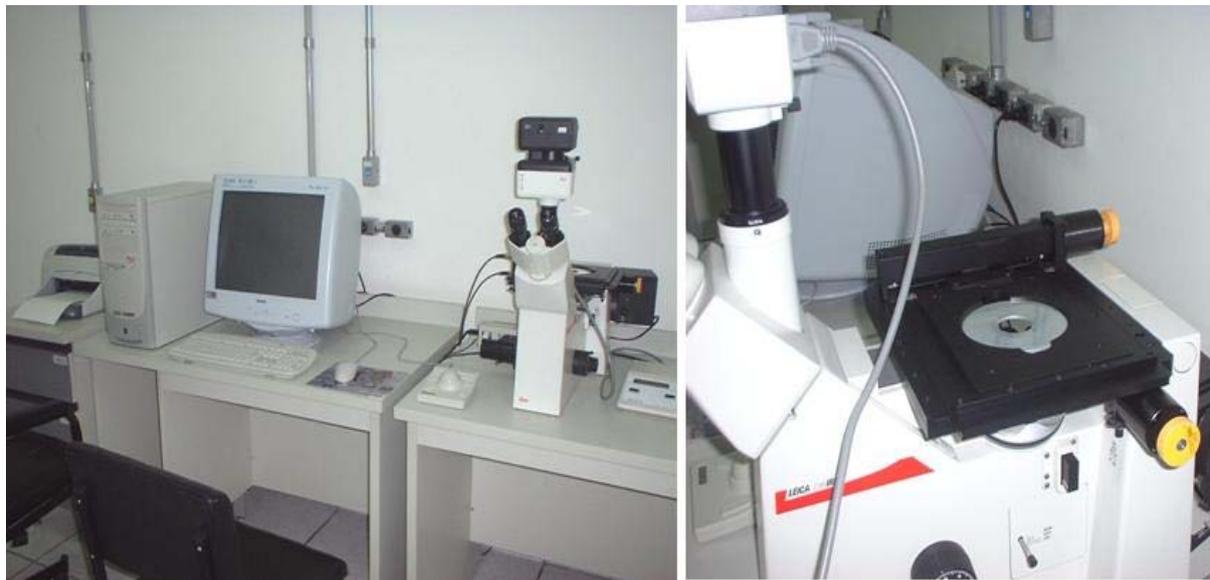
FIG. 8. The Leica Image Analysis Work Station (left) and detail of the motorised stage (right).

A special system was set up by the IPEN Institute in Brazil, to be used by participant of the regional project, in order to perform a thorough assessment of pit size distribution in tested coupons. Fig. 8 shows the Leica Image Analysis Work Station, used for this purpose.

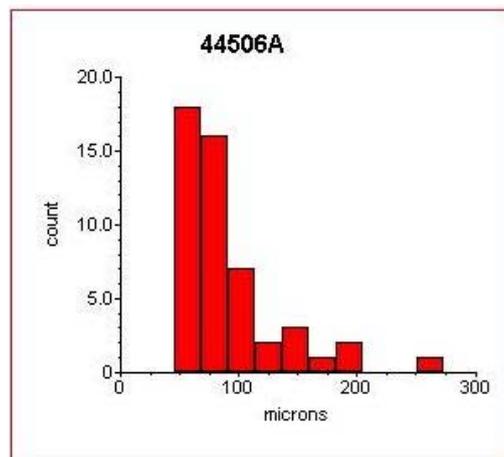
FIG. 9. Example of histogram obtained with the image analyser.

To concentrate in significant points and reduce the amount of time consumed in each analysis, only details larger than 30 μm are taken into account. As a result, a graphical distribution of the type shown in Fig. 9 is obtained as an output.

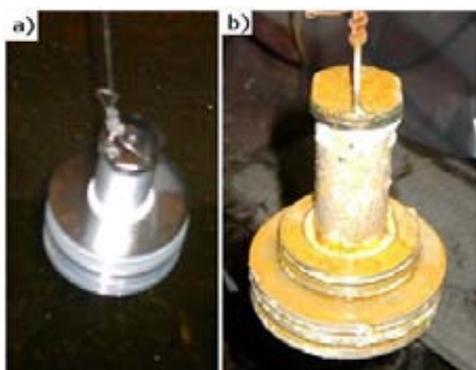
FIG. 10. (a) Test rack being immersed; (b) removed after 24 months from a spent fuel storage basin.

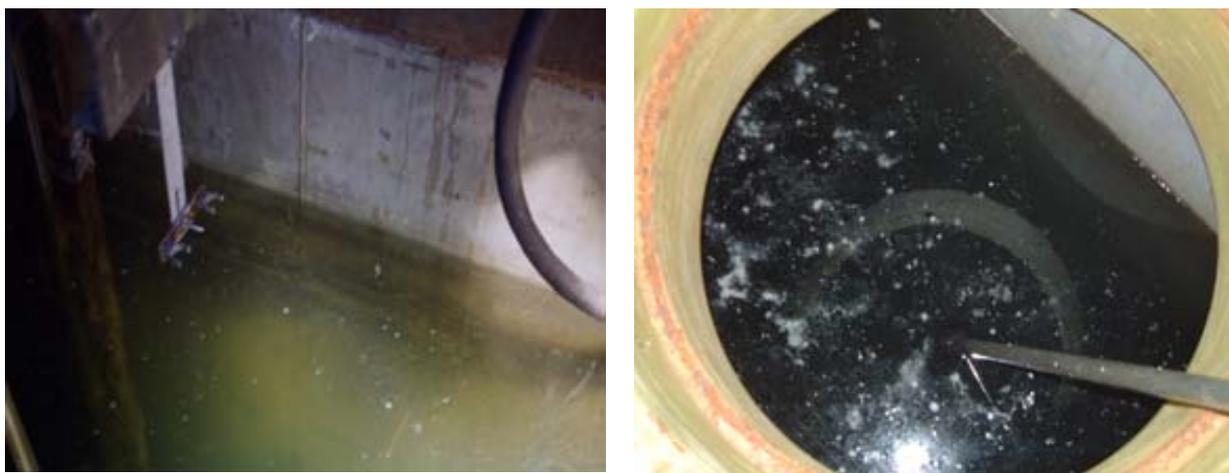
FIG. 11. Spent fuel storage facilities with solids floating on water surface.

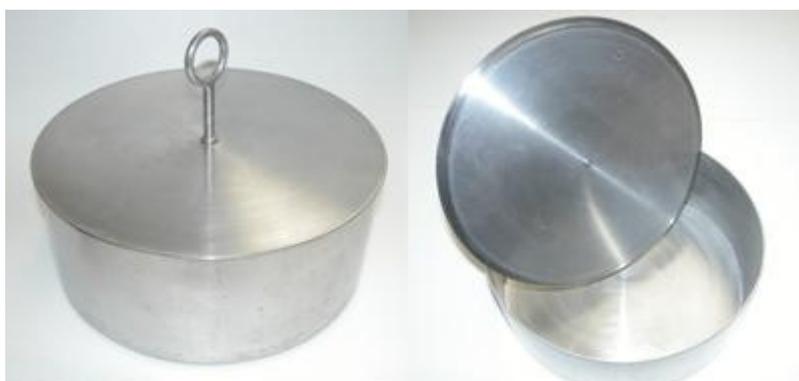
FIG. 12. Collector used at CCHEN, Chile. Material: AISI 304 stainless steel; dimensions: diameter 24.9 cm, height: 10 cm, Area: 486.9 cm².

A variety of collectors have been used by the participants of the CRP and regional project, and a few are shown in Figs 12 to 14. The main criterion in the design of the collector was to prevent the collection of solids floating on the pool/basin surface at the time of withdrawal of the collector. This criterion took into consideration that not all material floating on the pool surface is wetted and settles on surfaces. Regardless that some participant used acrylic, the recommended material for construction of the collector was stainless steel or aluminium.

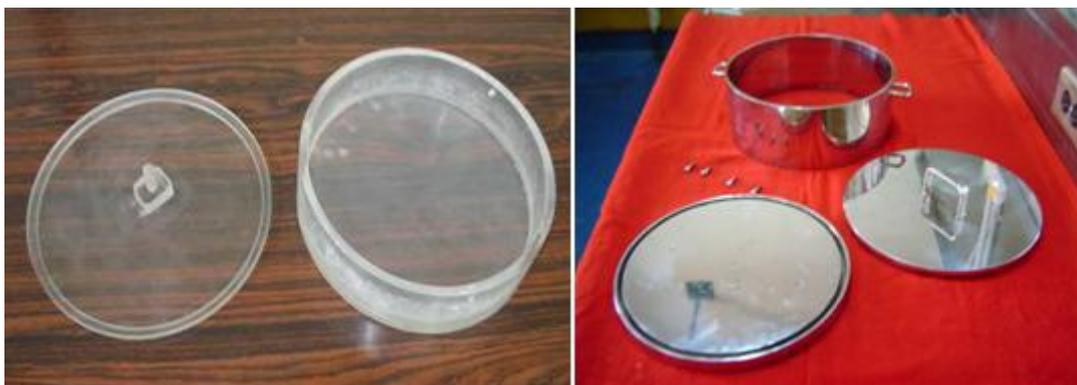
FIG. 13. Collectors used in: (left) CDTN, Brazil. Material: Acrylic, Dimensions: diameter: 18.9 cm, height: 3.8 cm, Area: 280.6 cm². (right) IPEN, Peru. Material: Aluminium, Dimensions: Diameter: 20 cm; Area: 314 cm².

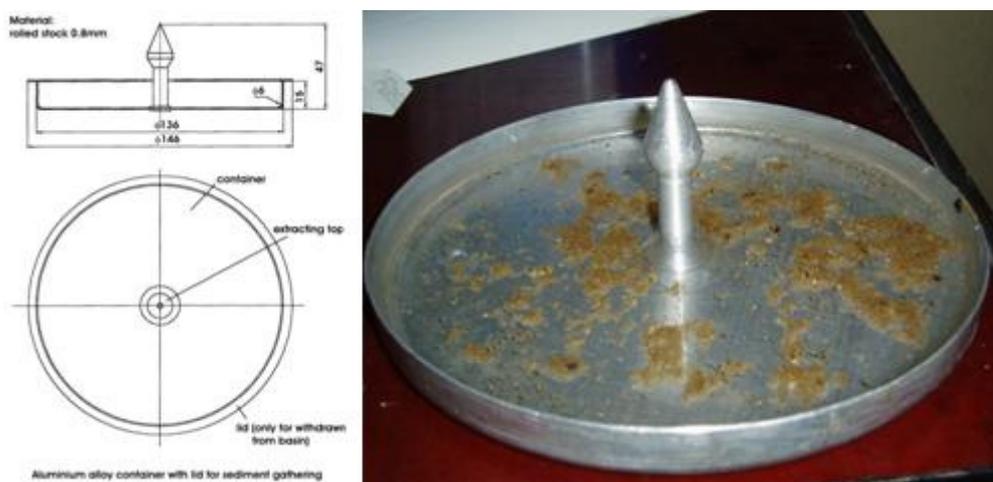
FIG. 14. Collector used in Romania. Made of Aluminium, with diameter equal to 20 cm (314 cm²).

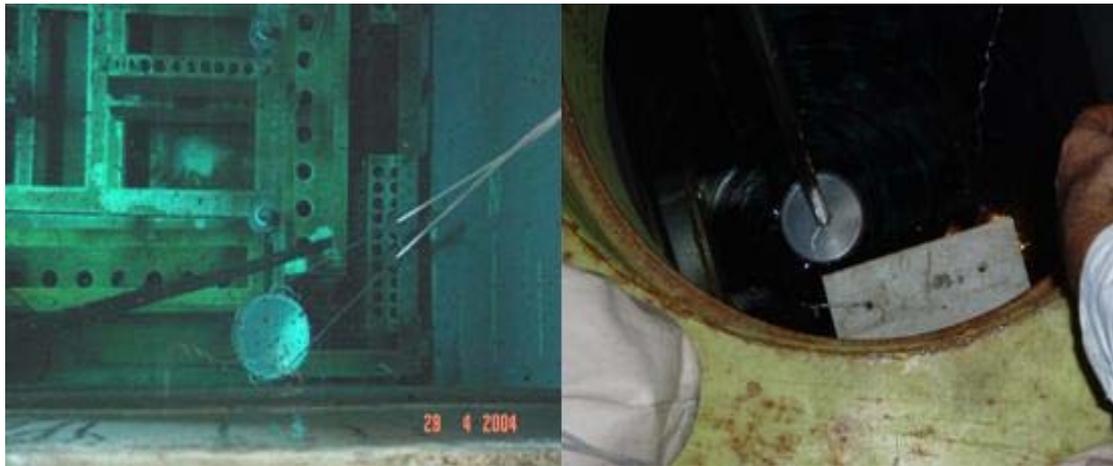
FIG. 15. Photographs showing the position of the collectors in: the reactor pool in Thailand (left) and the spent fuel basin in Romania (right).

Collectors were installed and removed after a specific duration (varied from 4-6 months) at the different sites. Figure 15 shows collectors in position at two different sites. The collectors were positioned close to the immersed corrosion racks. Prior to removal, the lids of the collectors were put in place. After removal from the reactor pool or the SFB, the water in the collector was stirred and then allowed to pass through a filter. The sediments were collected on a filter paper, dried in an oven at 100°C for 24 hours, weighed, mixed and representative specimens examined in a scanning electron microscope (SEM). The appearances of solids retained on filters or in the collector are shown in Fig. 16. An extreme case of sediment or sludge accumulation at a spent fuel basin is shown in Fig. 17. The techniques used for analysis varied, depending on access to or availability at a specific site. The techniques used were: (a) energy dispersive spectroscopy (EDS), (b) X ray diffraction (XRD), (c) X ray fluorescence (XRF), (d) mass spectrometry.

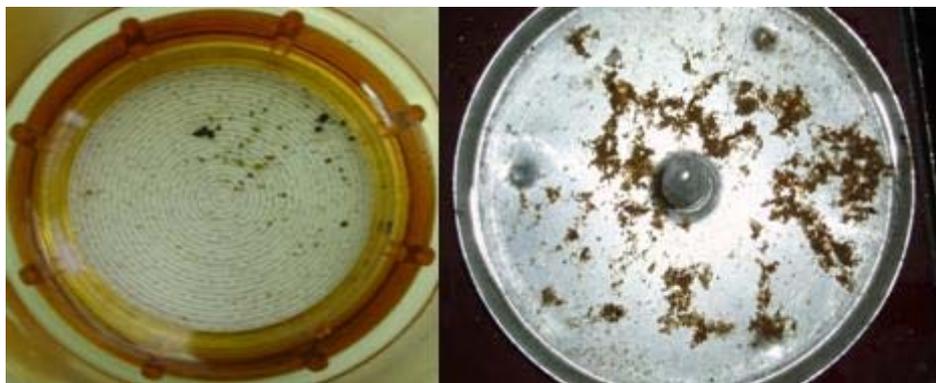
FIG. 16. Settled solids on a millipore filter (left) and the collector (right).

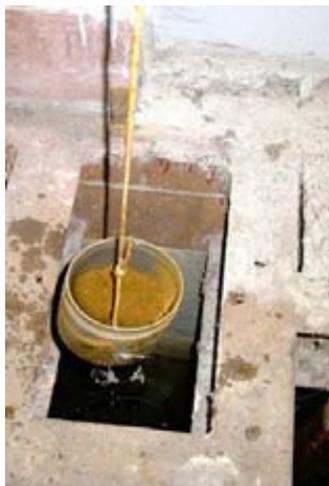
FIG. 17. A bucket of sludge being removed from the bottom of a spent fuel storage basin.

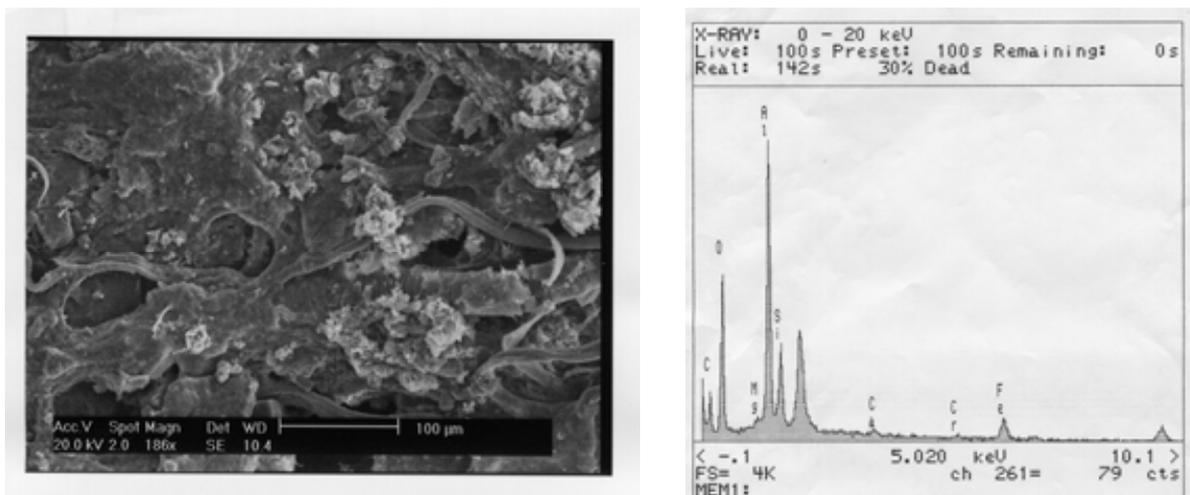
FIG. 18. Scanning electron micrograph(left) and X ray diffractogram (right) of solids collected from the spent fuel storage section of the IEA-R1 reactor in IPEN, Brazil.

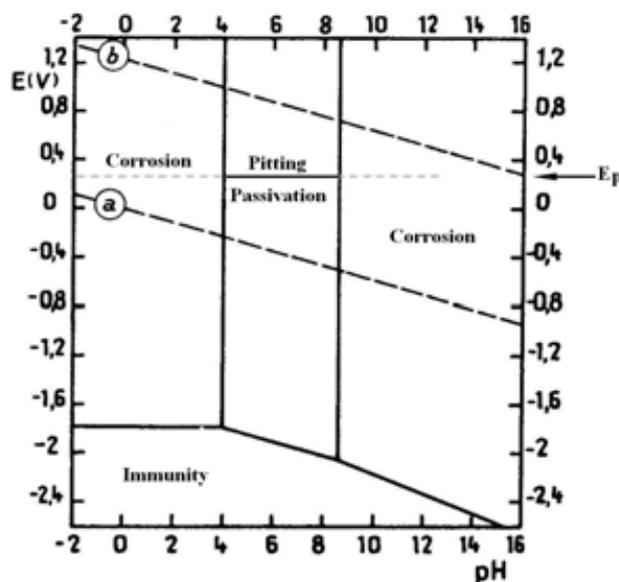
FIG. 19. Stability range of aluminium oxide.

Aluminium and its alloys present a good corrosion resistance in pure water due to the formation of a very protective oxide layer. This film is stable only in a certain pH interval, roughly from 4 to 8¹ (see Fig. 19). Any time the water pH is outside this range, metal dissolution will be produced, provided the electrode potential takes values above the equilibrium. In the presence of certain aggressive anions, mainly chloride, the passive layer will become unstable whenever the potential surpasses the pitting potential (E_p), and localised attack will occur. The lower E_p the more susceptible the aluminium is to pitting corrosion.

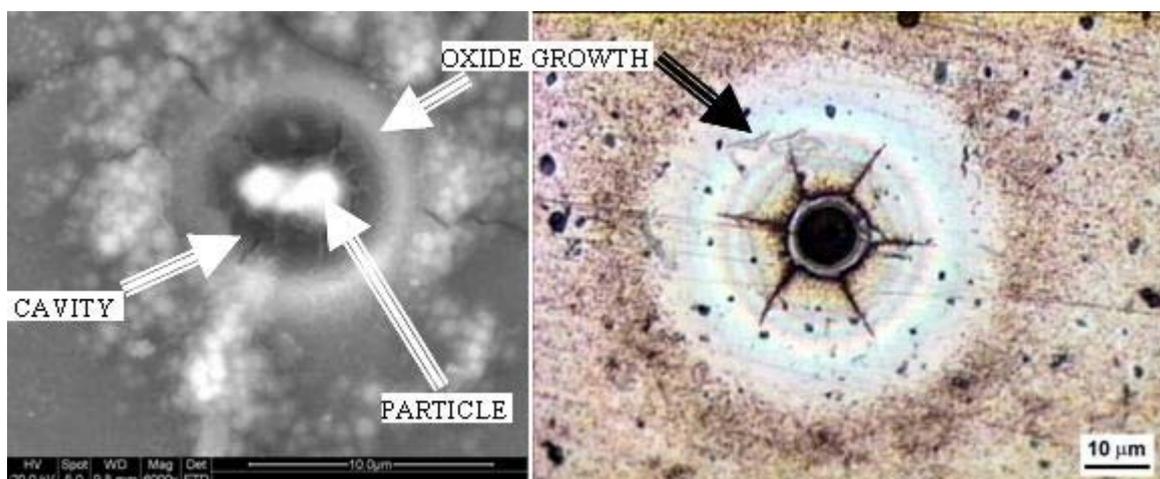
FIG. 21. Microscopic cathodic reaction effect. Left: SEM image. Right: optical microscope image.

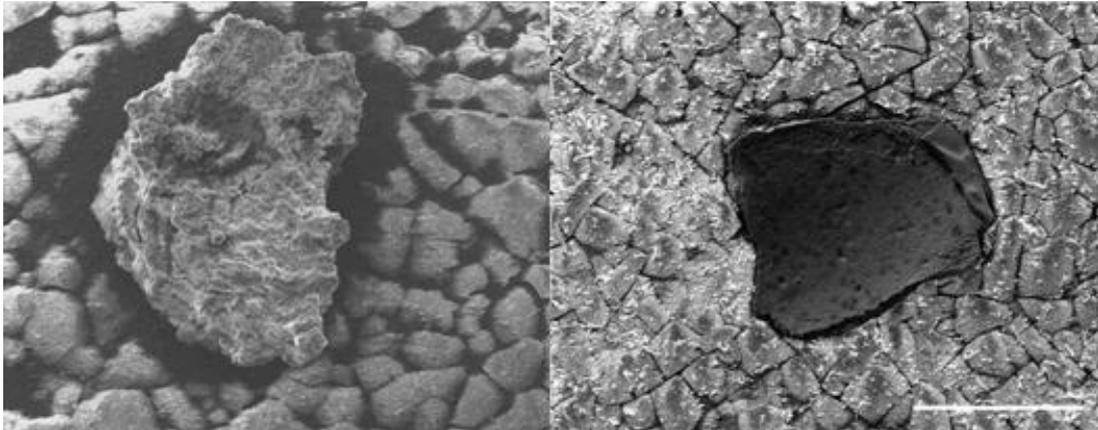
FIG. 22. Different behaviours of iron oxide particles. Left: hematite. Right: magnetite.

There are indications that this mechanism could be feasible at a macroscopic level too [12]. Some attack can be generated around magnetite particles deposited on AA 6061 samples after 40 days under pure water, but not if the particles are made of magnetite, as seen in Fig. 22.

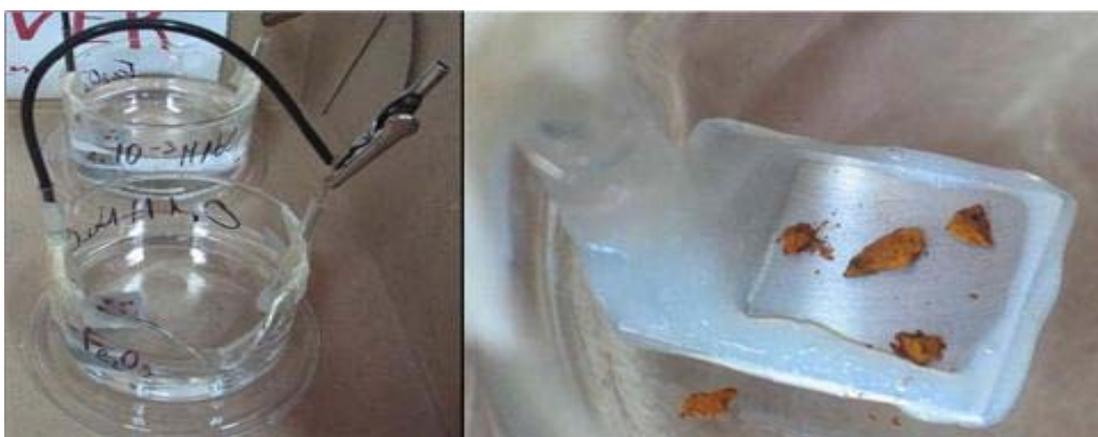
FIG. 23. Assembled galvanic couple in a cell (left). Sample detail, showing deposited oxide bits (right).

The sediment induced pitting produced in the laboratory resembles the effects observed in the basins to some extent, but not the penetrating corrosion observed on spent fuel stored for many years. In order to establish the influence of sediments in short term experiments, immersion tests were performed in waters simulating that of some of the surveyed basins. In some cases, the electrode potential was increased to help accelerating the process [14]. This was accomplished connecting aluminium 6061 samples to stainless steel wire cathodes, as depicted in Fig. 23. The anode-cathode area ratio was calculated so that the mixed potential is below but near 50 mV, the measured pitting potential of the aluminium alloy in the tested environment. The effect of hematite, magnetite and glass particles deposited on the aluminium surface was studied in Sodium Chloride solutions of various concentrations.

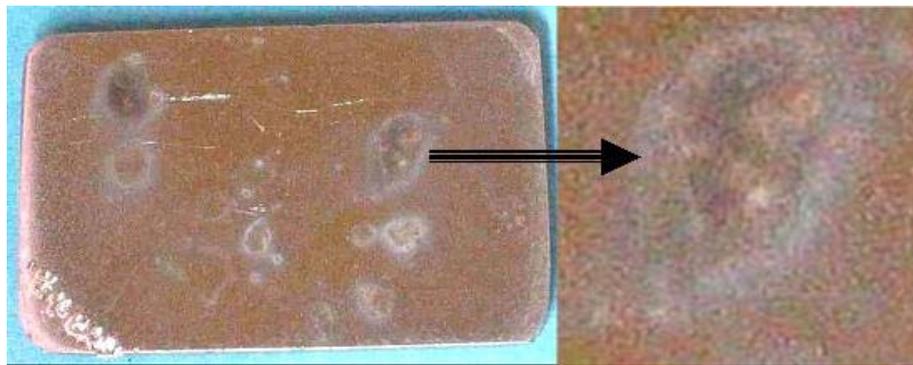
FIG. 24. Aspect of uncoupled sample immersed in NaCl 0.1N after 60 days. Stains were left by the sediments (left). No pitting is observed in the detailed view (right).

No pitting was found in isolated samples after the full immersion 60 days period, in a solution containing 40 ppm of chloride, as seen in Fig. 24. Only stains remain in the zones that were covered by the oxide particles, but no signs of attack. On the contrary, in only 7 days pitting was produced in samples coupled with stainless steel cathodes. Figure 25 shows the different aspects encountered in the various environments used. There is an obvious effect of chloride concentration. The more concentrated is the solution stronger is the corrosion attack on the samples. Both pitting and crevice corrosion are visible in waters with higher chloride contents, but the second form was exclusively produced under the resin, in the border of the working area.

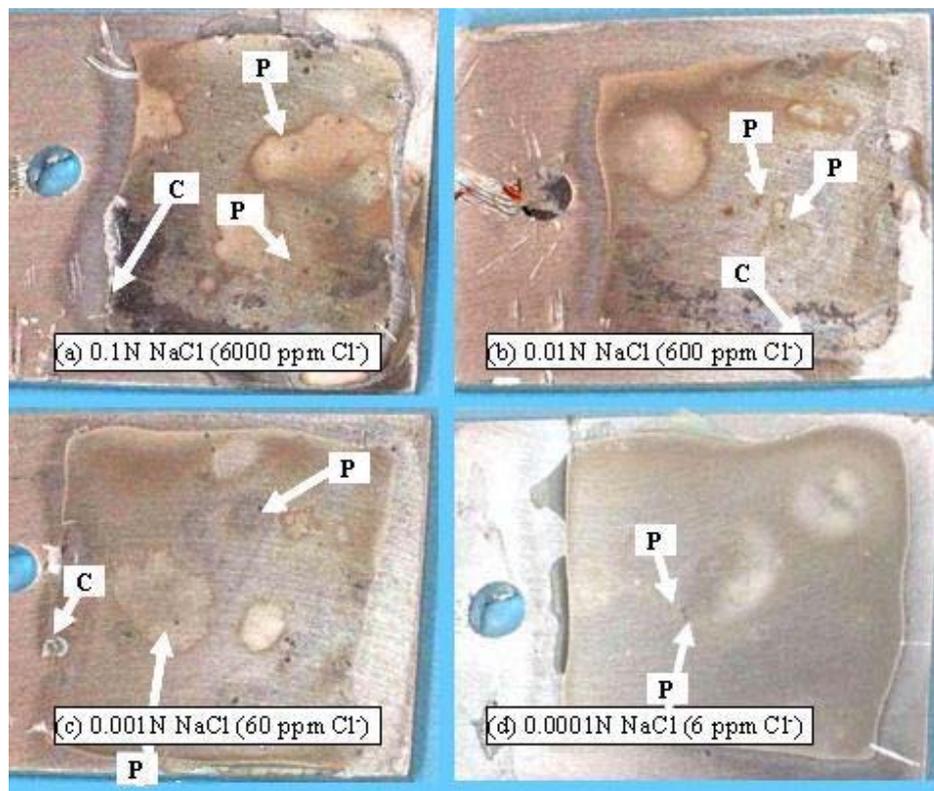
FIG. 25. Surface appearance of aluminium samples with hematite sediments after 7 days of exposure to NaCl solutions of different concentrations. Pitting is indicated with "P" and crevice corrosion with a "C". The stains produced by the sediments are still visible.

In the solutions with higher chloride concentration, pits are formed both under the deposits and on the free surface. However, in the 0.001N solution very few of them grew outside the sediments and in the 0.0001N one, all the encountered sites are located beneath the particles. Figure 26 shows one of these regions in detail. No attack is observed outside the zone covered by the sediment, but the entire portion that was coated presents signs of corrosion. The point where the pitting seems to be visible with the naked eye appears to be a composition of many tiny pits gathered in a cluster.

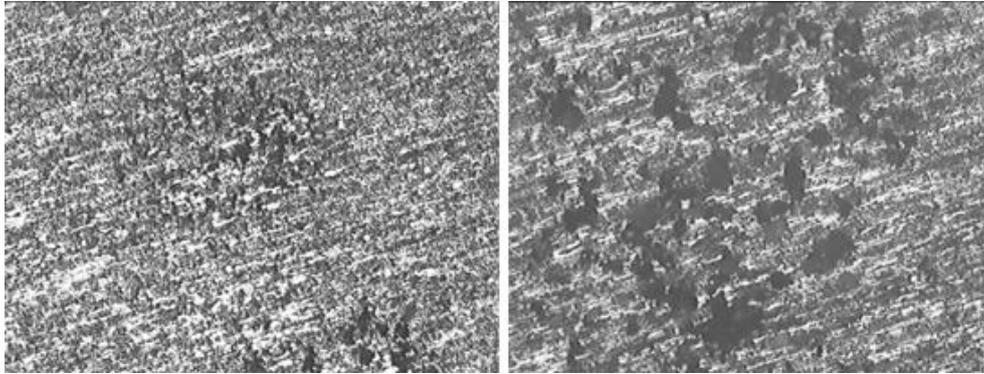
FIG. 26. Detail of surface under a deposit for a sample tested in 0.0001 N NaCl (FIG. 25). Left, region under deposit (200 μm). Right, detail of pitting attack (points marked with "P") (100 μm).

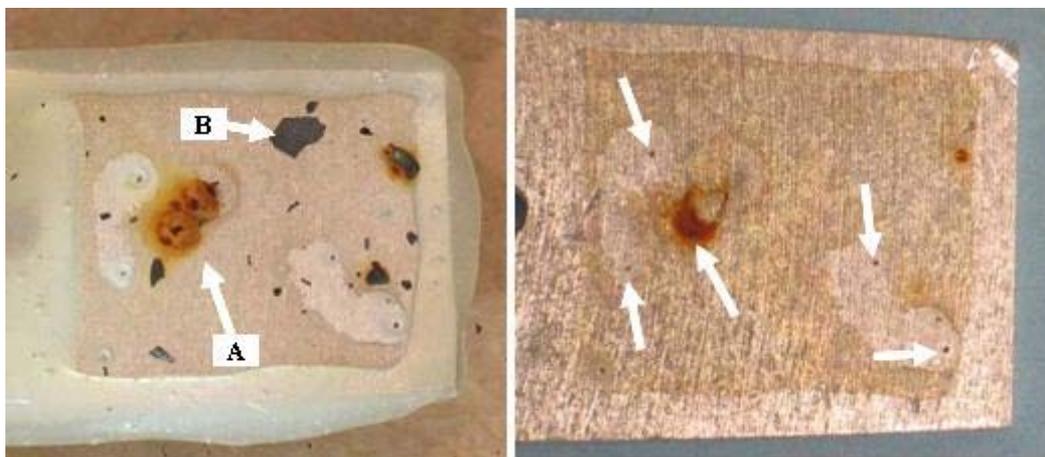
FIG 27. Sample tested with magnetite deposits, before (left) and after (right) cleaning. "A": transformed particle, "B": non-transformed particle. Arrows indicate pitting attack.

Figure 27 shows a sample tested with magnetite deposits during 7 days in a 0.001N NaCl (60 ppm chloride) solution, before and after removing the particles. Pitting corrosion is observed beneath and around sediments, but only associated with those fragments that transformed from magnetite to hematite, as indicated by the colour change. The easiness of non transformed particles removal, which did not leave any sign on the metal surface, indicates poor surface adherence, which in term may imply poor electric contact with the aluminium alloy.

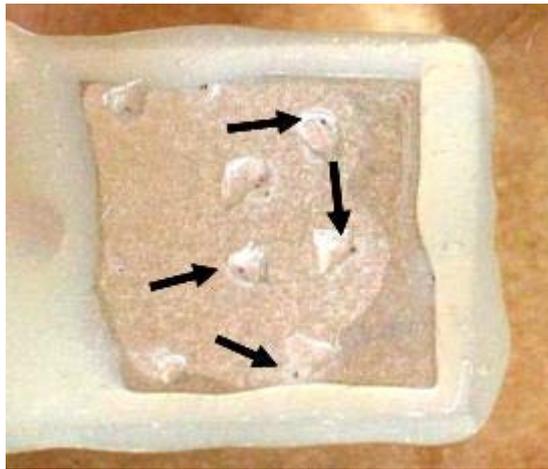
FIG. 28. Sample with glass particles. The pits can be seen through.

The main objective of utilising this material is to study the effect of particles that may be inert from the electrochemical point of view. In Fig. 28 a sample immersed 7 days in a 0.001N NaCl solution can be seen, before the termination of the test, with the glass bits on. Pitting can be appreciated through the transparent sediments, as indicated by the arrows.

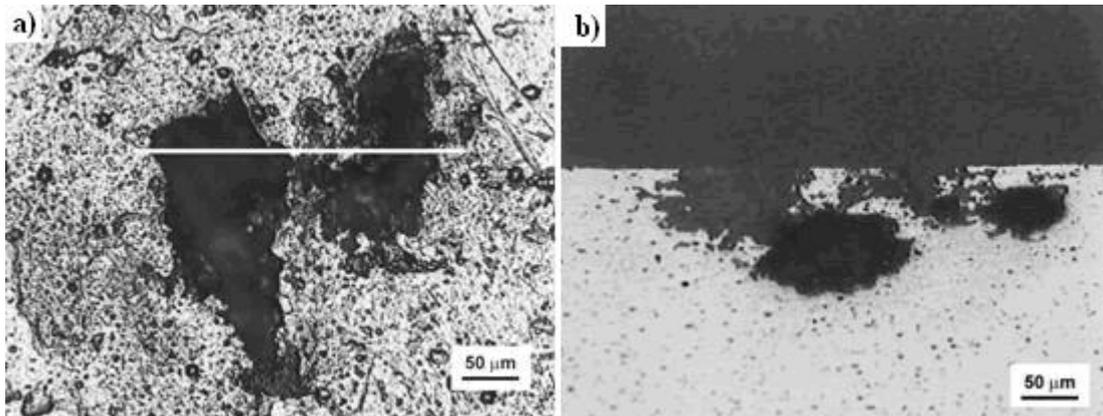
FIG. 29. (a): Pit formed under glass in a 0.001N NaCl. (b): Cross-cut of the same pit, along the marked white line.

A magnified view of one of these sites can be appreciated in Fig. 29a. Two contiguous pits can be seen. The metallographic cross section is depicted in Fig. 29b, where the depth of the attack can be established: 66 and 104 μm for each pit.

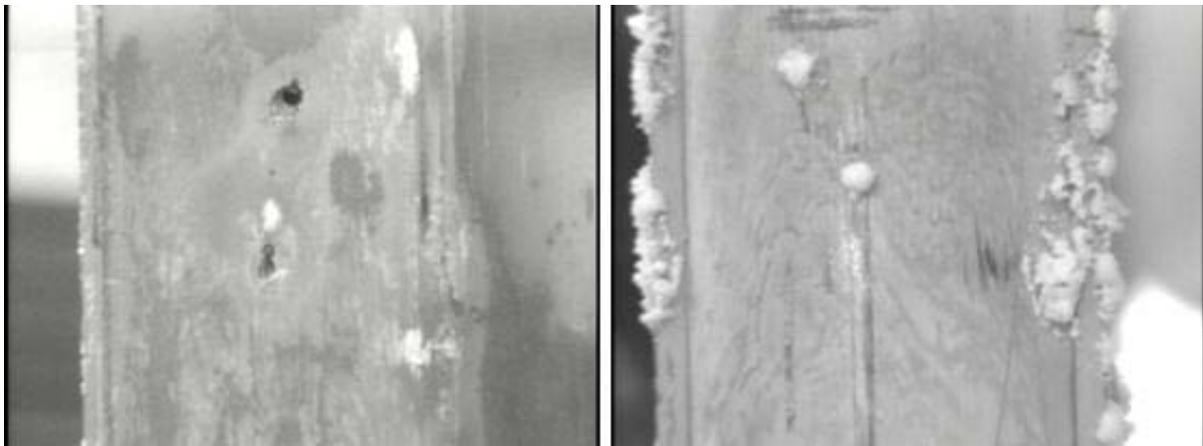
FIG. 30. Massive pitting (left) and crevice corrosion (right).

The first indication of fuel deterioration in CSF came to light in the early eighties, when a set of spent fuel elements was selected for use in the new RA6 reactor. In that occasion, a visual fuel inspection revealed that the elements were covered with a brown layer, mainly consistent of iron oxide coming from the corrosion of the carbon steel channel shielding caps [2]. Then, during the development of the IAEA CRP on Corrosion of Aluminium Clad Spent Fuel in Water (Phase I), it was demonstrated that 50-100 μm deep corrosion pits could be produced on aluminium coupons in periods as short as 60 days [2]. Finally, during the full inspection performed for the take back programme operations, the real corrosion state of the stored fuel was established [10]. Massive corrosion was found to have taken place in several fuel elements, which included in many cases fuel plate perforation, nuclear material loss of containment and fission products release. A few examples can be seen in Fig. 30.

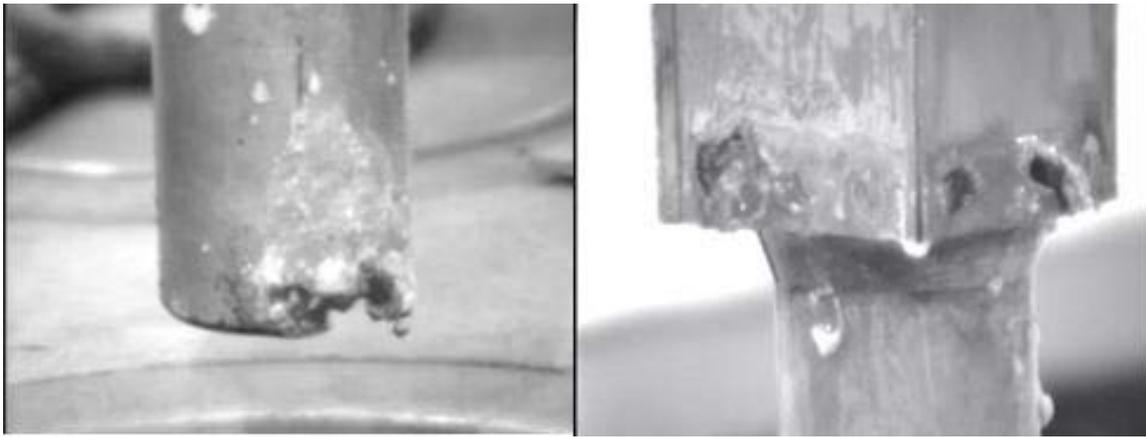
FIG. 31. Galvanic Corrosion in spent fuel. Left: contact with steel channel. Right: contact with steel screws.

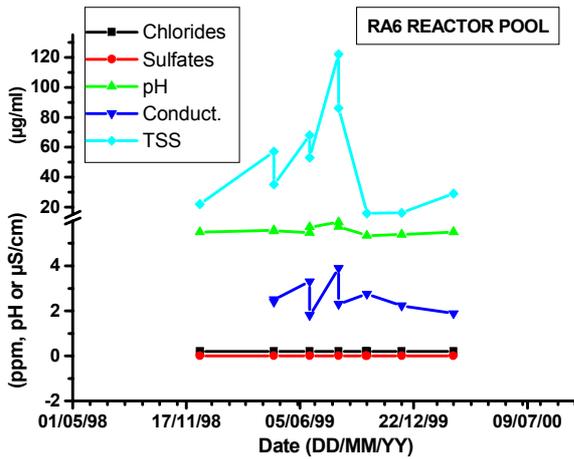
FIG. 32. Evolution of chemical variables in RA6 RP.

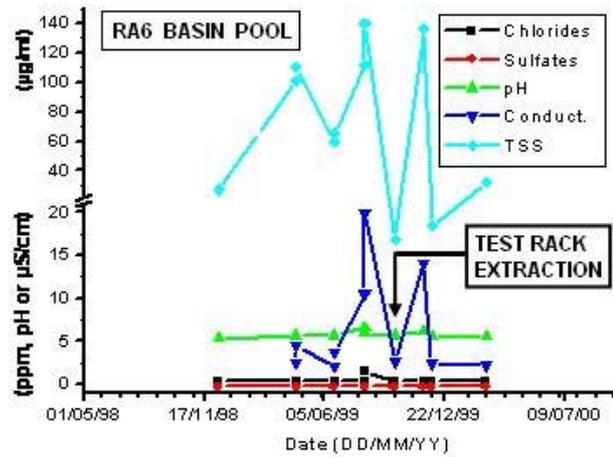
FIG. 33. Evolution of chemical variables in RA6 DP.

In Fig. 33, the withdrawal time of a corrosion test rack is marked. It was right after the peak in the water parameters excursion. Some special corrosion marks were encountered on the top coupon of the rack, on the surface pointing upwards. It consisted on a stained region of about 1 cm by 2 cm, in which the oxide had been removed. Tens of tiny pits were visible by eye. Some of them showed to be somewhat penetrating when viewed with a magnifier, as illustrated in Fig. 34.

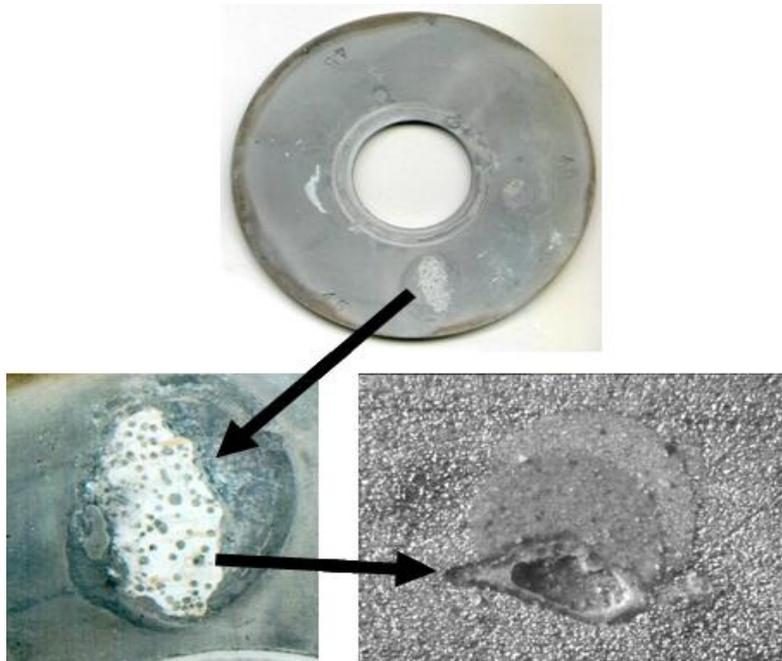
FIG. 34. Pitting observed on an AA 6061 coupon immersed in RA6 BP.

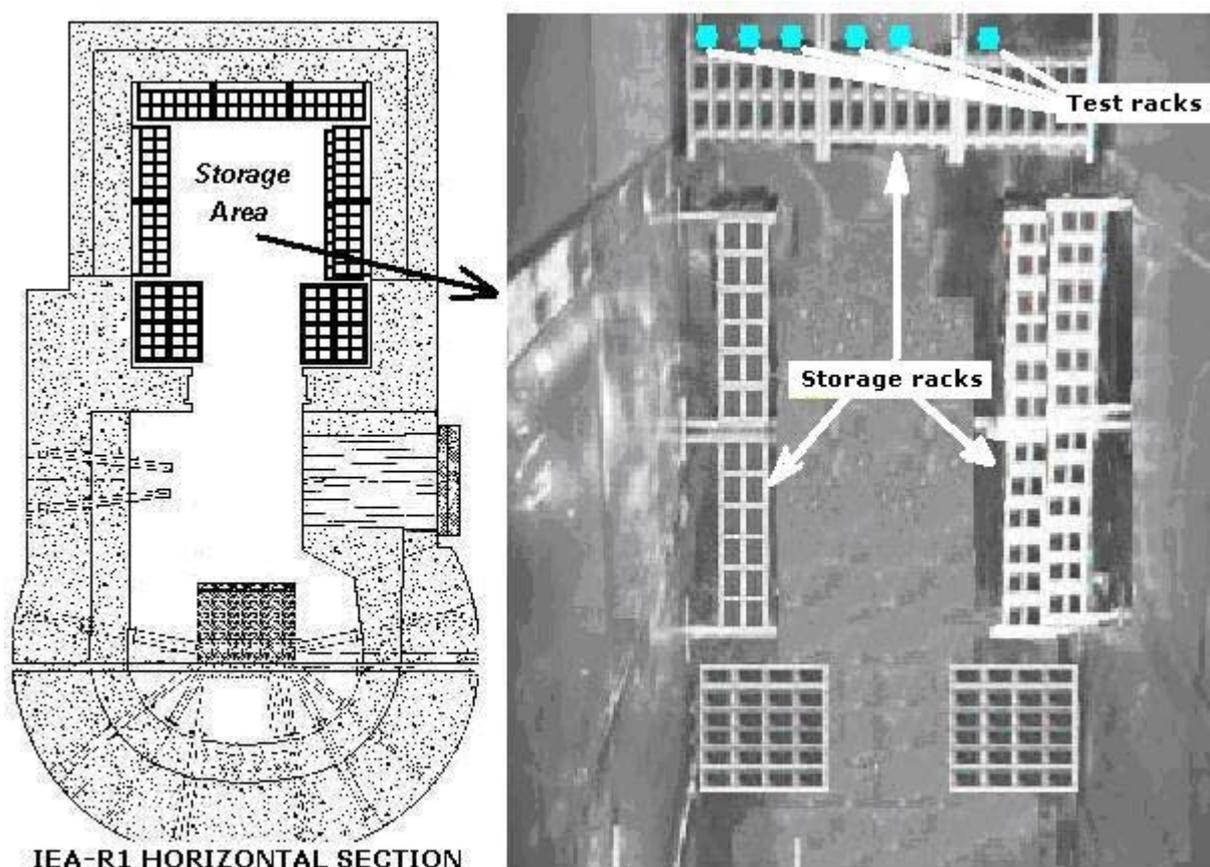
FIG. 35. Position of test racks in IEA-R1 reactor spent fuel storage section.

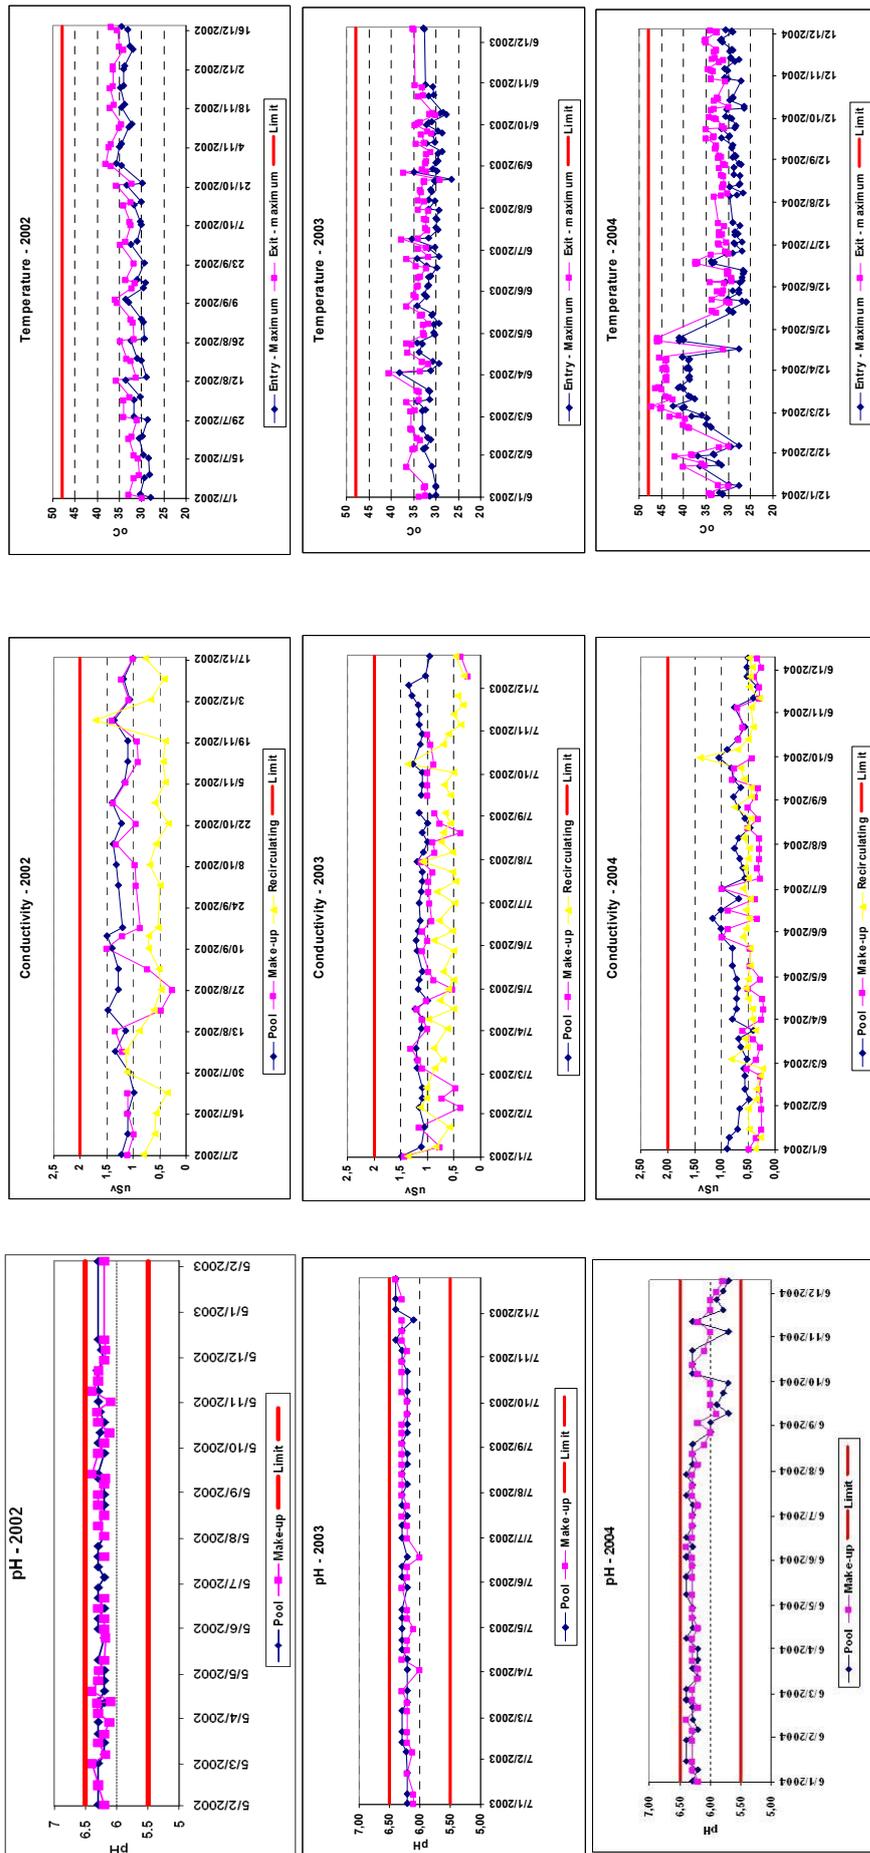
FIG. 36. pH, conductivity and temperature of the IEA-R1 reactor storage basin water in the period 2002-2004.

The temperature, conductivity and pH of the reactor pool were monitored at regular intervals. Fig. 36 shows graphically the variations in these parameters during the period 2002-2004.

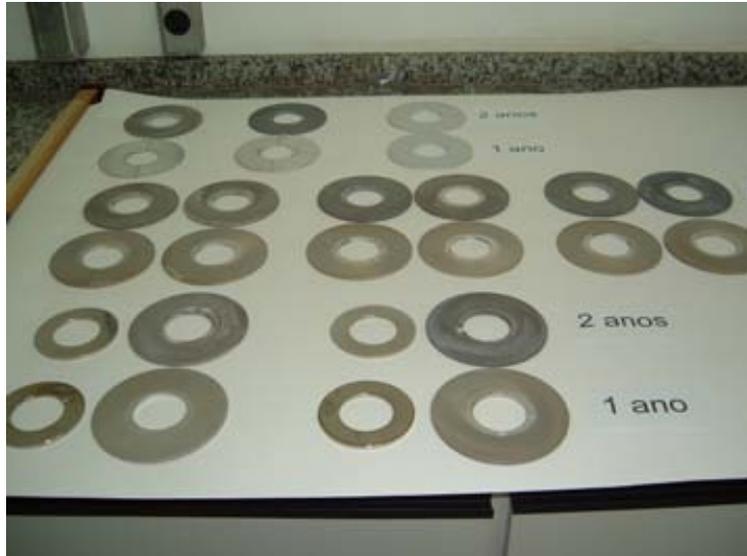
FIG. 37. Photograph of coupons exposed for 12 (1 year) and 22 months (2 years) to IEA-R1 SFSS.

The coupons of rack R2 were placed next to corresponding coupons from rack R1 withdrawn after 12 months of exposure for comparison and as shown in Fig. 37. It was evident that the surfaces of coupons of R2 were darker and stained. The extent of staining was similar to that observed on the other Al surfaces in the reactor.

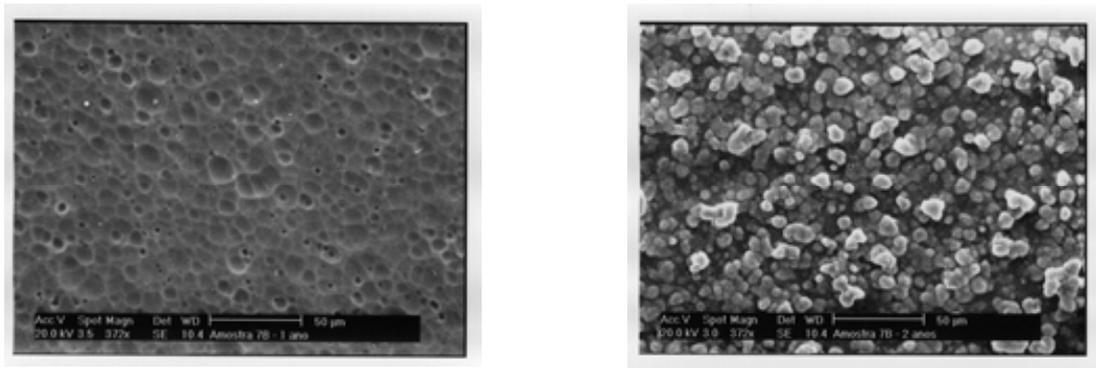
FIG. 38. Scanning electron micrographs of AA 1050 coupon exposed for 12 months (left) and 22 months (right) to IEA-R1 SFSS.

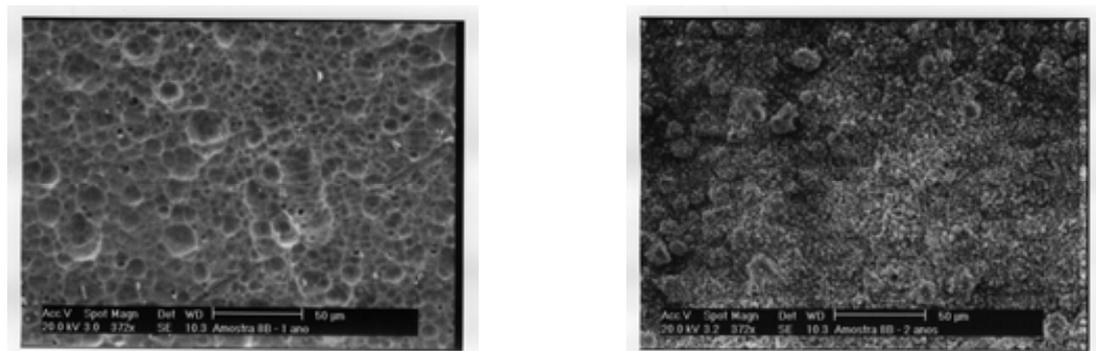
FIG. 39. Scanning electron micrographs of AA 6061 coupons exposed for 12 months (left) and 22 months (right) to IEA-R1 SFSS.

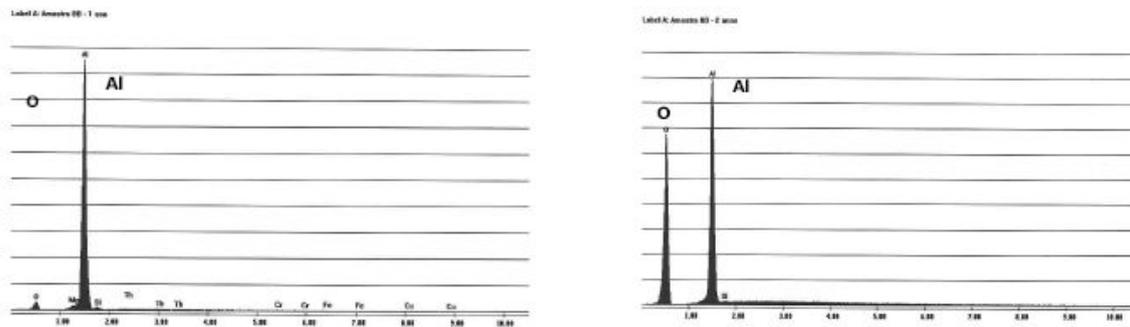
FIG. 40. EDS results of the surfaces of AA 6061 coupons exposed for 12 (left) and 22 months (right).

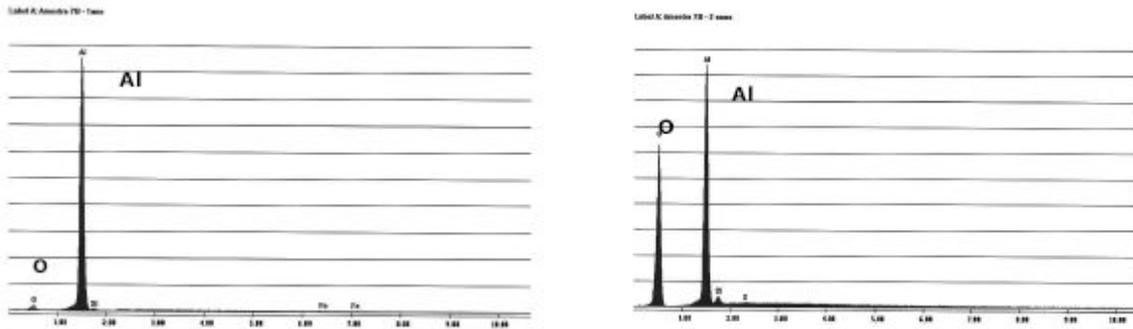
FIG. 41. EDS results of the surfaces of AA 1050 coupons exposed for 12 (left) and 22 months (right).

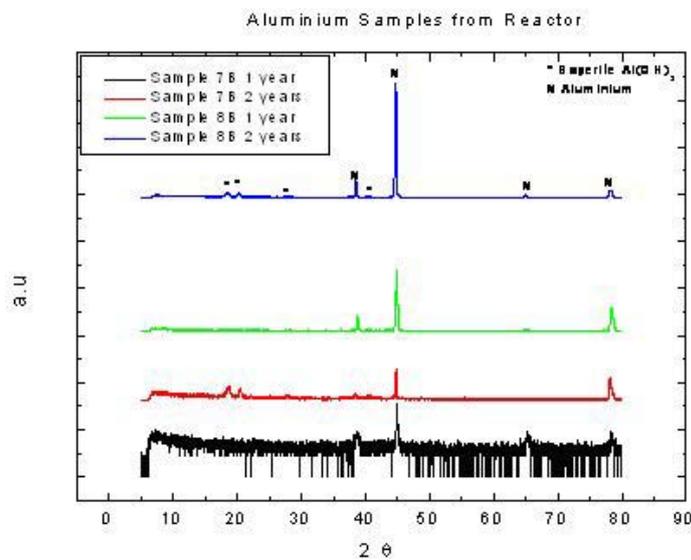
FIG. 42. X ray diffractograms of the surfaces of coupons exposed for one and two years to the reactor pool.
