IAEA-TECDOC-1637

***Corrosion of Research
Reactor Aluminium Clad
Spent Fuel in Water***

INTERNATIONAL ATOMIC ENERGY AGENCY
VIENNA, 2009

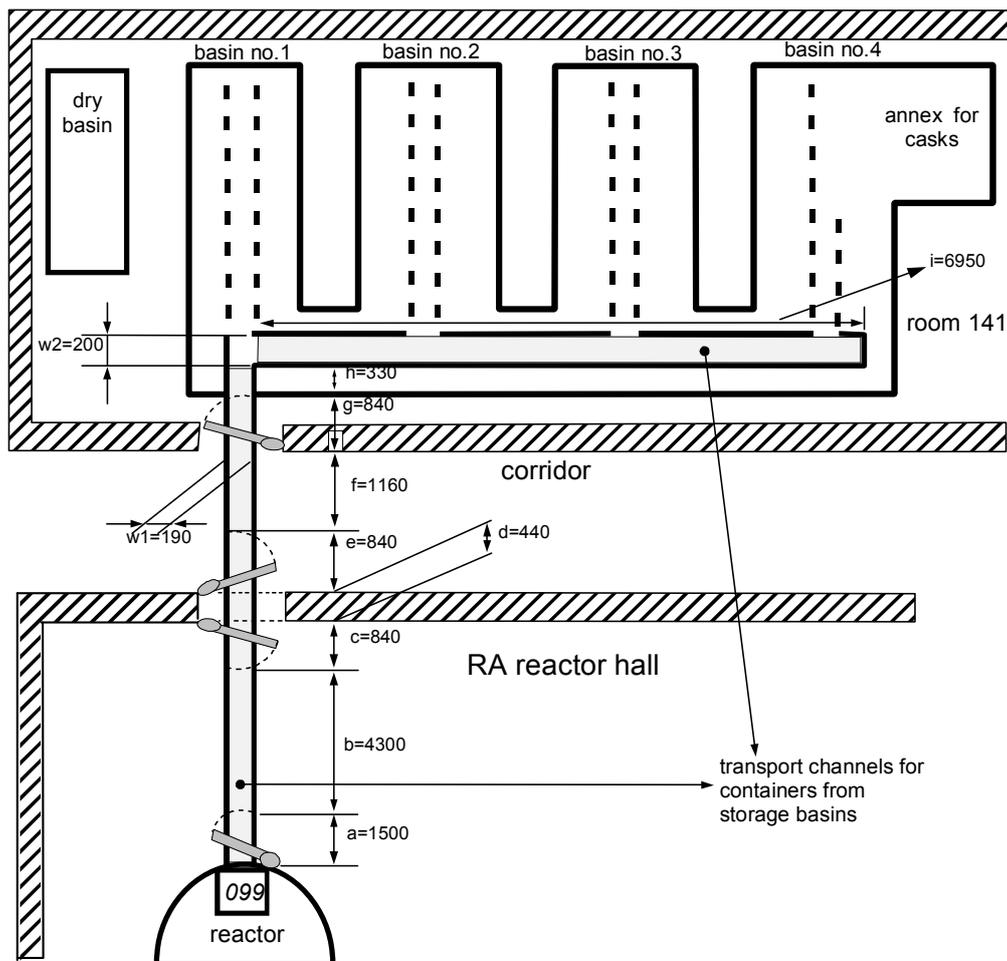
FIG. 43. Schematic diagram of the RA reactor spent fuel storage pool.

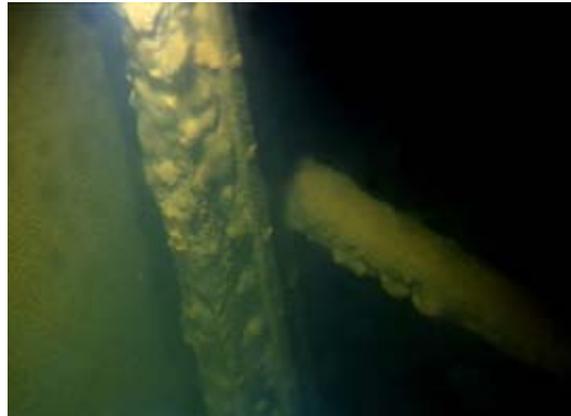
FIG. 44. Corroded steel structure inside of spent fuel storage pool.

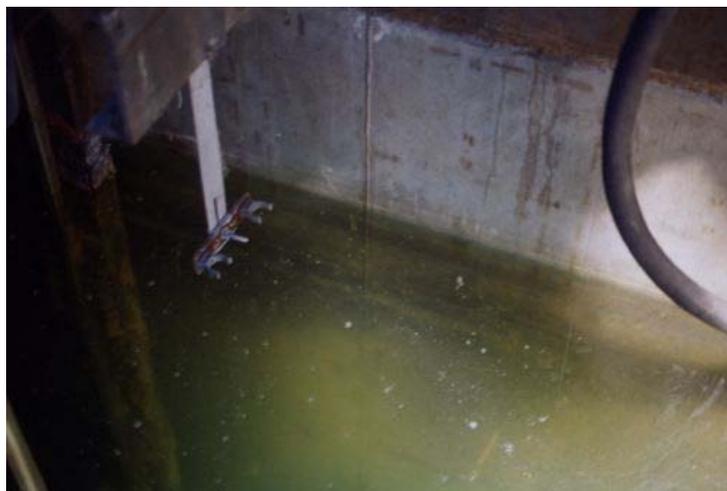
FIG. 45. Water surface of the spent fuel storage pool.

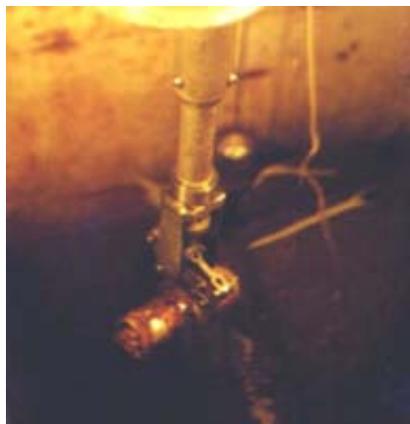
FIG. 46. Lost fuel slug being lifted from the bottom of the storage pool.

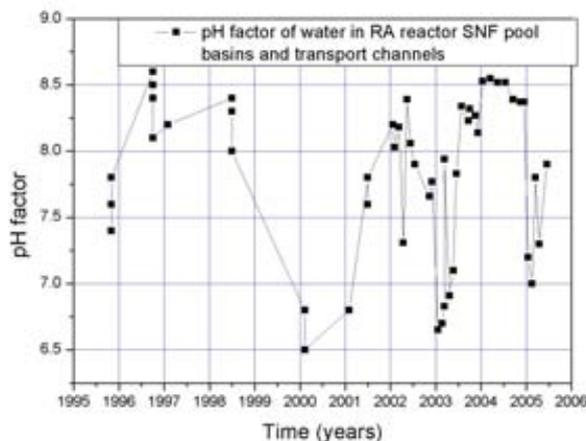
FIG. 47. Measured pH of water in SNF storage pool.

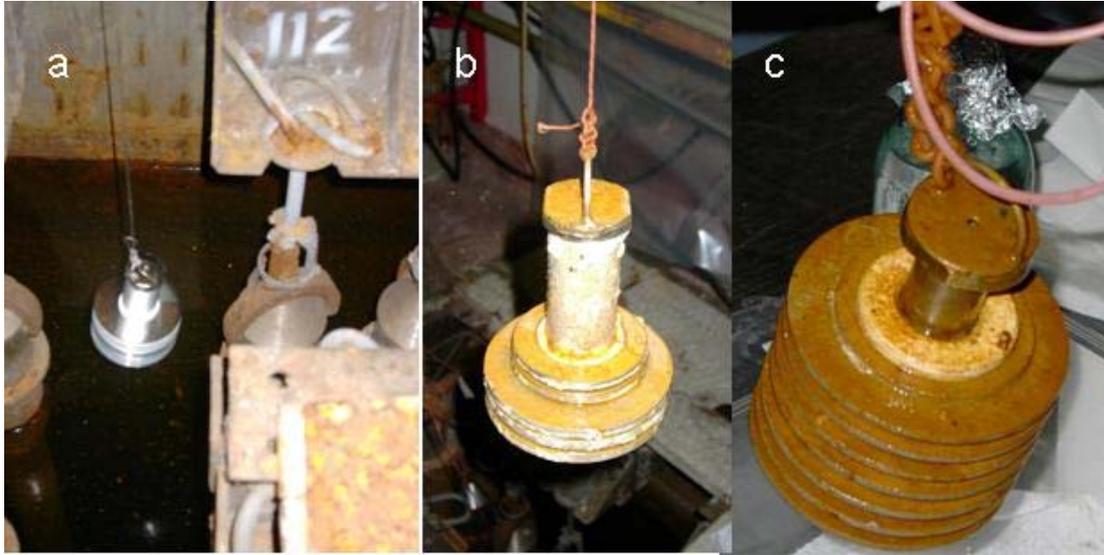
FIG. 48. CRP test rack being immersed in storage pool (a), removed after 24 month (b), and removed after 72 months (c).

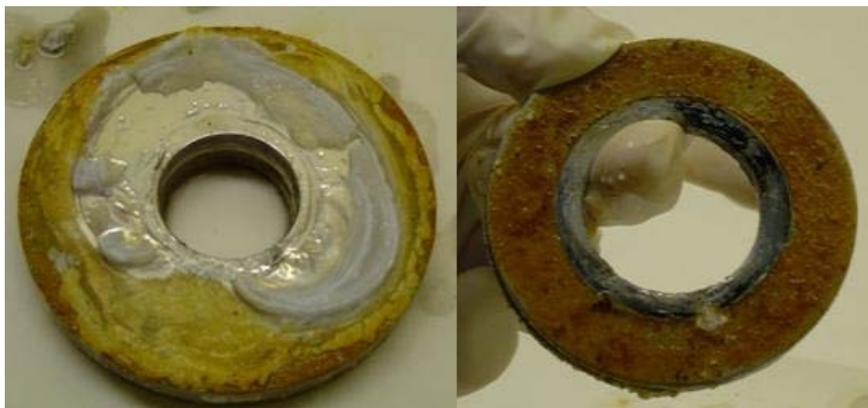
FIG. 49. Appearance of coupons after six years of exposure to the water on spent fuel basin showing White jelly-mushroom type sludge on front side of coupon AA 6061 of Rack#2.2 (left) and Dark-red sediments on front side of coupon SS 316 of Rack#2.2 (right).
