Demolition and Removal of Structures Damaged or Contaminated as a Result of the Fukushima Accident

January 2013

Tokyo Electric Power Company

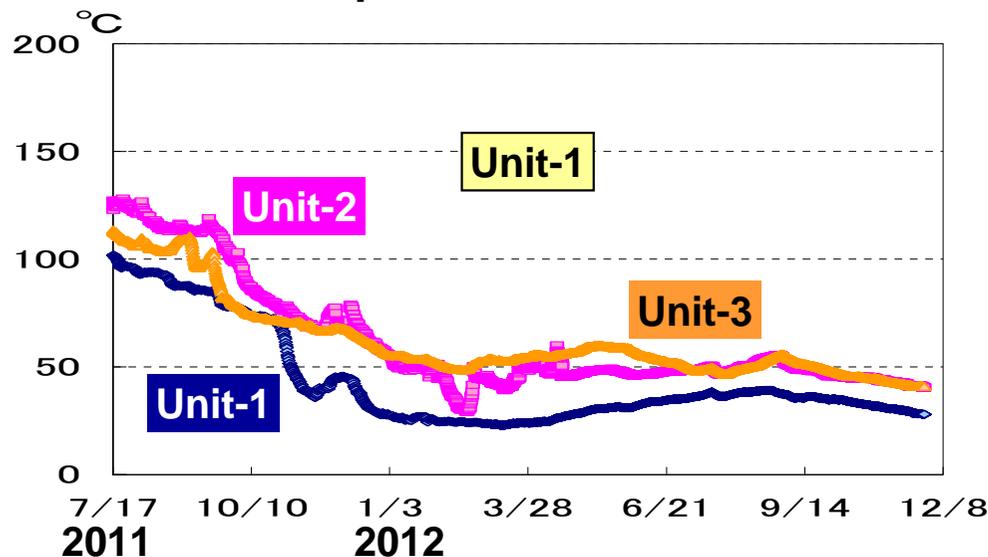
Temperatures of RPV bottom

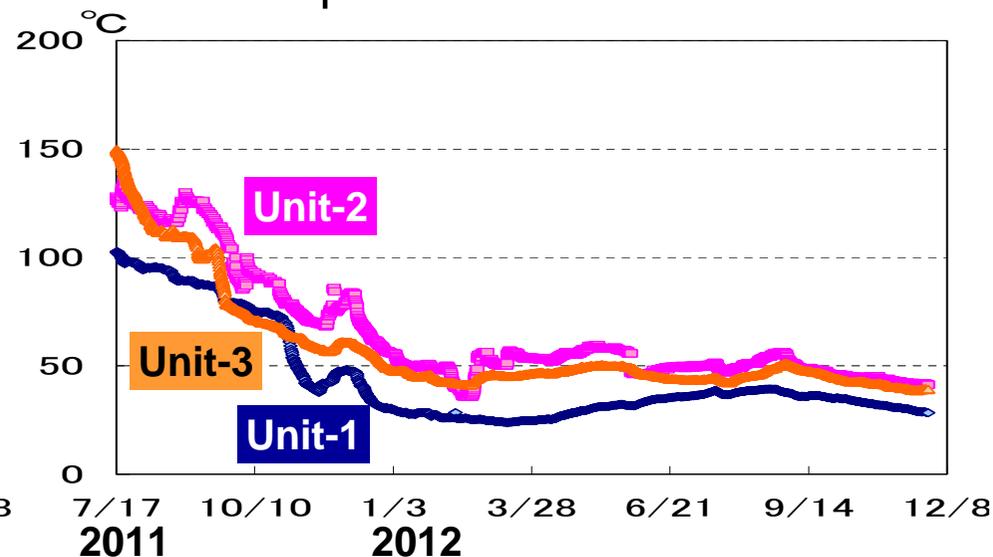
Temperatures inside PCV

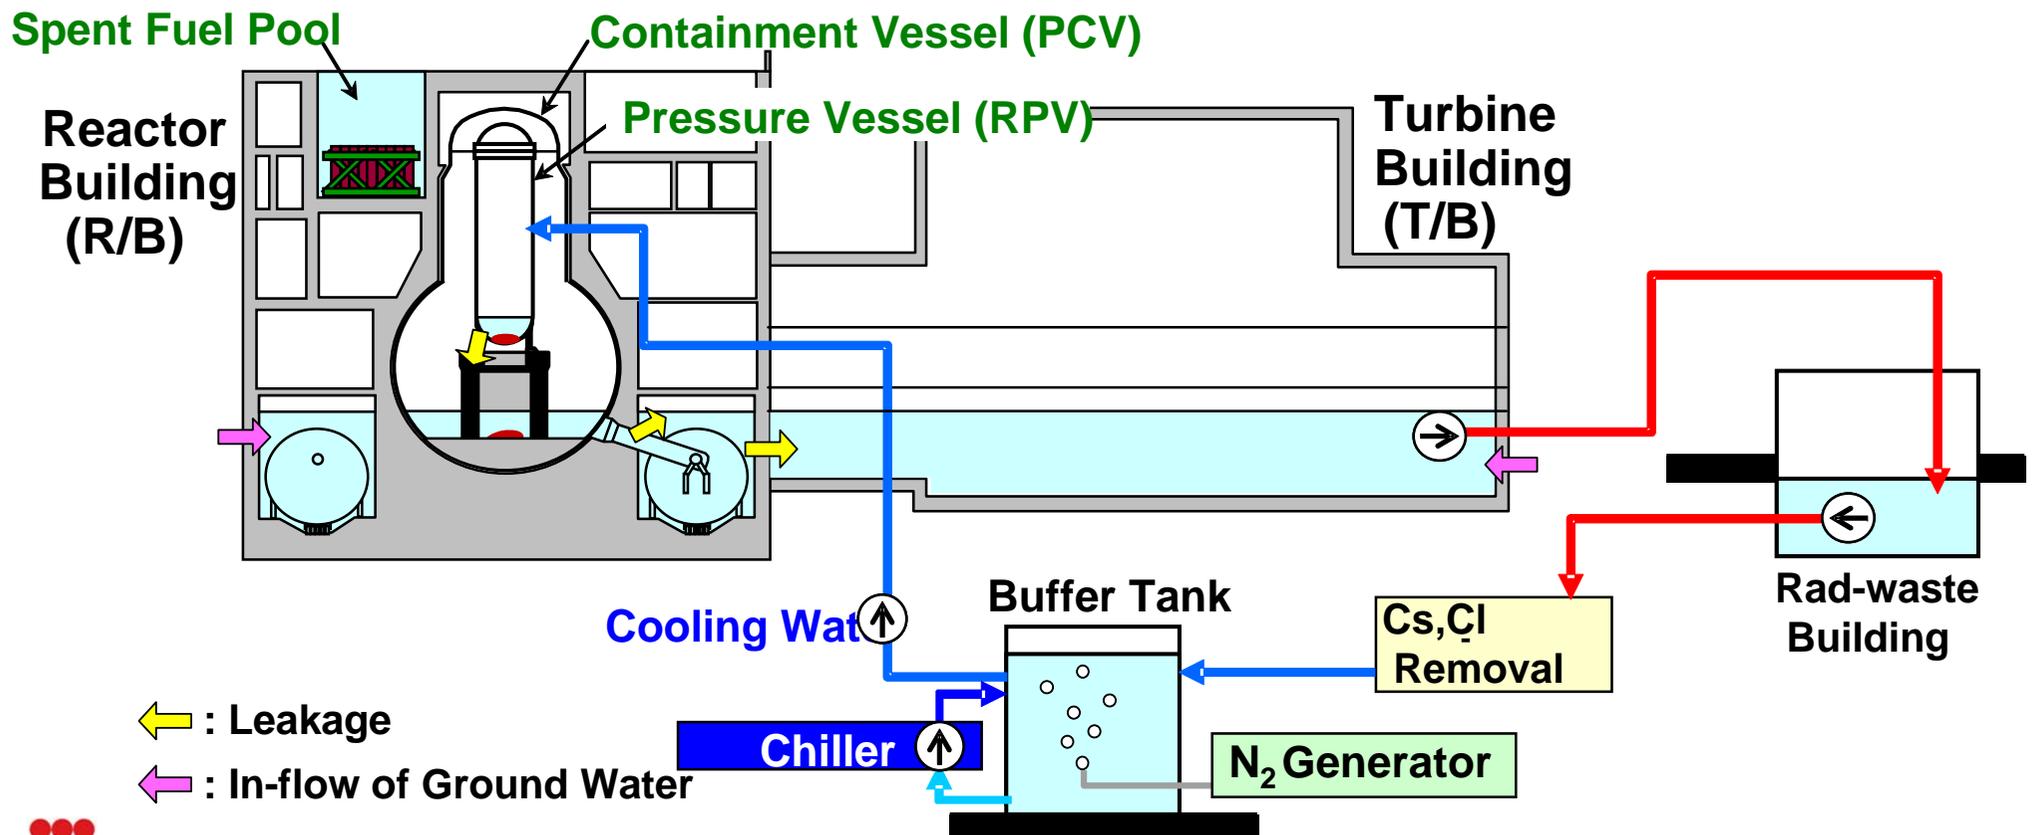
Circulating Water Cooling of 1F Units 1~3

- Cooling water is leaking from RPV, PCV and R/B to T/B
→ Accumulated water in T/B is re-used as a coolant after cleaned with Cs & Cl- removal system
- In-flow of ground water is increasing the amount of "contaminated water" to be processed by multiplex, diversity, independency systems.

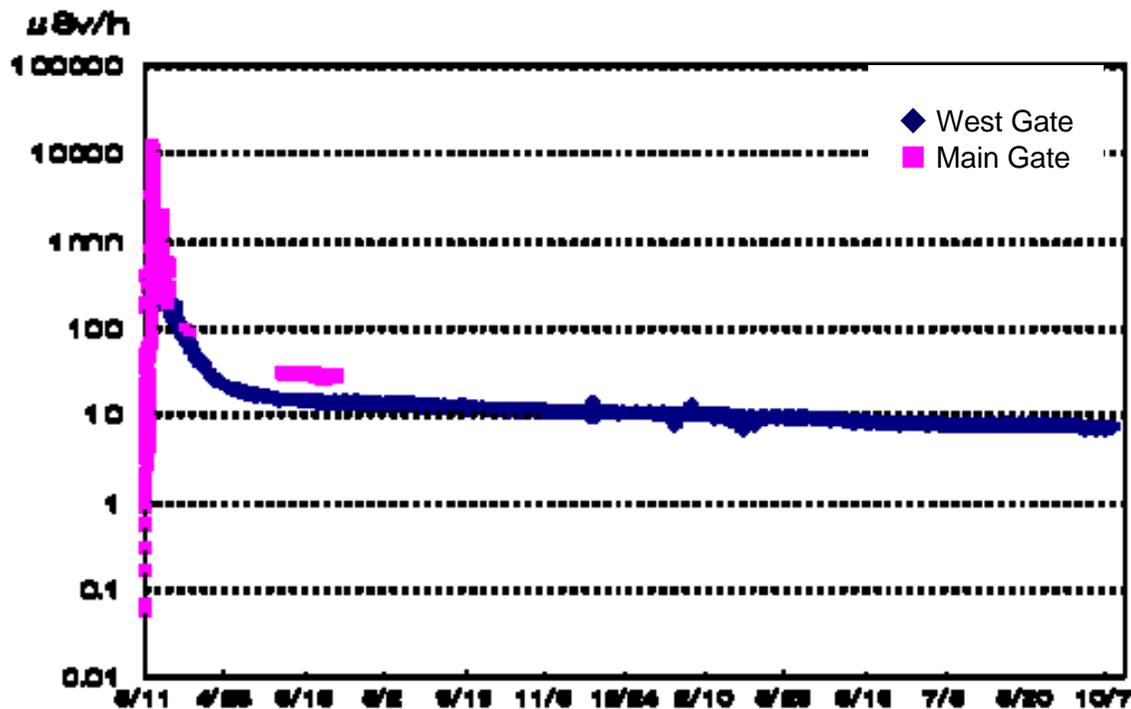
Dose Rate Trend at the Site Boundaries of Fukushima Daiichi

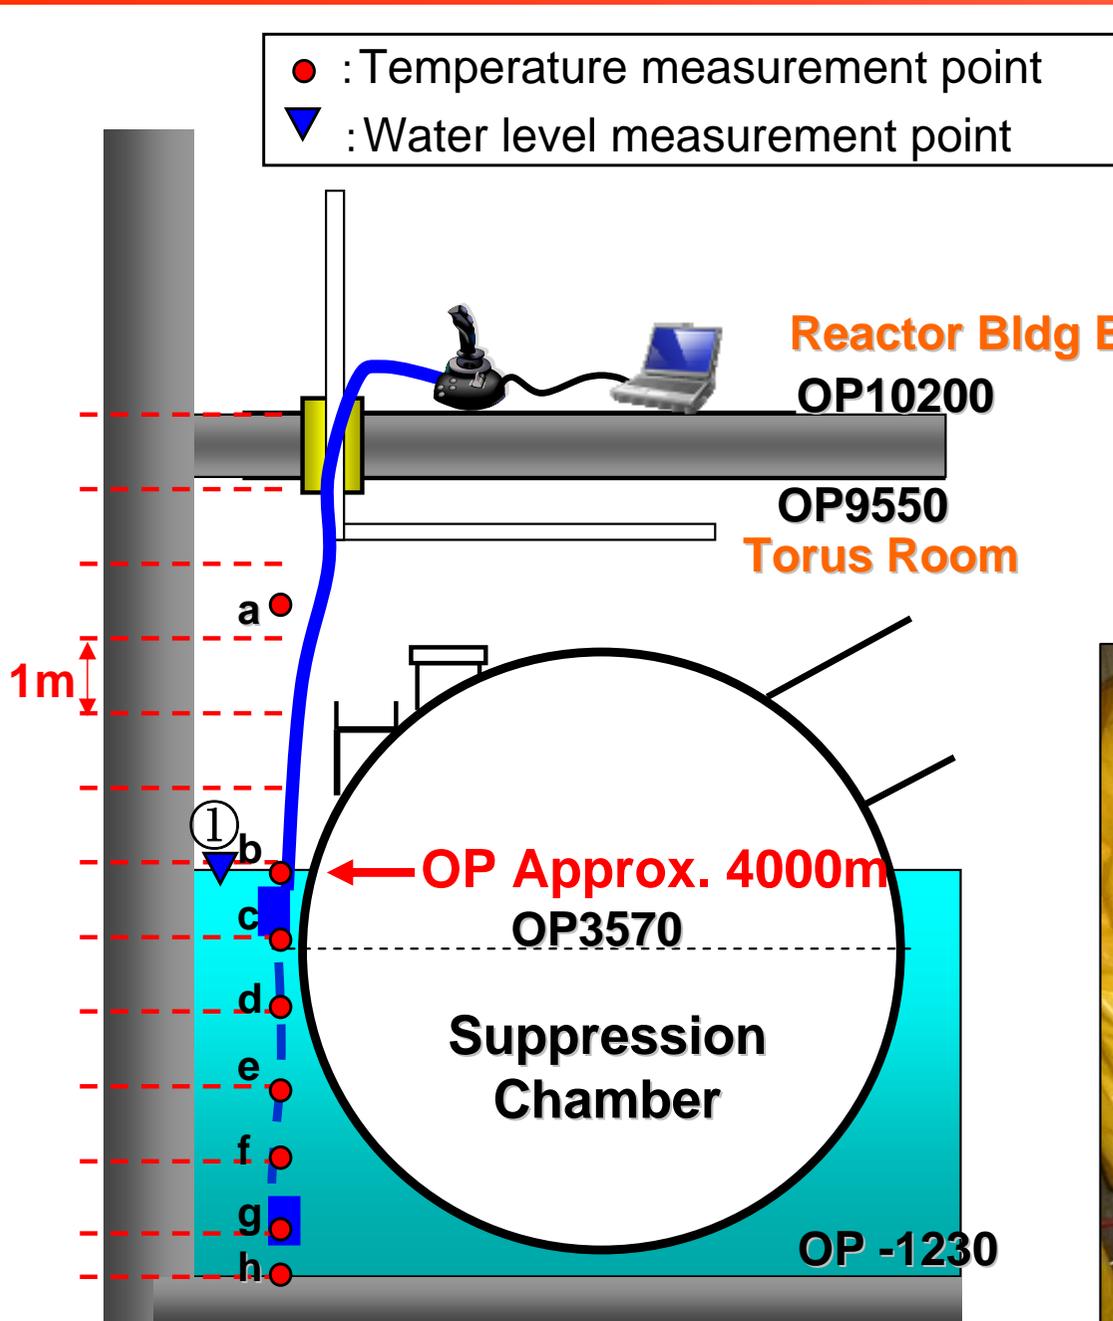
Unit 1 Torus Room Investigation (2012/6/26)

Water Level →

Temperature

a	OP.7700	28.8°C
b	OP.4000	37.2°C
c	OP.3200	34.0°C
d	OP.2200	34.0°C
e	OP.1200	34.8°C
f	OP. 200	34.1°C
g	OP. -800	32.4°C
h	OP.-1230	32.0°C

➤ Torus Room Investigation with CCD camera. (2012/6)

⇒ Torus Room Water Level: Approx. OP 4,000, Temperature: 32-37 deg.C

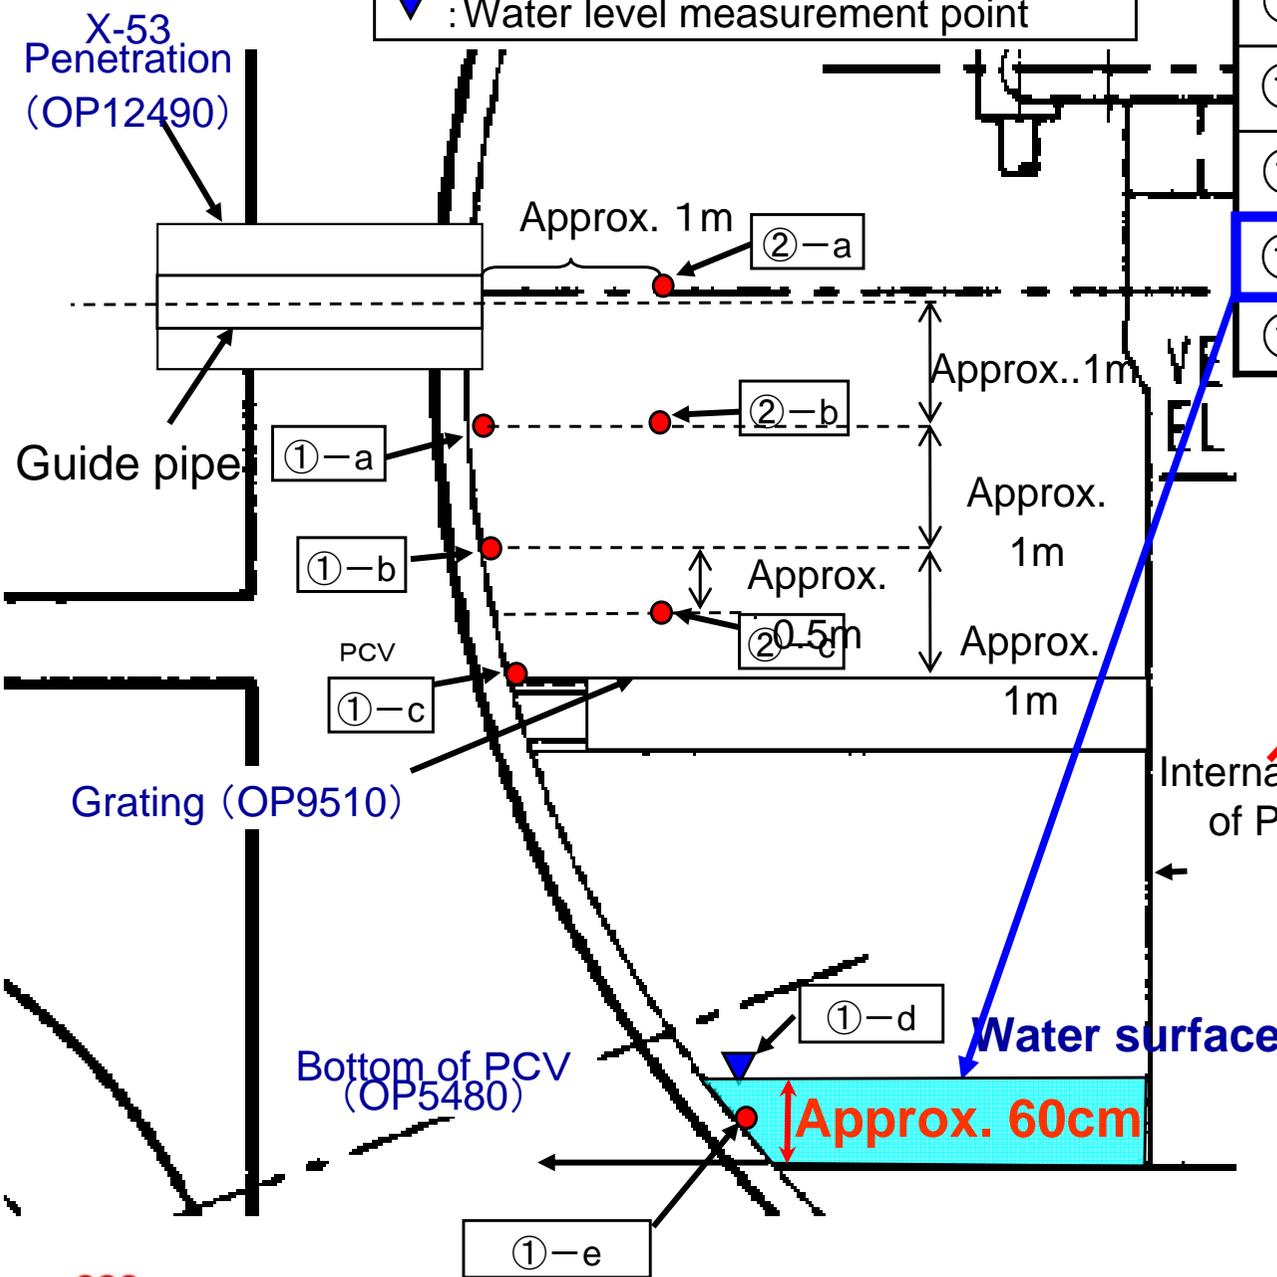
Unit 2 PCV Investigation (2012/3/26)

● : Temperature measurement point
 ▼ : Water level measurement point

①-a	42.8°C	②-a	44.9°C
①-b	43.0°C	②-b	44.6°C
①-c	43.5°C	②-c	44.5°C
①-d	Approx. 60 cm + bottom of PCV		
①-e	48.5~50.0 °C

- **PCV Investigation by Borescope** (2012/1, 3)
 - ⇒ **Water Level: Approx. 600 mm + PCV Bottom,**
 - Water Temperature : Approx. 50 deg C**
- **Robot survey in the Torus Room** (2012/4)
- **Water level measurement in the Torus Room** (2012/6)
 - ⇒ **Torus Room Water Level OP3270**

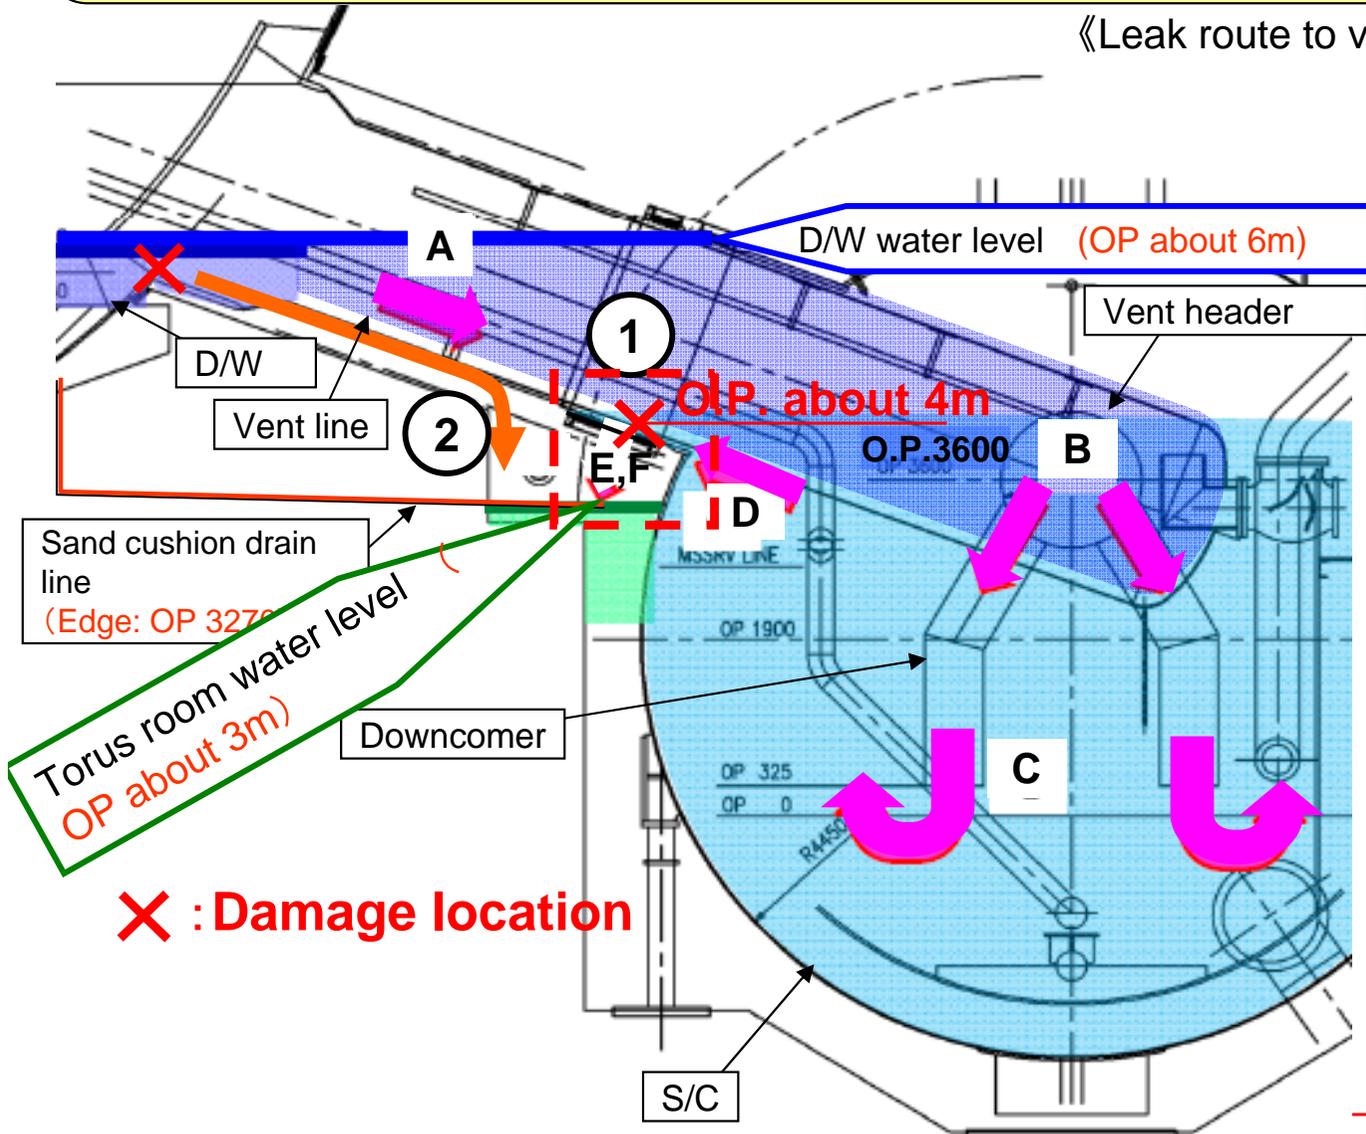
《Leak route to vent line bellow covers bottom edge》

A	D/W → vent line
B	Vent header → Downcomer
C	Downcomer → in S/C shell
D	Vent nozzle → vent line gap
E	Water outflow from vent line bellows damaged area
F	Water instillation from bellow cover bottom edge

X : Damage location

Leak detection of Unit 2 Suppression Chamber

- Possible locations (1) Vent line bellow cover bottom edge gap (→)
 (2) Vent line and penetration (frame) gap (→)
 (3) Lower Part of Suppression Chamber (S/C)

⇒ Attempts of robot investigations on (1) and (2) are being made since Dec. 2012.

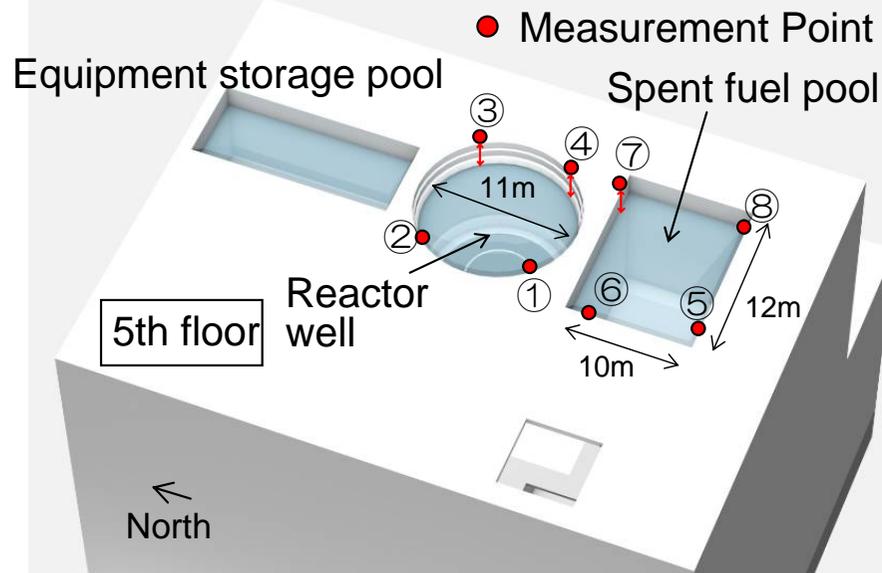
Measurement Point (on the 5th floor)

Measurement results

Reactor well	Measurement Date		
	Feb 7, 2012	Apr 12, 2012	May 18, 2012
①	462	476	492
②	463	475	492
③	462	475	492
④	464	475	492

Spent fuel pool	Measurement Date		
	Feb 7, 2012	Apr 12, 2012	May 18, 2012
⑤	—	468	461
⑥	—	468	461
⑦	—	468	461
⑧	—	468	461

Current Topics 2 - Confirmed that the building has not tilted -1

- Distance between 5th floor level and water surface was measurements three times on Feb. 7, Apr. 12 and May 18, 2012
 - The measured data at the 4 corners were almost the same.
- We confirmed that the floor surface of the 5th floor, water surfaces of the spent fuel pool and the reactor well were leveled.

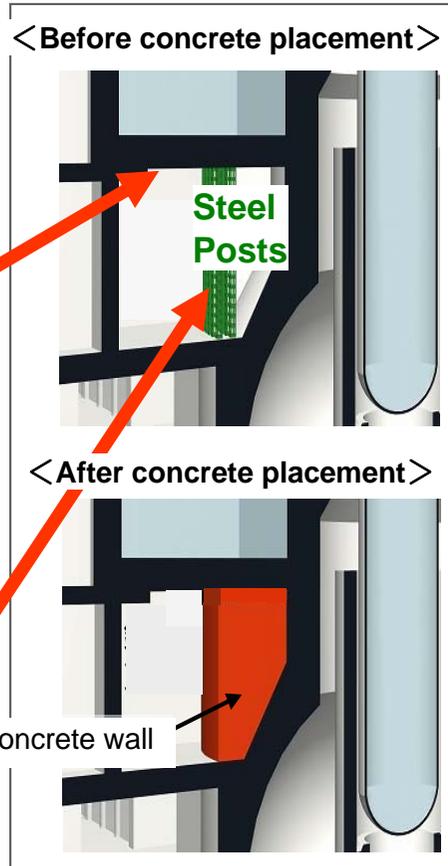
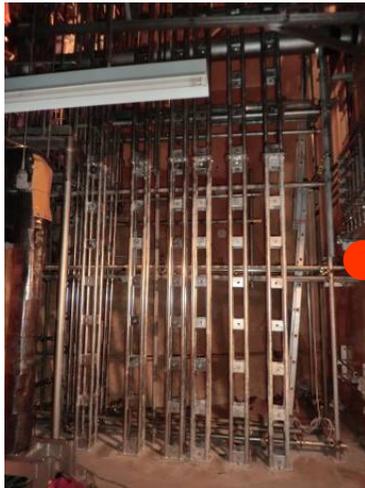
Photo① View from lower floor (Before concrete placement)

- ✓ Support structure at the bottom of the spent fuel pool was installed. This increased the seismic safety margin by 20 %.

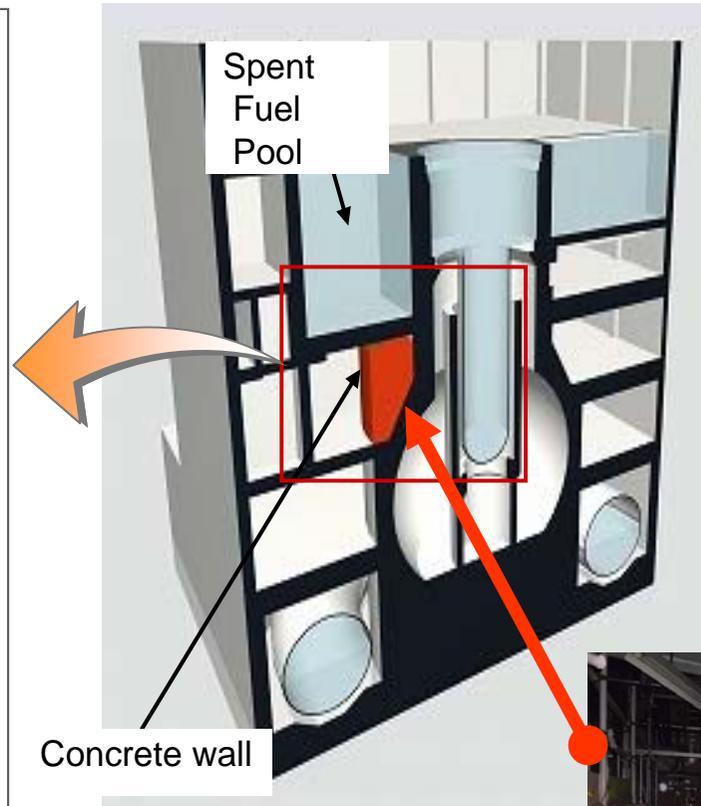
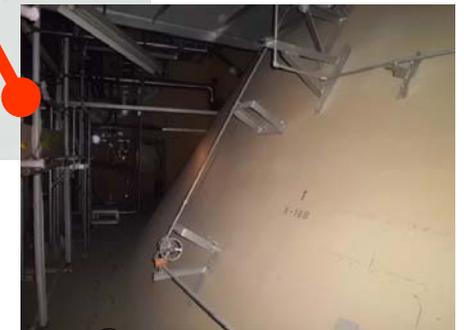
Photo② Steel posts installed condition (Before concrete placement)

Photo③ Surface of the 2nd floor shell wall (Before concrete placement)

※Concrete placement (red) after posts installation (green)

※ Photo① May 21, 2011 Photo② June 15, 2011 Photo③ May 20, 2011
 ※ Completed reinforcement on July 30, 2011

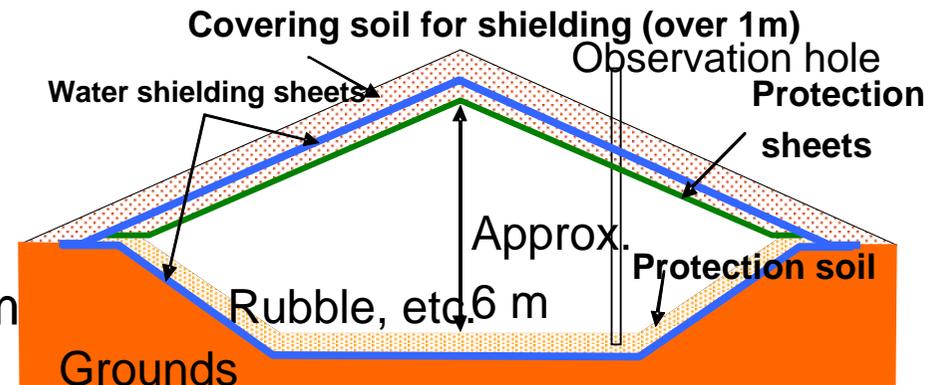
A-A' Cross-section View

Overview of Covering Soil Type Temporary Storage Facility

- ✓ 49,000 m³ of concrete/metal and 61,000 m³ of Cut-down trees are stored.
- ✓ Temporary storage facilities with shielding measures using soil and sandbags, etc were built to reduce radiation dose at the site boundaries.

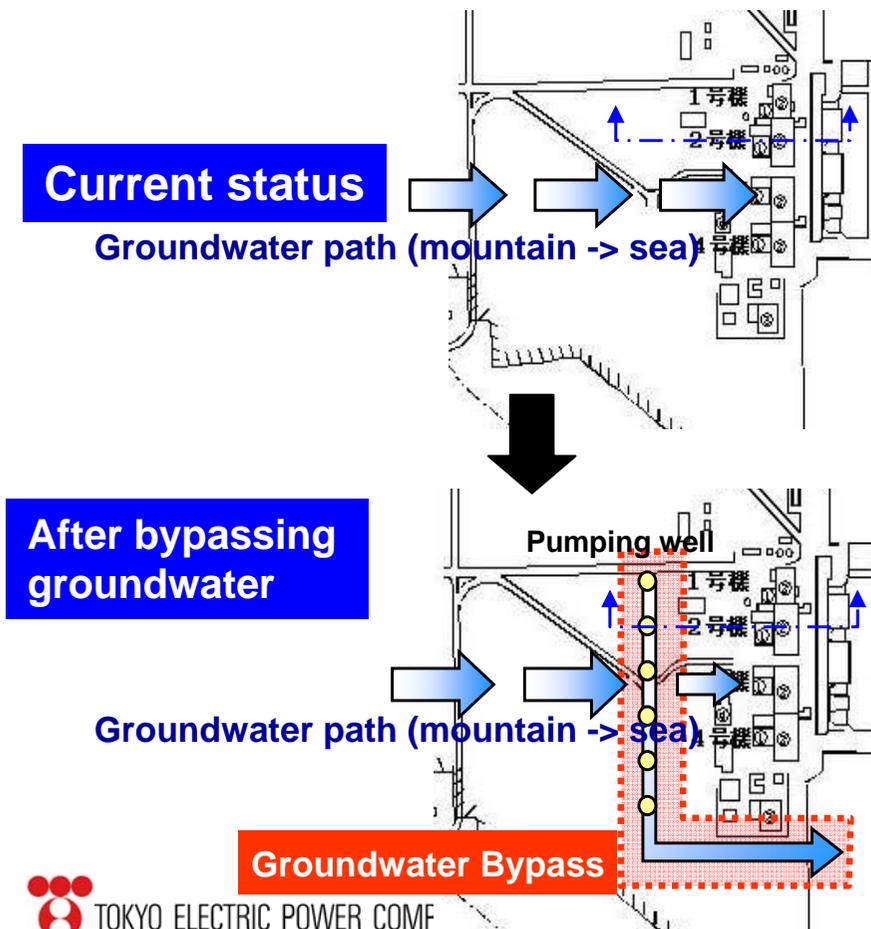
Groundwater bypass : Suppressing groundwater inflow to the buildings by changing the water path via pumping up the water flowed from the mountain side.

Groundwater bypass

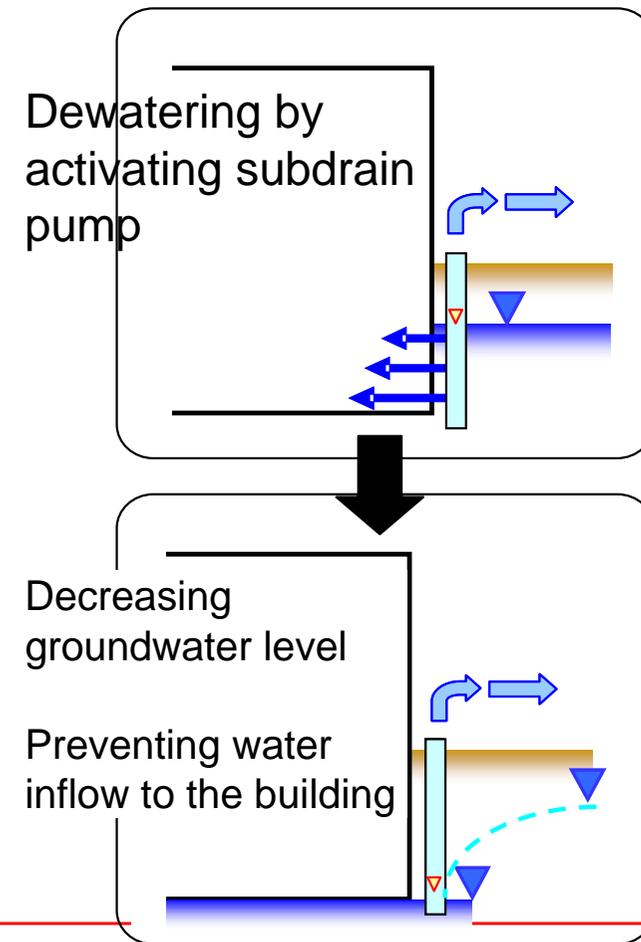
Pumping up groundwater (subdrain*) : Suppressing groundwater inflow to the buildings by decreasing groundwater level via pumping up the subdrain water.

*In order to balance groundwater level, groundwater in subdrain pits is periodically pumped up.

Pumping up groundwater (subdrain)

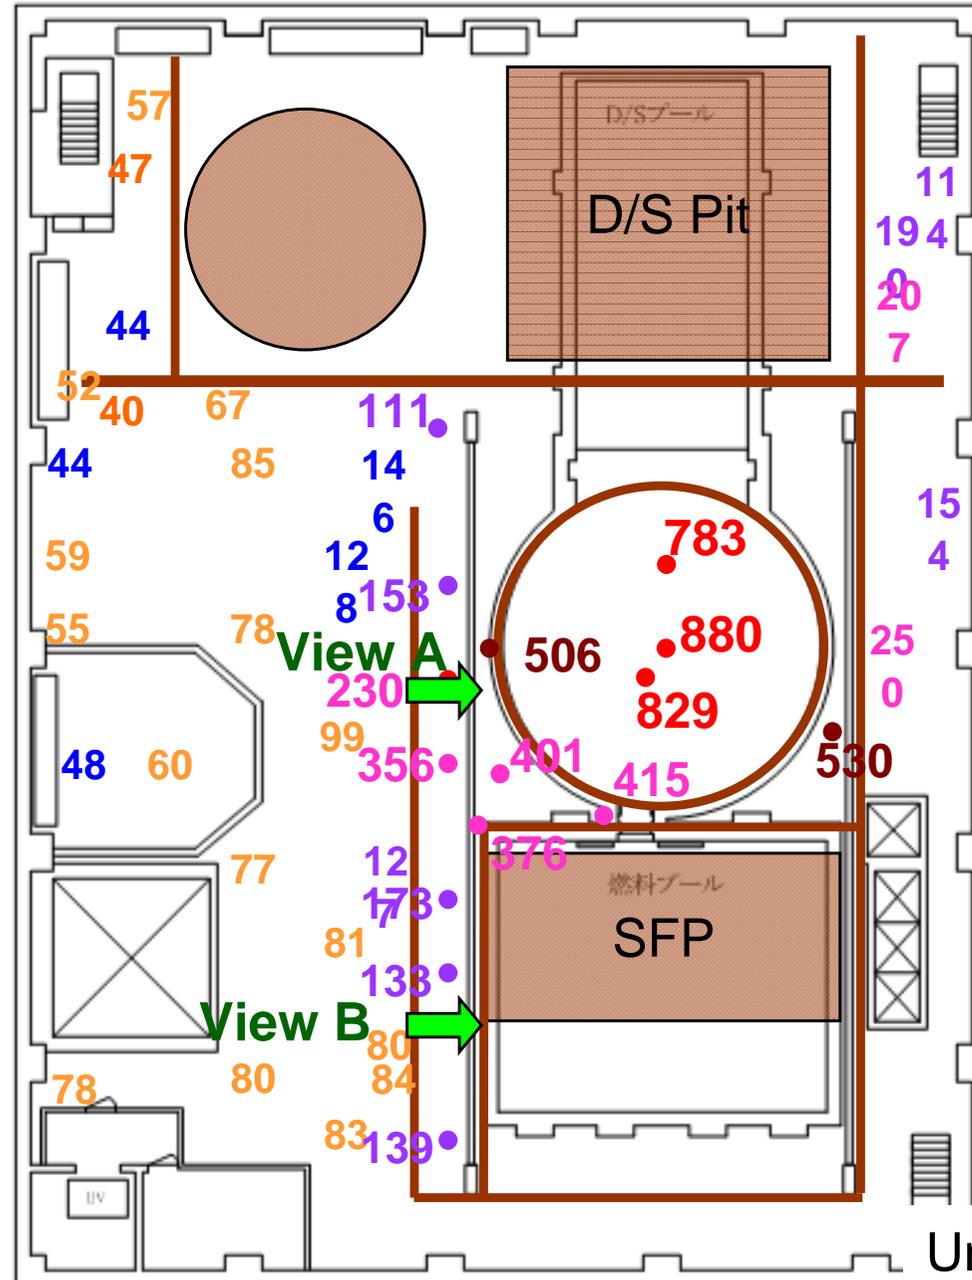
Dose Rate Map of Operating Floor (Unit 2)

Unit: mSv/h

~ 880 mSv/h on
Operating Floor of Unit 2

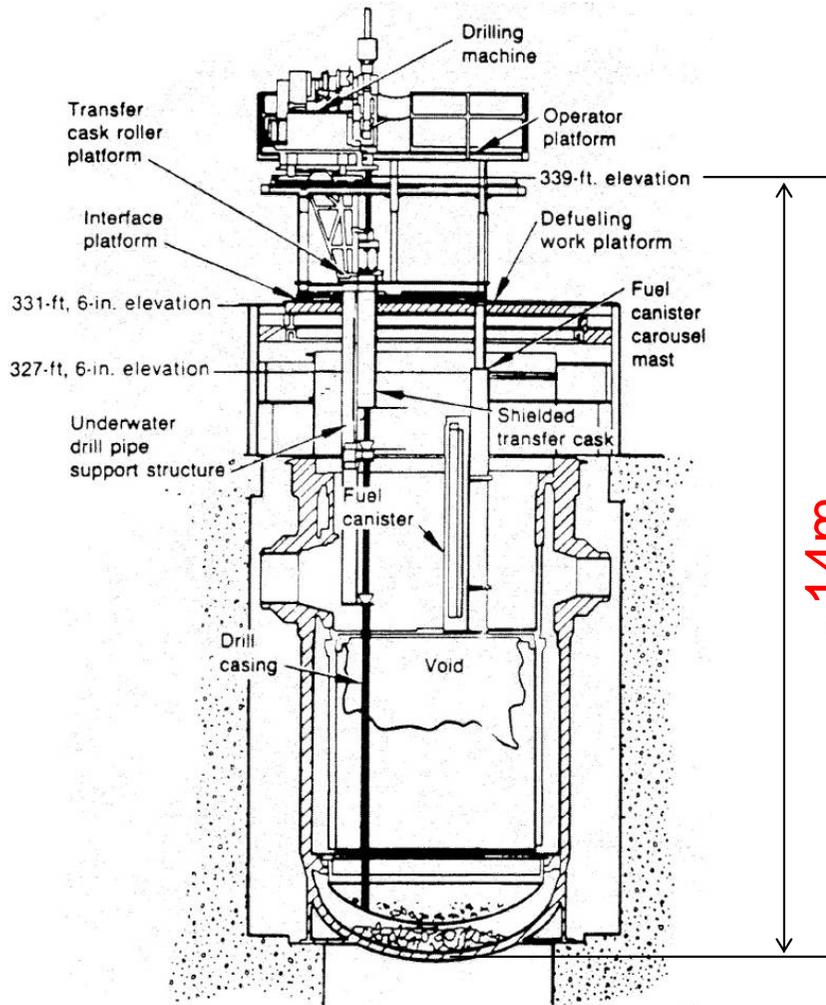
Core Boring Machine for TMI-2

The Cleanup of Three Mile Island Unit 2,
Project 2558-8 Final Report, EPRI NP-6931 (1990)

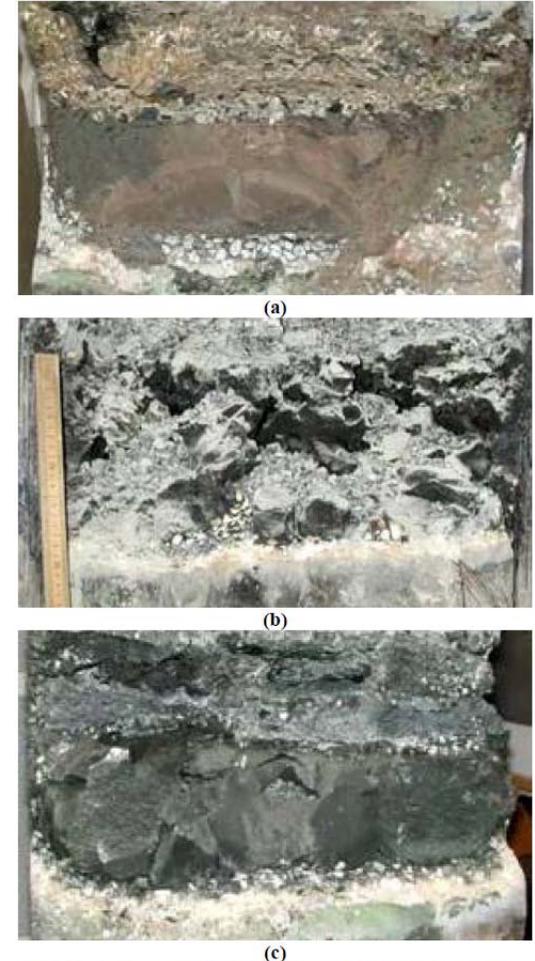
Figure 3-9. Axial Debris Morphology for Test:
(a) CCI-1, (b) CCI-2, and (c) CCI-3.
