# THE RADIOLOGICAL ACCIDENT IN THE REPROCESSING PLANT AT TOMSK

THE RADIOLOGICAL ACCIDENT  
IN THE REPROCESSING PLANT  
AT TOMSK

INTERNATIONAL ATOMIC ENERGY AGENCY  
VIENNA, 1998

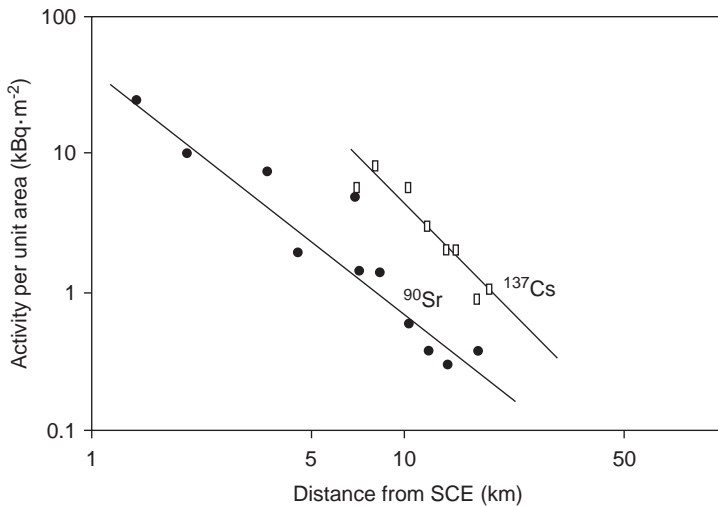
FIG. 4. Soil contamination in 1993 due to  $^{137}\text{Cs}$  and  $^{90}\text{Sr}$  as a function of distance to the north of SCE.

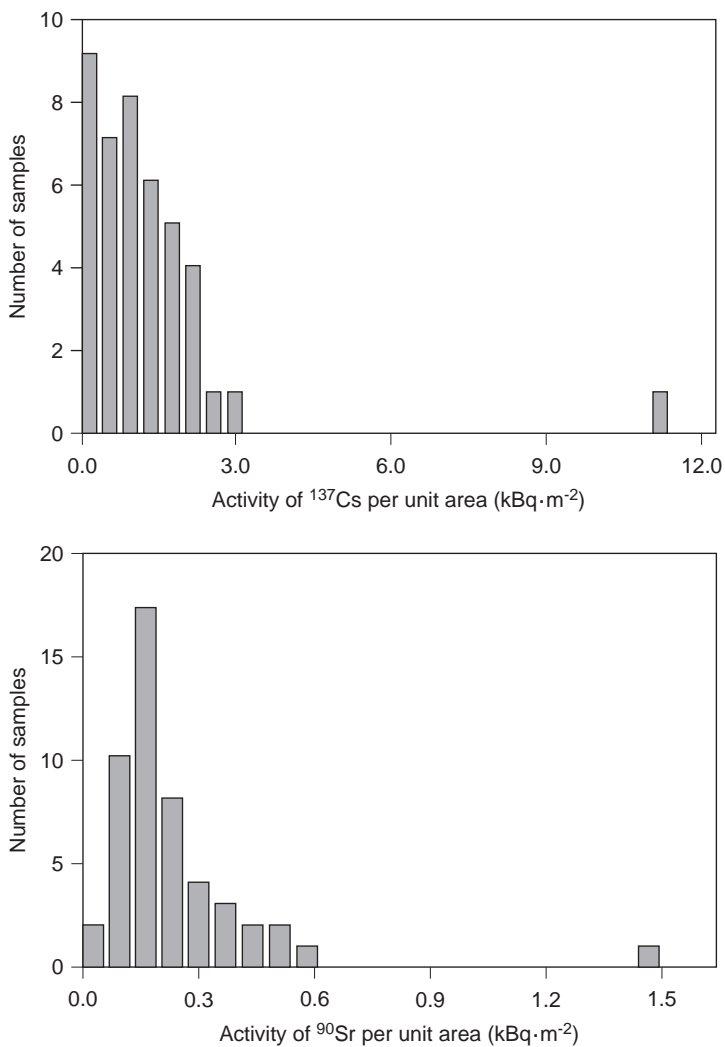
FIG. 5. Distribution of the contamination at Georgievka due to  $^{137}\text{Cs}$  and  $^{90}\text{Sr}$ .

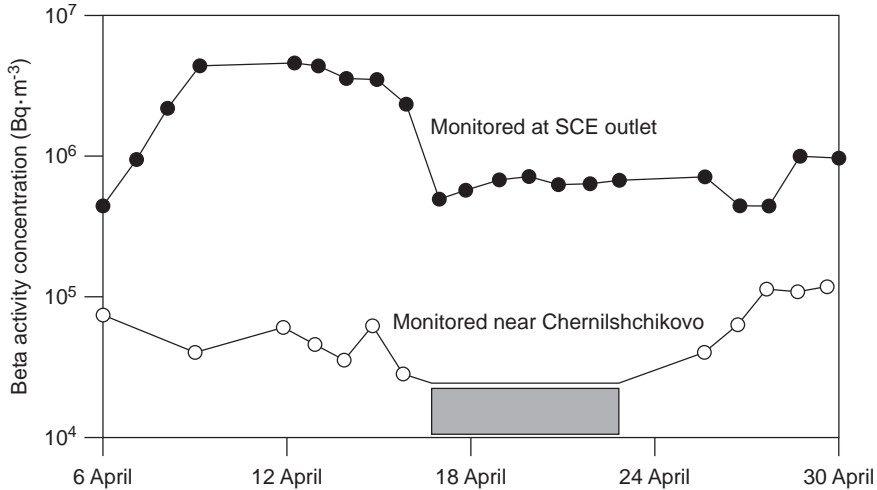
FIG. 14. Total beta activity concentration measured in water from the Tom river during April 1993. The shaded area indicates a beta activity below  $2 \times 10^4 \text{ Bq}\cdot\text{m}^{-3}$  from 17 to 23 April.

was registered towards the end of April. This mirrors the results of the SCE outflow, as does the clear drop in activity below the detector threshold from 18 April. The results obtained from these measurements are shown in Fig. 14.

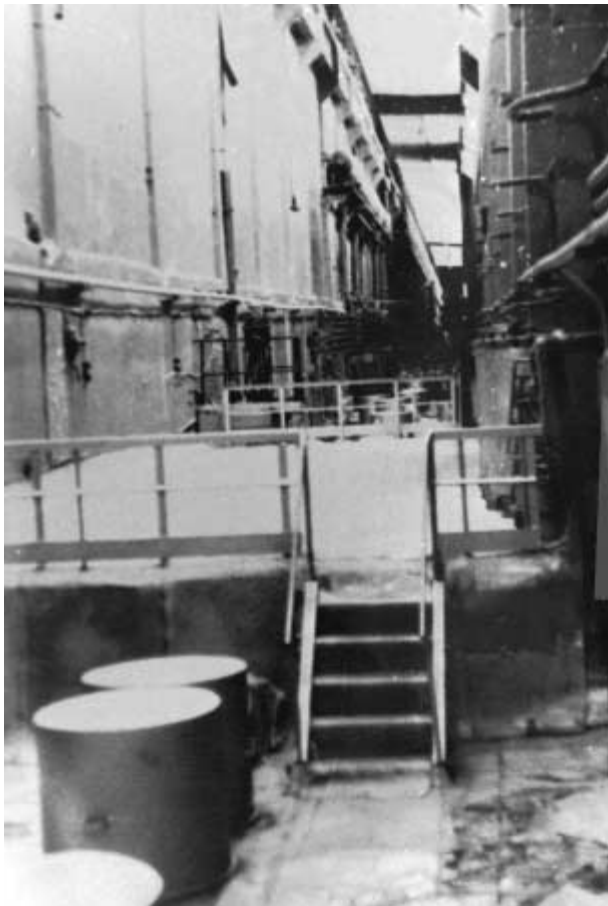
*Photo 3. The area around the installation after restoration.*

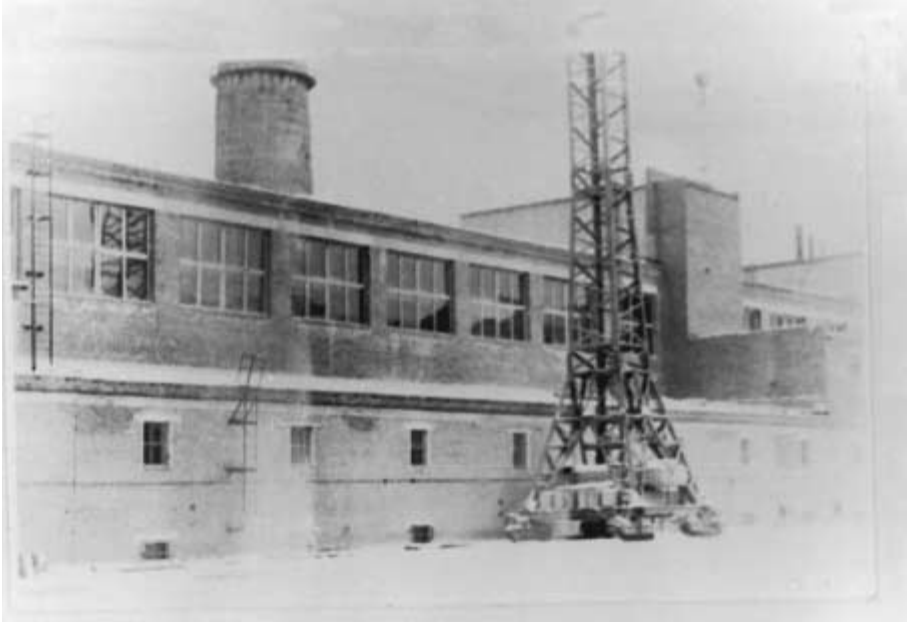
*Photo 4. View of Building 201 after restoration.*

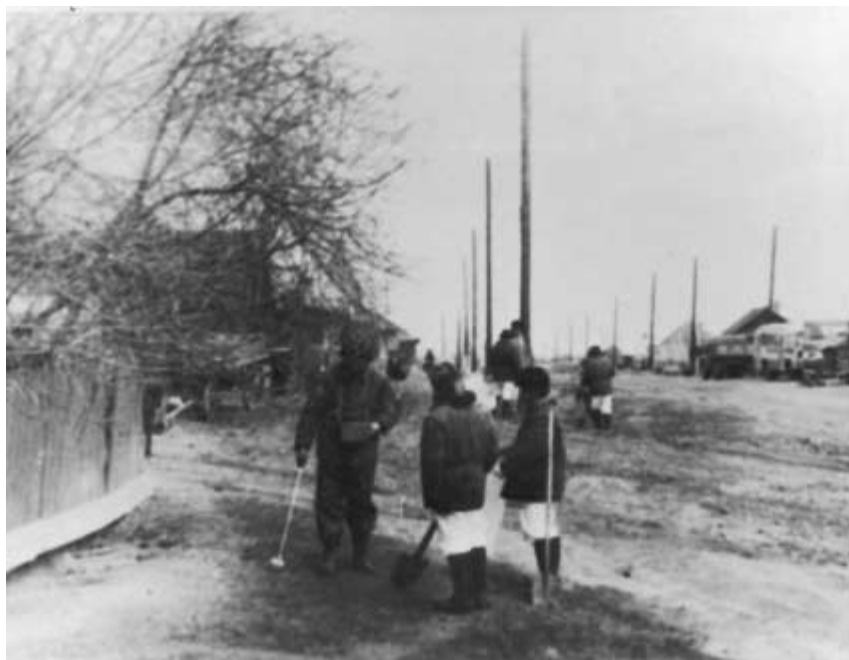
*Photo 5. Monitoring the main street in Georgievka.*

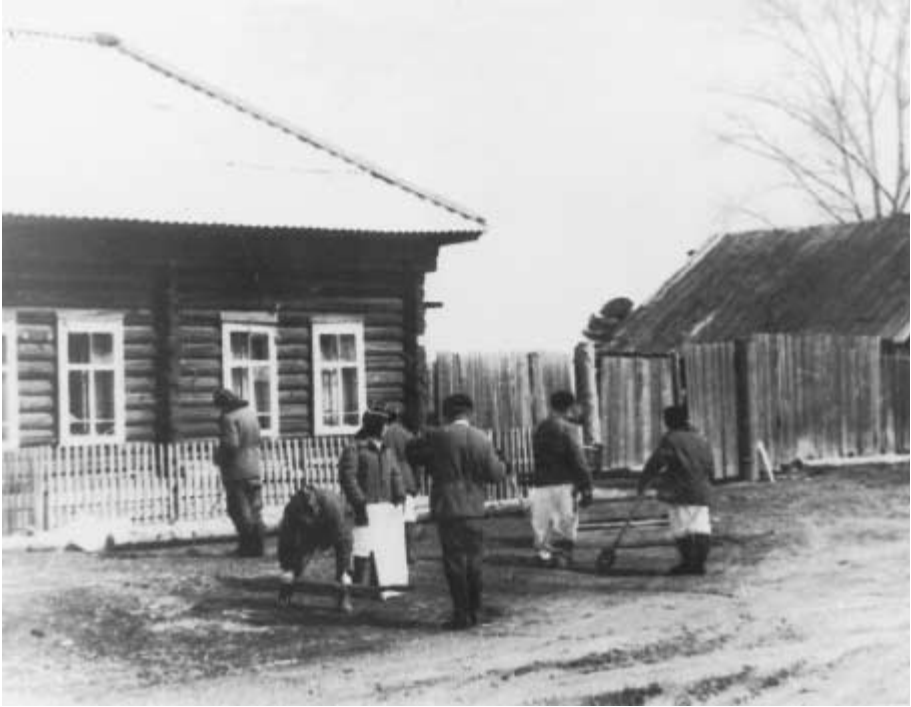
*Photo 6. Removal of contamination near a home in Georgievka.*

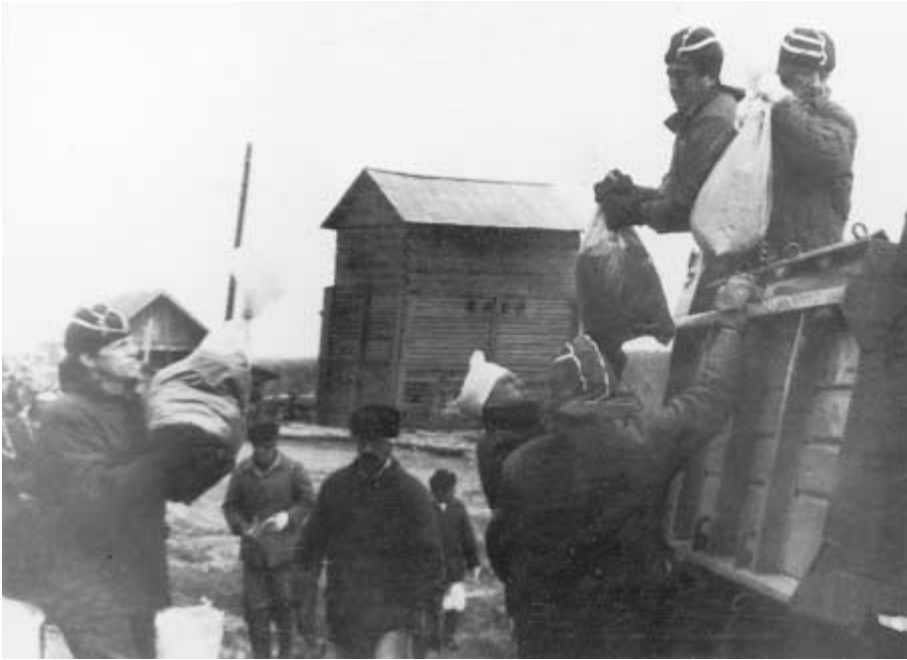
*Photo 7. Removal of contaminated soil and snow from Georgievka.*
