The Fukushima Daiichi Accident

Technical Volume 2/5 Safety Assessment

THE FUKUSHIMA DAIICHI ACCIDENT

TECHNICAL VOLUME 2 SAFETY ASSESSMENT

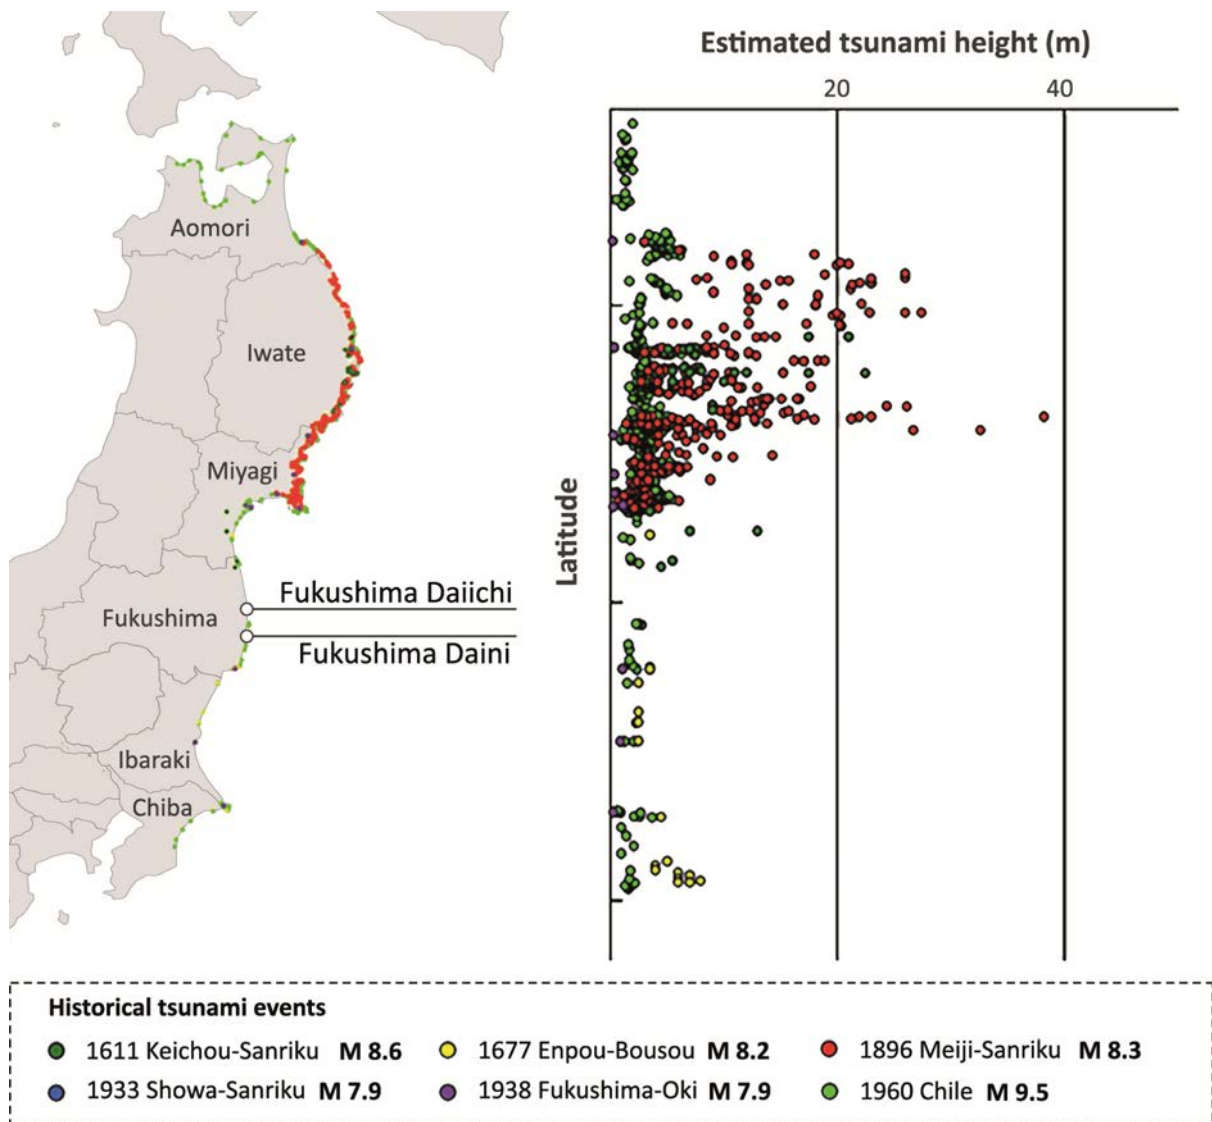
FIG. 2.1-6. Historical tsunami records [33].

- The use of historical records dating from a very recent period of a few hundred years only. No conservative assumptions were made regarding the need to take account of the potential occurrence of extreme events (i.e. a typical period of recurrence of the order of 10 000 years).
- The correspondence between the lack of historical records of tsunami flood levels at the specific location of the Fukushima Daiichi and Daini sites and the lack of data on the occurrence of earthquakes in the offshore area in front of the sites, i.e. a seismic gap for that seismogenic source which coincides with the lack of a high level of tsunami flooding phenomena.

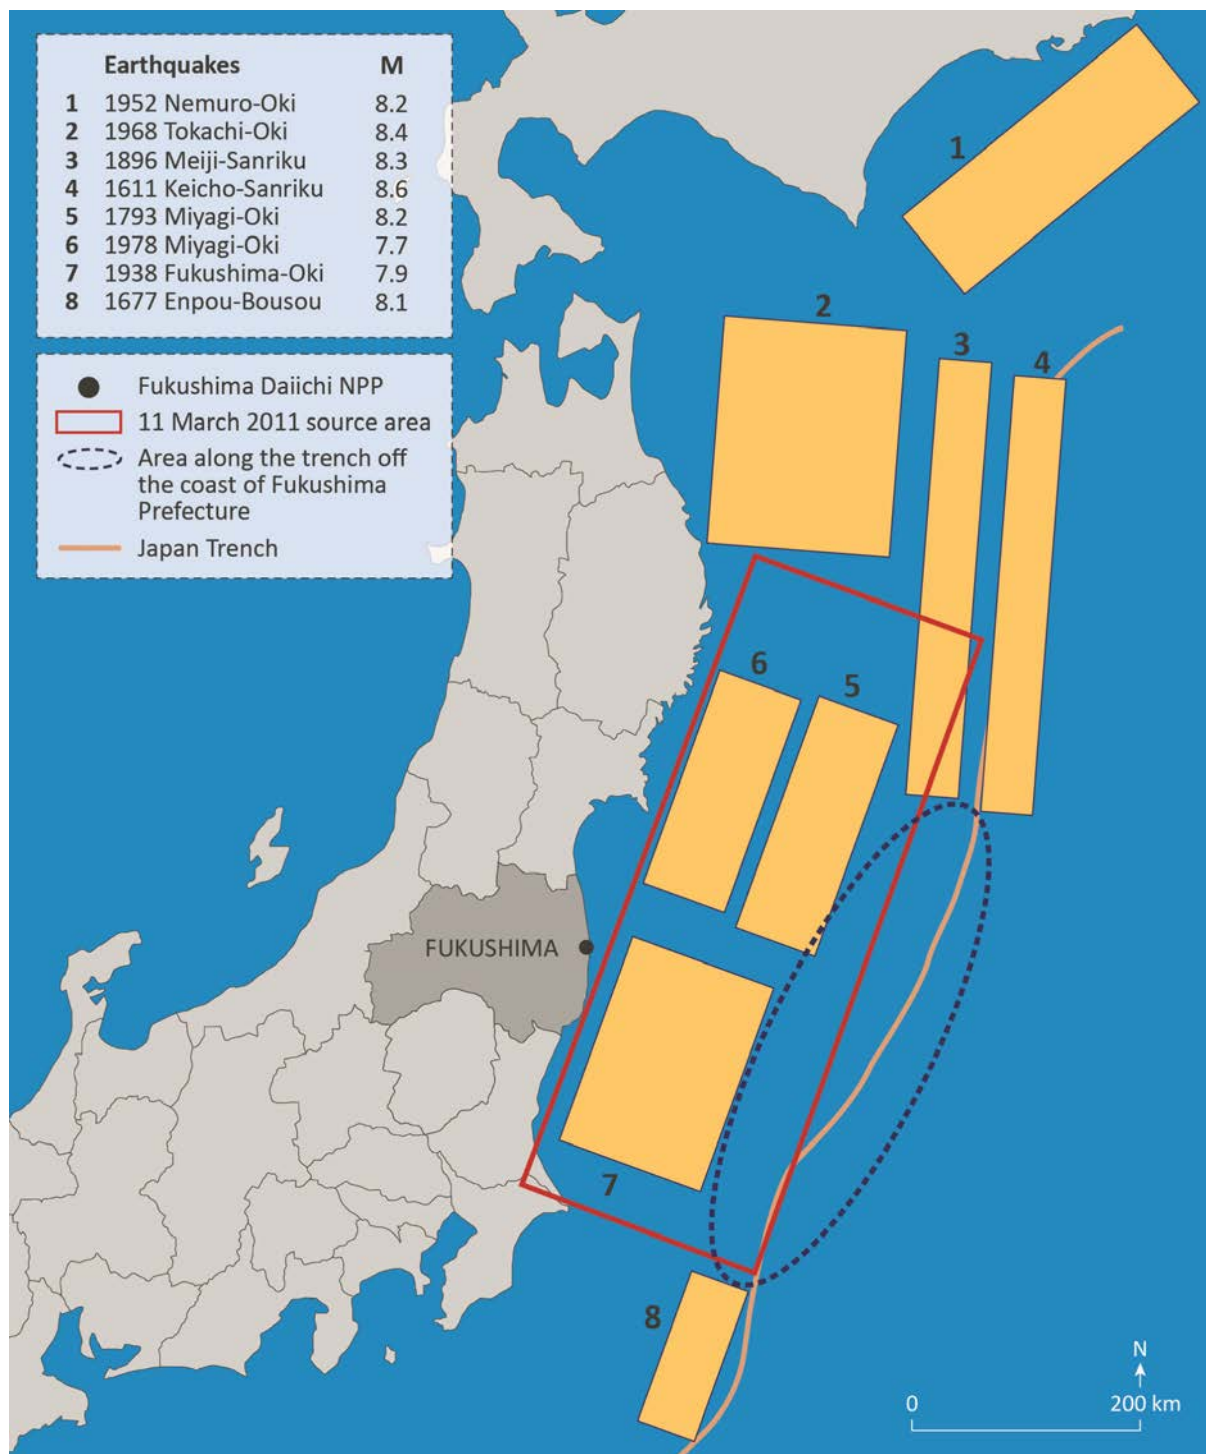
FIG. 2.1–10. Standard source model as defined by JSCE guidance, 2002 [26].

The application of the JSCE methodology in 2002 for re-evaluating the design tsunami at the Fukushima Daiichi NPP is illustrated in Fig. 2.1–10, where the eight zones of potential tsunami sources are indicated. It should be highlighted that the offshore trench fault source in front of the Fukushima Daiichi NPP is not included in that re-evaluation.

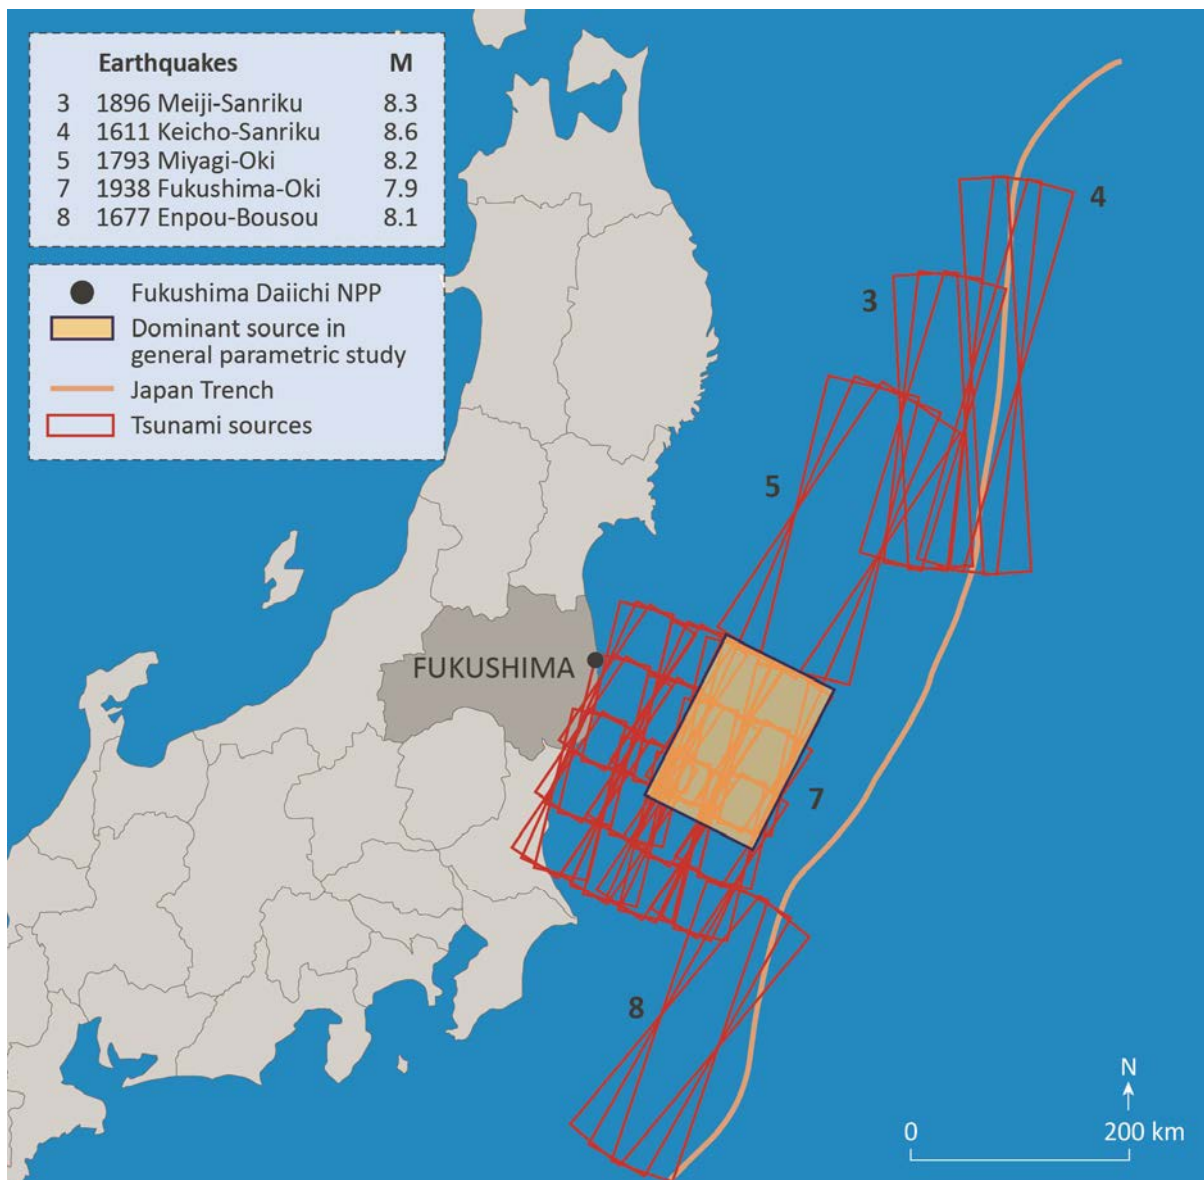
FIG. 2.1–11 Scenario of tsunamis for calculations performed by TEPCO in 2002 [33].

One hundred and forty-five simulations (see Fig. 2.1–11) were performed, with the dominant source being the one identified as No. 7 with M 8, corresponding to the earthquake at Fukushima-Oki (M 7.9) in 1938, which was assumed at M 8 in the calculations.

As a result of these calculations by TEPCO, the tsunami hazard water levels (maximum and minimum) were obtained with a maximum high water level of OP +5.7 m, while the minimum water level of OP –3.60 m was calculated on the basis of the 1960 Chile earthquake (M 9.5).

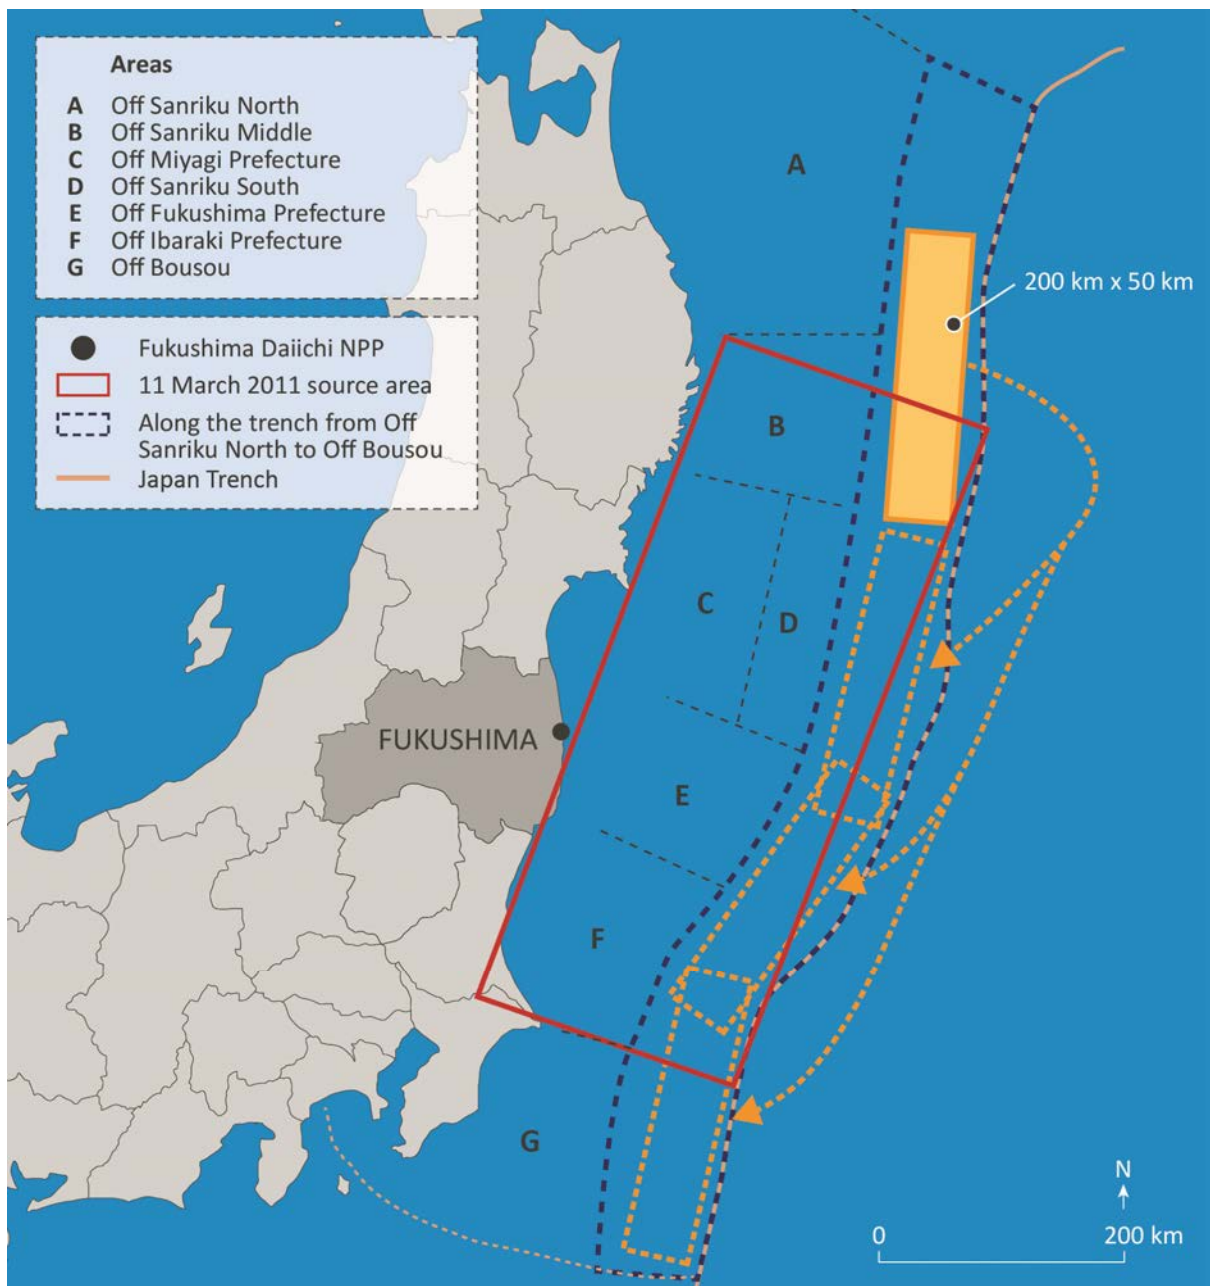
FIG. 2.1–16. Earthquake regions as determined by the Headquarters for Earthquake Research Promotion (HERP) for the Fukushima Daiichi and Daini sites as used by TEPCO in 2008 [36].

Because the HERP proposal did not specify a wave source model, TEPCO conservatively used the wave source model of the M 8.3 Meiji Sanriku earthquake of 1896. This earthquake occurred off the coast of Iwate Prefecture, more than 100 km north of Fukushima, and resulted in a tsunami of 38 m.

The results of this second trial calculation carried out by TEPCO in 2008 for the Fukushima Daiichi and Daini NPPs are shown in Fig. 2.1–16, as presented by TEPCO during the meeting with the IAEA of 10–14 February 2014 [33].

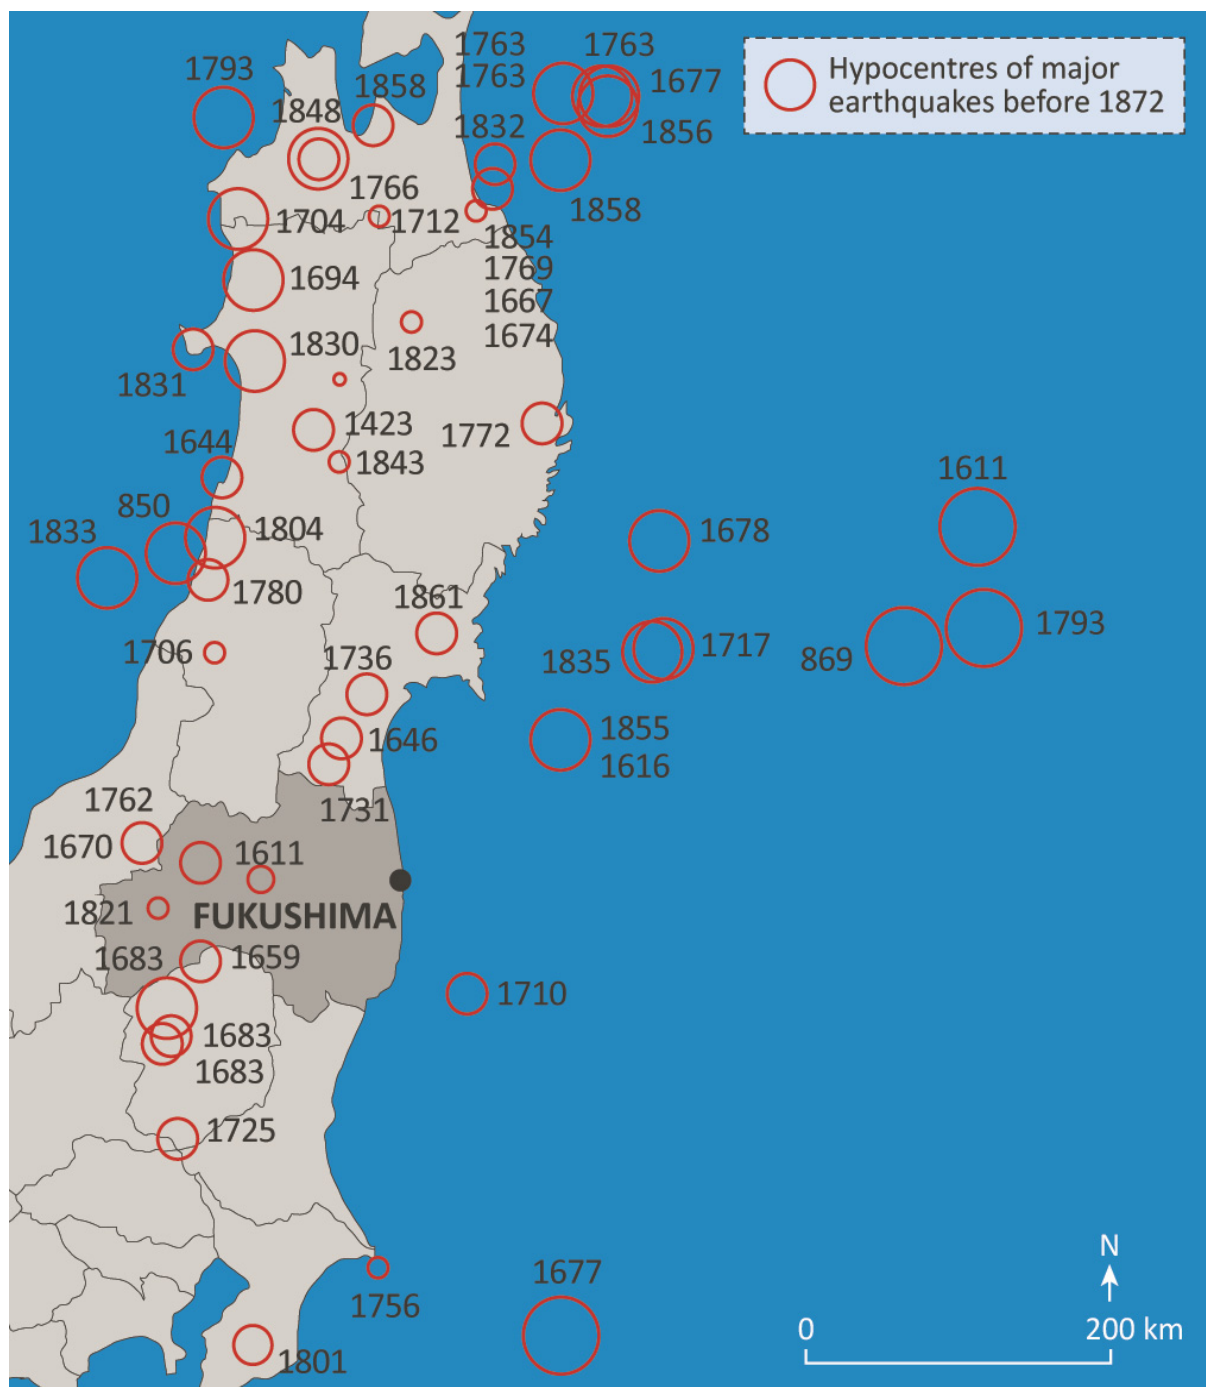
FIG. 2.1–17. Jogan 869 earthquake and tsunami potential locations [33].

TEPCO conducted the trial calculation with magnitude 8.4 and with the assumed location of the tsunami source as proposed by Satake et al. [35]. This model is based on data obtained from soil deposits from the Jogan tsunami through paleo-tsunamigenic investigations. As indicated by TEPCO [33], Satake et al. [35] did not determine the Jogan tsunami source model because of the lack of deposit data of that tsunami and the need to conduct additional tsunami deposit survey investigations in Fukushima and Ibaraki Prefectures.

Five boreholes were dug along the coast in the vicinity of the Fukushima Daiichi and Daini NPPs to investigate the existence of evidence of the Jogan 869 tsunami. Three boreholes, located to the south of the site, yielded no evidence of tsunami deposits, while two boreholes located to the north of the site showed evidence of tsunami deposits at 0.5 m depth in one of them and between 3 m and 4 m depth in the other. TEPCO indicated that the results obtained from the deposit investigations showed some inconsistencies with respect to the trial calculation using the source model proposed by Satake et al. [35]. Therefore, additional investigations were proposed to be carried out.

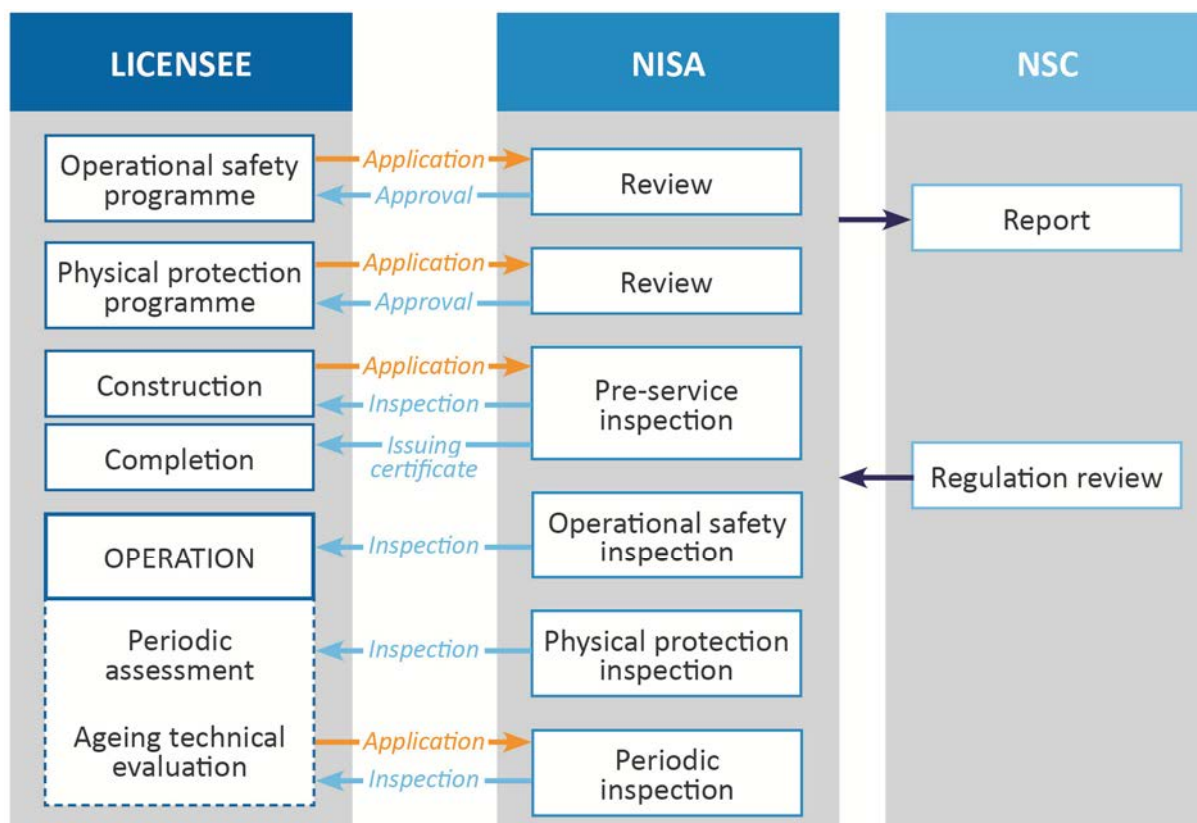
FIG. 2.5–2. The regulatory inspection process at the time of the accident for the operating stage of NPPs [92].

The regulatory inspection programme at the time of the accident at the Fukushima Daiichi NPP was rigidly structured by law, including the type and frequency of inspections and the rights of access by inspectors. This approach limited the effectiveness of regulatory inspection and enforcement in verifying the safety of licensees' activities and compliance with requirements.
