# **Repair of the NRU Reactor Vessel: Technical Challenges and Lesson Learned**

David S. Cox

Atomic Energy of Canada Limited

**International Conference on Research Reactors:  
Safe Management and Effective Utilization**

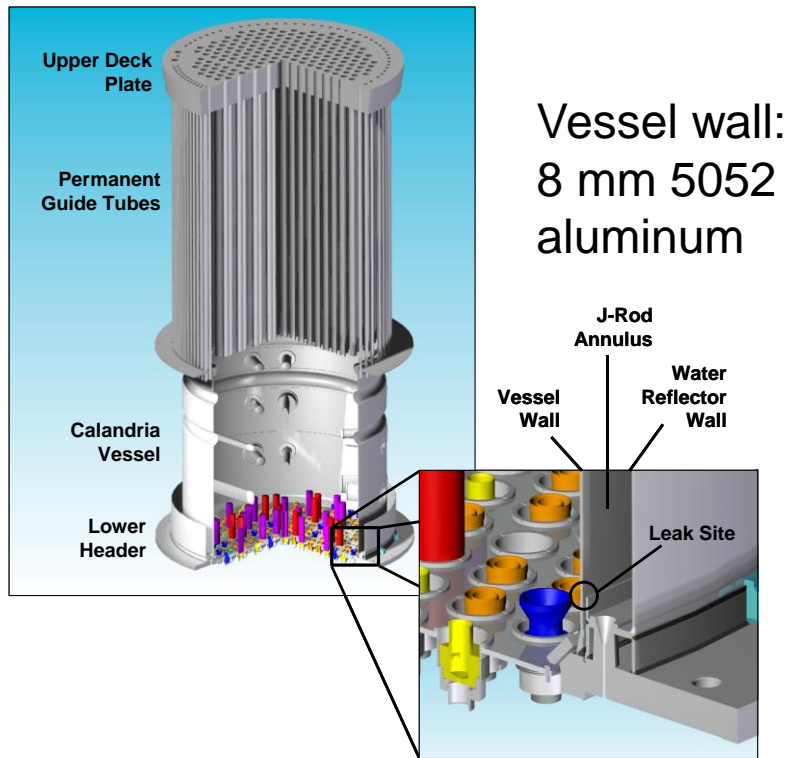
# Heavy Water Leak- 2009 May 14

- Minor heavy water leak from the vessel into the surrounding annulus detected (~5 kg/h)
  - Visual inspection determined that the leak site was in the vessel wall at the bottom of the annulus
  - Determined that the heavy water leak was due to corrosion of the reactor vessel wall from the outside
  - Additional areas of corrosion around the base of the vessel also required remediation
  - Decision made to remain shutdown for an extended period to repair the vessel

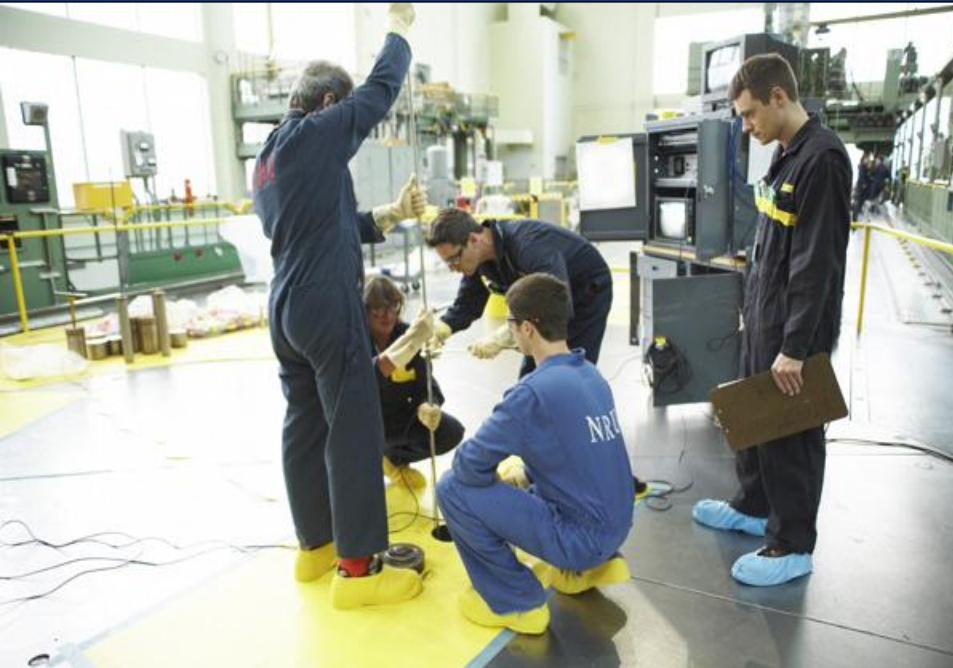
# Condition Assessment of Vessel

One of largest single NDE inspection campaigns ever carried out in the nuclear industry.

- Remote video inspections
- Ultra-sound examination
- Eddy current probes
- Over two million inspection results
- Four phases

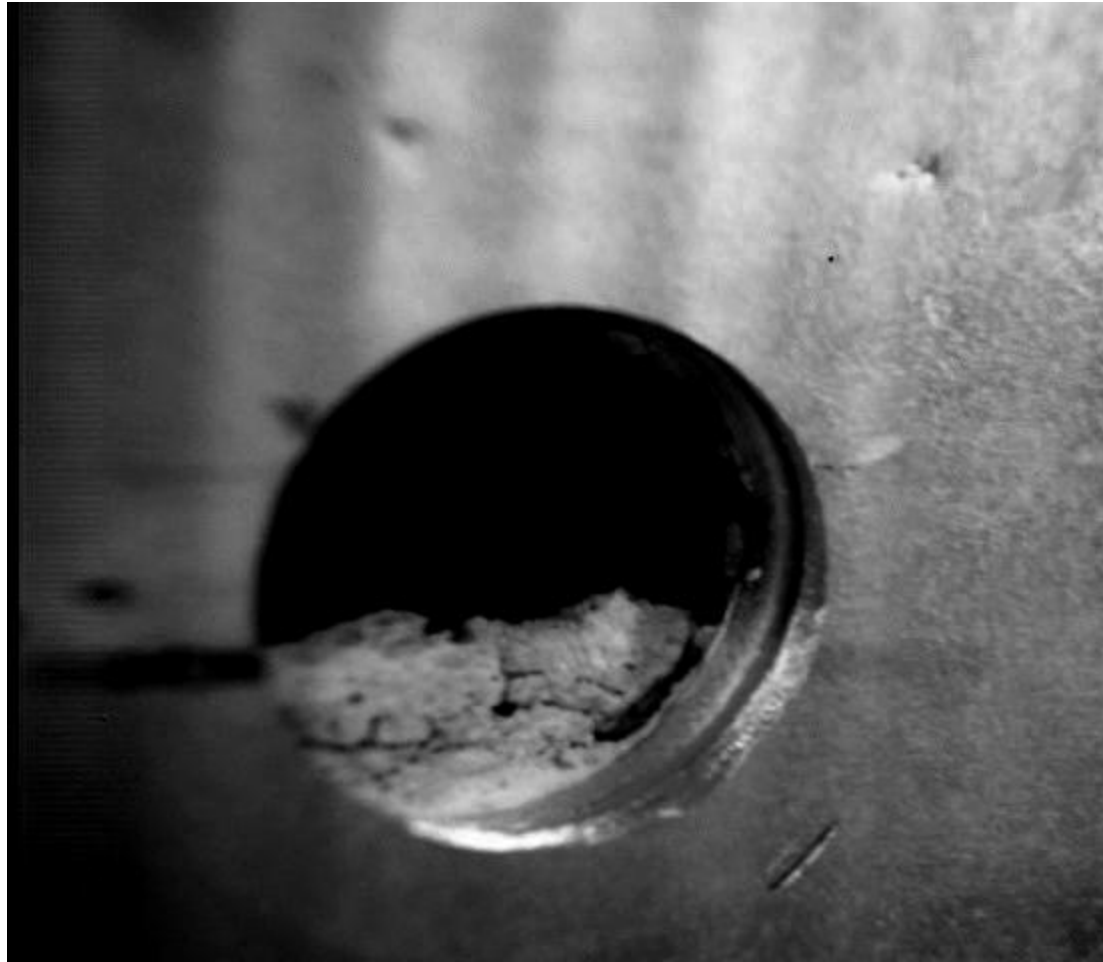
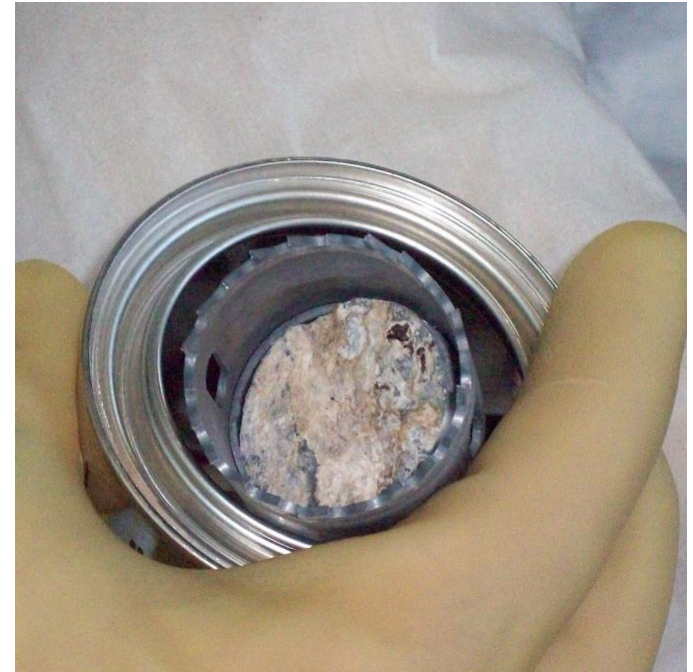
# Corrosion Coupon

- J-rod annulus designed to be filled with carbon dioxide gas and kept dry
- However:
  - Aging of CO<sub>2</sub> system reduced gas flow
  - Light water ingress from reflector leaks into J-rod annulus
  - Air ingress from openings in J-rod annulus
  - High radiation environment
- Created the conditions for radiolytic production of nitric acid
- General wastage corrosion in wetted regions, and localized corrosion at air/water interface

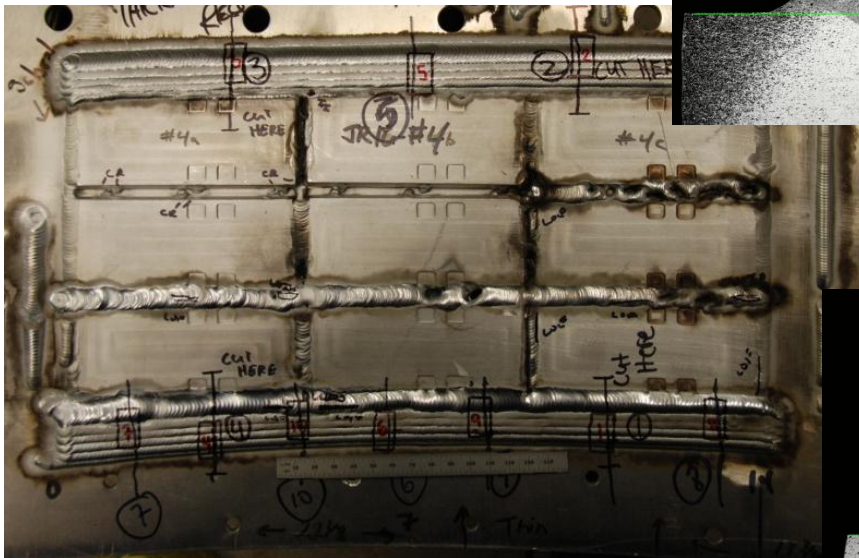
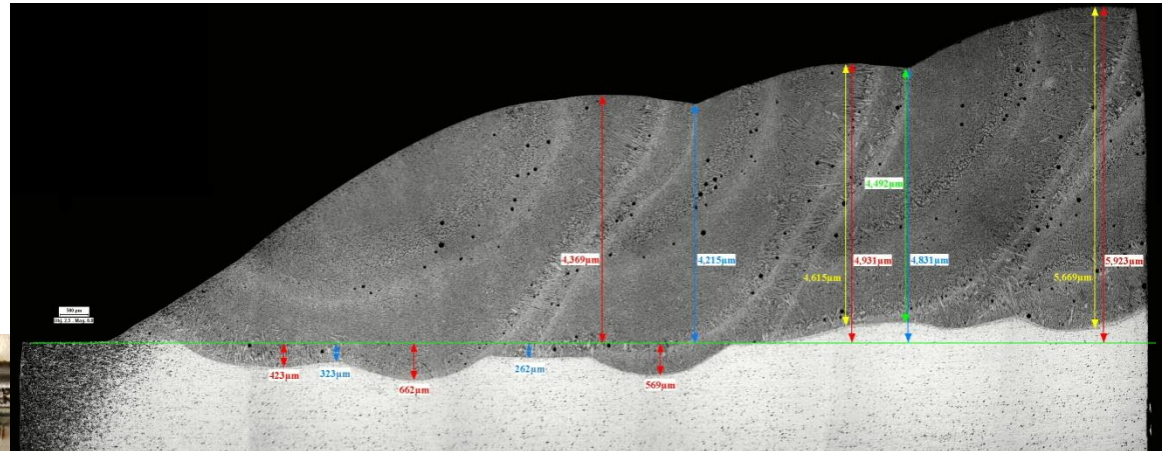
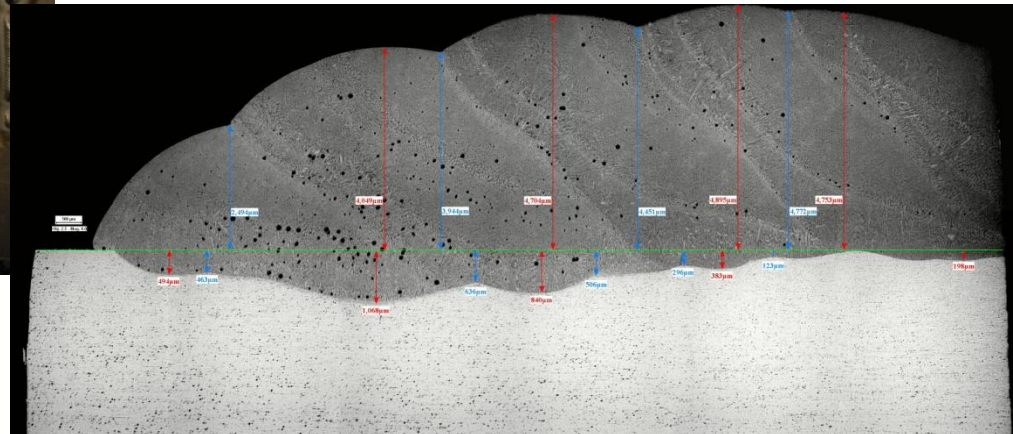
## Cross Sections

# Qualification of the Welding

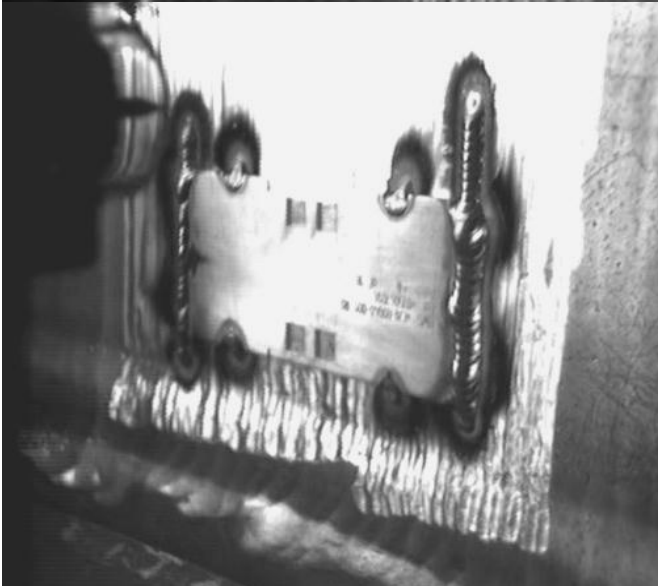
Backing  
strip  
placement

# Repair at JR-41 – The Leak Site

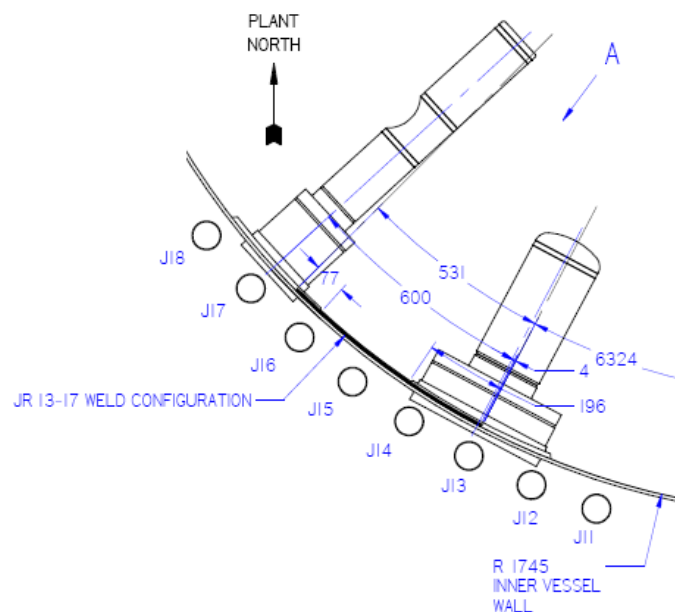
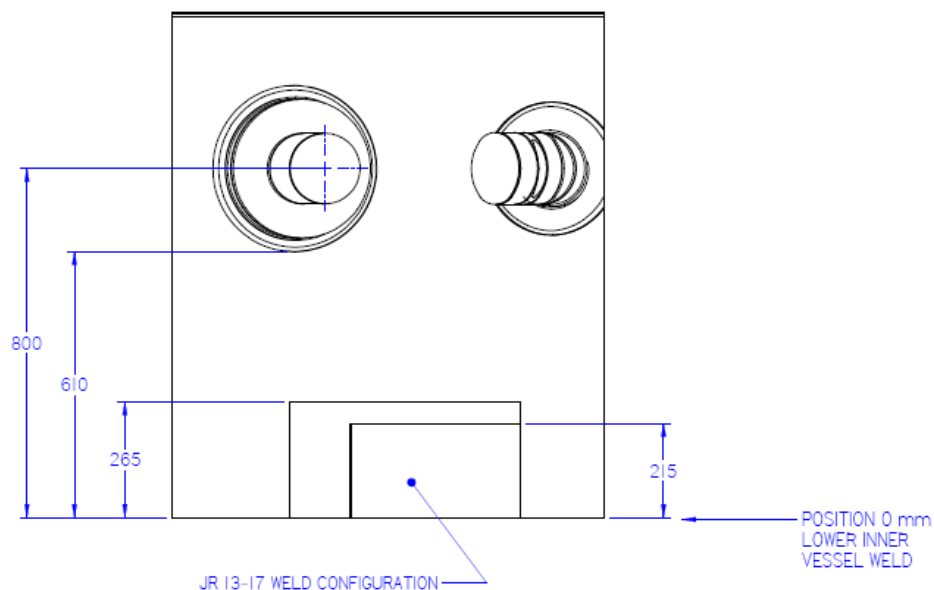
## WELD CONFIGURATION FOR J-ROD 13-17

- Two through wall penetrations
- Thinning to less than 1mm
- Located below and between two re-entrant cans
- Large area: W x H  
59 cm x 26 cm  
10.4" x 23"

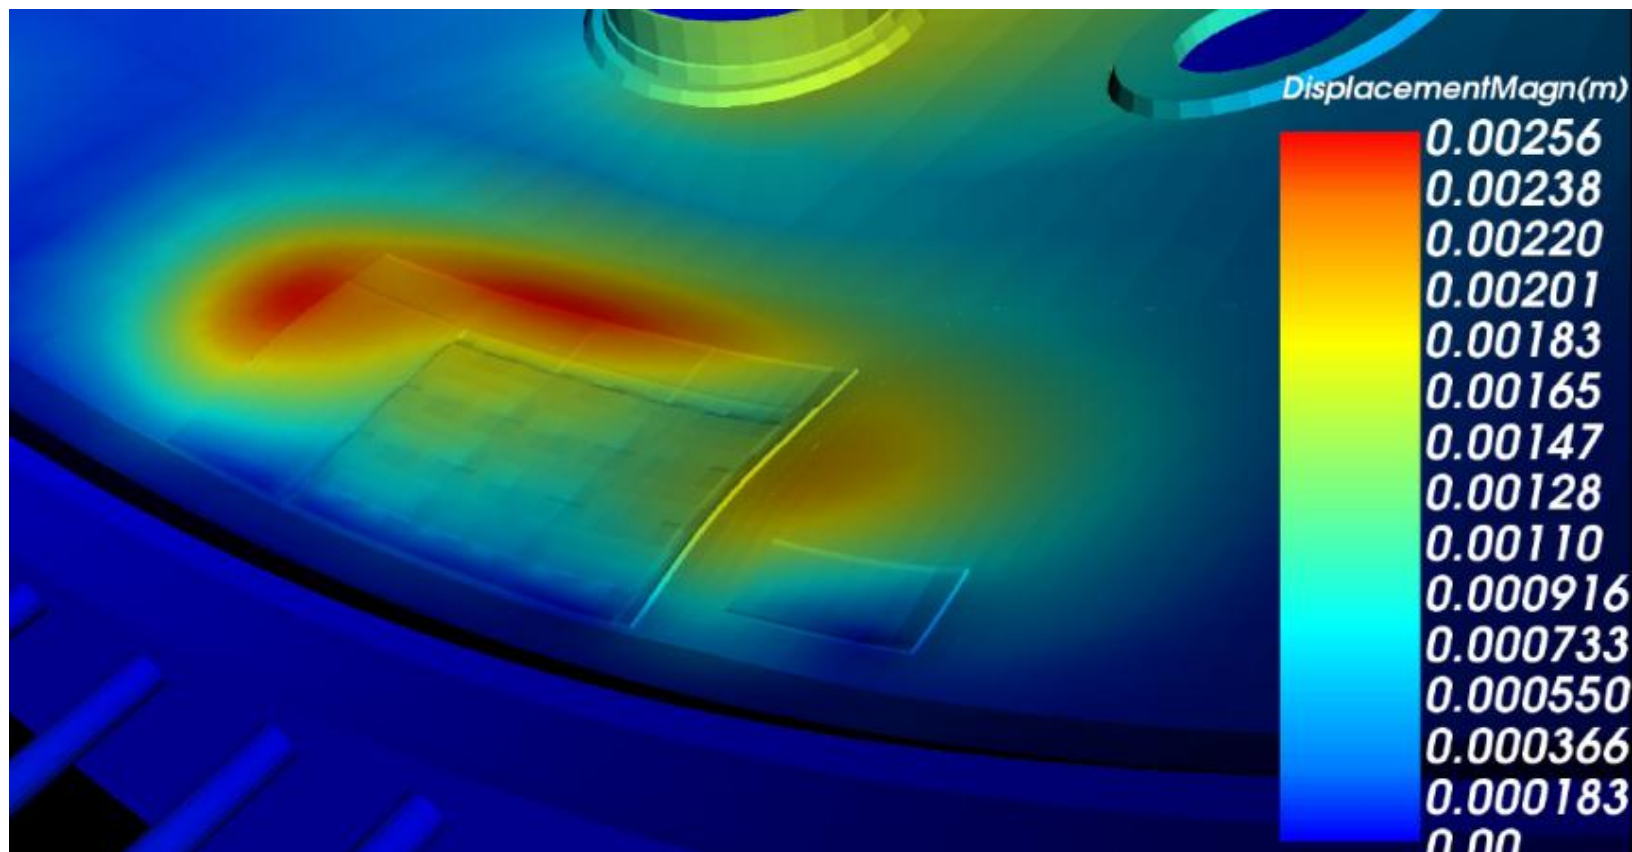
# Weld Stress Analysis

Prediction of loading on vessel seal, and displacement of vessel wall, in response to weld stresses
