International Conference on Research Reactors: Safe Management and Effective Utilization

Corrosion Induced Leakage in the Radial Beam Port of the 3 MW TRIGA Mark-II Research Reactor of Bangladesh

M. Ali Zulquarnain

Atomic Energy Research Establishment
Bangladesh Atomic Energy Commission
Email: zmaliee@gmail.com

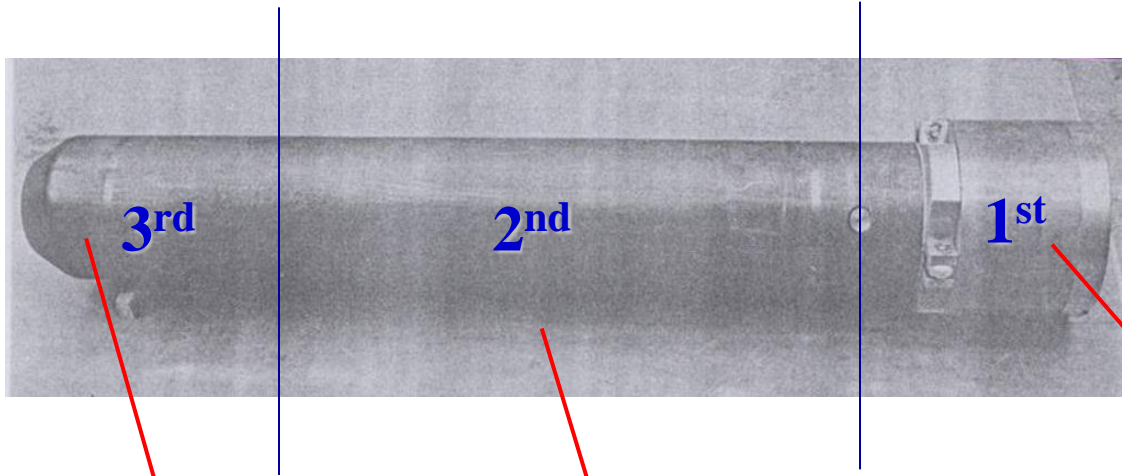
3rd part

Broken parts of the radial beam port

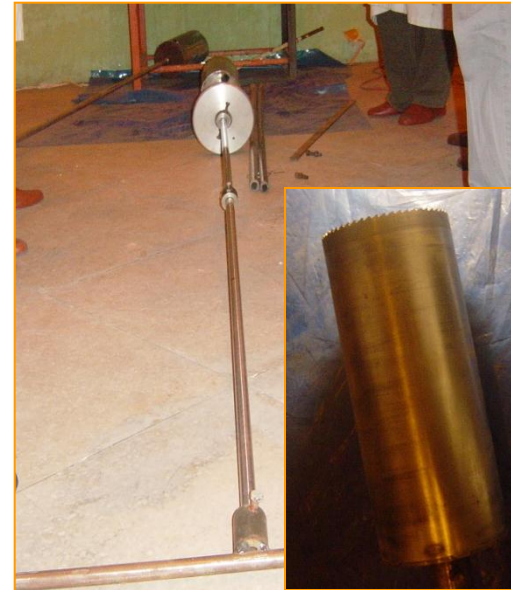
- Then with the approval **Regulatory Authority** the graphite plug was trimmed off by using an **auger** (circular-saw like cutting tool) and then taken out.

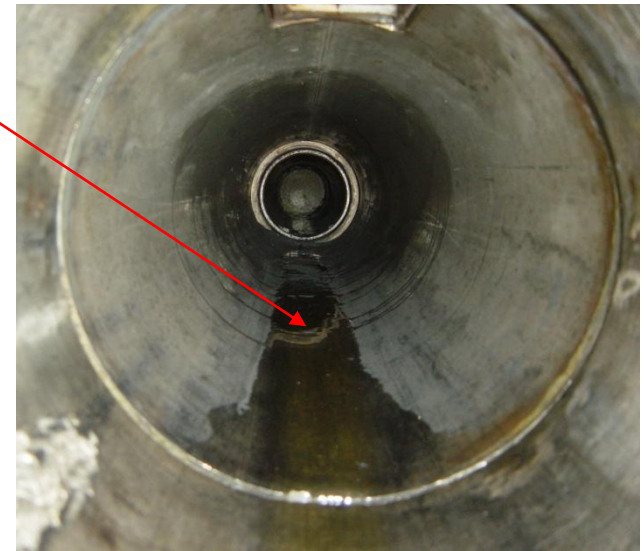
- A couple of days after the stuck out graphite plug had been removed, reactor pool water was found to be leaking through the beam port.
- Leakage of water was stopped temporarily by wrapping a **rubber strap** around the leaking part of the RBP-1.

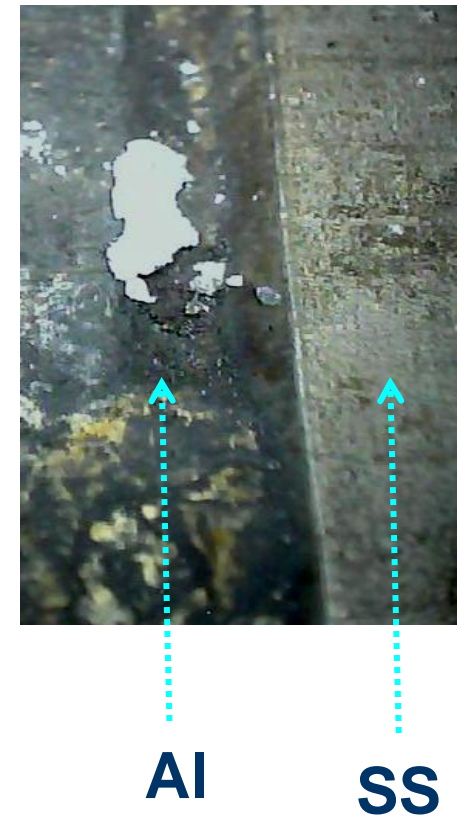
- The pictures clearly show **corrosion damage** in the form of **metal removal** and **pits** on the inner bottom surface of the aluminium pipe.
- Brown stains are observed on the surface of the SS pipe, but there does not exist any **pit** or **mark of metal removal**.

- The analysis revealed that the damages in terms of corrosion had been initiated at the **Al-SS interface** where a **SS sleeve/ socket** had been used to cover the circumferential gap between the SS and Al pipes.

- **The interface with the sleeve/socket around it was not wrapped with sealant during pouring of concrete.**
- **As a result moisture from the surrounding concrete found its way to the gap between the Graphite plug and Aluminium pipe.**

- Later these moistures initiated the corrosion process onto the Aluminium pipe.
- The continual presence of moisture transformed the protective Aluminium Oxide layer into **Aluminium Hydroxide**, which is **porous** and cannot prevent air and moisture to seep through it and attack the fresh Aluminium underneath.

- The cracks and/or pits resulted as the corrosion went through the **inter-granularity** of the Aluminium pipe and **allowed water from the reactor tank to** sip through and drain out of the beam port.

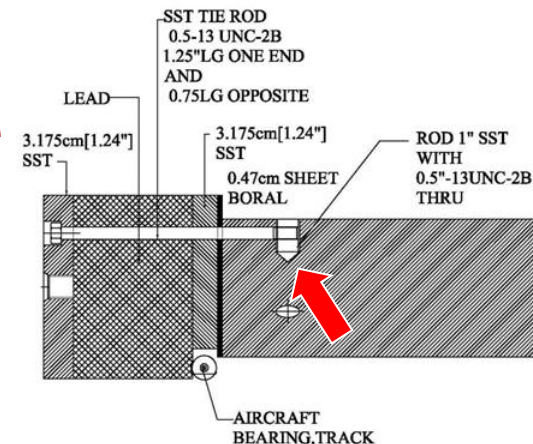
- A minor lapse during the installation work initiated the leakage problem of the BAEC RR.
- All 4 Graphite plugs got broken at the area where nuts were inserted. The design made the plugs very fragile.
- Maintenance manual did not mention any requirement for routine inspection of the beam ports (BPs) & plugs.
