INTERNATIONAL
ATOMIC ENERGY
AGENCY

THE RADIOLOGICAL ACCIDENT
IN SAMUT PRAKARN

INTERNATIONAL ATOMIC ENERGY AGENCY
VIENNA, 2002

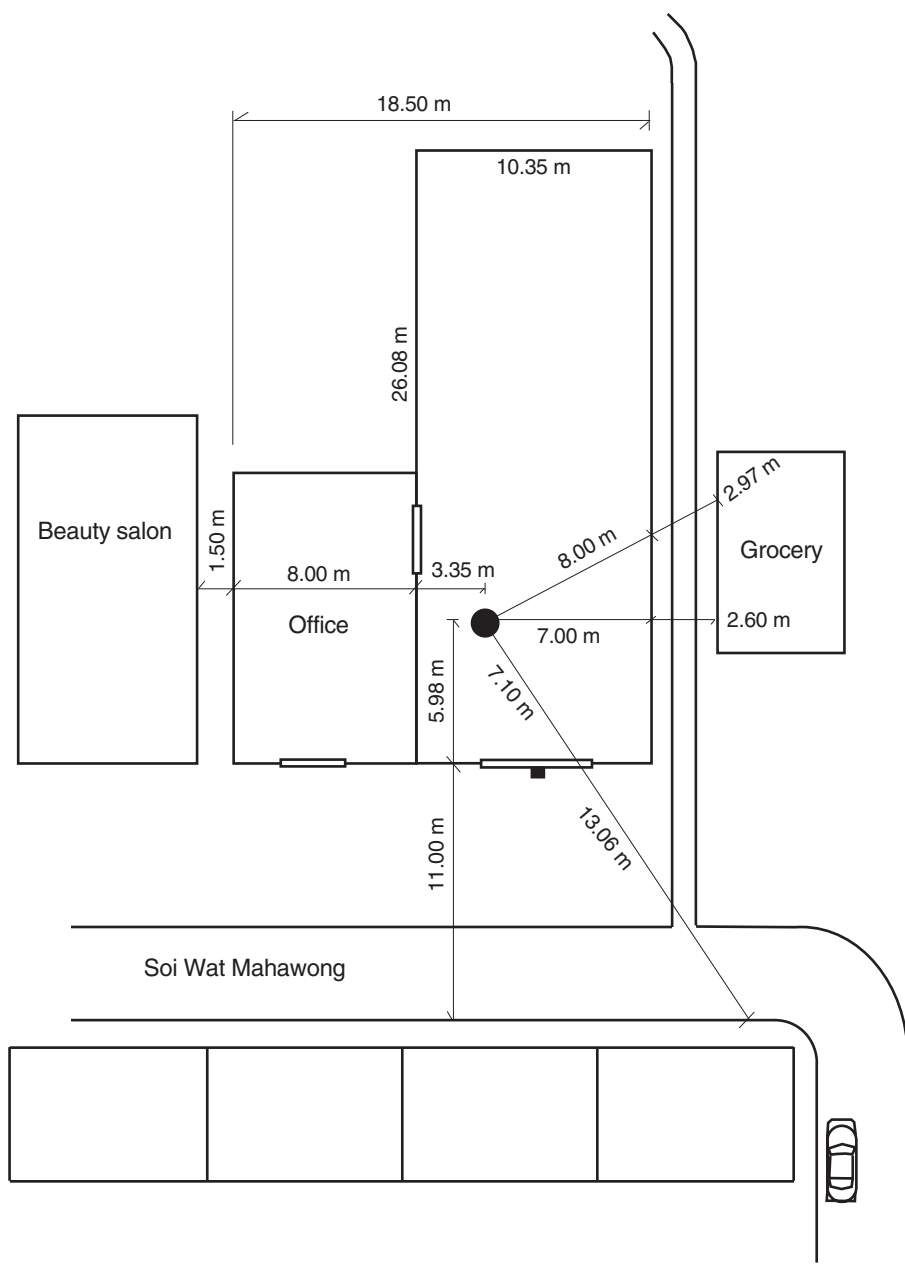
FIG. 6. Plan of the junkyard and its vicinity.

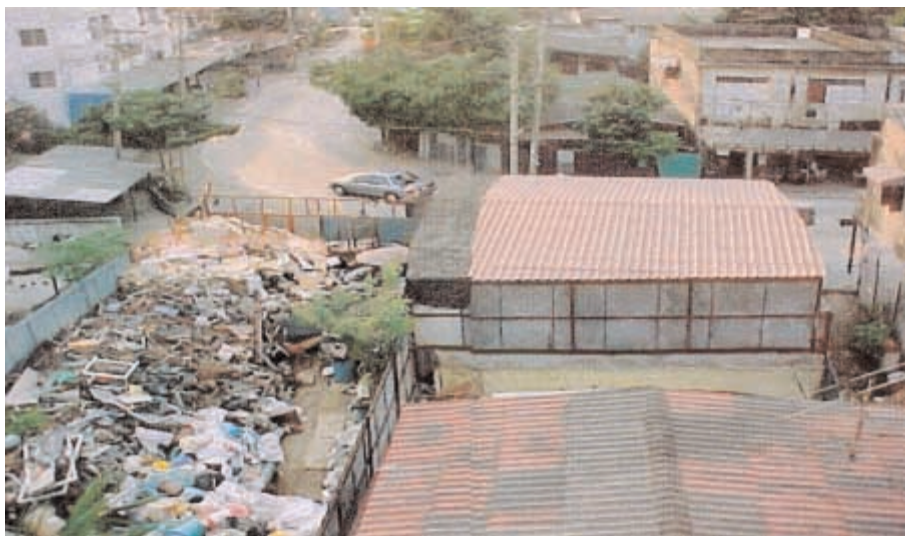
FIG. 7. Elevated view of the junkyard. Scrap piles are on the left; the building in the centre is the junkyard office, the building across the street is the residence of P7 and P8 (junkyard owner and husband) in which P9 (maid and part time junkyard worker) and P10 (mother of P7) also resided.

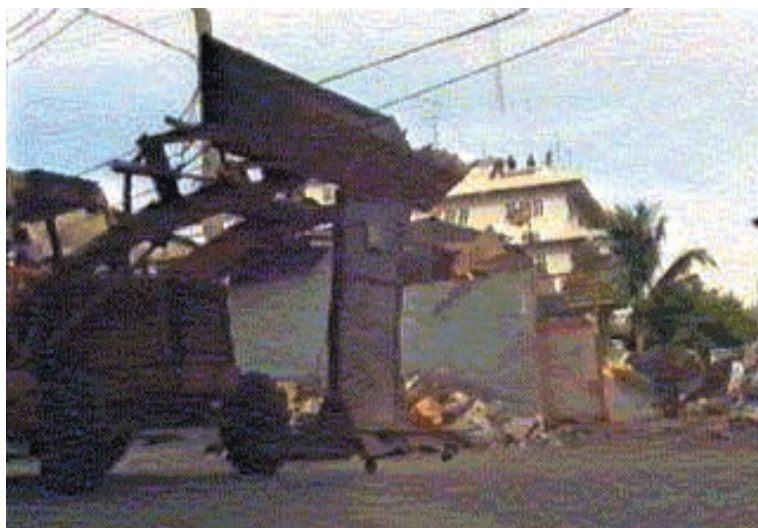
FIG. 8. Back hoe/front loader moving a lead barrier for use in recovery operations (taken from a video image).

To clear a path to the location of the source within the junkyard, a heavy iron fenced entry gate and some scrap were removed with the help of a mechanical excavator. This excavator was also used to place a lead wall 5 cm thick by 1 m wide by 2 m high near the source to provide some shielding to individuals trying to find and recover the source. The dose rate behind this shield was reduced more than twenty-fold. Spotlights and two closed circuit television (CCTV) cameras and monitors were installed to facilitate the operation (Fig. 9).

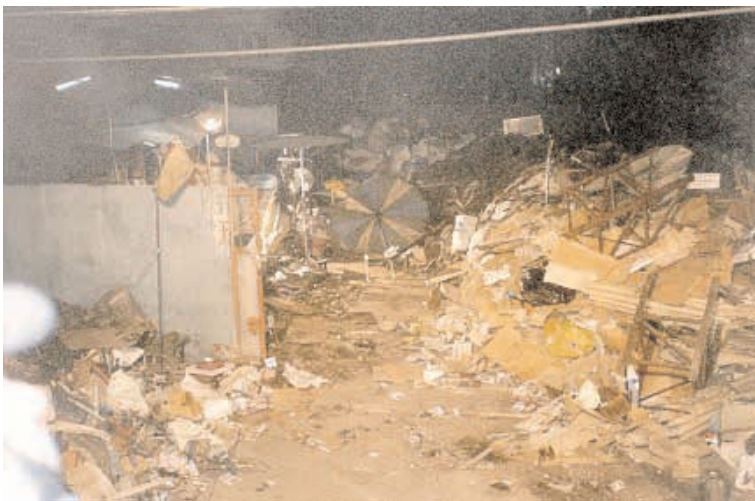
FIG. 9. View of the junkyard rigged for night time operations (taken from a video image).

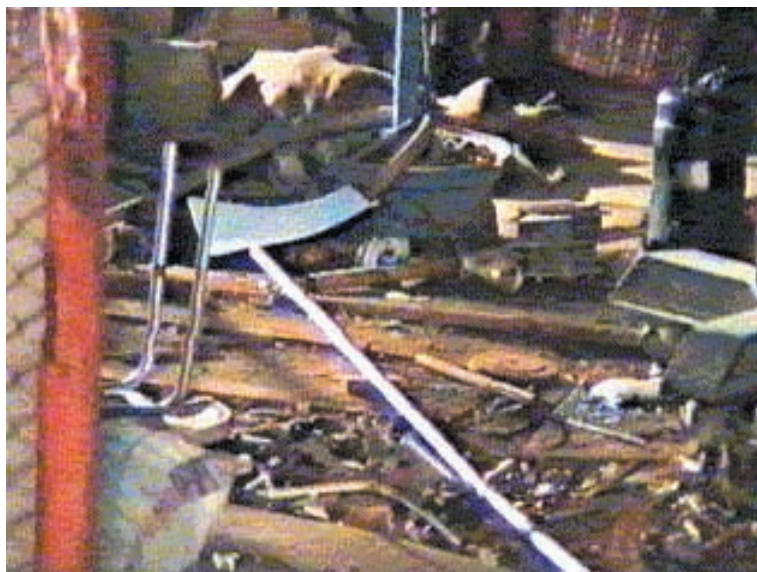
Finally, in an effort to locate the source accurately, a fluorescent screen was used. The fluorescent screen was of a size suitable for image intensification for diagnostic X ray films. However, even with the floodlights turned off, the moonlight was so bright that the source could not easily be located with the fluorescent screen. Personnel had to wait until the moonlight had diminished for suitable darkness in which to use the screen accurately. At around 21:00 on 19 February 2000, the position of the source within the remaining pile of scrap was accurately determined. However, many pieces of scrap metal still surrounded the source (Fig. 10).

FIG. 10. A luminescent screen was used to determine the location of the source accurately (taken from a video image).

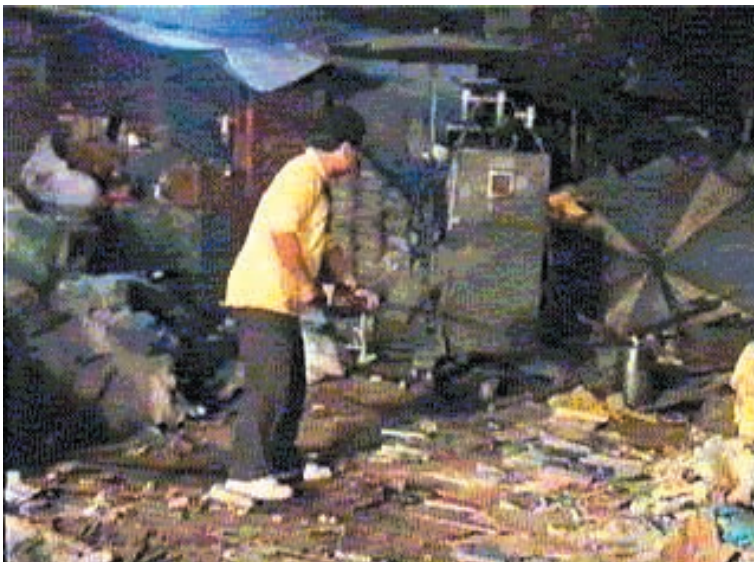
On 20 February 2000 at 00:20, the source, which had been estimated to be about 4 cm long and 2.5 cm in diameter, was retrieved. Tongs 2 m in length were used to pick up the source and place it into a lead shielded container (Fig. 11). The radiation levels in the scrap pile and the yard were surveyed again after removal of the source and container. Only background radiation levels were found, confirming that the source had been successfully removed. In situ gamma spectrometry was performed and the source was identified to be ^{60}Co . The source activity was estimated at roughly 15.7 TBq (425 Ci).

FIG. 11. Transfer of the retrieved source to a shielded transport container (taken from a video image).

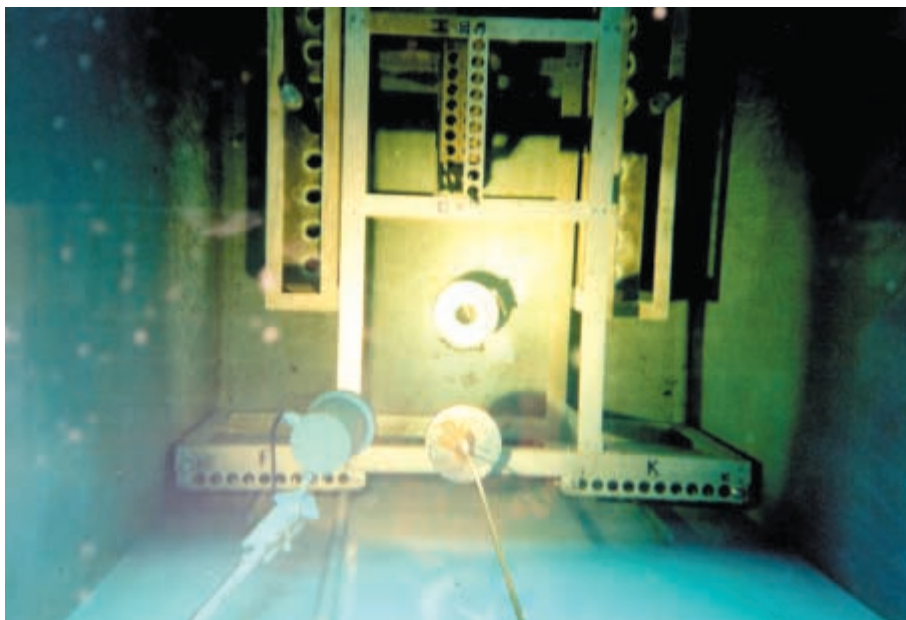
The source was transported to safe storage at the OAEP on 20 February 2000. The lead container containing the source was placed under 4.5 m of water in what was formerly a spent fuel storage pool (Fig. 12).

FIG. 12. Storage location of the retrieved source.

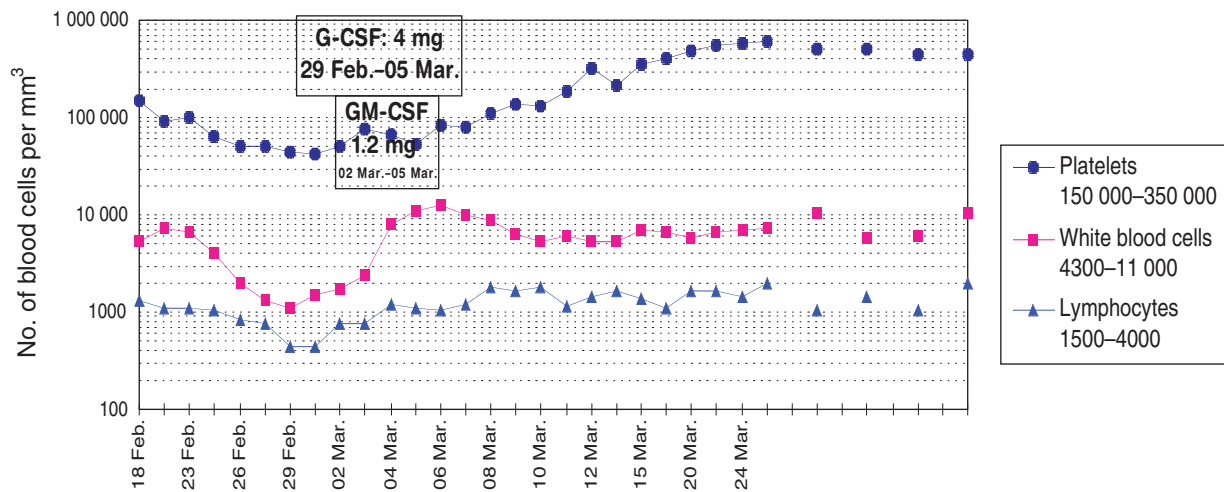
At Rajavithi Hospital, he was treated with a combination of G-CSF (1000 µg/d, which was 20 µg/kg per day on 3 and 4 March, and 500 µg/d, which was 10 µg/kg per day, on 5 March 2000) and granulocyte macrophage colony stimulating factor (GM-CSF) at 300 µg/d, and other treatments he received were as at Samut Prakarn Hospital. His white blood cell count and platelet count increased, and he was taken off G-CSF and GM-CSF on 6 March 2000 (see Fig. 15).

FIG. 15. Haematological chart for P1 while in hospital.

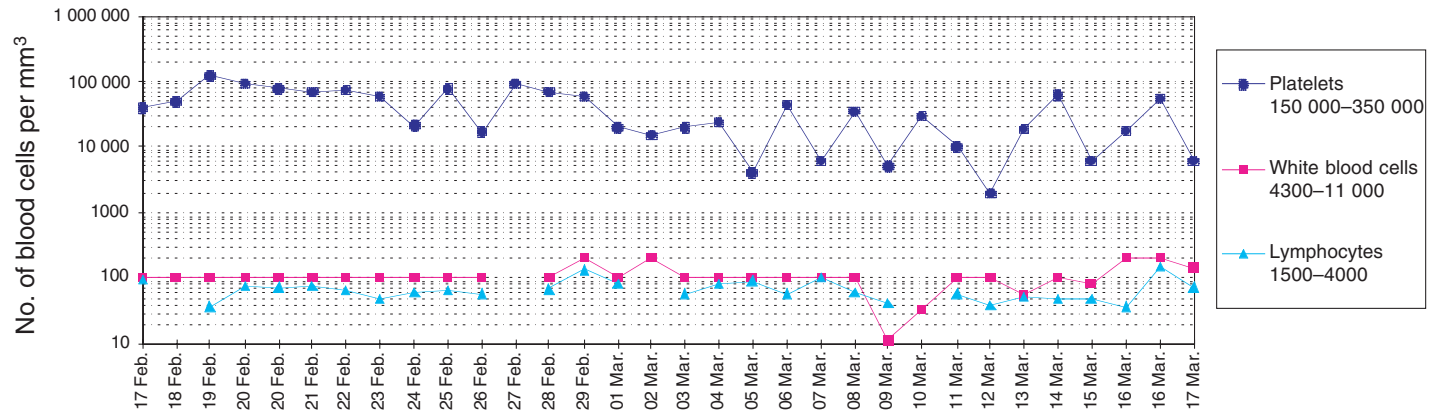
P5 was admitted to Samut Prakarn Hospital on 16 February 2000 with burned and swollen hands. On 17–18 February, his white blood cell count was 100 mm^{-3} , his platelet count was in the range 40 000–50 000 and he had a high fever (Fig. 23).

FIG. 23. Haematological chart for P5 while in hospital.

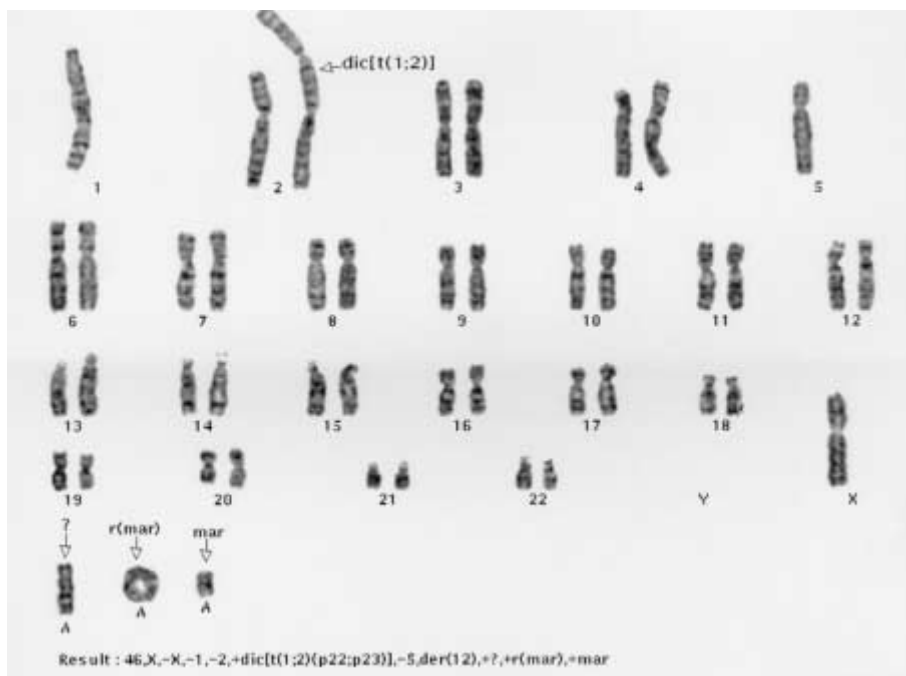
Samples of peripheral blood were drawn on 29 February 2000 from P5–P10. The analysis showed no metaphases in the white blood cells of P5–P9. It was thus concluded that the radiation doses these individuals had received had been sufficient to ablate leukopoiesis. On 1 March 2000, the bone marrow of P10 displayed a complex chromosomal abnormality, presenting seven different patterns, including ring and dicentric chromosomes (Fig. 27).

FIG. 27. Dicentric and centric ring chromosomes in the karyotype of P10 four weeks after exposure.

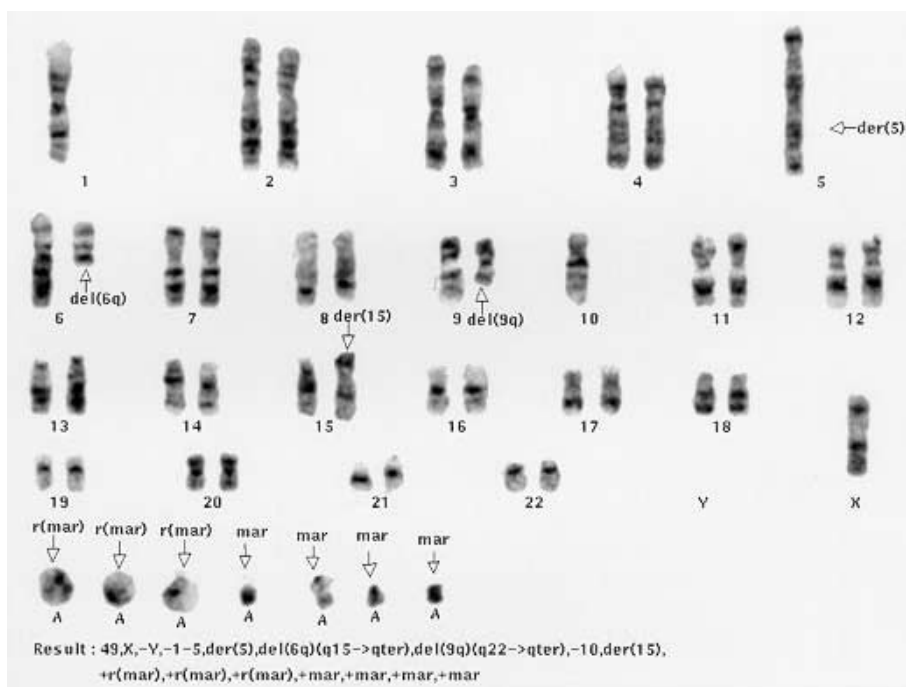
Peripheral blood samples from P2–P4 were taken on 14 March. P3 and P4 presented normal (46, XY) karyotypes, while P2 displayed eight different abnormal patterns, including triple rings (Fig. 28). Some cells showed an unremarkable karyotype. The varieties of the abnormalities shown in the peripheral blood, together with the normal karyotypes, suggests a variation attributable to severe but localized radiation exposure.

FIG. 28. Triple ring chromosomes in the karyotype of P2 six weeks after exposure.
