Material Degradation and Related Managerial Issues at Nuclear Power Plants

Proceedings of a Technical Meeting
Vienna, 15–18 February 2005

**MATERIAL DEGRADATION AND
RELATED MANAGERIAL ISSUES AT
NUCLEAR POWER PLANTS**

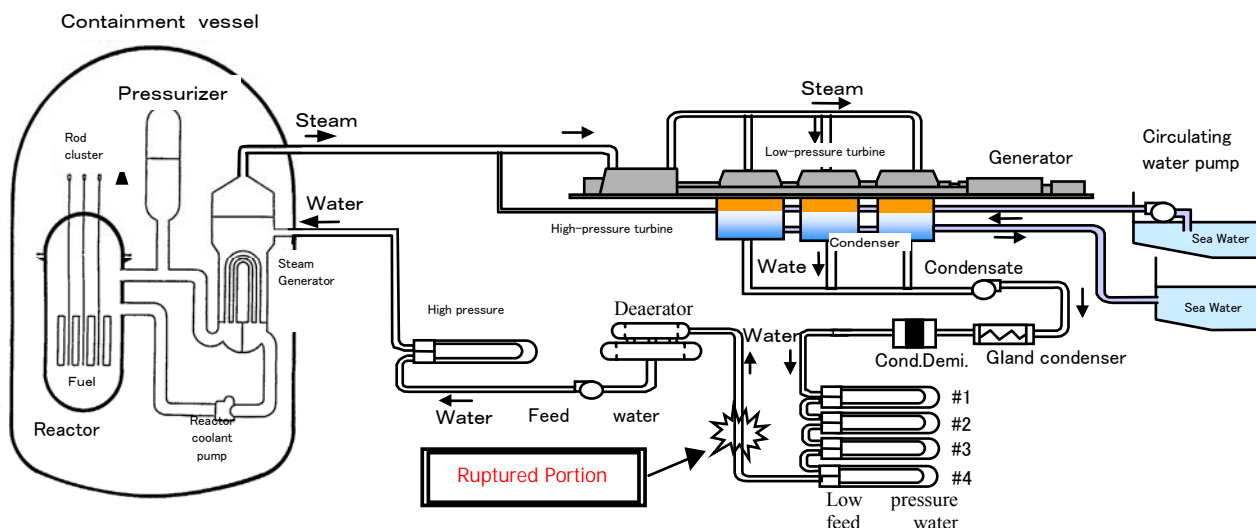
Fig. 1. Mihama unit 3 system diagram.

A secondary side carbon steel pipe ruptured (see figures 2 and 3). Thinning had developed at the downstream of an orifice due to the combination of erosion caused by the mechanical action of the internal water flow and corrosion caused by chemical reaction. The pipe had gradually lost its thickness, which led to a loss of strength and eventually to a rupture from internal pressure (about 1 MPa). The investigation has revealed that the dimple pattern typical in this kind of phenomenon was found on the inner surface of the pipe.

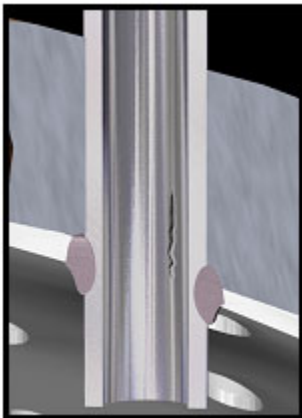
Fig. 3. Depiction of Through Wall Cracking Leakage.

The Davis-Besse organization believed that the boron accumulated on the RPV head was due to leaking control rod drive mechanism flanges above the RPV head and that such accumulation would not cause corrosion due to the elevated temperatures at that location. This boron accumulation on the top of the RPV head was not fully removed during refueling outages and it masked the typical “popcorn” boron indication from a nozzle containing a crack (see Figure 4). Accordingly, the boric acid emitted through the nozzle crack was allowed to corrode the carbon steel head creating a cavity.

To resolve the degradation of the reactor vessel head FENOC initially considered repairing the damaged area but ultimately decided to replace the head. An unused head from an uncompleted facility was procured and installed on the Davis-Besse reactor vessel. The service structure for the head was modified to enable enhanced inspections in the future. A new head, with nozzles constructed of Alloy 690, a material less susceptible to PWSCC, has also been ordered and will be installed in a future outage.

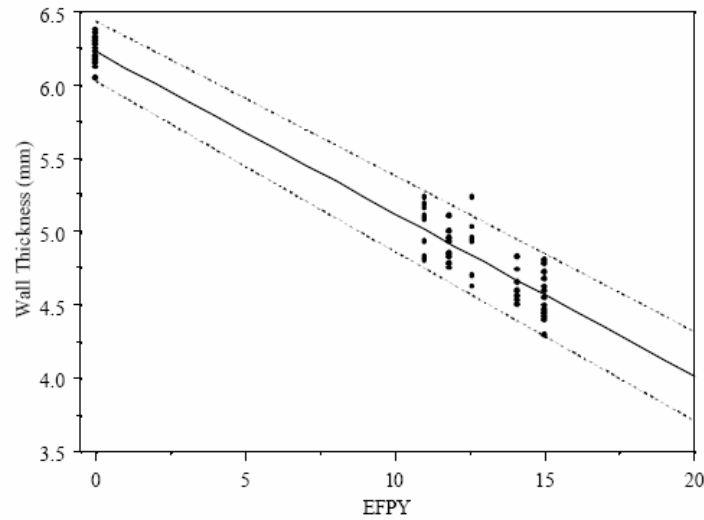
Fig. 3. Typical example of wall thinning rate assessment. The solid line is the mean wall thickness calculated using a weighted linear regression. The dashed lines enclose the 95% prediction interval.

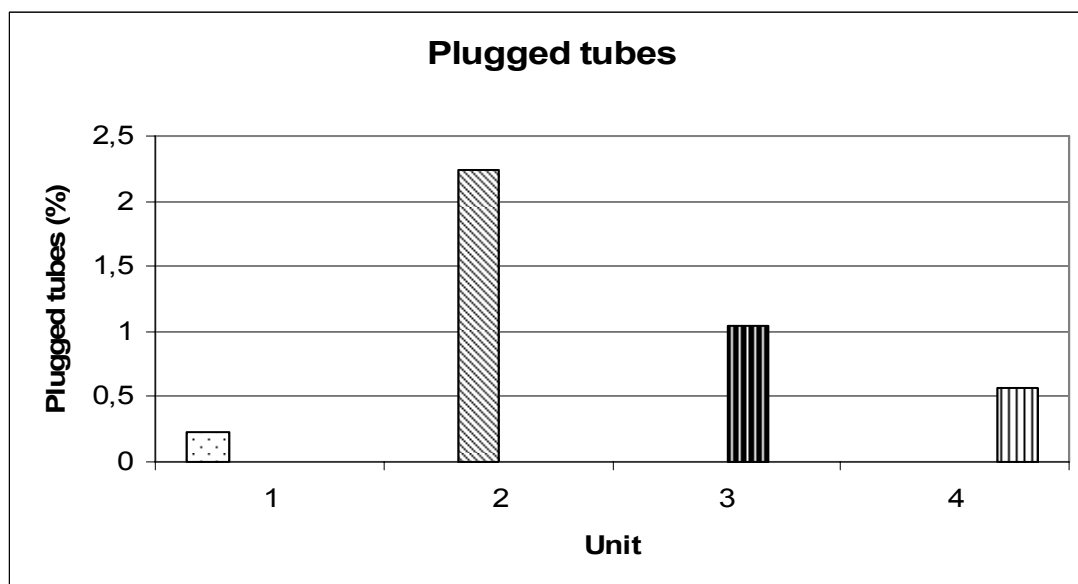
Fig. 1. Percentage of plugged tubes on SGs.

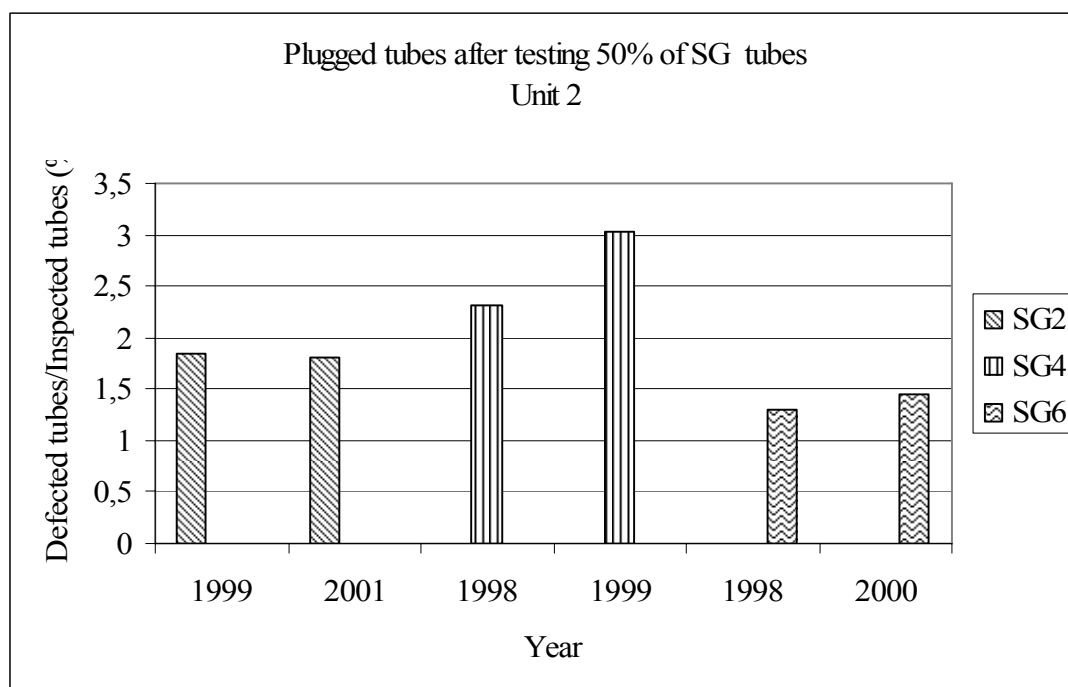
Fig. 2. The frequency of defect in Unit 2.
