Unusual occurrences during LMFR operation

*Proceedings of a Technical Committee meeting
held in Vienna, 9–13 November 1998*

IAEA-TECDOC-1180

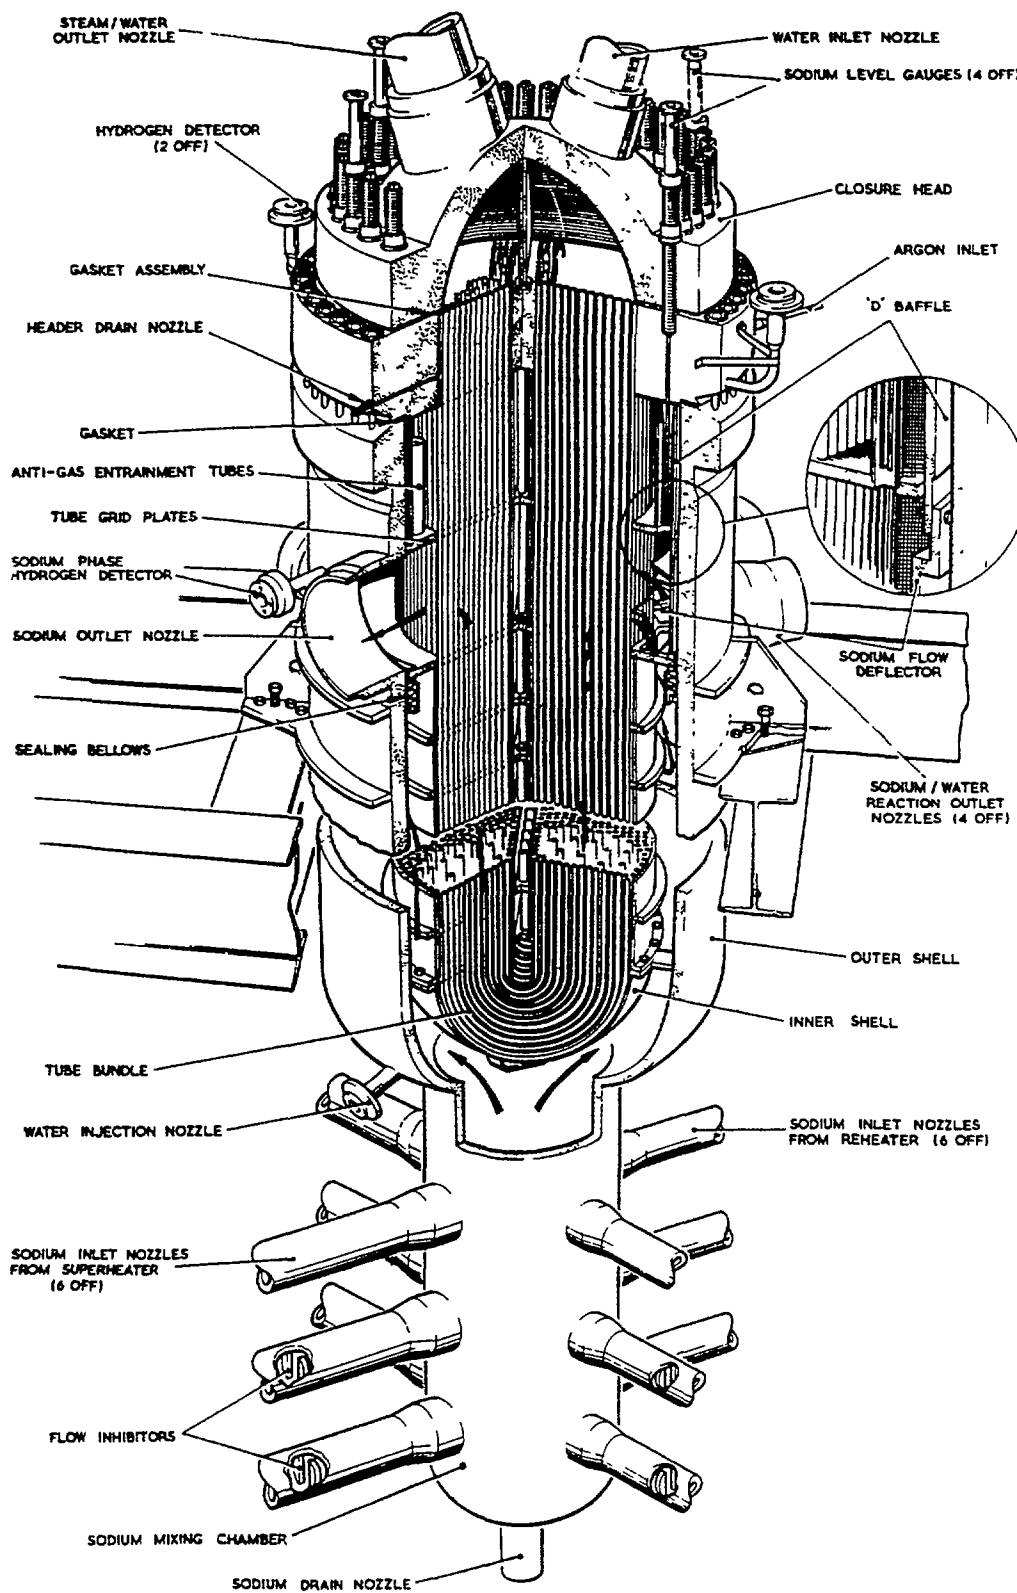
Figure 1.2. A PFR Evaporator

The 33 leaks experienced in the ferritic steel evaporator units (Figure 1.2) were relatively benign as ferritic steel is not so subject to caustic stress corrosion, but the effect on availability while leaking tubes were being repaired was considerable.

The evaporator gas space leaks were all associated with cracking of the tube-to-tubeplate welds. These were hard and had high residual stresses because there was no post-weld heat treatment. None of the evaporator leaks gave evidence of wastage damage to the neighbouring tubes, probably because they were detected early by the installed gas-space hydrogen detection system. This was based on katharometers and was very sensitive, being capable of detecting leaks as small as 0.1 mg/s. The leaks were repaired by plugging the affected steam tubes.

Nevertheless it appeared that one leak would, after a few days or weeks of further operation, cause others. It was concluded that residual caustic reaction products in the gas space above the sodium caused further cracking of welds and initiated more leaks after an incubation period. Sodium flooding of the tubeplate at a temperature in excess of 400 °C for periods in excess of 24 hours had some success in removing reaction products. It was also required to wash out sodium hydrides which could lead to false hydrogen detection signals when they dissociated at high operating temperatures.

This did not cure the problem completely, however, and eventually it was concluded that washing with hot sodium did not remove caustic material from the roots of pre-existing fine cracks in the welds, so that in the presence of the residual stresses corrosion continued and the cracks grew to give rise to further leaks.

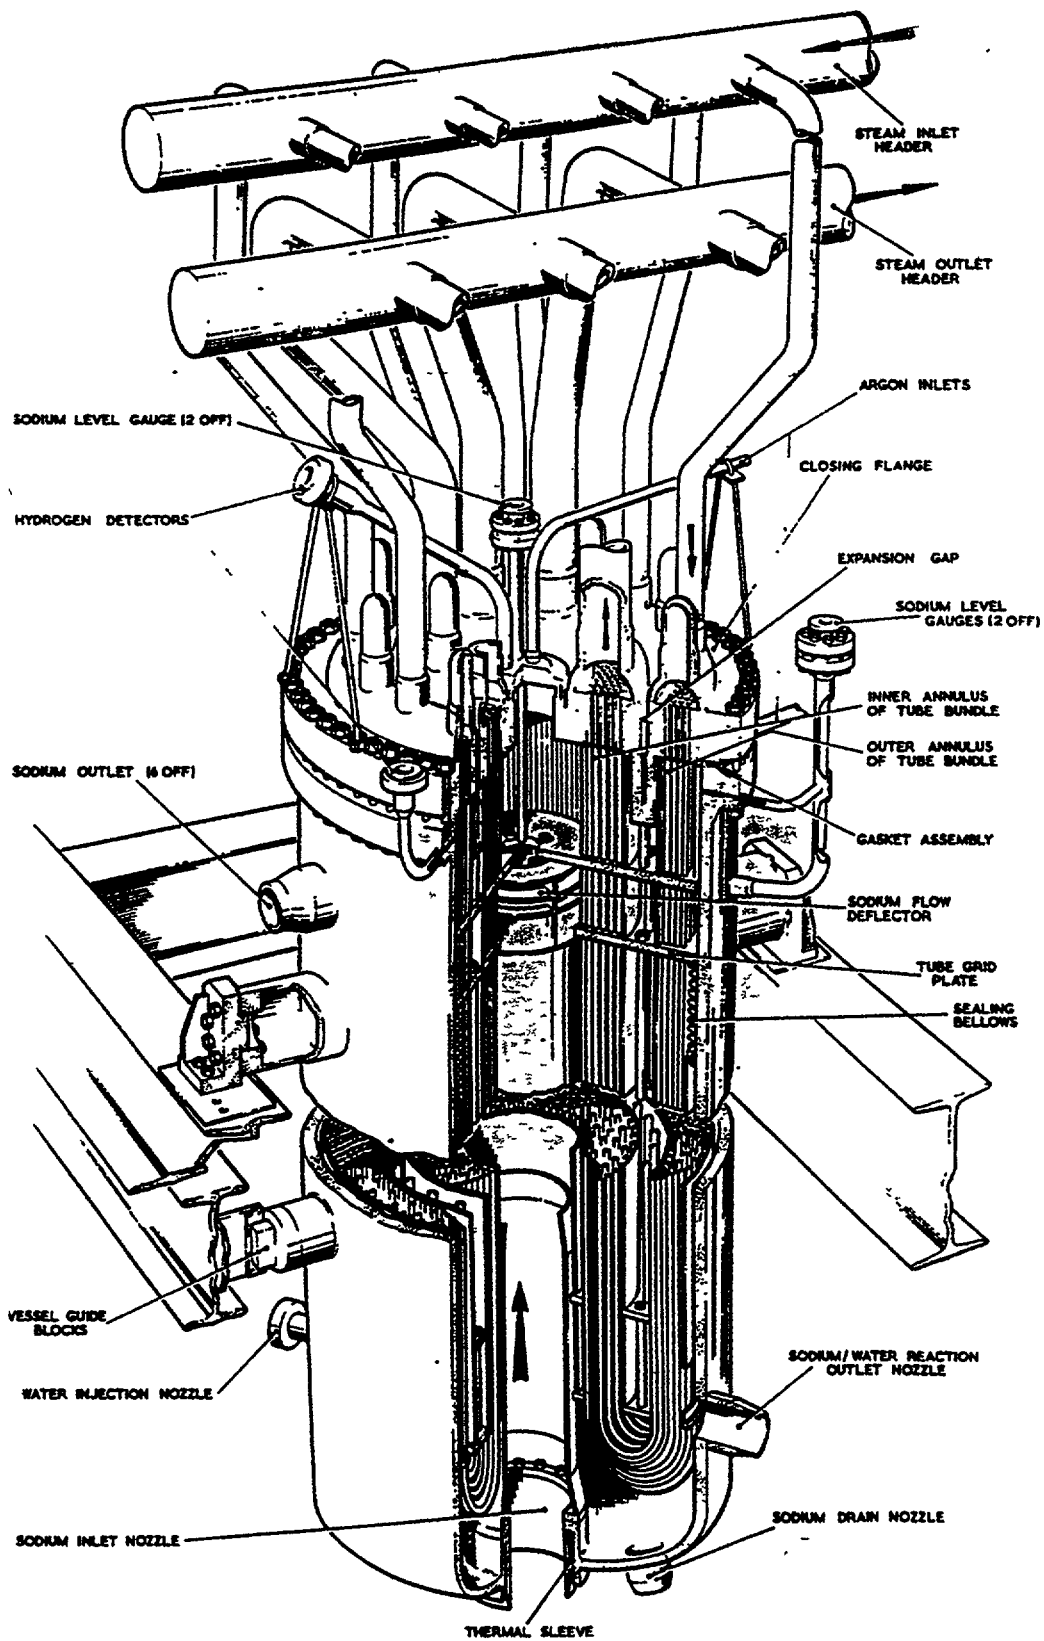
Figure 2.1 An Original PFR Superheater

It was confirmed shortly after the incident that a large under-sodium leak had occurred in superheater 2. Figure 2.1 shows one of the original PFR superheaters. After the sodium circuit had been cleaned to remove reaction products the superheater tube bundle was removed from its vessel in a nitrogen-filled bag and examined. This revealed that between two tube support grids one of the six baffle plates forming the central sodium inlet duct had become detached, and the remaining 5 plates in this region were deformed. Considerable distortion of steam tubes could be seen through the aperture left by the missing baffle plate.

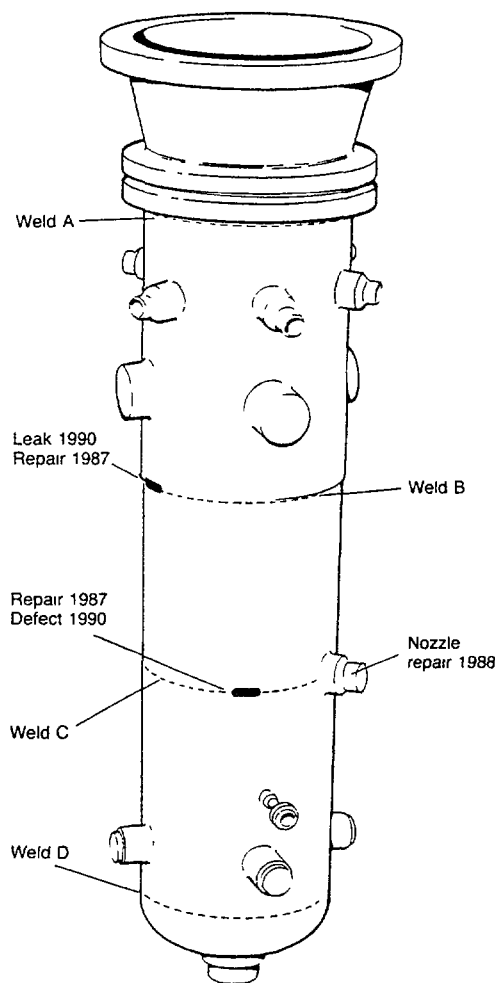
Figure 3.1. PFR Reheater 1 Vessel

Figure 3.1 shows a typical steam generator vessel. The vessels were manufactured from cold rolled annealed type 321 (18Cr 10Ni 1Ti) austenitic steel plate. Three cylindrical courses, together with a flanged upper end and a domed lower end, were welded using type 347 (19Cr 9Ni 1Nb) weld metal. Manual metallic arc weld root runs with submerged arc weld fill were used. During manufacture the welds were inspected and in some cases inclusions and other defects were found. These were ground out and made good with additional rectification welds. None of the welds was stress-relieved. The vessels were considerably overdesigned to withstand a continuous pressure of 34.5 bar, although the operating pressure was only 2 bar.

The first crack occurred on a reheater pipework tee junction in 1983, and the second on a superheater pipework reducer in 1986. Both caused minor sodium leaks. The cause of the cracks was not identified at the time. Both leaks occurred at welds in which the large crystal grain size indicated severe overheating during fabrication.

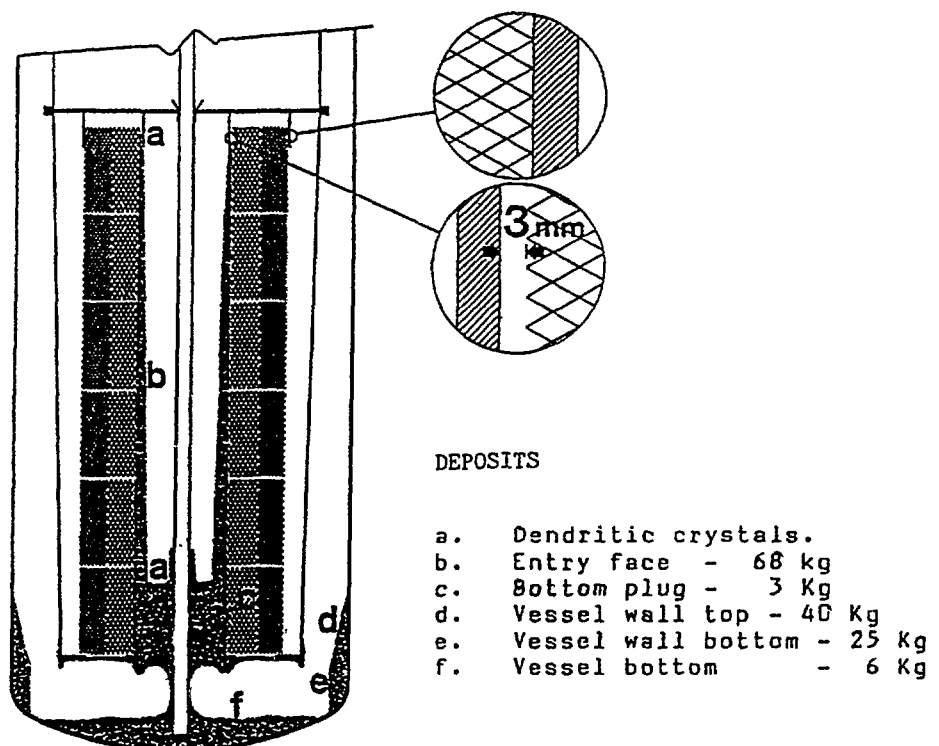
Figure 4.2. The Location of Deposits in the PFR Secondary Cold Trap

The results of the examinations are shown in Figure 4.2. The deposits in the mesh were mixtures of sodium, sodium oxide and sodium hydride of varying composition, while the deposits on the sides and bottom of the vessel consisting virtually entirely of residual sodium. Detailed examination of the mesh doughnuts showed that the deposits were largely confined to the inner part of the annulus and the bottom, which was completely blocked.

Inefficient operation of the PFR secondary cold trap led to impurity loadings below the theoretical maximum. Improved trapping techniques aimed at avoiding cooling the sodium too far below its saturation temperature, and more careful operation solved the problem after 1981.

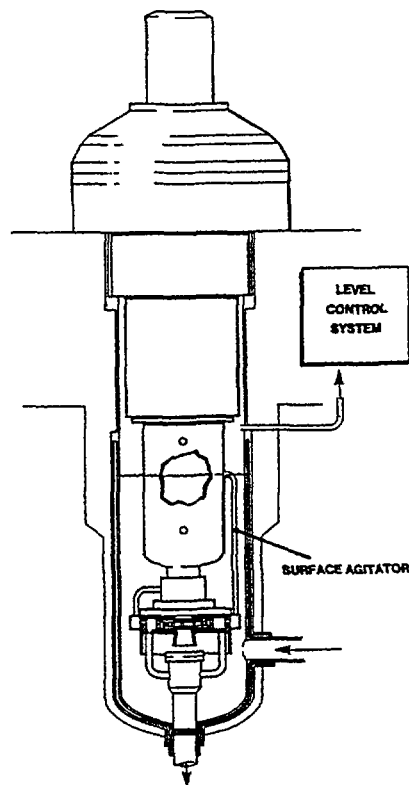
Figure 5.3. Modification of the PFR Primary Cold Trap Pumps

During maintenance it was noted that oxide or hydride could be seen floating on the surface of the sodium in the pump tank. It was considered that such material, if raised inadvertently into the vent or feed lines, would contribute to the blocking of the gas valves. In 1988 both main and standby pumps had seized during the year, so during refurbishment a modification was carried out on the pumps to deal with the accumulation of these solid impurities. A jet of sodium was diverted from the discharge sides of the pumps to disperse the deposits and prevent valve blockages, as shown in Figure 5.3. This modification was not entirely successful in preventing further blockages and the pumps seized again in 1989 and 1990.

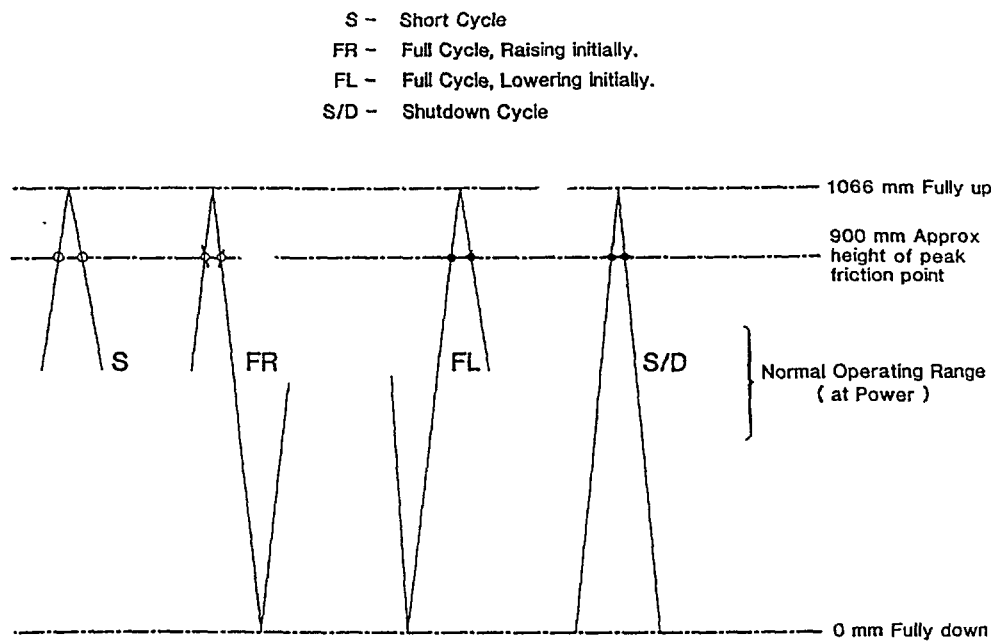
Figure 6.2. Movement of the PFR Absorber Rods during Exercising

Typical rod movements during exercising are shown in Figure 6.2. The exercising was found to have the effect of reducing friction. Peak friction occurred at about 900 mm (see Figure 6.2) but the magnitude depended on whether the rods were raised or lowered first. Lowering first reducing friction levels. Figure 6. 3 shows an actual trace of friction for a control rod, which in this case started by being raised. The actual weight of absorber plus extension tube is 230 kg. The dotted line marked FINISH is an immediate partial repeat of the test showing the decrease in friction resulting from the first test.

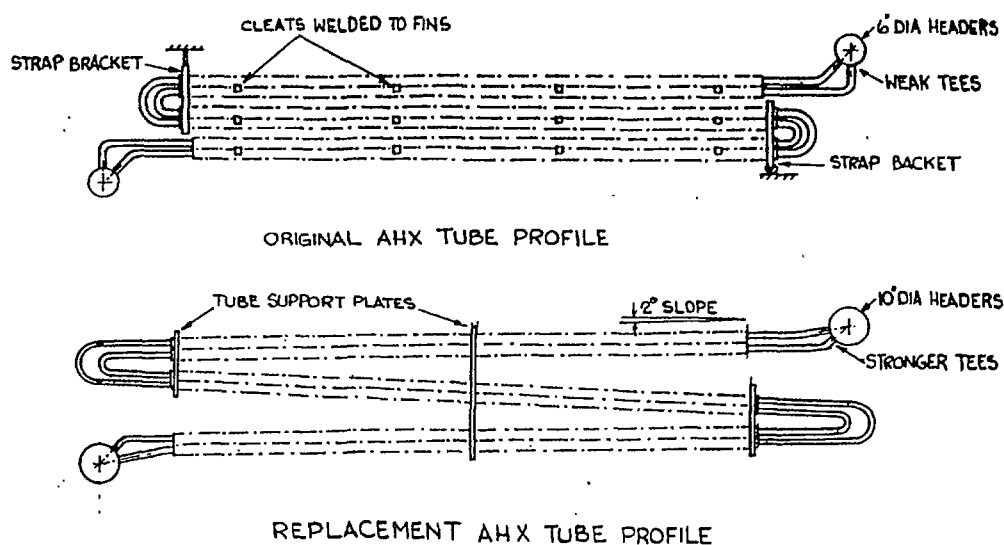
Figure 7.2. The Original and Replacement PFR Thermal Syphon Air Heat Exchangers

Although the thermal syphon system operated well, by 1984 it had become apparent that the AHXs suffered from a systematic fault leading to failures and leaks. Each AHX consisted of forty serpentine parallel tubes welded to pulled tees in two headers, as shown in Figure 7.2. The tubes were finned along the straight lengths but plain at the bends, which were clamped together and supported. Further rigidity was provided by cleats which were welded to the tops of the fins on adjacent tubes. Flow of NaK was from the top down. Leaks were occurred at the welds between the tubes and the pulled tees in the headers.

The measurements indicated that the problems occurred essentially because the AHX tubes were in parallel, and were horizontal with no fall to ensure good filling. When the AHXs were filled gas locks were occurring at the pipe bends. The gas-locked tubes remained cold, and as a result oxide impurities could be precipitated causing permanent blockages. Because of temperature differences between a cold blocked tube and the adjacent hot tubes to which it was clamped, large stresses were imposed. As a result the weakest point in the system, the weld between the tube and the header, was stressed, suffered cracking and eventually leaked.

Replacement AHXs (RAHXs) were manufactured to an improved design which avoided the problem of gas locks and afforded greater toleration of loss of flow in individual tubes. The following changes were made and are shown in Figure 7.2.

1. A 2° slope was given to the tubes to give better venting and drainage.
2. Each tube was given individual support,
3. The tube-header connections were reinforced.
4. Larger diameter headers were fitted to give better NaK distribution.

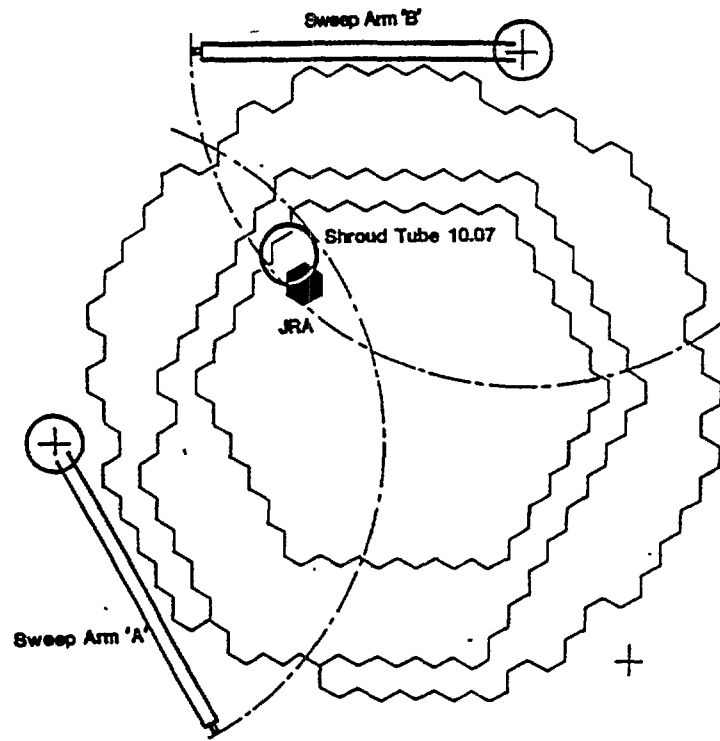
Figure 8.1. Location of an Elongated Subassembly in the PFR Core by the Sweep Arms

Immediately before refuelling operations in PFR three sweep arms were employed to ensure that there were no obstructions above the core which would prevent rotation of the rotating shield, as shown in Figure 8.1. At the start of a reload in 1988 the sweep arms were found to contact or partially contact objects in two core positions. These positions were identified as containing subassemblies with cold-worked EN58B steel wrappers, with a calculated dose of greater than 60 displacements per atom (dpa).

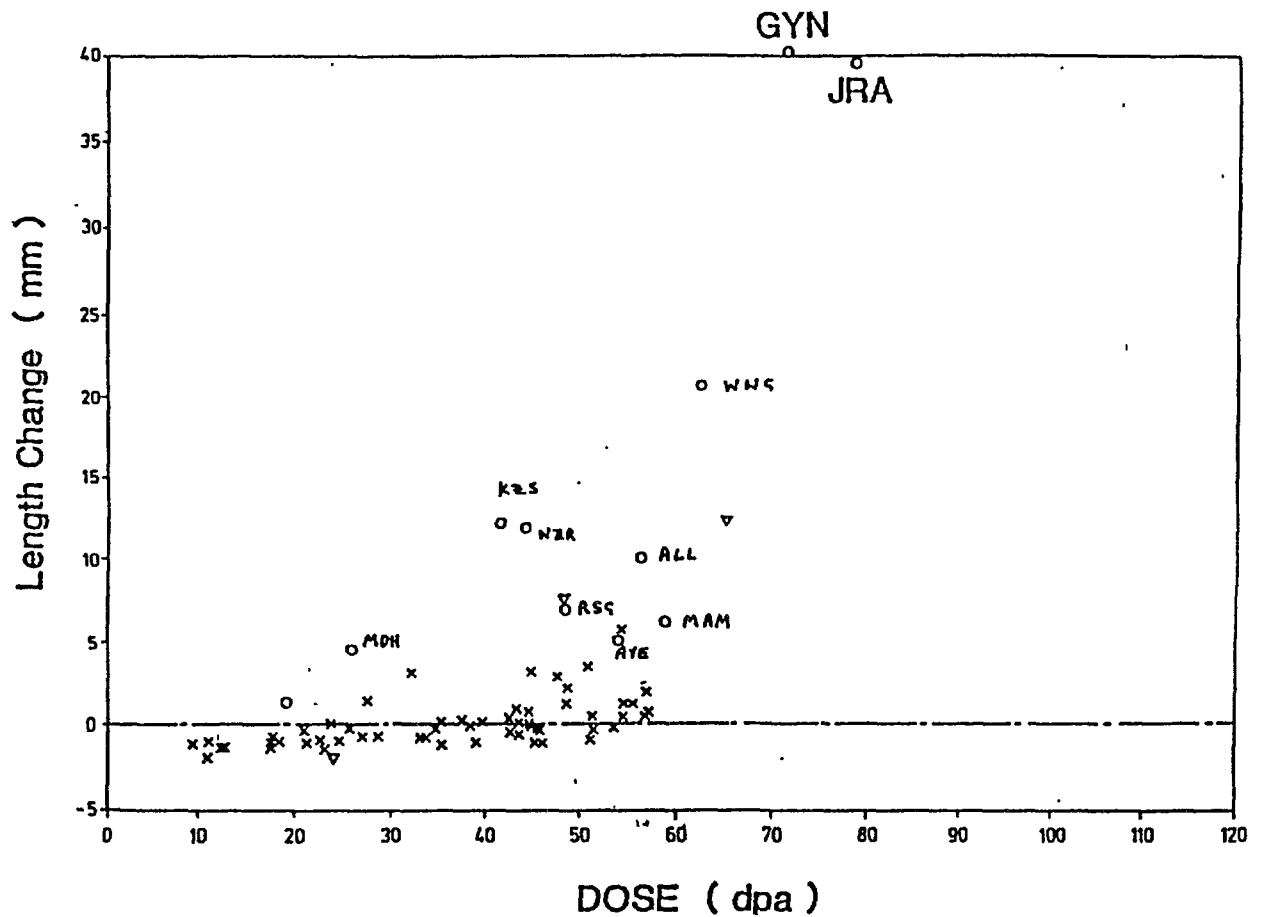
Figure 8.2. Increase in Length of EN58B Subassemblies in the PFR Core

Using a special tool the heights of all subassemblies of the same material were checked. A distinct trend of rapid increase of growth at doses above 50 dpa was revealed as shown in Figure 8.2, although not all subassemblies were affected. Two subassemblies in particular, "JRA" and "GYN" (see Figure 8.2), had measured growths of about 40 mm. As a result all components with predicted doses likely to exceed 50 dpa by the end of the next run were removed from the core. Considerable difficulty was experienced in handling the severely distorted components and special tools had to be manufactured for their extraction and removal from the reactor.

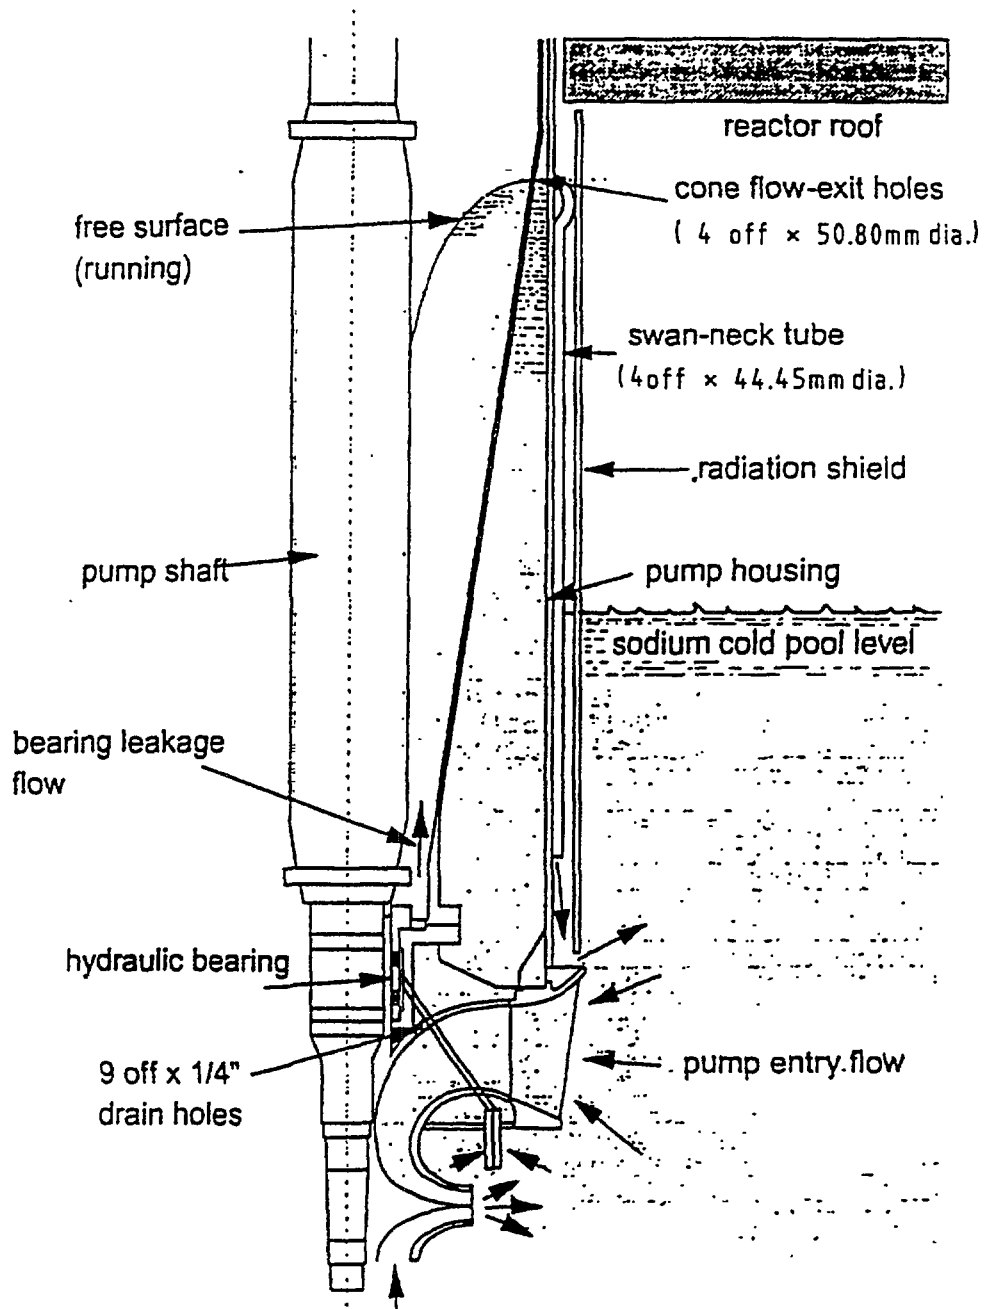
Figure 9.3. Detail of a PFR Primary Sodium Pump Housing

During this period of operation some 65 litres of oil had been lost from the pump upper seal oil systems, part of which is believed to have entered the reactor vessel. When the reactor was taken critical no effects of the oil were observed. It is suspected, however, that as a result of the spill the filter on PSP 2 valve ("O" in Figure 9.2) failed due to high differential pressure because it became blocked by oil-sodium reaction products. It is also thought that partial blockage of the pump casing overflow pipe (Figure 9.3) was to lead to the major problem in 1991.

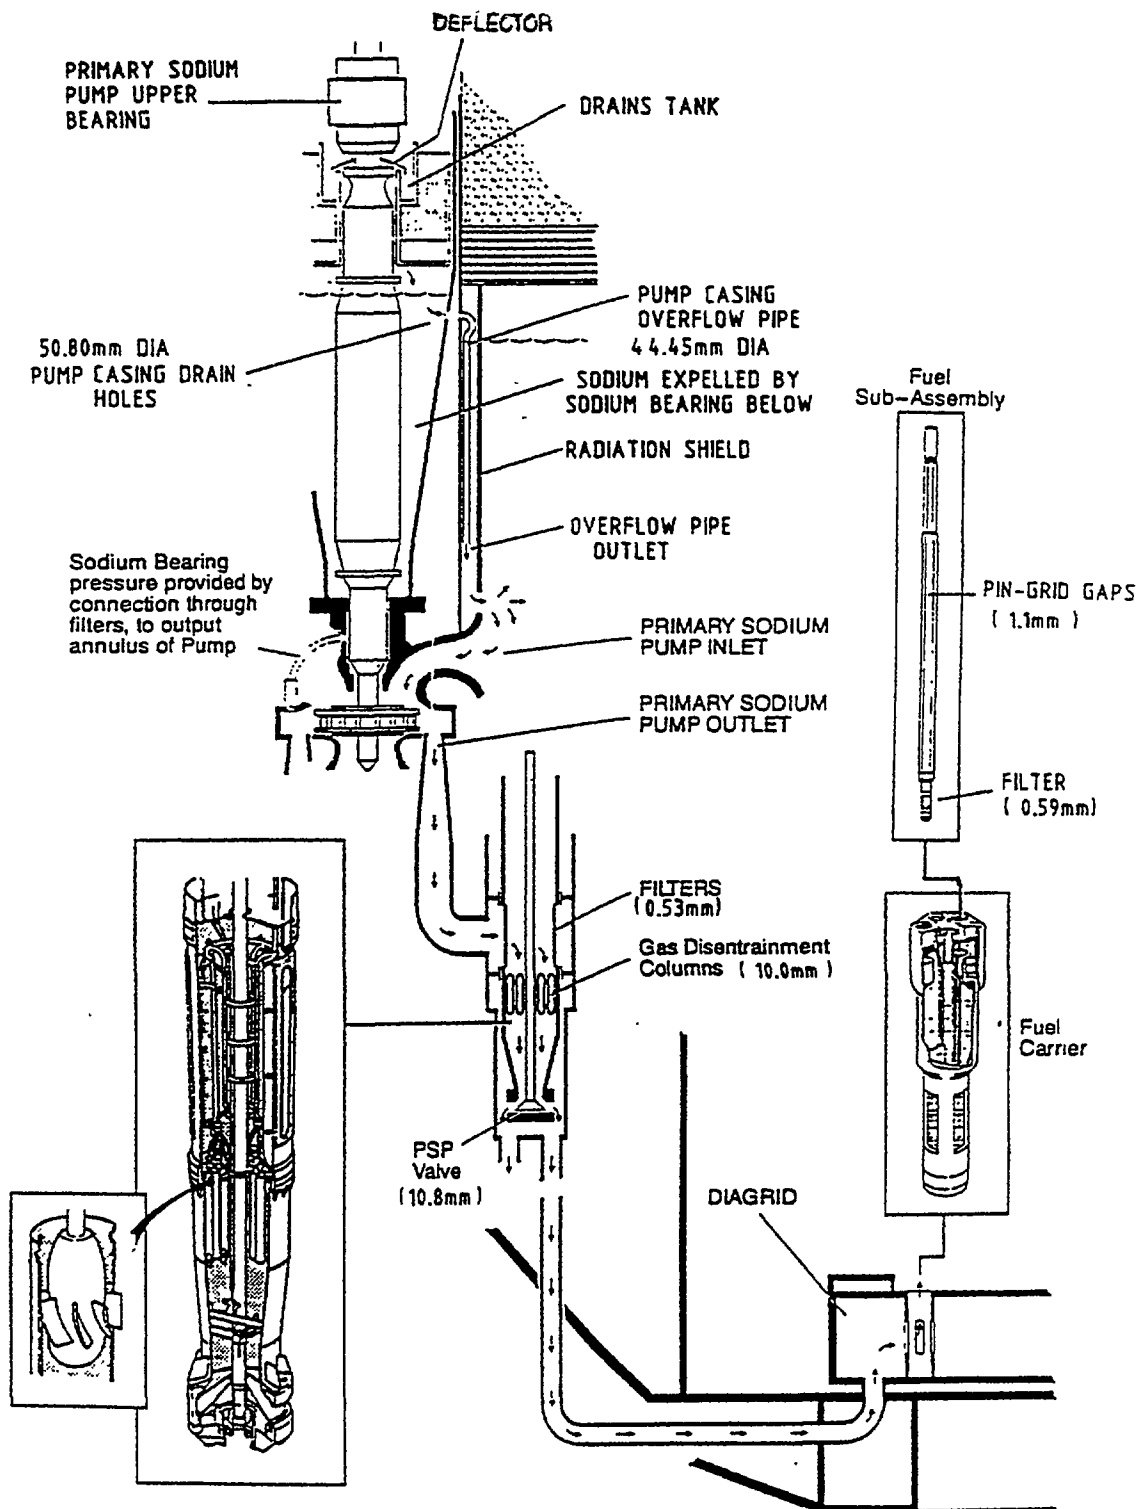
Figure 9.4. Filter Mesh Sizes in the PFR Primary Circuit

fell and the flow of coolant through the core increased. A similar sequence of events occurred a few weeks later, when flows and current returned to normal. Although no oil spill was recorded it is now believed that oil had entered the system and blocked the filter of PSP 1, causing it to fail in stages. When it had failed completely and offered no resistance the coolant flow returned to its normal value.

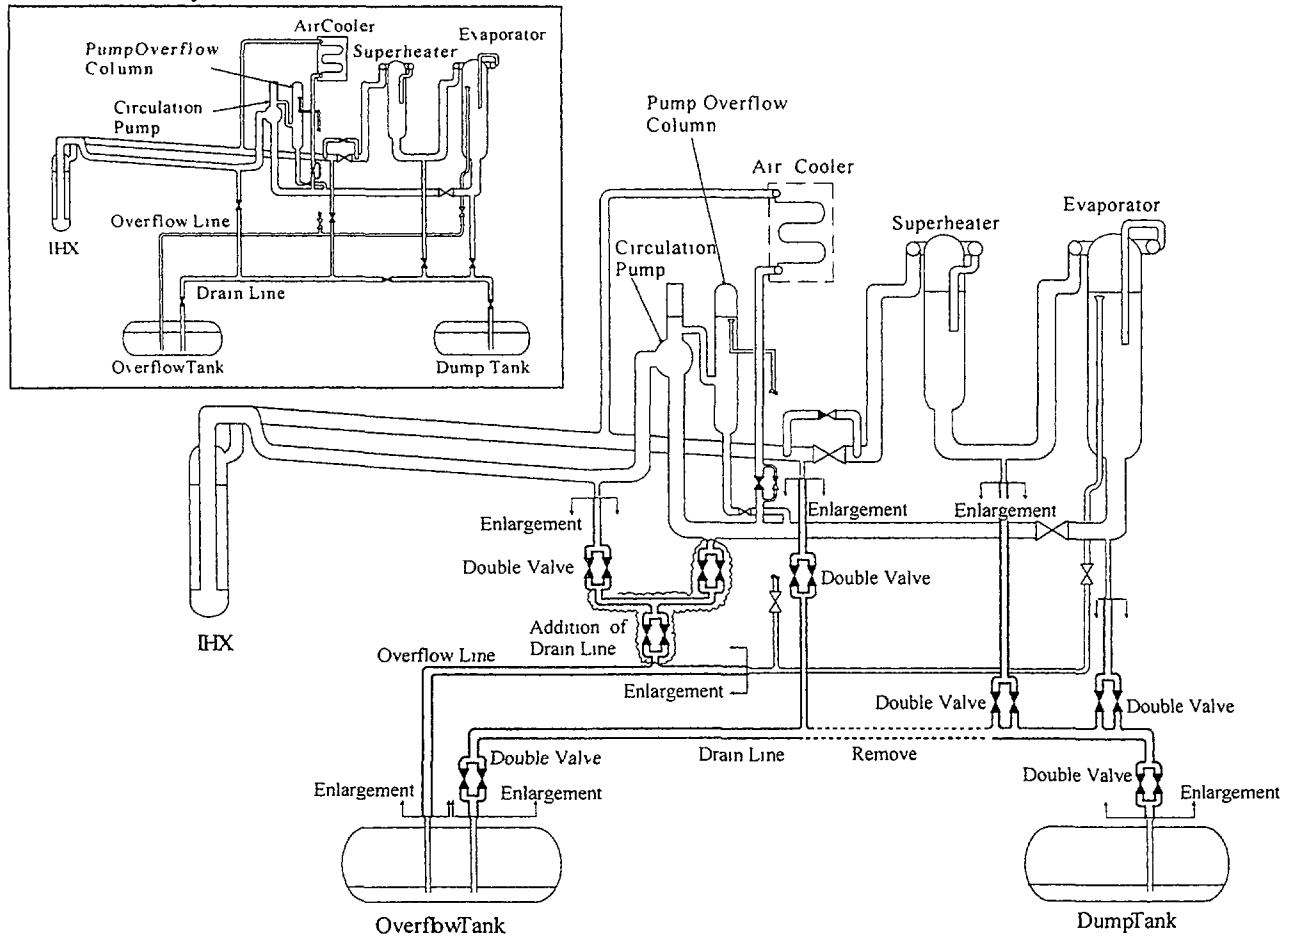
Fig. 9. Modified drain system.

To reduce the quantity of sodium leakage, the drain system was found to require two improvements. One is the addition of a new drain line pipe at the inlet of the secondary pump. The other is the replacement of all drain lines by pipes of larger diameter. In the existing system, each drain line has two drain valves in series to prevent accidental draining by single valve action error. In future so as to assure the draining, each drain line will have double drain valves in parallel. After these improvements, the drain time will be shortened from approximately 50 minutes to 20 minutes. It is estimated that it takes 40 minutes from the occurrence of sodium leakage to finish the drain for the secondary circuit. The modified drain system is shown in Fig.9.

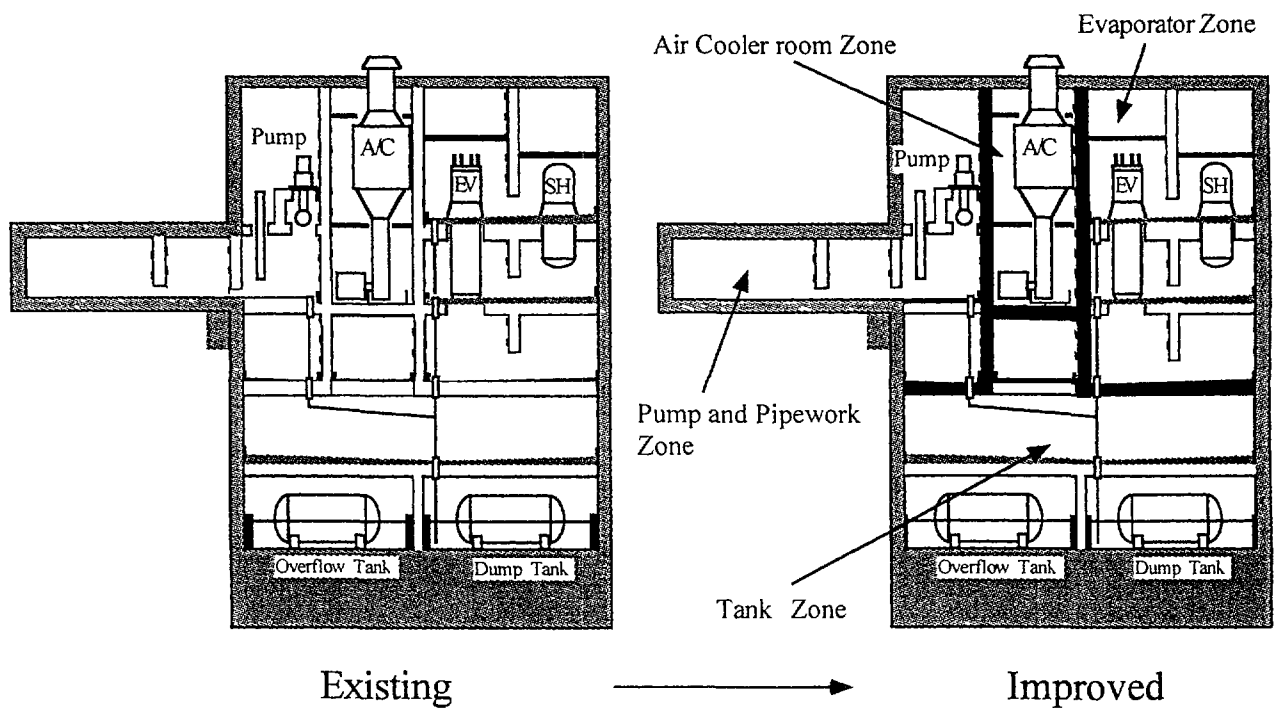
Fig. 10. Partition of the secondary circuit area.

To limit the diffusion of aerosol and the combustion of sodium more quickly, the area associated with each secondary circuit will be divided into four smaller zones. At first, more than four smaller zones were considered because partition is effective in controlling the diffusion of aerosol. However, it was found to be difficult to provide a dust-tight structure for some of the large openings between the proposed zones which allow air transfer. It was also difficult to prevent pressure in smaller zones from increasing and it is almost impossible to replace the existing ventilation ducts. Hence, four zones were adopted as the optimal solution. The openings for the cables or pipe penetrations through the wall between each zone will be improved to be almost airtight and additional isolation dampers will be fitted in the ventilation ducts between each zone. Pressure release lines will be installed to prevent an increase in internal pressure resulting from the smaller zones. The partition of the secondary circuit area is shown in Fig.10.

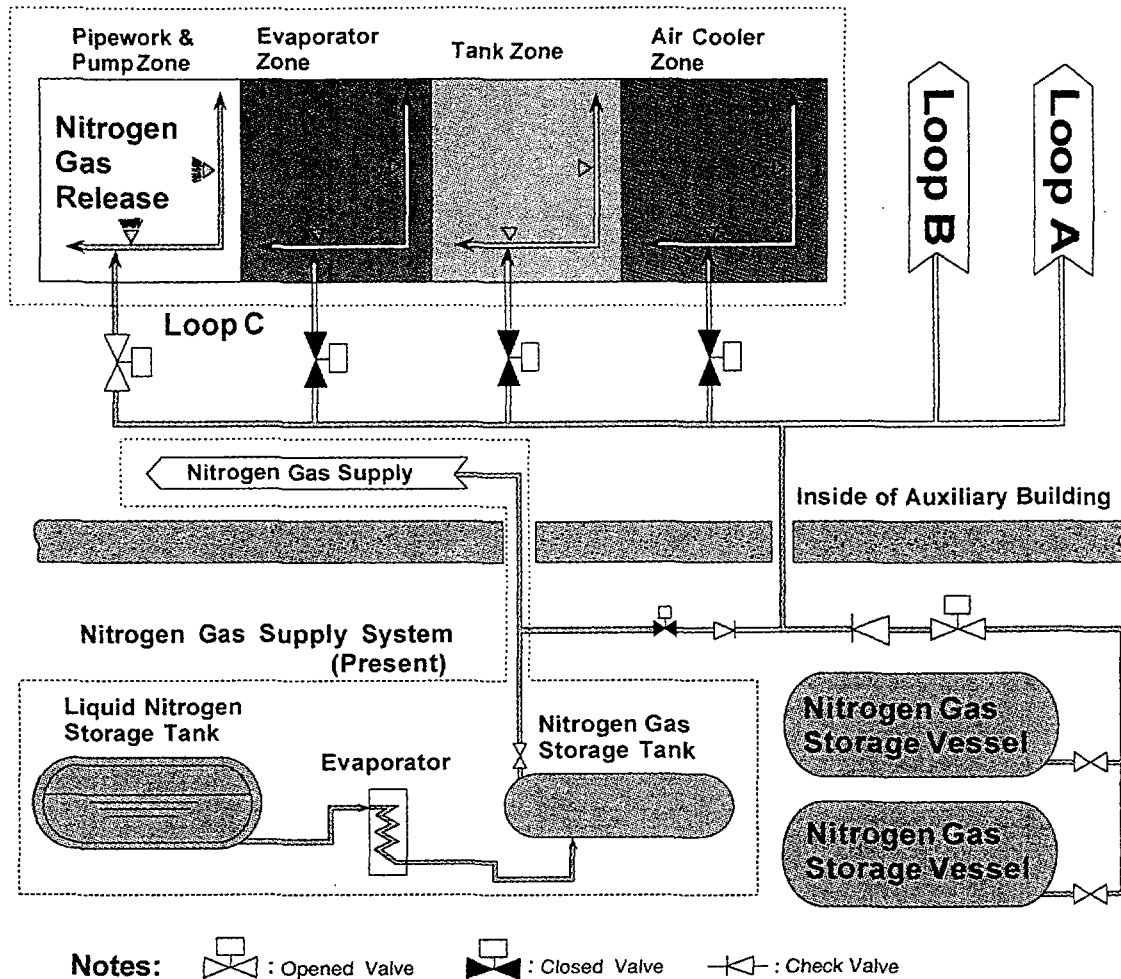
Fig. 11. Nitrogen injection system.

To extinguish the sodium fire more quickly and to prevent it from re-igniting in contact with oxygen, a nitrogen gas injection system will be installed to cut off the supply of oxygen. The nitrogen injection system is shown in Fig.11. The tanks are common to the entire system and the piping is connected to the each zone. After the personnel evacuation of the secondary circuit is confirmed, the operator will release nitrogen gas into the affected zone. According to an assessment of the relationship between nitrogen flow rate and extinguishing time, if more than 10,000 Nm³/h of nitrogen gas is injected, a sodium fire can be extinguished within 15 minutes for any sodium leak rate.

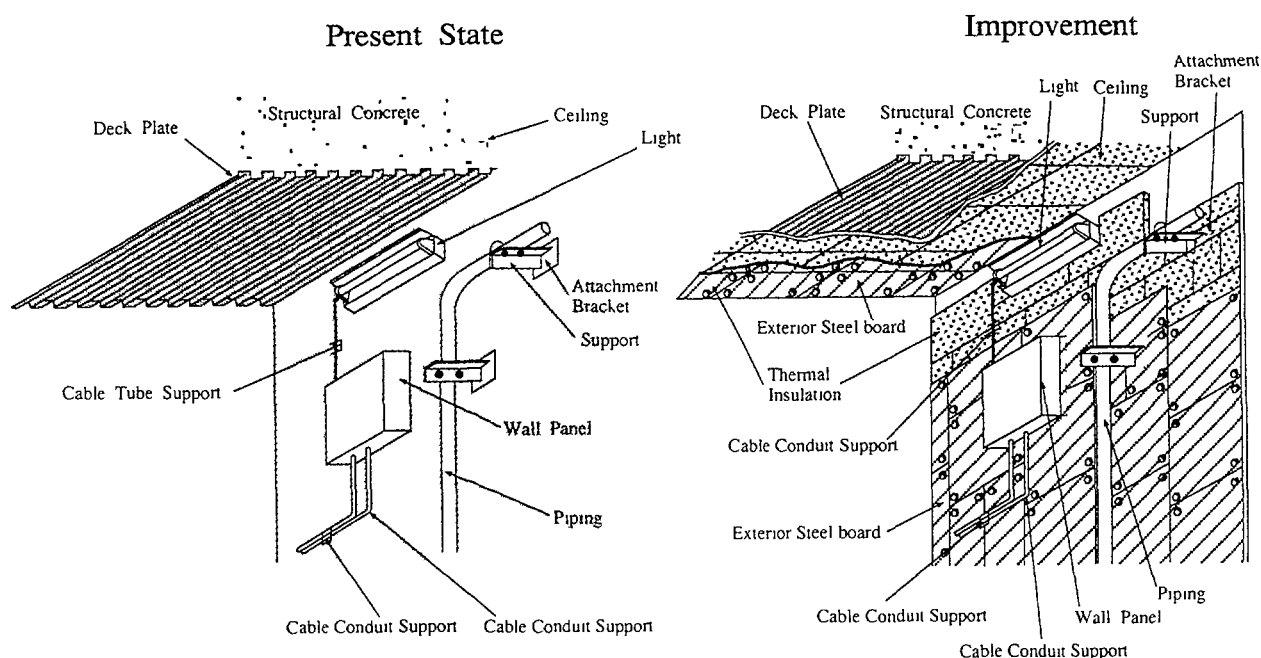
Fig. 12. Thermal insulation for walls and ceiling.

To reduce the water release from the structural concrete, thermal insulation will be fitted to the walls and ceilings. This is important because if a large amount of water vapor is released from the concrete during a sodium leak, there is an increased probability of generation of hydrogen and corrosive hydroxide in the chemical composition of the sodium debris. By using insulation, the temperature rise of the wall can be brought down to under approx. 100°C. The structure of thermal insulation is shown in Fig.12.

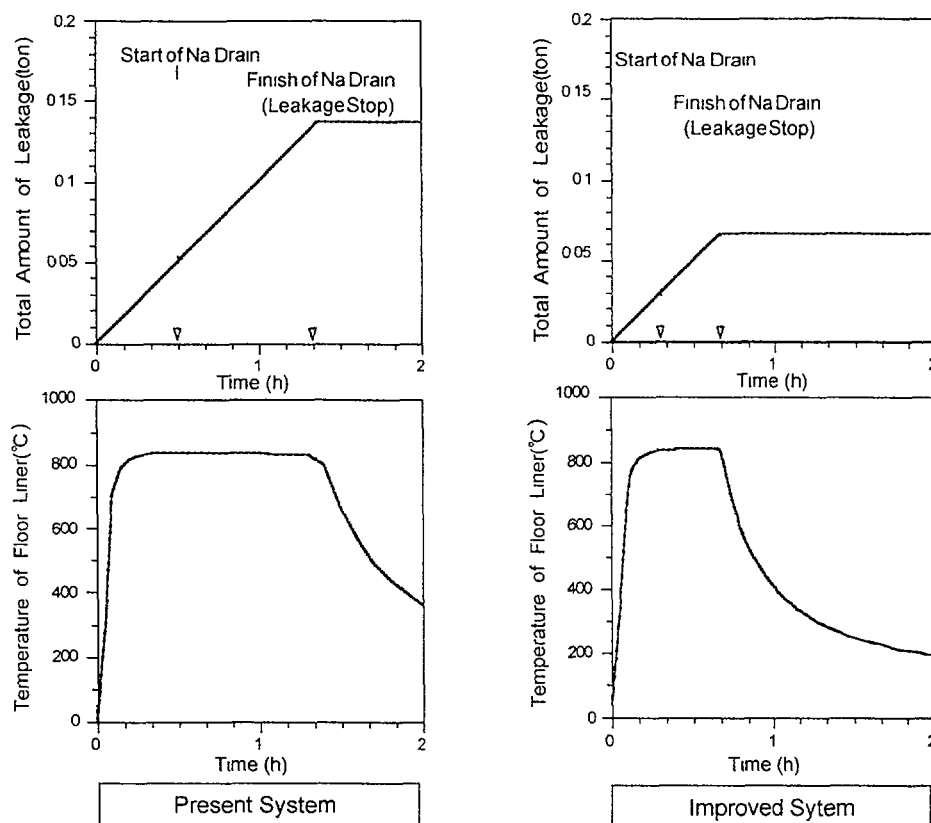
- (1) Since the duration of the leakage is shortened approximately 40 minutes by the modified drain system, the total amount of leakage will be reduced to approximately 50%. The period of exposure to high temperature decreases (See Fig.13).

Fig. 13. Effectiveness of improvements (pipework room, leakage rate: 0.1t/h) (without nitrogen release).

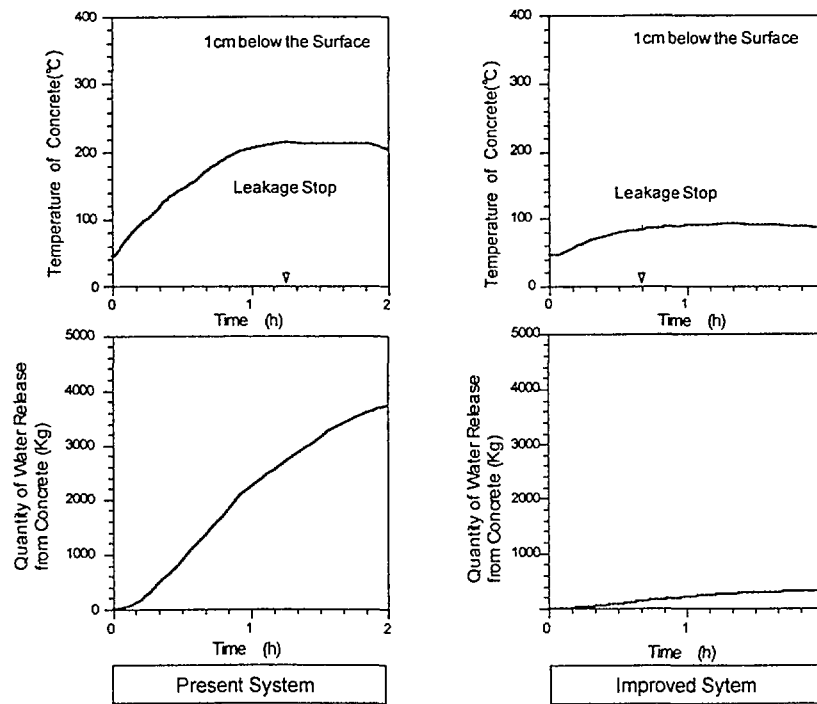
- (2) Since the temperature rise of the concrete is reduced from over 200 centigrade to approximately 100 centigrade by the thermal insulation on the walls and ceilings. At this temperature, the water release is considerably reduced. (See Fig.14).
- (3) Since the ventilation system is shutdown automatically and the air inventory in the room is reduced by the division into four smaller zones, oxygen concentration in the combustion room and neighboring room is reduced. (See Fig.15).

Fig. 14. Effectiveness of improvements (pipework room, leakage rate: 10t/h) (without nitrogen release).

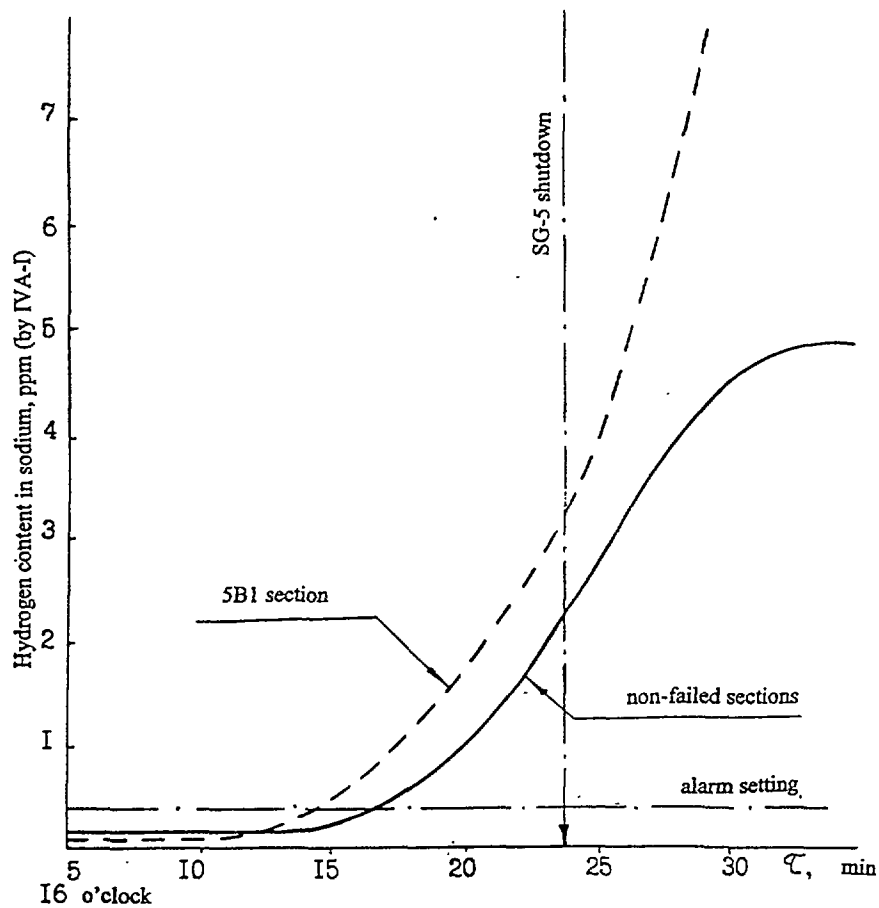
Six minutes after SG shutdown both inlet and outlet sodium valves of the suspected section were closed, and its draining started. During 1 hour, 17 m^3 of sodium was drained, and plugging of the evaporator drain piping was revealed.

FIG. 5. Behaviour of hydrogen content in sodium caused by SG-5 leak.

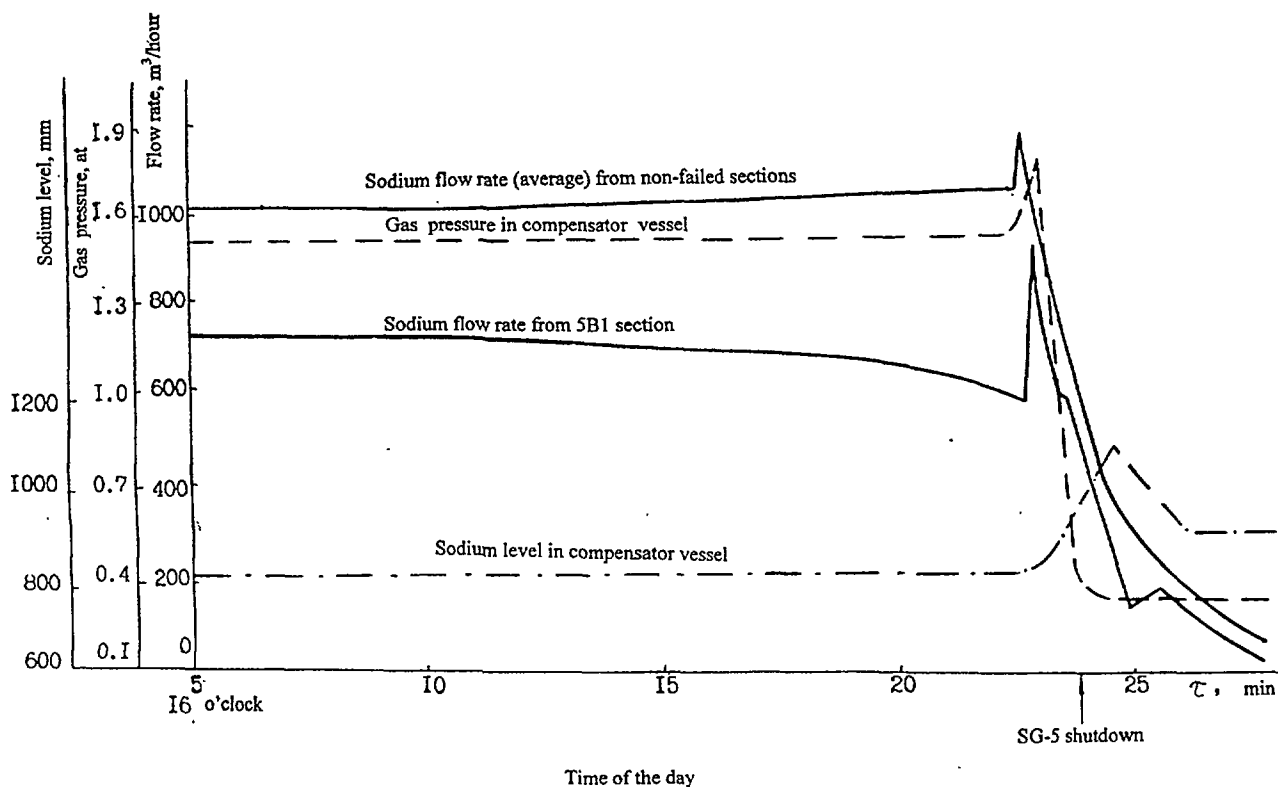
FIG. 6. Change of secondary circuit parameters caused by SG-5 leak.

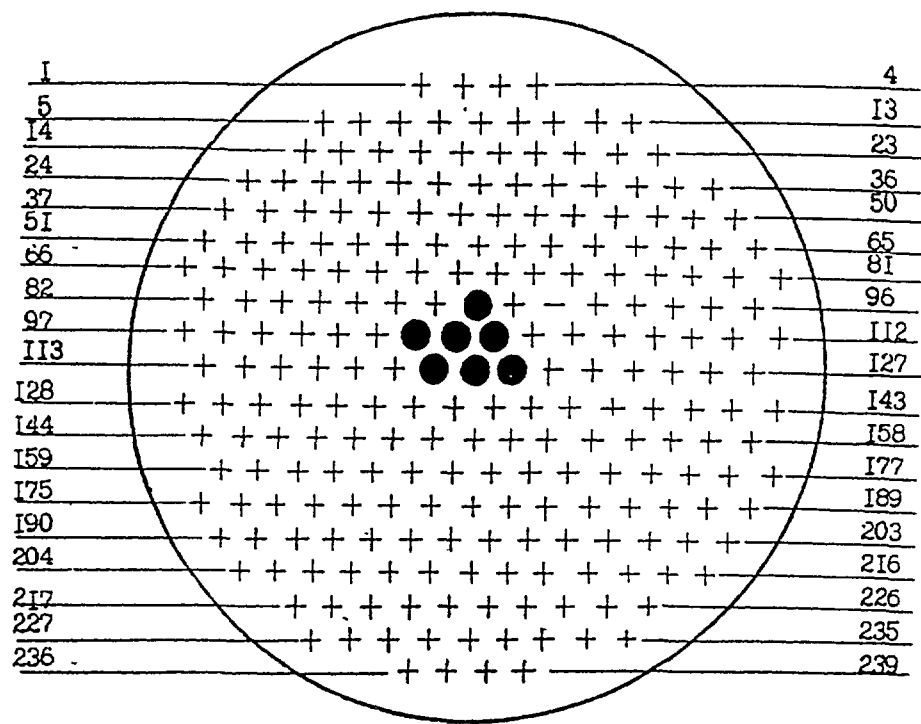
After its draining the module was pressurized with air, and 7 failed tubes were revealed in the central area of the tube bundle (Fig. 7). In the course of dismantling of the tube bundle it was shown that through defects, i.e. local thinning of the tube walls caused by metal dissolution were found on tube sections between spacer grids at about 6500 mm distance from the upper tube plate (Fig. 8). Wall thickness decrease was revealed on two more tubes. Metallurgical defect of the tube wall, which had not been revealed on the stage of incoming gauging, and which manifested during operation, could be the cause of the initial leak in this case.

● - tube having through defect

FIG. 7. Cartogram of failed tube locations in 5SB1 module.

Repair works were devoted to the replacement of failed module with the new one.
