Unusual occurrences during LMFR operation

*Proceedings of a Technical Committee meeting
held in Vienna, 9–13 November 1998*

IAEA-TECDOC-1180

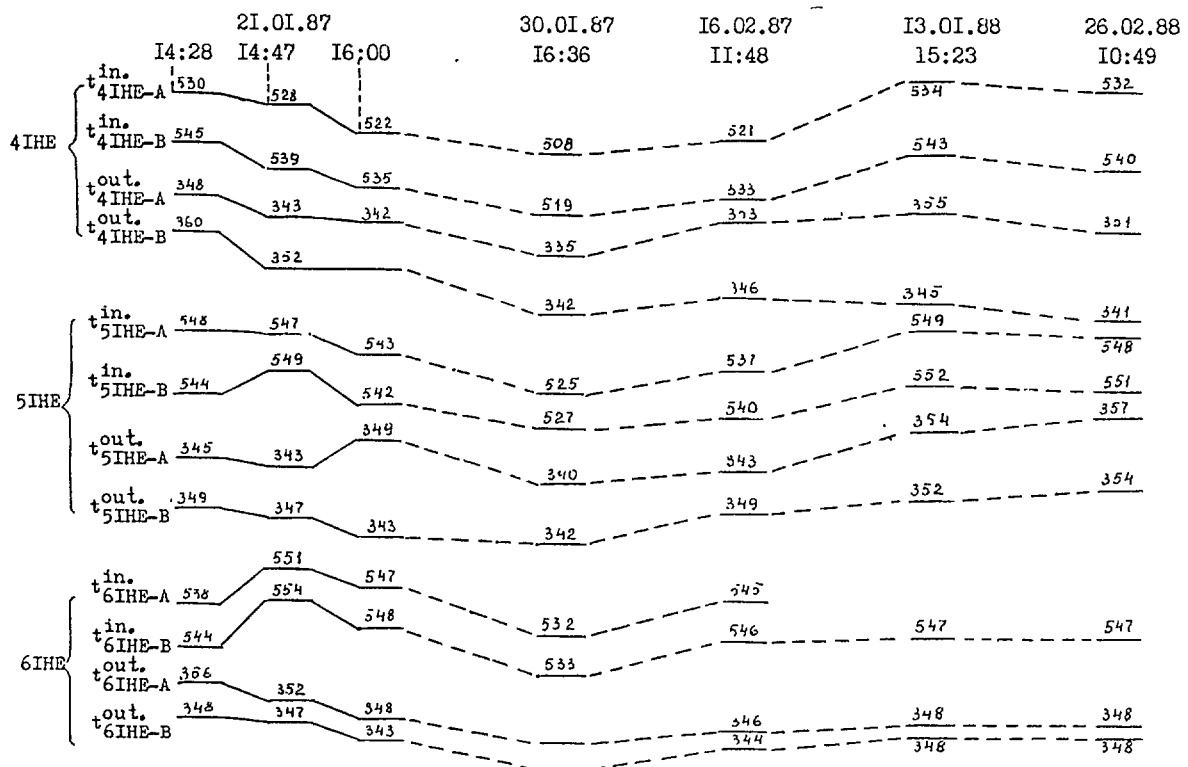
During the period from 14:29 to 14:36, spontaneous change of some reactor parameters was detected (Figs. 9-11). This resulted in redistribution of power between the primary loops without any change of reactor thermal power (there were no changes in the current readings of ionisation chambers). This, in its turn, caused slight redistribution of electric load of the turbine generators. There were the following changes of the reactor parameters during this period (6 minutes):

FIG. 11. Reactor BN-600 parameters variations 21.01.87–26.02.88.

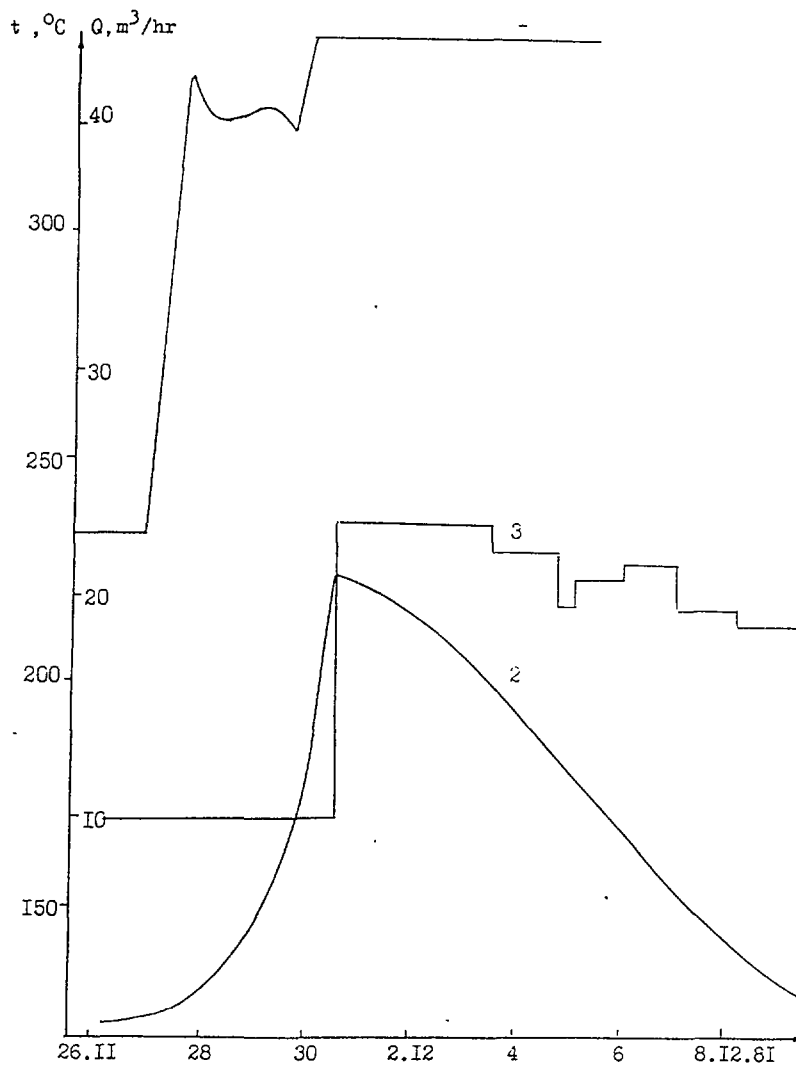
In November-December 1981, one of the early cases of abnormal behaviour of plugging meter temperature (referring to the content of impurities soluble in the coolant) was detected. Parameters of the system prior to this event and their further evolution are shown in Fig. 12. The increase of the coolant temperature was preceded by various procedures related to the replacement of the primary components. These resulted in the ingress of large amount of air into the CGP. In the course of this work, sodium was purified using cold trap, and the plugging temperature was always lower than that of the flowing sodium, this difference being over 100°C just before the increase of temperature.

FIG. 12. First circuit main parameters variations from 14.11.81–10.12.81

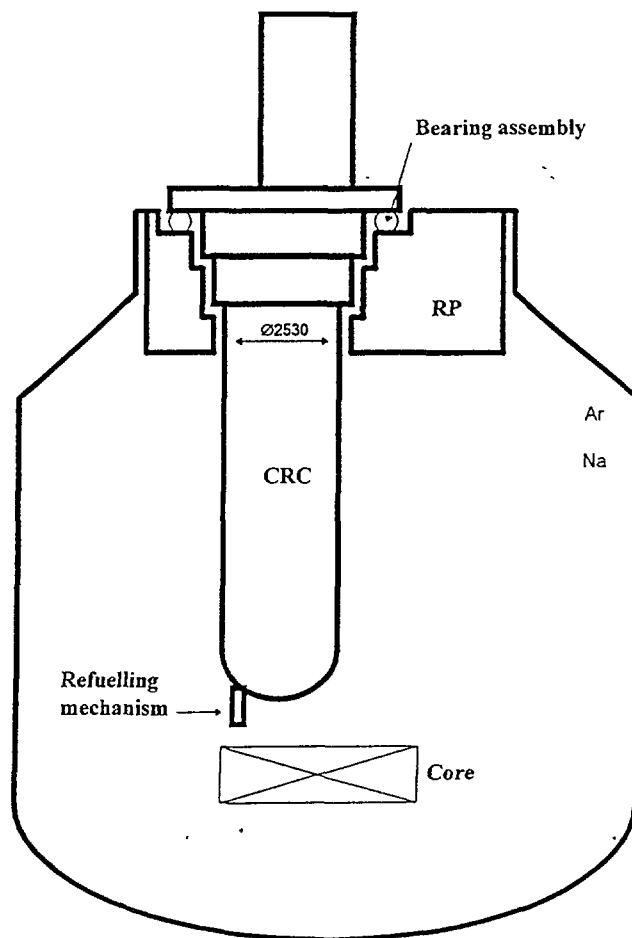
FIG. 13. Scheme of the BN-600 reactor vessel with rotating plugs.

During recent several years, growing increase of torque of the central rotating column (CRC) has been observed within some angle of its rotation. By 1997, it reached as high as about 60% of permissible value determined by the strength and capacity of its drive. In 1997, CRC bearing assembly was inspected by drilling special opening and using endoscope, and some amount of sodium was detected there (Fig.13). This phenomenon was interpreted as a result of sodium vapour transfer from the reactor cover gas via the gap between the CRC and rotating plug (RP) and subsequent accumulation of sodium and its compositions in the CRC bearing assembly.

Works on partial withdrawal of the CRC from the reactor vessel were scheduled in order to provide access to the bearing assembly for the sodium removal, and

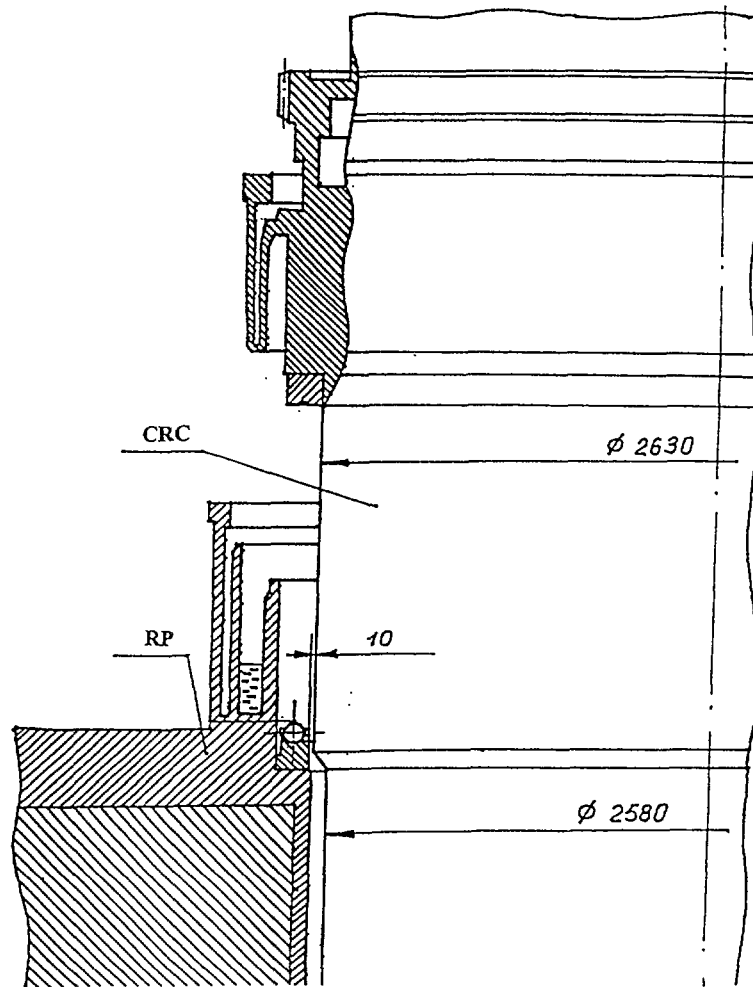
FIG. 14. Relative location of CRC and RP after CRC withdrawal.

CRC withdrawal (Fig. 14) confirmed that almost 100% of the bearing assembly surface was covered with sodium deposits filling the gaps between the bearing balls and cages. Besides, high density sodium deposits filled the gap between CRC and RP in the areas of seizure.

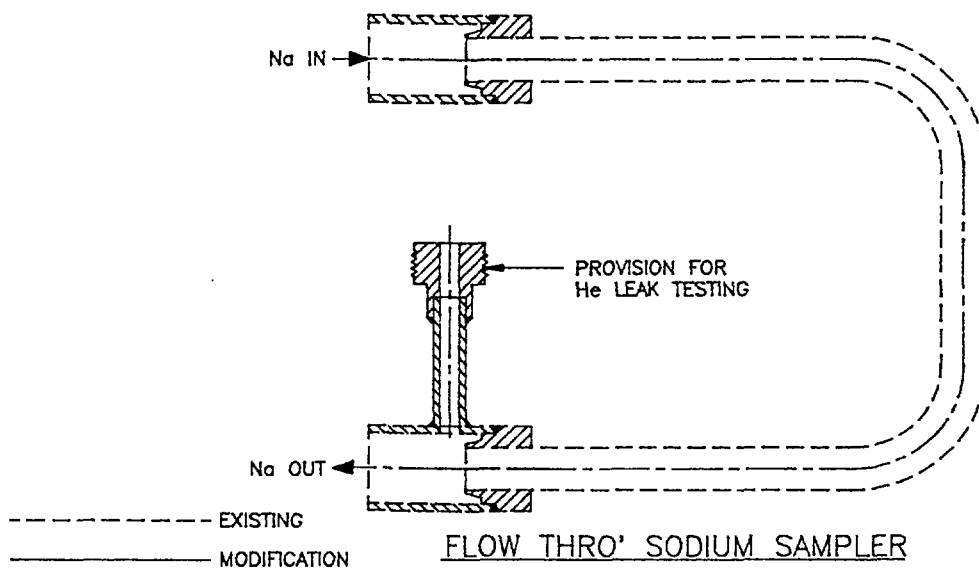
Fig.5

3.1.1 While preheating secondary cold trap during initial commissioning (Oct 84), about 2.5 l of NaK leaked out from the NaK jacket through spark plug type high level probe. Investigation revealed the failure of the level probe due to high pressure during preheating because of nonavailability of adequate expansion space in the jacket. The fire was put out effectively in 15 min by dry chemical powder (DCP). Modifications were done to prevent recurrence by capping of level probes and providing an argon pot of 20 l capacity to allow free

3.1.2 Secondary sodium sample is required to be taken twice a year for chemical analysis. About one litre of sodium leaked out (Sept 87) through a swagelok coupling while putting in service the secondary sodium flow through nickel sampler. The fire was fought using DCP and CO₂ extinguishers and was put off in 30 min. To prevent recurrence, provision was made for helium leak testing of swagelok coupling joints after installation of the sampler. Over flow type sampler with conoseal joints for better leaktightness and more representative sampling was also installed in one of the secondary loops.

3.1.3 During adjustment of pressure setting of the regulating valve in supply argon system (May 88) about 2 l of NaK backed up and leaked out from the NaK bubblers provided for supply argon purification. The NaK leak was carefully collected in a tray covered with DCP and safely disposed off within 30 min. As a remedial measure, a backflow trap of 50 l capacity was introduced on the upstream side of bubbler and a pressure equalising valve was provided across it.

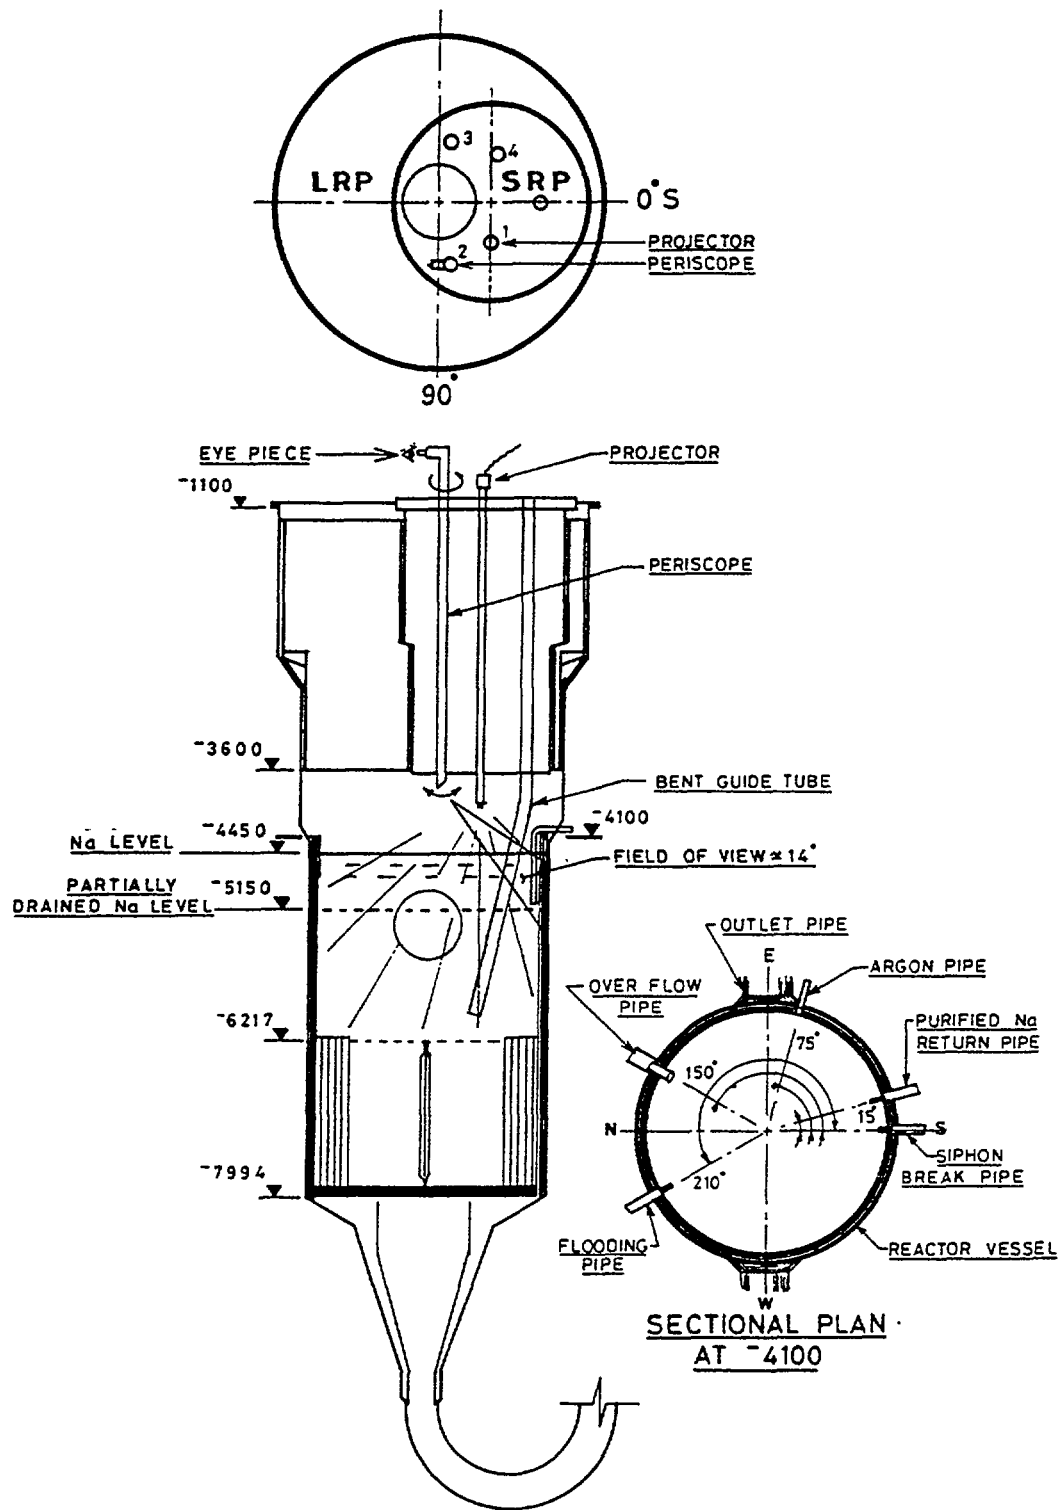
Fig.7

Three techniques were developed and utilised to assess the bend of the guide tube, viz., optical inspection, ultrasonic air gauging and mechanical disc gauging. Optical inspection was carried out with a periscope/projector system (Fig 7). Sodium was drained to expose the heads of SA and the bend of guide tube was measured by finding out the radius of sweep of its

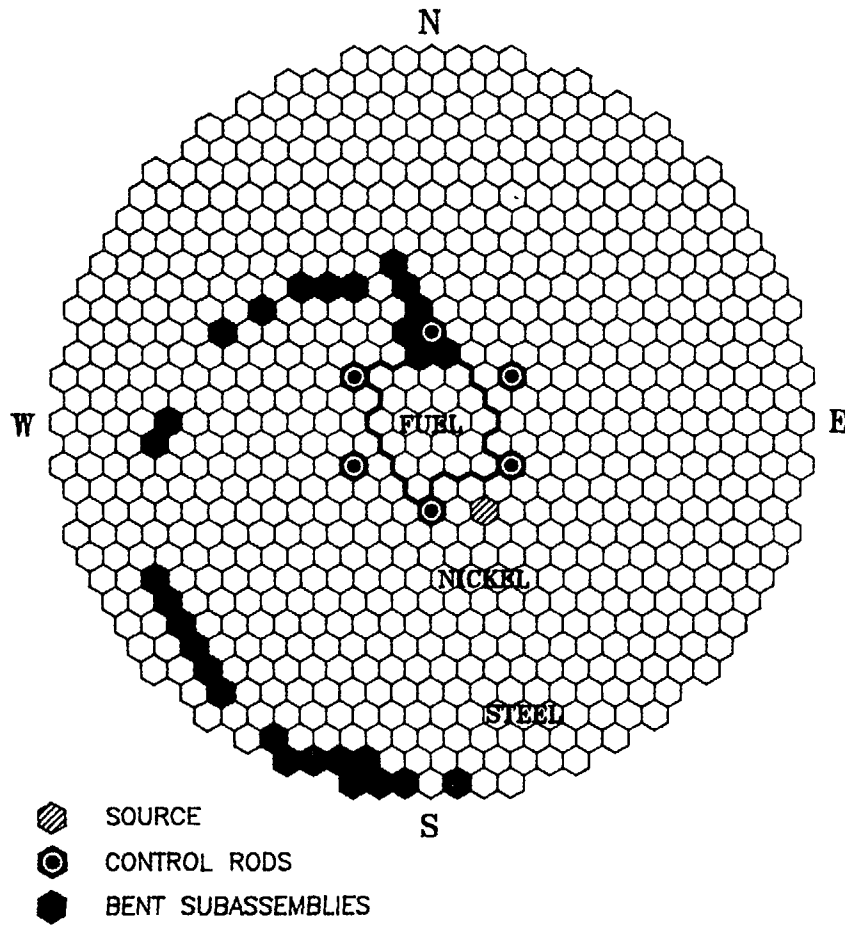
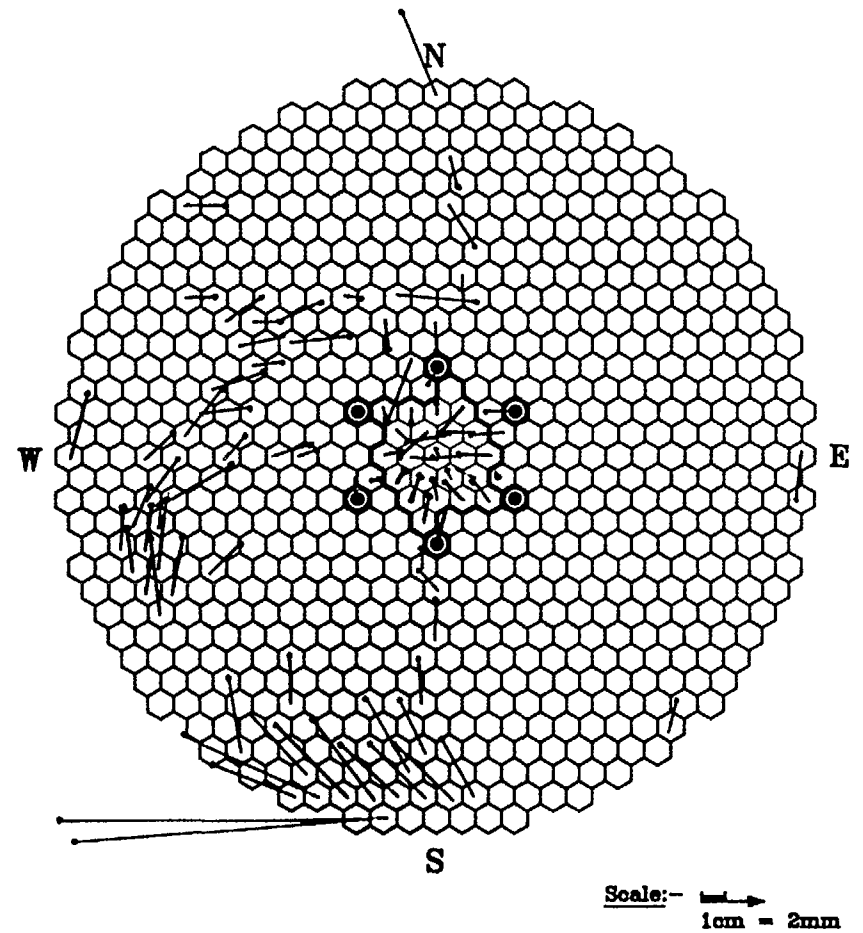
bottom tip with reference to heads of SA when it is rotated on its own axis. This inspection also indicated a lifted SA at the periphery where manoeuvres to lower the fuel SA were earlier made. Slight deformations of the heads of some of the reflector subassemblies along two spiral paths were also seen (Fig 8). Ultrasonic air gauging method involved lowering of an

DAMAGED SUBASSEMBLIES DURING FUEL HANDLING INCIDENT

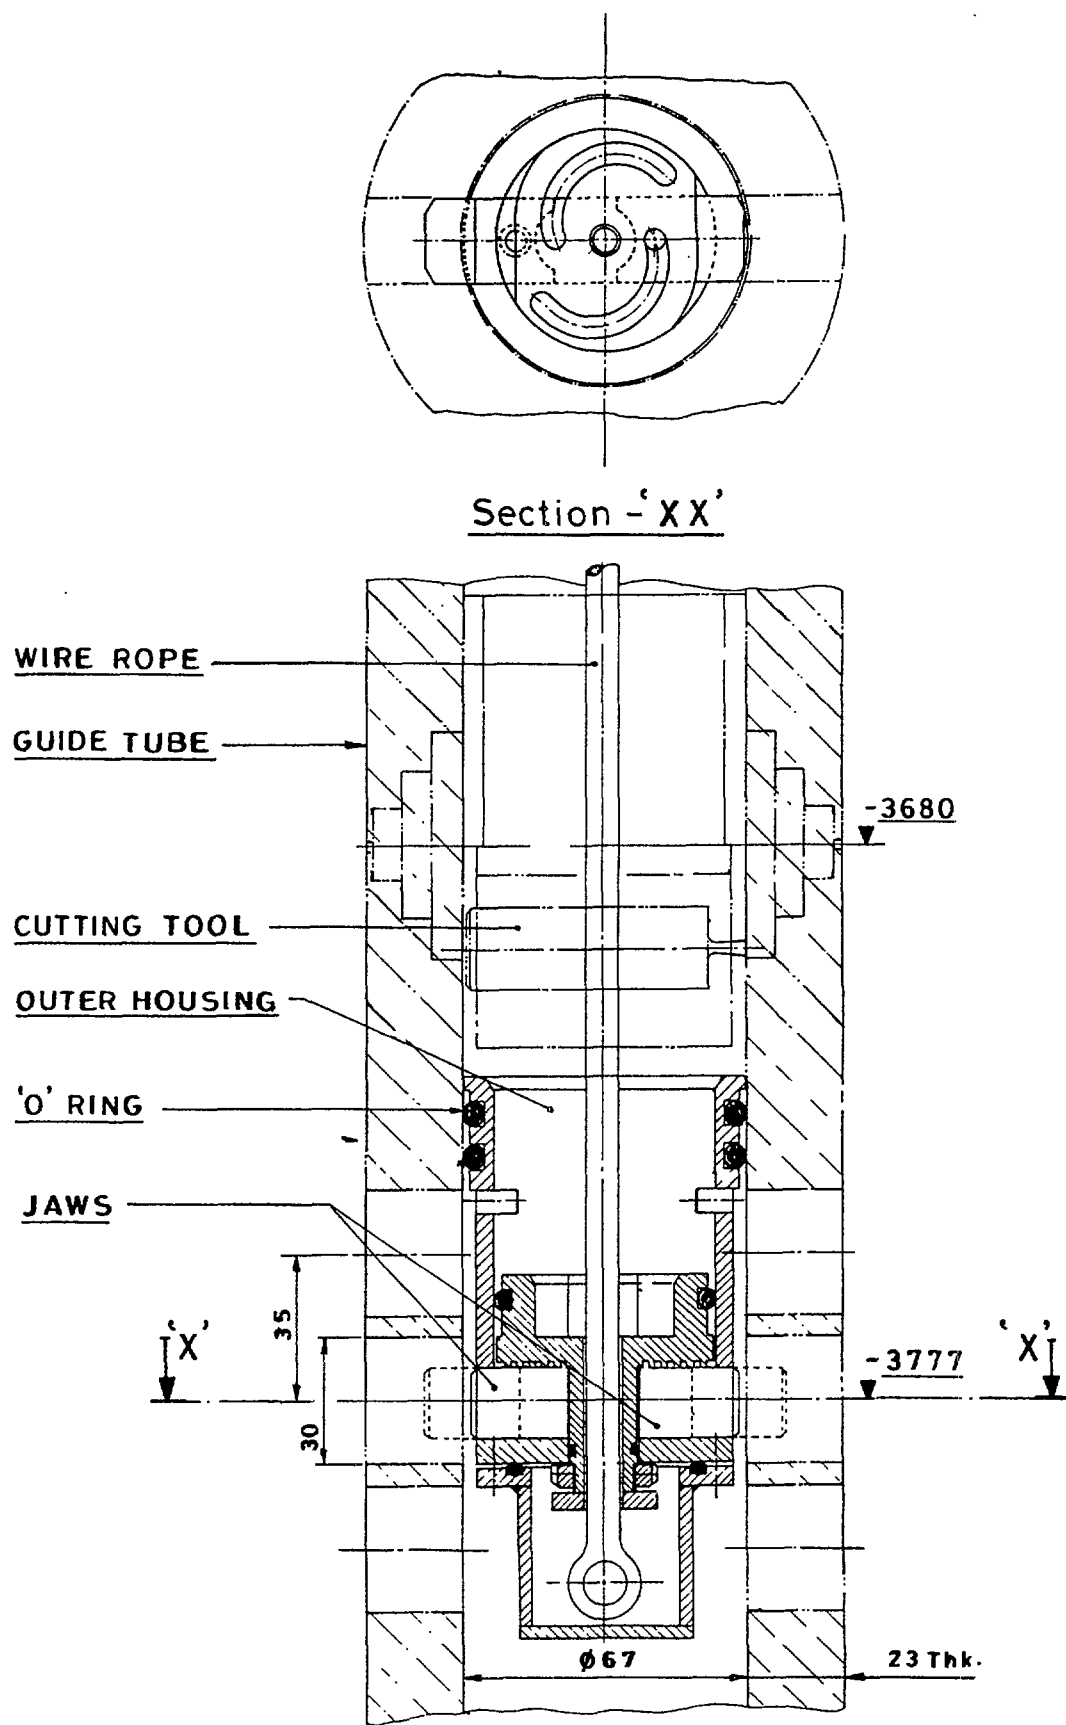
Fig.9

The design of leaktight remote cutting tool had the following special features; The cutting to be done at a depth of 3 m, the tool to be accommodated within the guide tube bore of 67 mm and provide a depth of cut of 23 mm without tool chatter, the bottom portion of the cut guide tube to be held in position till the top part is removed, no cutting chips should fall into the reactor and leak tightness should be maintained during the cutting operation. An elegant remote cutting tool having these features was developed and it consisted of assembly of telescopic tubes for transmitting the rotational movement to the tool and controlling and monitoring the axial travel and depth of cut from the top. No lubricant was used and special features were provided to recover all the chips generated. This tool also employed a leaktight plug anchored to the bottom part of the guide tube to maintain leaktightness w.r.t. reactor cover gas, to collect the chips generated and to hold the bottom part during complete process of cutting and retrieval (Fig 9). The cutting sequence was carefully chosen to permit radial entry of the tool holder along the guide tube thickness during the last stages of cutting, thus avoiding tool chatter. After successful mockups, the tool was perfected and with microprecision the in-situ cutting and retrieval of the damaged guide tube was successfully completed in May 88. Measurement of the profile of the cut guide tube indicated a deformation of 350 mm, bearing full testimony to the reliability of the various remote methods employed to measure the bend.

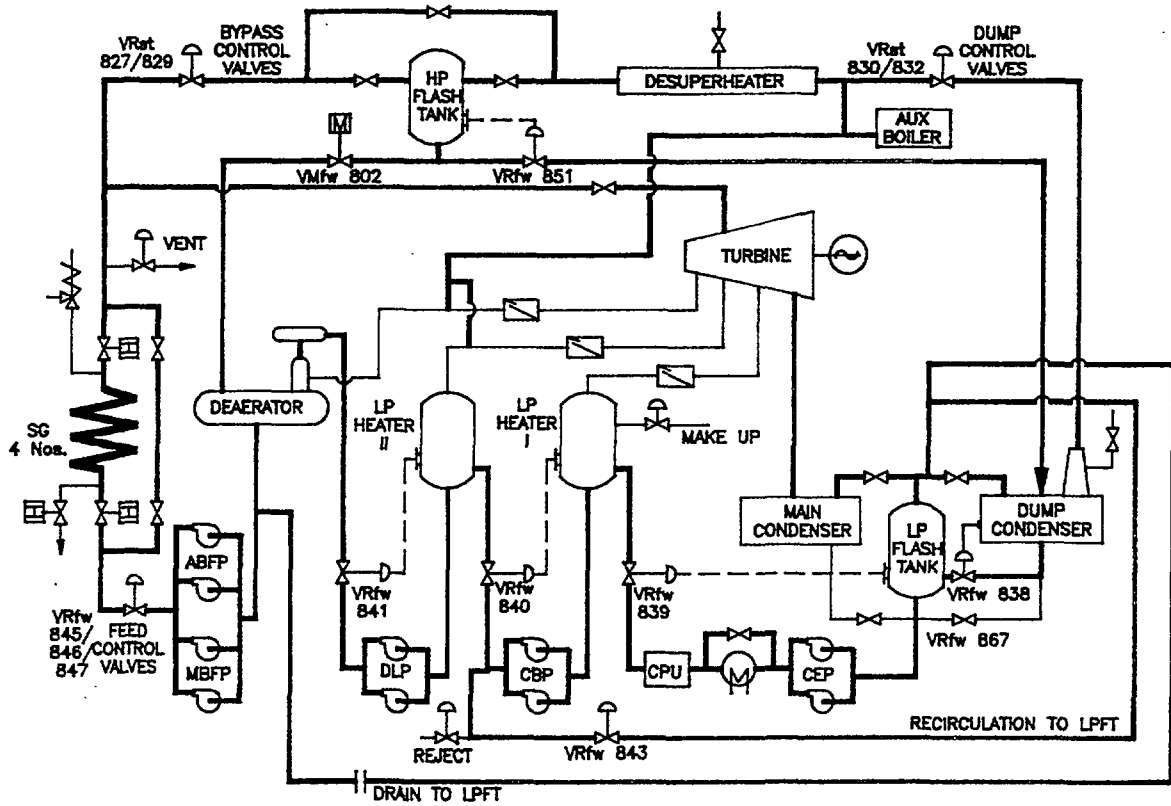
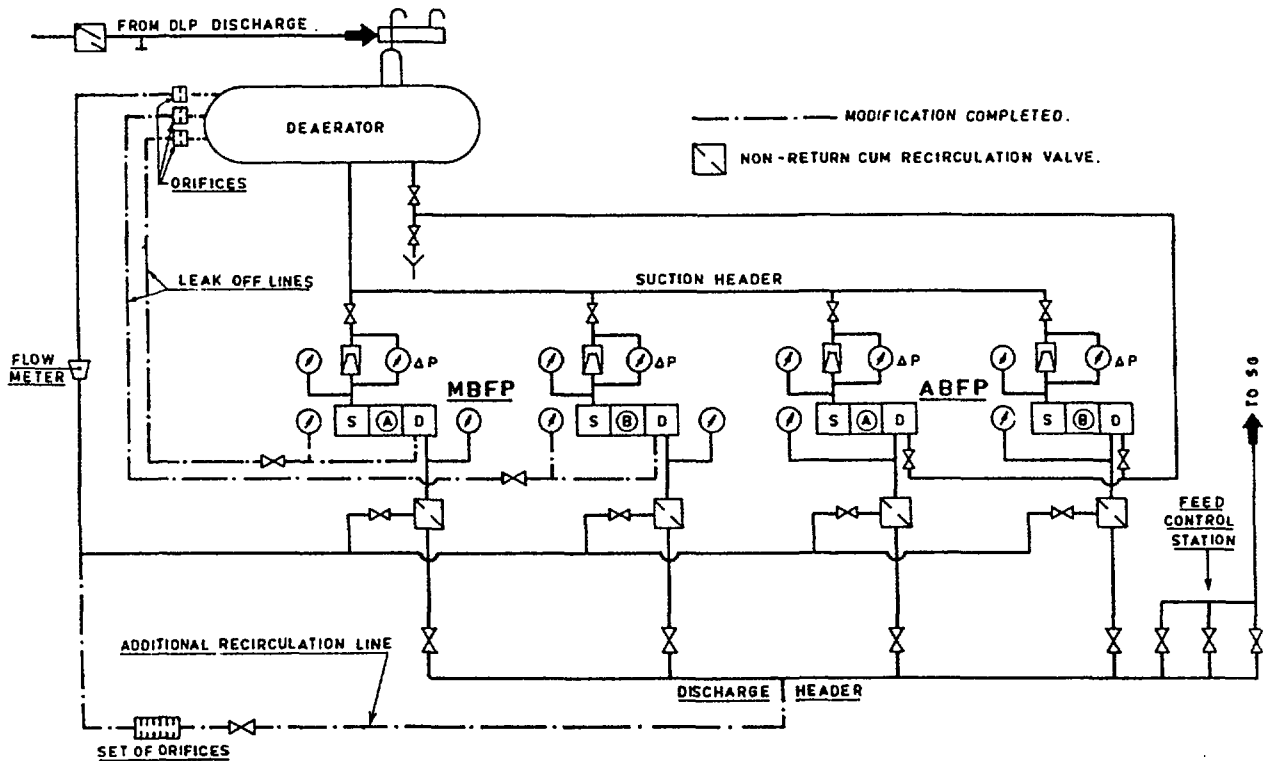
Fig.10

Steam water circuit (Fig 10) consists of condensate extraction pump (CEP) taking suction from main condenser (MC) and dump condenser (DC) through low pressure flash tank (LPFT), two contact type low pressure (LP) heaters, a deaerator working at 13 Kg/cm² pressure to provide 190°C feed water and MBFP to supply water to SG at 125 Kg/cm². MBFP is a 10 stage barrel type pump designed for a feed water temperature of 196°C, delivering 89 m³/h flow at a head of 1770 mlc with operating speed of 5700 rpm and input horse power of 580 kW. The required NPSH is 6.9 mlc (actual test value being 5 mlc). As per design, the balancing leak off from the pump discharge is fed to the pump suction.

One of the two MBFBs has since been replaced with indigenous make. This pump operates at 3600 rpm with same Q- H characteristics, without any hydrostatic bearing and having lower NPSH requirements (4.3 mlc).

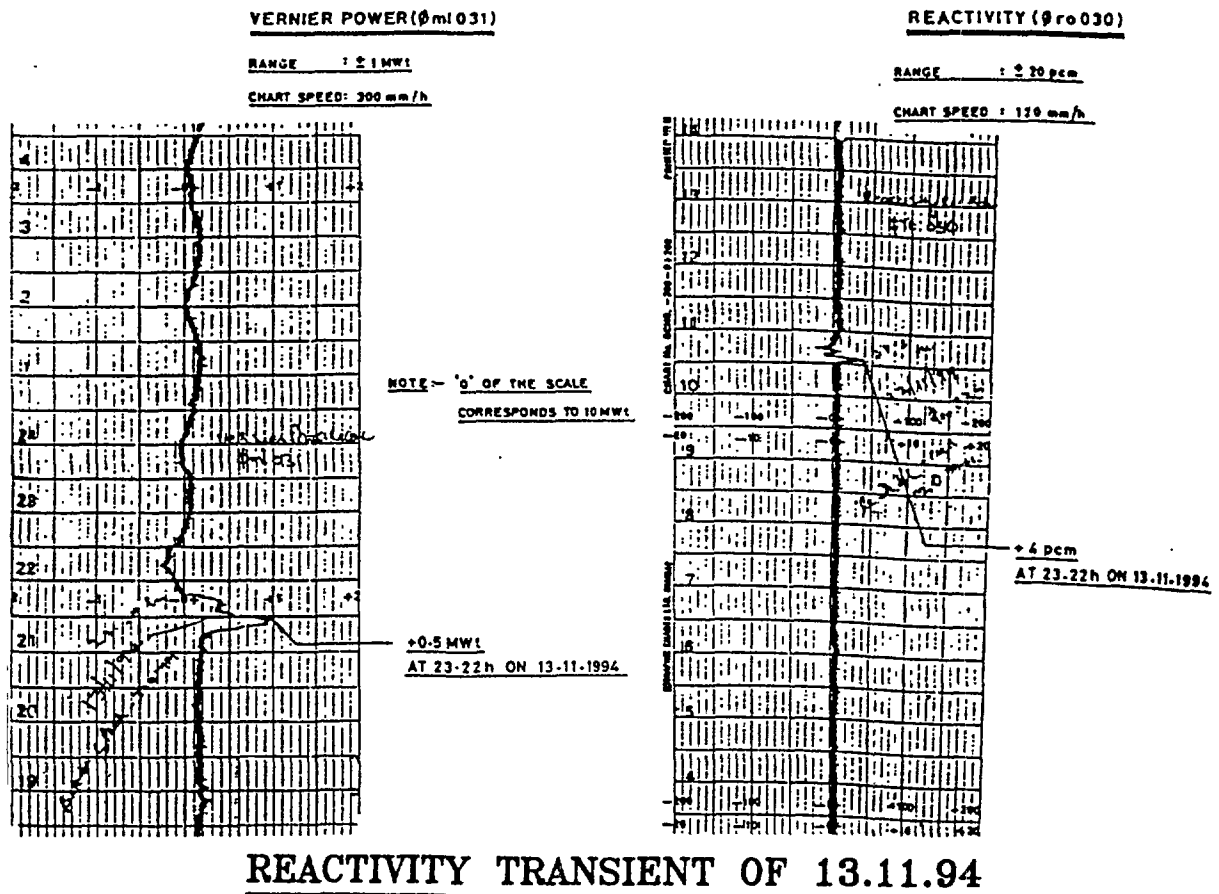
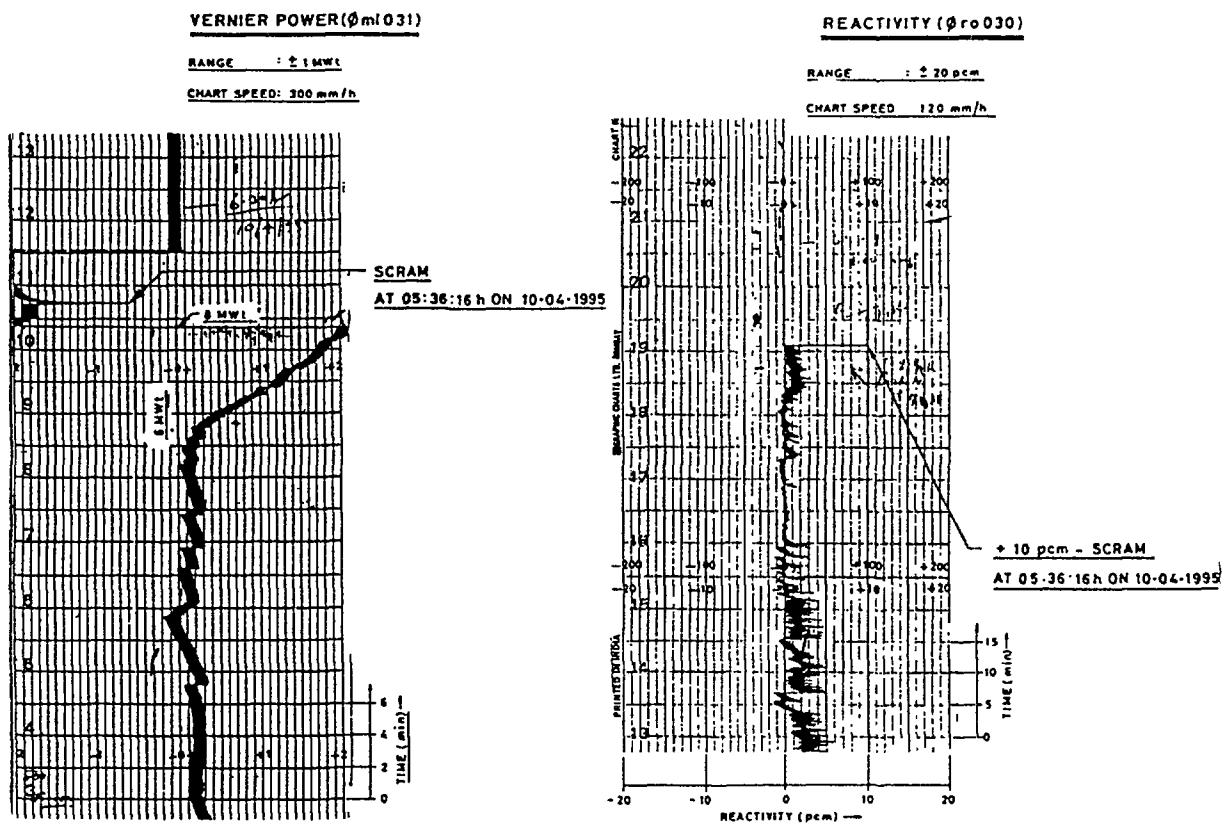
Fig.11

The changes in process parameters resulting in decrease in core inlet temperature causing reactivity transient were studied. The required inlet temperature change to cause the two transients were estimated to be -3.1 and -4.9°C respectively. Extensive tests on the influence of changes in primary, secondary and feed water flow and steam pressure were studied at 9.5 MWt power and the results are given in Table 1.

All these experiments have shown that these events are reversible as well as recordable by various chart recorders provided in the control room. As no change in any process

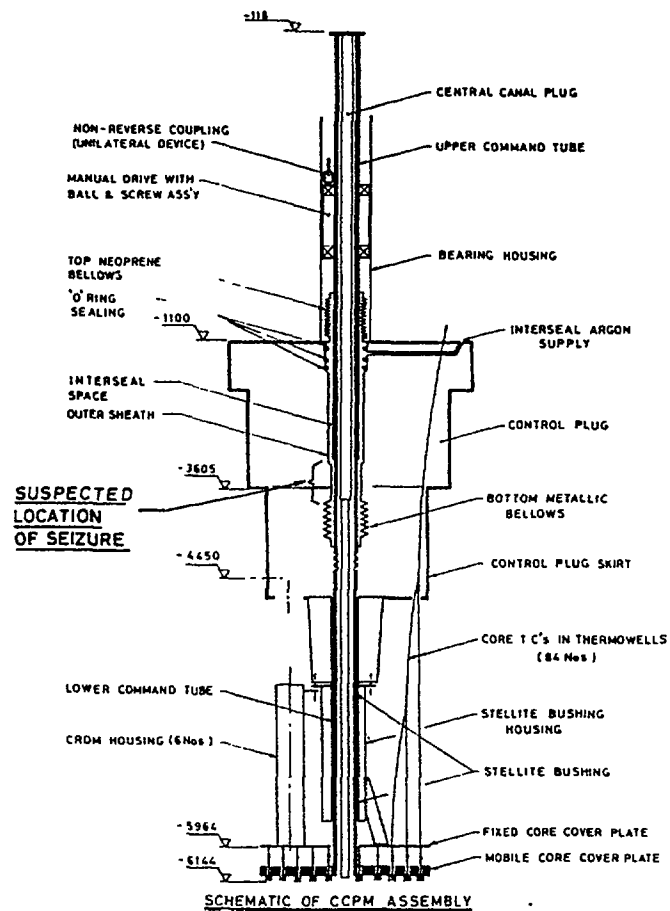
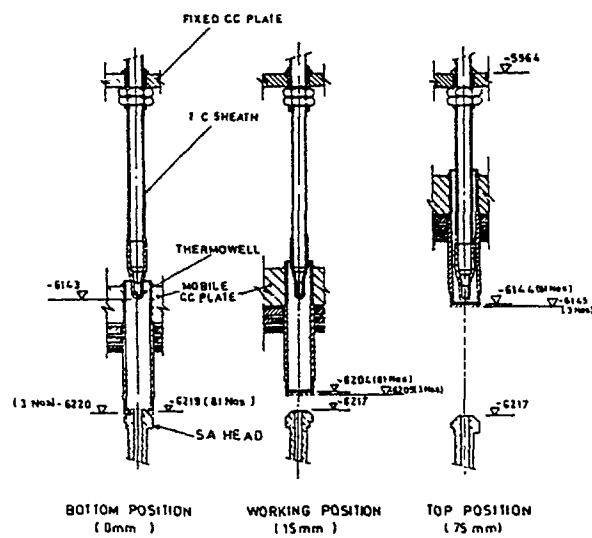
Fig.12

No smear of sodium oxide or any other foreign matter could be found by these three techniques. Load deflection measurement in the horizontal direction indicated the possible area of seizure to be below the step in the outer sheath and above the SS bellows (Fig 12) and the most likely reason could be mechanical interference. Further investigations are pursued. Cumulatively, about 8 months were spent for various investigations.

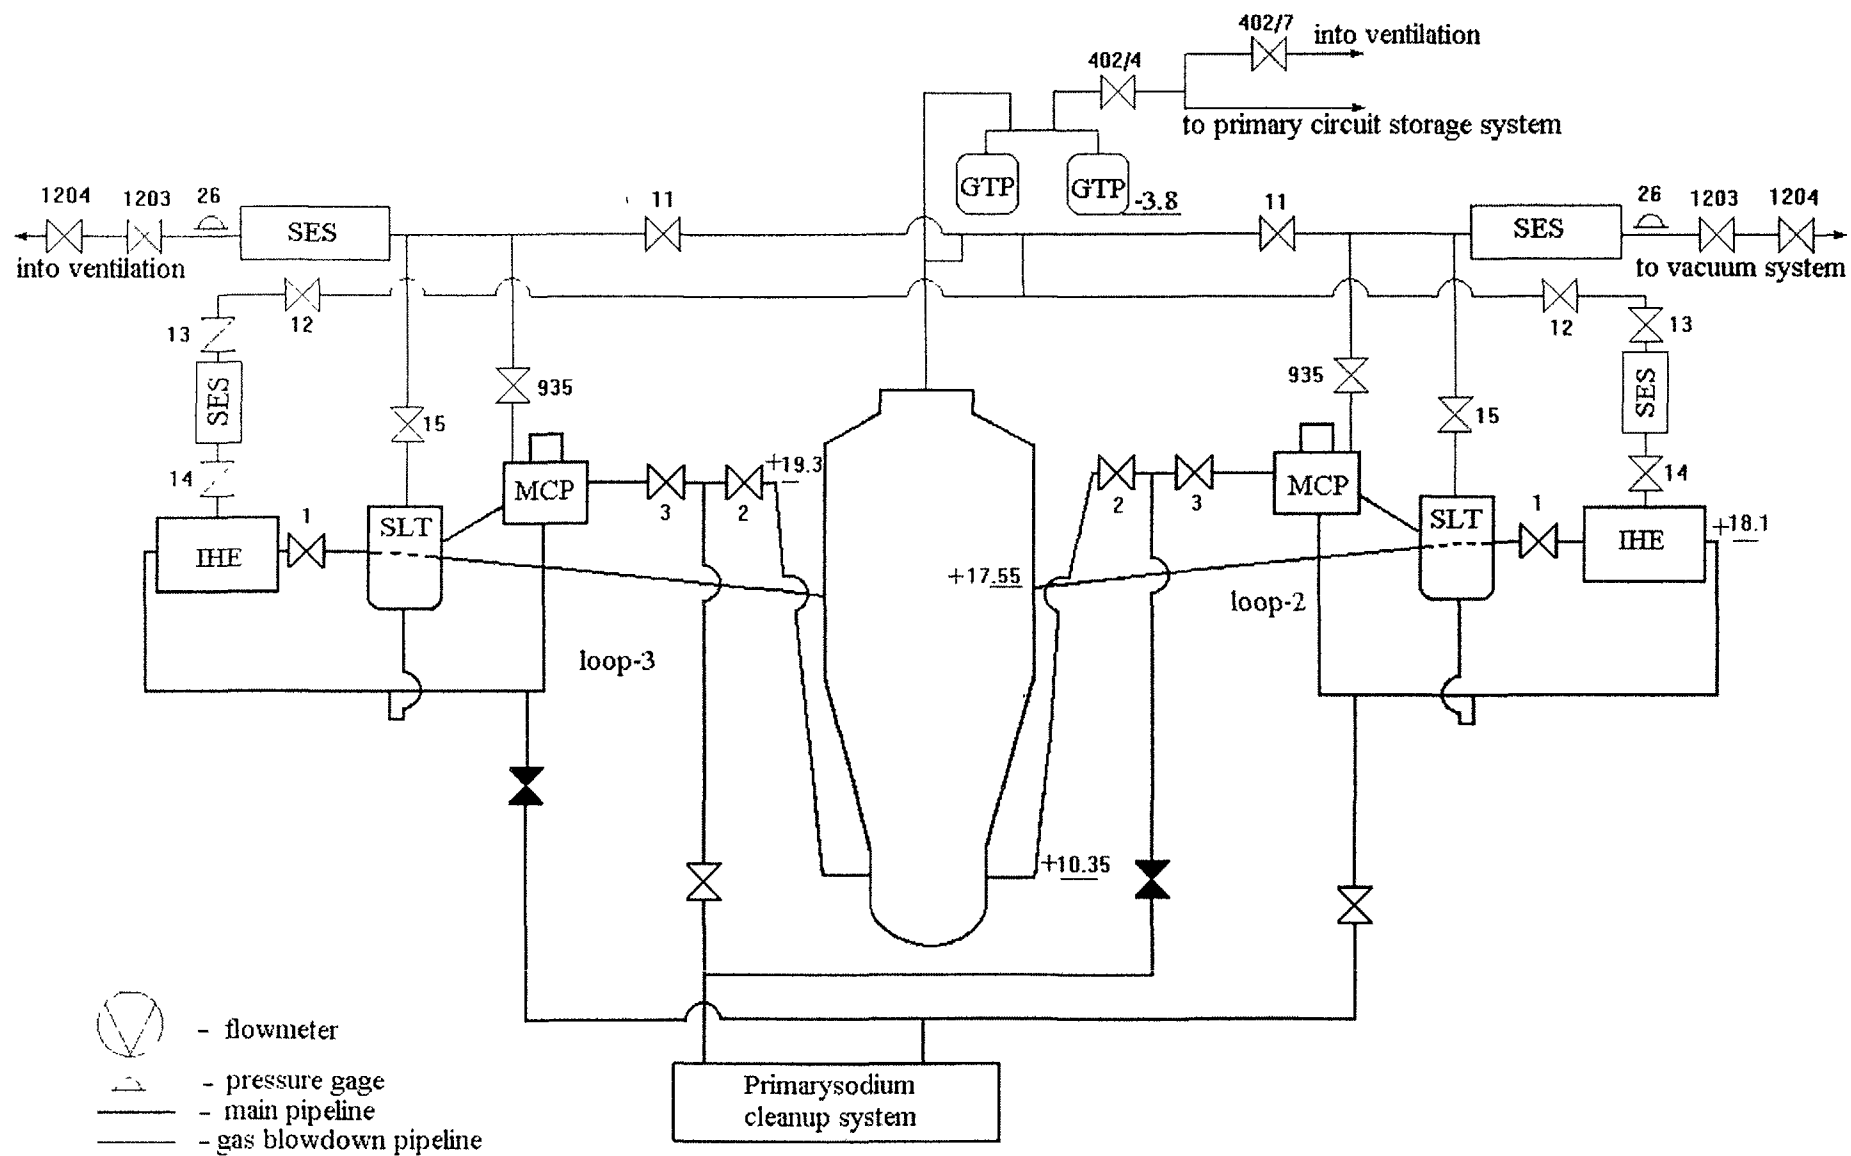
FIG.4 Scheme of sodium ingress in gas-type pressurizer.

The second occurrence in this group is «Sodium ingress in gas-type pressurizer through pipeline of primary sodium cleanup system and blow-down pipeline of failed MCP-2 while primary sodium cleanup system was being connected to the primary circuit» (FIG.4). The primary sodium cleanup system, connected with pipelines with pipelines of loops-2 and 3, is general for all sodium coolant of primary circuit. Loop-2 was on maintenance and separated from primary circuit with isolation gate valves N 1,2. When personal began to put into operational primary sodium cleanup system, it was fed from pressure pipeline of MCP-3

and, by mistake, discharge pipeline of primary sodium cleanup system was connected with pipeline of failed loop-2. Immediately after supplying of sodium flow rate, sodium level in MCP-2 tank began to grow. After filling MCP-2 tank, it chanced sodium ingress in gas-type pressurizer through blow-down pipeline of MCP-2 and blow-down pipeline connecting reactor gas cover with gas-type pressurizer. Sodium level in reactor vessel began to fall and the pressure in primary circuit gas cover began to grow, because of electroheating of gas-type pressurizer was failed. Reactor was emergency shutdown. After reactor emergency shutdown, sodium ingress in gas-type pressurizer was ceased. After as this occurrence was happened, procedure of connection of primary sodium cleanup system to the primary circuit was changed. At present, according to procedure, the primary sodium cleanup system is connected only to pipelines of one loop.

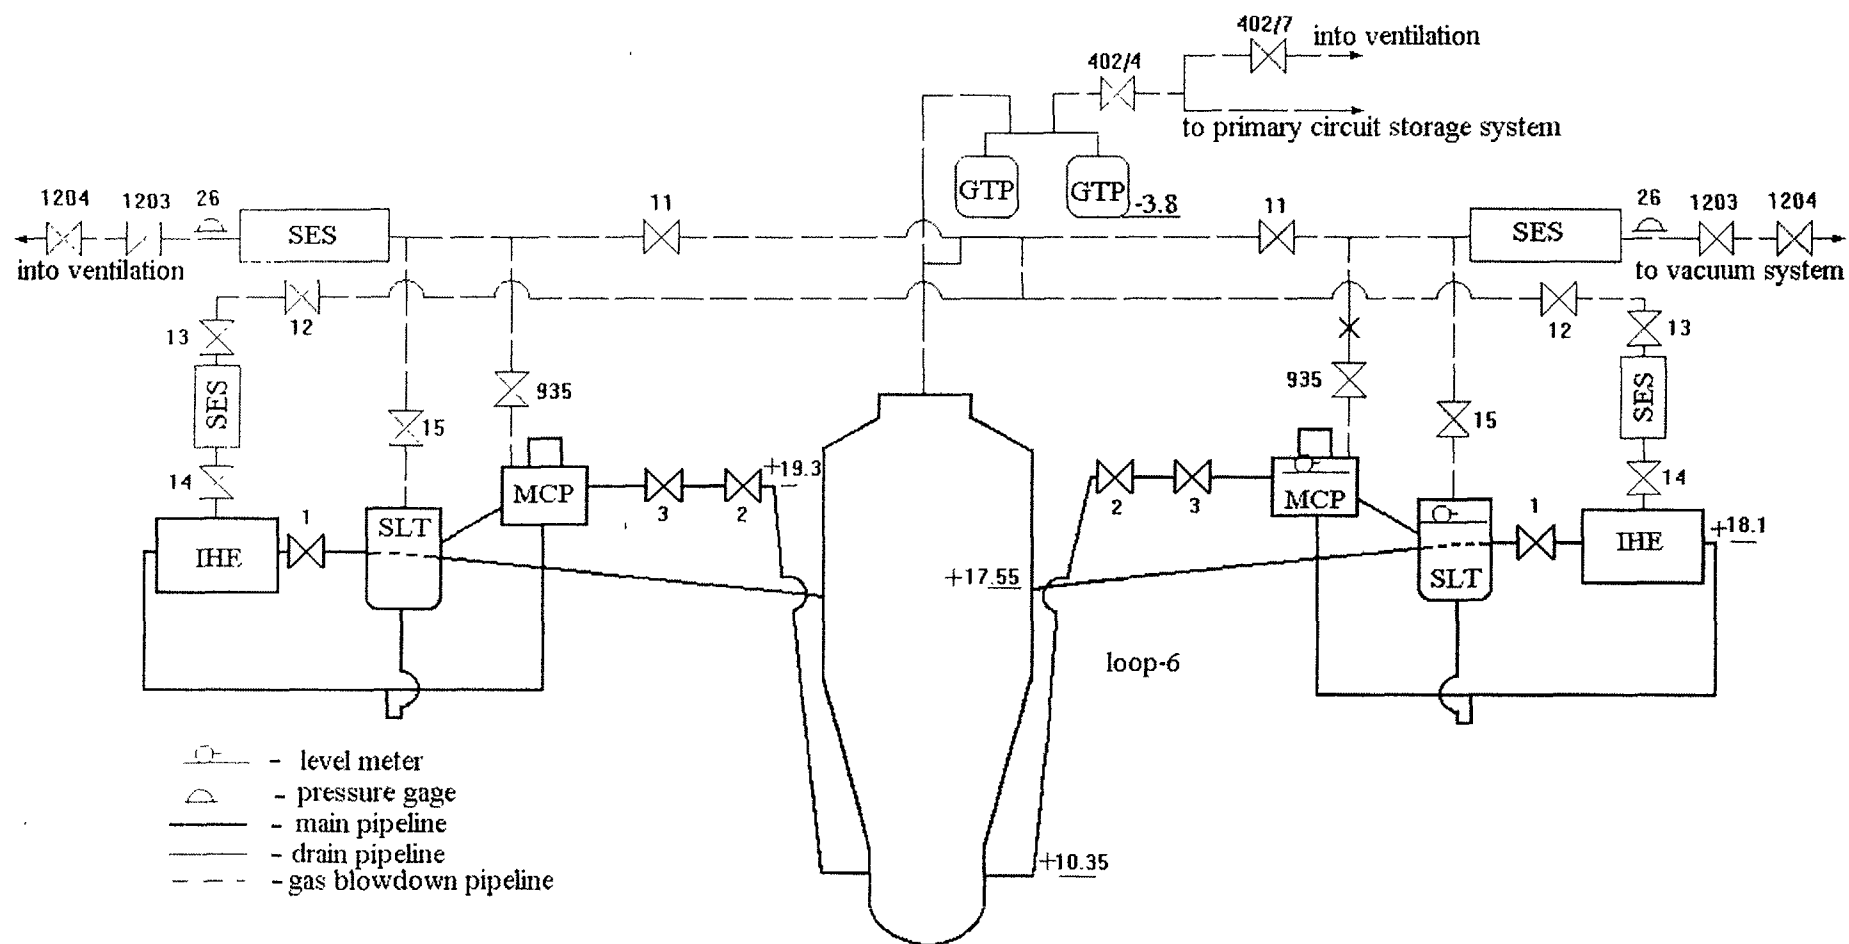
FIG.6 Scheme of blow-down pipelines of primary circuit.

The second occurrence in that group is «Destruction of the blow-off line of MCP-6 due to corrosion damage of the pipeline while unit was being operated at rated power» (FIG.6). Because of local overheating of pipeline section of blow-off of MCP-6 there was accelerated corrosion damage of the pipeline. The blow-off line of MCP-6 was unsealed. This unsealing was detected only on decrease of pressure in the MCP-6 gas cover, because of the outflow of protective gas from MCP-6 gas cover was insignificant and the growth of sodium levels in MCP-6 tank and leakage drain tank-6 was not watched. The increase of aerosol activity was within the limits of norm. After separating MCP-6 gas cover from reactor gas cover, it was organized feeding of protective gas for equalization pressure between MCP-6 gas cover and reactor gas cover. Really controlled temperature on thermocouples, which control this section of blow-off line, was within the limits of order threshold of electroheating. The defect was eliminated after ending of reactor microcampaign.

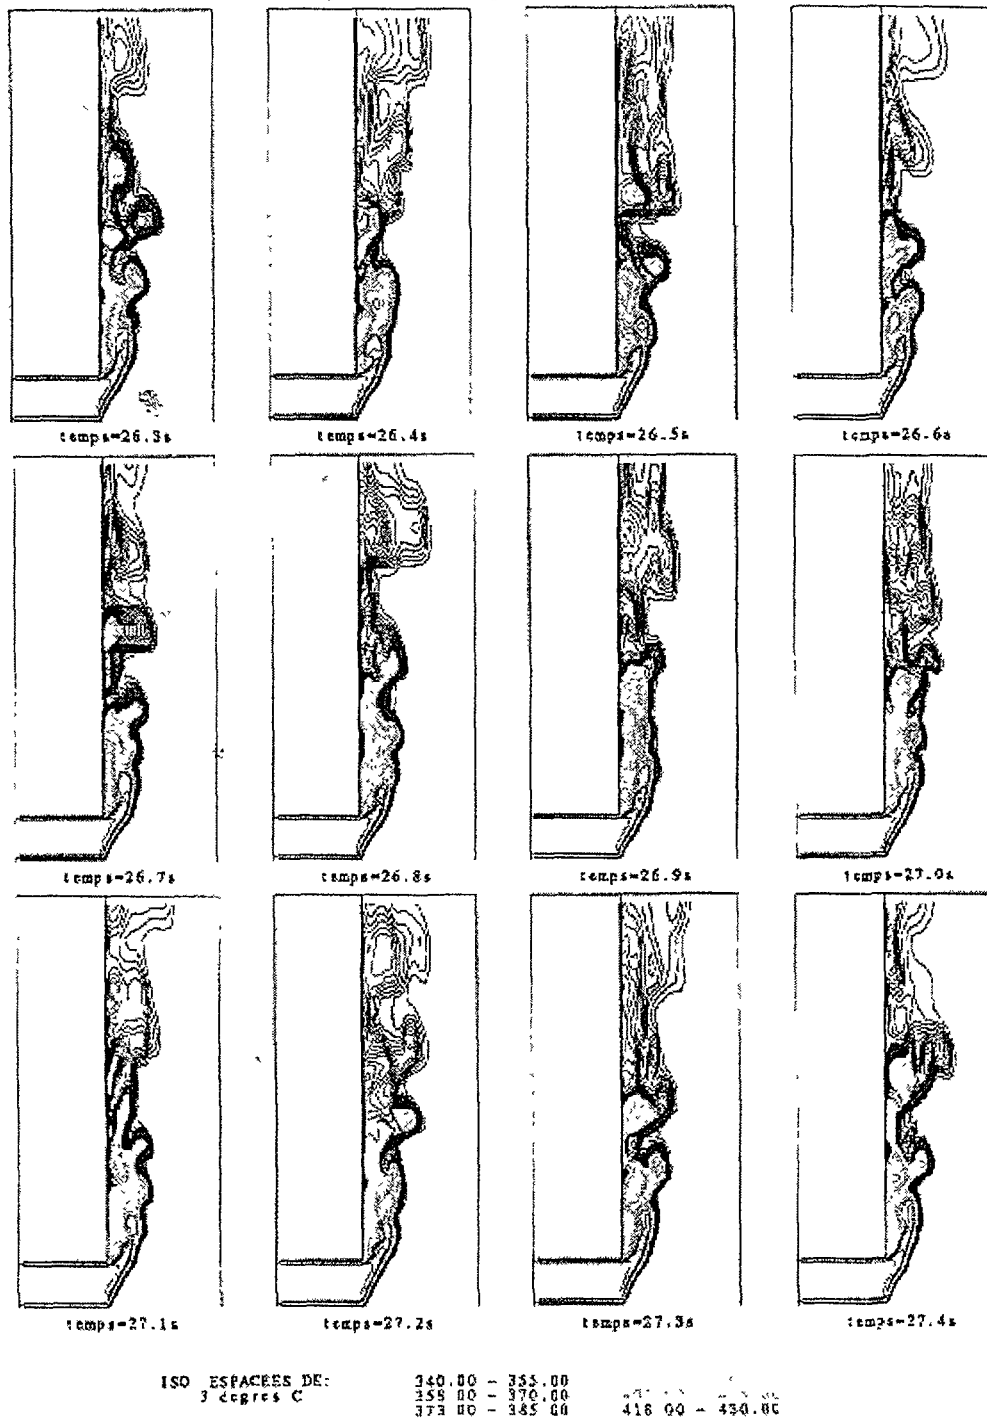
LIGNE SECONDAIRE PHENIX
 Simulation des grandes échelles du mélange
 en aval d'un piquage
 Evolution dans le temps des isothermes
 dans le plan de symetrie longitudinal

Studies conducted on the PHENIX reactor in this field provided the first practical industrial application of recent developments in thermomechanics, particularly those concerning the Large-Scale Simulations of turbulence in the calculation of flow instabilities. Thus, the mixing of fluid sprays at different temperatures having led to the cracking of a secondary piping zone at a «T» level were analyzed in their fluctuating aspect. This study, incidentally, has become presently the object of international intercomparisons (see figure 2).

FIG. 2 : PHENIX Secondary Line
Large-Scale Simulation of the mix downstream from a sampling/connection.
Evolution in time of isotherms, in a lengthwise symmetry view
