Unusual occurrences during LMFR operation

*Proceedings of a Technical Committee meeting
held in Vienna, 9–13 November 1998*

IAEA-TECDOC-1180

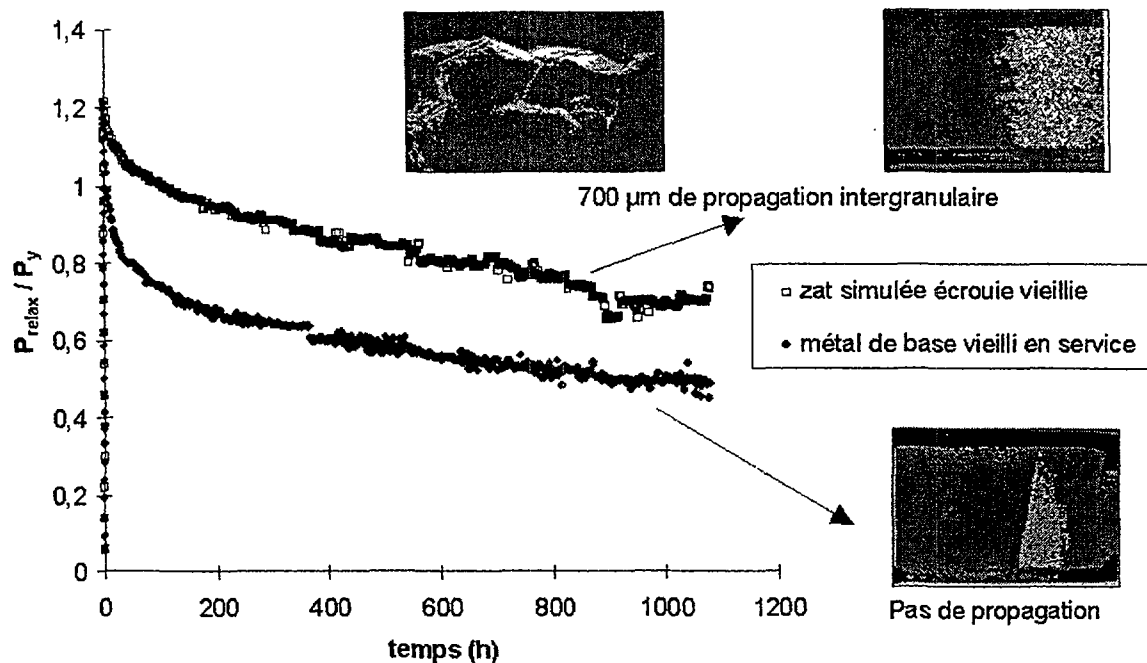
ESSAIS DE RELAXATION SUR EPROUVETTES CT

First and foremost, this concerns the Z6 CNT 18-10 steel which is known to have a certain sensitivity to the phenomenon termed relaxation cracking. Observed on certain parts of the major secondary pipes, in the buffer tanks and on the headers on the top floors of steam

generators, the problem was to approach it quantitatively so as to establish definite conclusions about other components. A procedure was designed, designating as its point of departure, the strained state and the precipitation of the zones in question as principally determining the cracking. This state was simulated on a mass material, and the intergranular cracking under only one imposed movement was reproduced in a laboratory. (see figure 3)

FIG. 3 : Experiments of relaxation with CT specimen
(squares) : simulated heat effected zone (hardened and aged)
(diamonds) : aged basis metal (in service)

This result, unusual in light of the present day acquired experimental data (almost exclusively built on new material), at least proves that important ingredients contributing to cracking have been identified in simulations of the thermally affected zones of the welds. A damage model has been elaborated and adjusted on the basis of tests causing the multi-axialty of the strains to vary. The overall procedure will thus be available very soon in order to deal with industrial situations.
