# Major Influential Phenomena on the Accident Progressions of Fukushima Daiichi NPP

Masanori Naitoh The Institute of Applied Energy mnaito@iae.or.jp

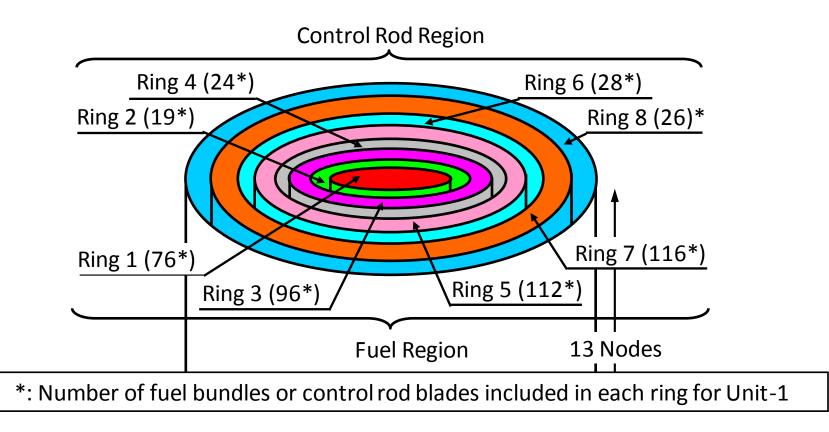
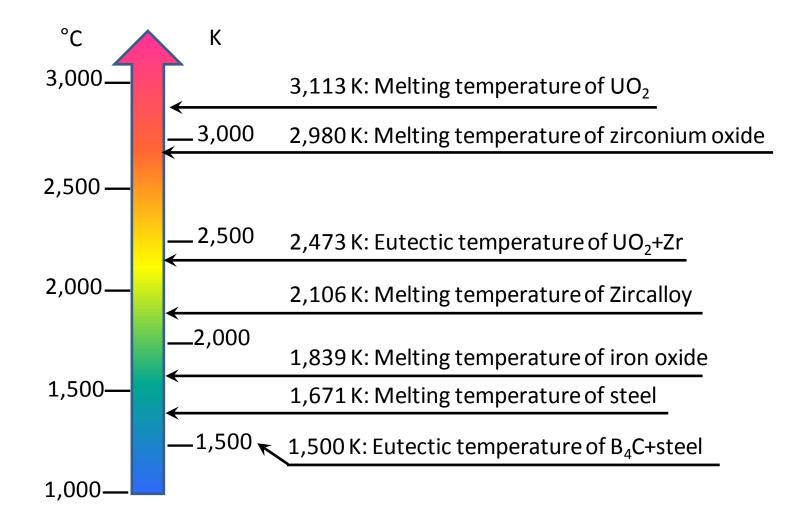
# Node Division in Core Region

- *r-z* 2D coordinates
- Radially 8 rings and axially 13 nodes
  - 4 rings for the fuel region and 4 rings for the control rod region.
  - Axially 10 nodes were allocated to the active fuel region.

- There still are uncertainties which affect very much the melt behaviors.
  - Node division in core region [Finer node division, especially in *r*-direction, is required.]
  - Mass flow rate of sea water injected into the core
     Possible RPV bottom damage (IRM/SRM melt) if the mass flow rate would be slightly less than the current estimation.
  - Time delay for effective core cooling (water injection into the downcomer region resulting in bottom reflooding)
  - RCIC part load performance under two-phase flow condition
