THE RADIOLOGICAL ACCIDENT IN GOIÂNIA

THE RADIOLOGICAL ACCIDENT IN GOIÂNIA IAEA, VIENNA, 1988 STI/PUB/815 ISBN 92-0-129088-8

FOREWORD

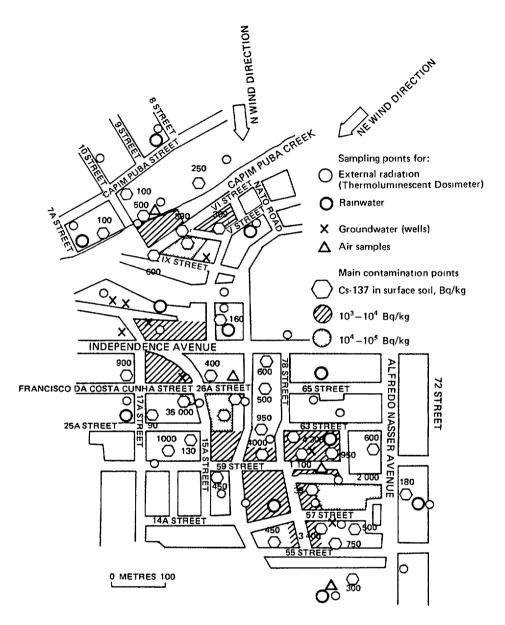
FIG 16. Plan of the Aeroporto section of Goiânia showing the locations of the principal sites of contamination and the sampling points.

In the main these objectives had been achieved by Saturday 3 October, with seven main foci of contamination (see Fig. 16) having been identified. In retrospect, this could be considered as the end of the urgent initial phase of the response in that the major sources of hazard were under control. However, as will be seen later, it was still possible to discover other less severely contaminated areas, and to have to set up controls

Figure 16, indicative of this extensive measurement programme, shows broad dose rates and contamination bands around the several principal foci. More detailed dose rate measurements are shown in Fig. 20 (for the house and yard where the source capsule was first ruptured) and in Figs 21 and 22. Figure 23 shows a typical less contaminated site where contamination had been brought in by residents and visitors.

The distribution of radioactivity levels for about 400 soil samples is shown in Fig. 16. The levels ranged from 10^2 to 10^5 Bq·kg⁻¹ and decreased with distance from the main foci. They reflected the wind pattern, showing the effects of resuspension and further dispersion. Soil profiles later showed that for any specific radioactivity at the surface, the top 15 mm of soil retained an average of 60% of the caesium. (See Photograph 19.)

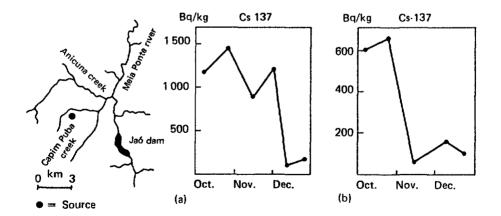
FIG. 18. Plan of rivers in Goiânia and plot of concentrations of caesium-137 in sediment samples from (a) Anicuna creek and (b) Jaó dam.

During the initial phase of the response the response team had formed a general picture of the sites and the extent of the contamination. They had identified seven main areas of contamination. These sites were mostly in urbanized suburbs where small vegetable gardens and fruit trees were common, and where there were also some chicken coops. All houses have a piped supply of fresh water and are linked to the sewerage system. In some places there are artesian wells, but they are only used during prolonged periods of water shortage. Sewage water and rainwater are both discharged to Capim Puba creek. This flows to the Meia Ponte river, which passes through Goiânia from the north-east to the south-west (see Fig. 18).

Caesium chloride is highly soluble, and its dispersion from the broken source capsule into the environment was increased by the rainfall. It had initially been thought that, because of the high rainfall, the contamination would either have been washed into the clay soil and retained or been drained off. This was not the case, however The high temperatures dried out the ground and high winds caused resuspension and dispersion. Indeed, the scale of the effect came as a surprise. For some houses, contamination deposited on roofs was the major contributor to dose rates indoors, and the roof tiles had to be removed.

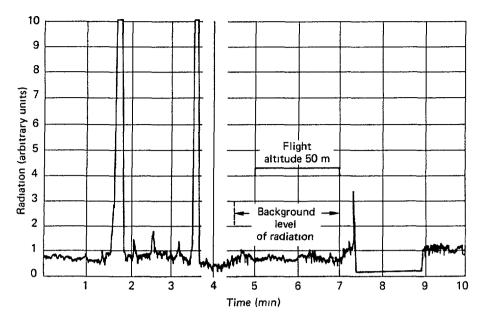
FIG. 19. A recorder trace from an aerial radiation survey The background reading was taken at 50 m altitude over open land away from the contaminated area of Goiânia The peaks represent radiometric anomalies over contaminated areas.

During the course of the initial phase of the response, it was necessary to confirm that all the major sources of contamination had indeed been traced. To do this, an aerial survey of Goiânia was carried out by helicopter on 7 and 8 October. A portable battery powered gamma spectrometer having NaI(Tl) detectors with a total volume of 840 cm³ was used. After testing on the ground, a test flight was made away from contaminated sites to measure local background radiation. Tests were also done to check that the down-draughts due to the helicopter rotor did not significantly resuspend and further disperse the contamination. Most of the survey was flown at an altitude of 40 m, and a circle of radius 80 m was effectively monitored. The ground speed was between 50 km \cdot h⁻¹ and 70 km \cdot h⁻¹. Over two days, all the urban areas of Goiânia were monitored (about 67 km²). This confirmed that no sites of major contamination had been missed, and one discrete spot of radio-activity was found that gave rise to a dose rate of 21 mSv \cdot h⁻¹ at 1 m (Fig. 19 shows a typical analogue record obtained over contaminated areas)

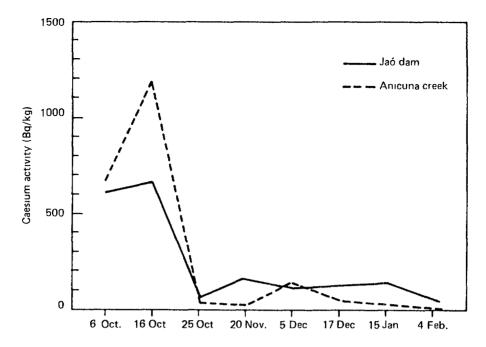
FIG 24. Time variation of radioactivity due to caesium-137 in sediments from Anicuna creek and Jaó dam

Monitoring of the hydrographic basin was initially performed during the first days of October and included surface water, suspended matter, bottom sediments and fish and the screening of the river bottom. This included, in particular, the Capim Puba creek, a tributary of the Meia Ponte river that receives both flood control water and sewage from the area of the three most contaminated sites. In addition, a survey was conducted on the sewerage system of the district. Monitoring showed no significant radioactivity. (See Fig. 24.)

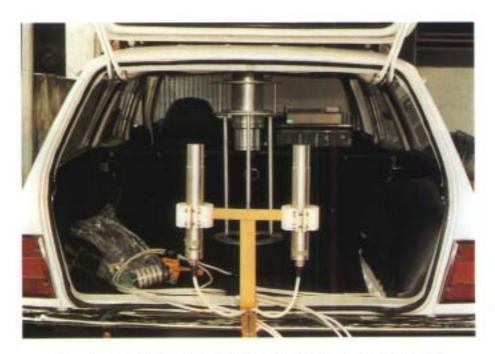
quarters of the city. Later on a set of detectors was mounted at the back of a car. (See Photograph 6.) Both 100 mm \times 100 mm NaI(Tl) detectors and Geiger-Müller (GM) type detectors were used. One problem encountered was that the electronics were sensitive to temperature variations, and a car with air conditioning was required. The monitoring programme had two phases. The first phase lasted until December and was primarily aimed at monitoring the area outside the main foci of contamination. After Christmas a second survey was carried out once these foci had been decontaminated.

6. Mobile radiation monitoring: Nal and GM detectors mounted on a car.

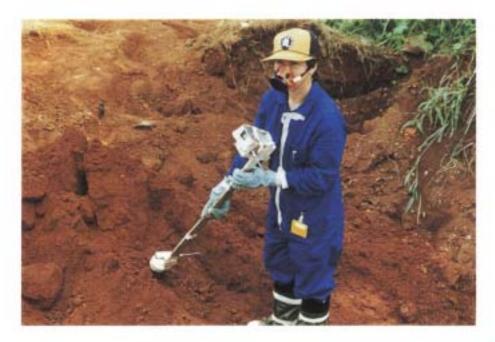
19. Monitoring soil for contamination.

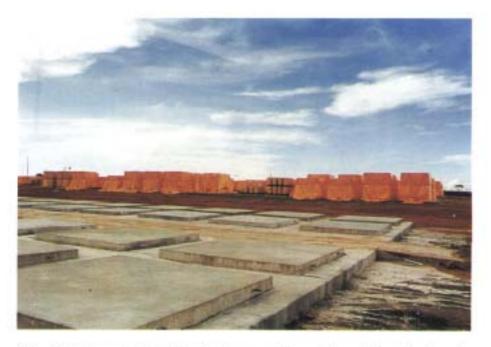
Finally, a sampling system was designed to monitor water (mainly rainwater) from the platforms continuously. (See Photograph 24.) A system of natural barriers (including a small dike used for environmental studies) was built to slow the flow of draining water and to increase the absorption of caesium within the area of the depository.

24. The temporary storage site, showing concrete bases with runoff sampling channels.

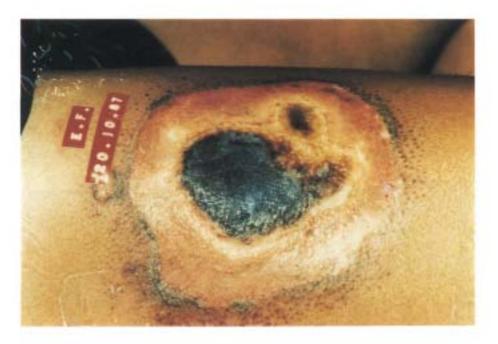
25. A radiation induced lesion on the thigh about 25 days after irradiation.

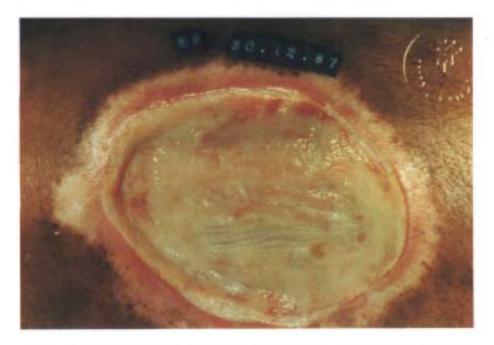
26. Injury has extended into musculature of the thigh. Lesion 100 mm × 120 mm.

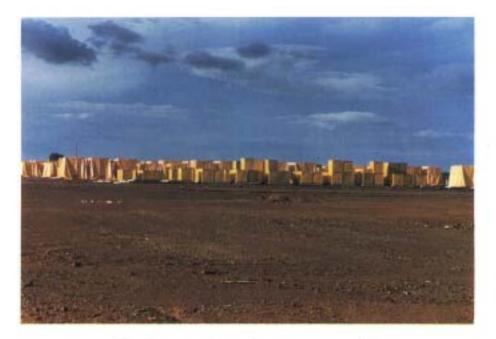
27. Waste containers at the temporary storage site.

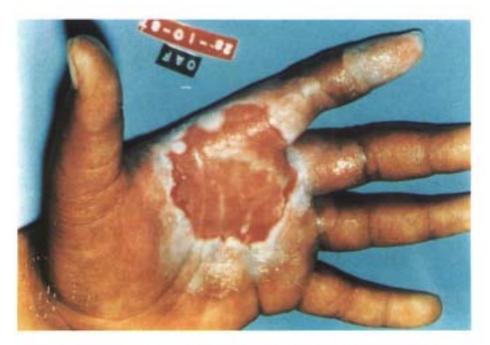
29. Bulla completely broken down and injury extended to index and middle fingers.

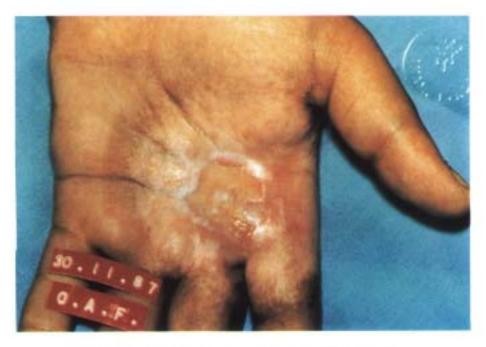
30. Partial healing of lesion on palmar surface of the hand.

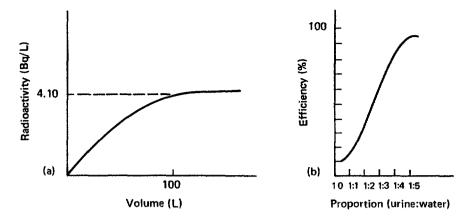
FIG. 25. (a) Quantity of caesium-137 retained by a volume of cationic resin as a function of the volume of dilute urine (one part urine to four parts water). (b) Variation of the efficiency of retention of caesium-137 as a function of the dilution of urine (at a flow rate of $6 L \cdot h^{-1}$).

S100-Lewatit cationic resin was used to decontaminate urine. The maximum efficiency obtained in this process was about 90% using a flow rate of $6 \text{ L} \cdot \text{h}^{-1}$ and a dilution of four parts water to one part urine. The saturation curve of the resin and the variation in its efficiency as a function of dilution are shown in Fig. 25.

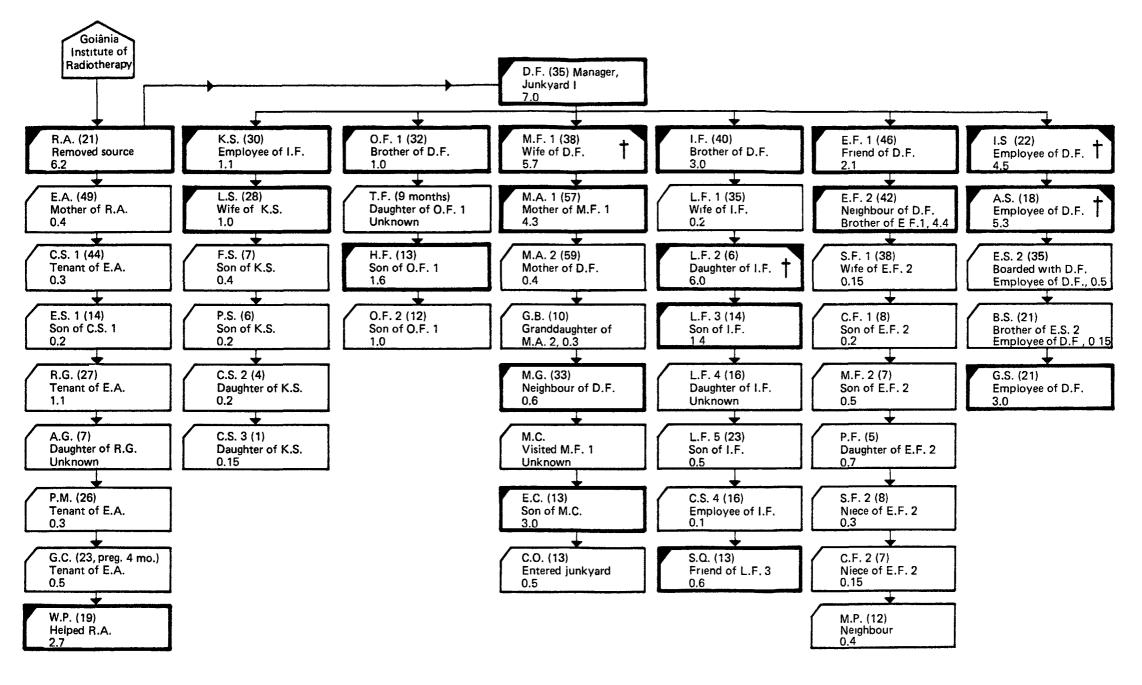
FIG. 8. Schematic diagram of the dispersal of caesum-137 in the accident in Goiânia. The diagram is based on a drawing made shortly after the discovery of the accident in attempting to reconstruct what had happened. It is reproduced in the format in which it was originally drawn even though it differs in minor details from what is now considered to be the best description of events (see the text of the report). Key: (1) the derelict clinic of the IGR; (2) removal of the rotating source assembly from an abandoned teletherapy machine by R.A. and W.P.; (3) source assembly placed in R.A.'s yard near houses rented out by R.A.'s mother E.A.; (4) R.A. and W.P. break up source wheel and puncture source capsule; (5) R.A. sells pieces of the source assembly to Junkyard I; (6) Junkyard I. the caesium

chloride is fragmented and dispersed by I.S. and A.S. via public places; (7) D.F.'s house: contamination is further dispersed; (8) visitors and neighbours, e.g. O.F.1, are contaminated; (9) E.F.1 and E.F 2 contaminated; (10) I F.'s house; other arrows indicate dispersion via visitors and contaminated scrap paper sent to other towns; (11) contamination is spread to Junkyard II; (12) contamination is spread to Junkyard III, (13) K.S returns to the IGR clinic to remove the rest of the teletherapy machine to Junkyard II; (14) M.F.1 and G.S. take the source remnants by city bus to the Vigilância Sanitária; (15) contamination transferred to other towns by M.A.1. (By courtesy of CNEN, Brazil.)
