Reflectivity Reduction of Retro-Reflector Installed in LHD due to Plasma Surface Interaction

Abstract: Optical reflectivity of the retro-reflector installed in LHD as the first mirror was reduced seriously by plasma wall interaction. In order to understand the mechanism of the reflectivity reduction, optical and material properties of the mirror surfaces have been examined extensively. It was found that the deposited impurity layers caused the serious reduction of the reflectivity. Formation of iron oxide, bulges structure and He bubbles are the major factors for the reflectivity reduction in the wide wave length range.

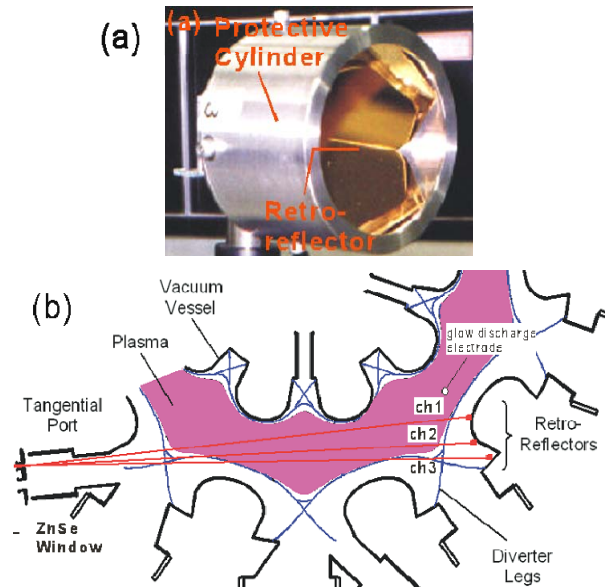
It was reported that the optical reflectivity for CO₂ laser decreased during rather long glow discharge cleaning for the start-up of the cycle and following main plasma discharges and glow discharge cleaning [9]. The materials of the inner wall of vacuum vessel (protection wall) and the divertor were 304 SS, whose main components were Fe, Ni and Cr, and isotropic graphite, respectively.

Fig. 1 (a) Retro-reflectors installed in LHD. Gold-plated flat reflectors are seen. (b) Positions of the retro-reflectors and laser beams are shown.

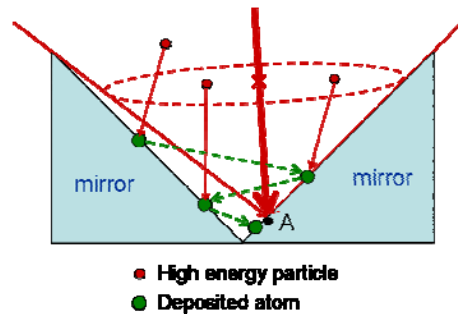
The area near the cubic corner (points **c**, **d** and **e**), where the laser beam passed, was thickly covered by impurity deposition with very rough surface. Therefore formation mechanism of the rough surface is discussed in the following. On the mirror surface both high energy particles from the plasma and impurities come. The former sputter not only the mirror but also impurity atoms deposited on the surface. Some part of the sputtered atoms goes away from the reflector but some of them deposit again on the mirrors. As illustrated in Fig.13, deposited atoms are transported toward the cubic corner by the successive sputtering. At the area near the cubic corner deposited atoms have almost no way to get out from the reflector because each mirror is closely surrounded by the other two mirrors. Namely impurities deposited on the mirror surface pile-up at the narrow cubic corner part by the successive sputtering collision of the energetic particles from the plasma. We can say that impurity deposition is unavoidable for retro-reflectors if both impurities and high energy particles arrive on the mirror surfaces directly. High accumulation of sputtered impurities will occur not only in retro-reflectors but also roof reflectors and the parts where two or more surfaces meet together and form hollow structure, if they face plasma directly.

Fig. 13 Incident direction of impurities and high energy particles at point A, and inter-mirror movement of impurities by sputtering.

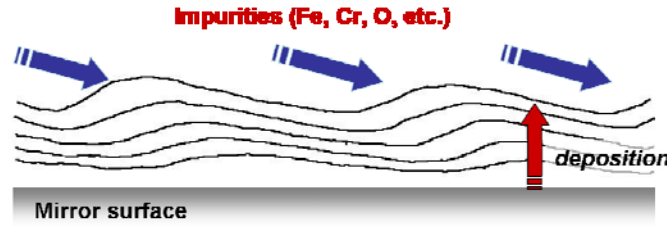
direction of the impurities is not perpendicular to the mirror surface but inclined toward the aperture or the main plasma. If the injecting direction is inclined against the mirror surface as illustrated in Fig.14, wavy surface develop once the surface become uneven and development of the wavy structure is suppressed at the down stream area of the large projections due to the shadow effect of the projections. In case of the retro-reflectors average injection direction of impurities inclined against mirror surfaces, so once the surface become uneven the wave structure develop.

Fig. 14 Development of wavy surface by oblique injection of impurities.
