Root Cause Analysis of Swelling Problem in *Kartini* Reactor

BATAN (Indonesian National Nuclear Energy Agency)

Description of KARTINI reactor

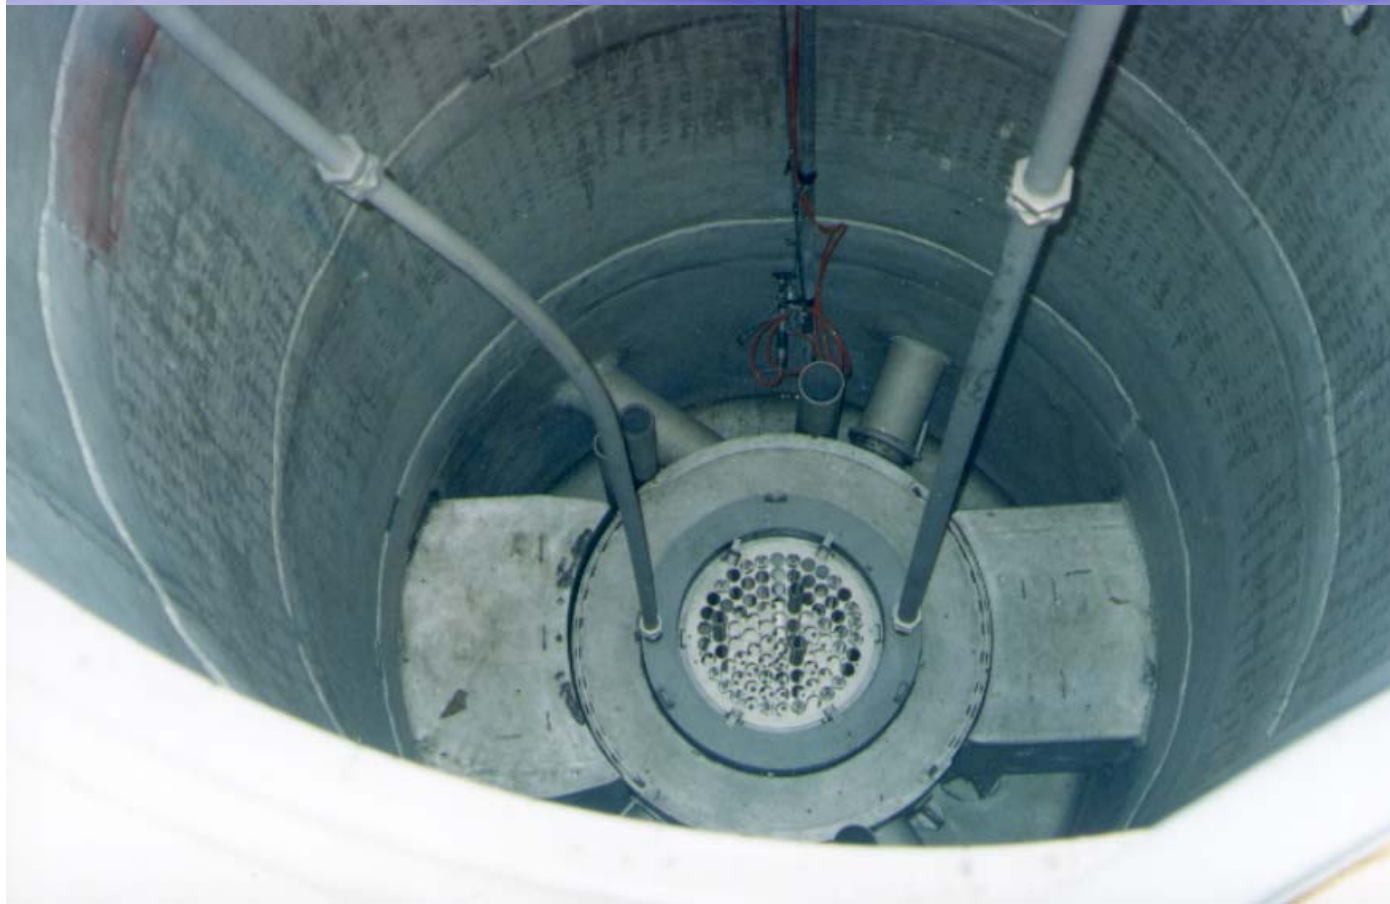
In general : the pool liner was in good condition, thickness and hardness survey were consistent with the service history.

3 areas of interest were observed :

- A small area with apparent thinning
- A small crack (analysed as an original manufacturing defect)
- Two small areas of bulging under the thermalizing column (S1 and S2).

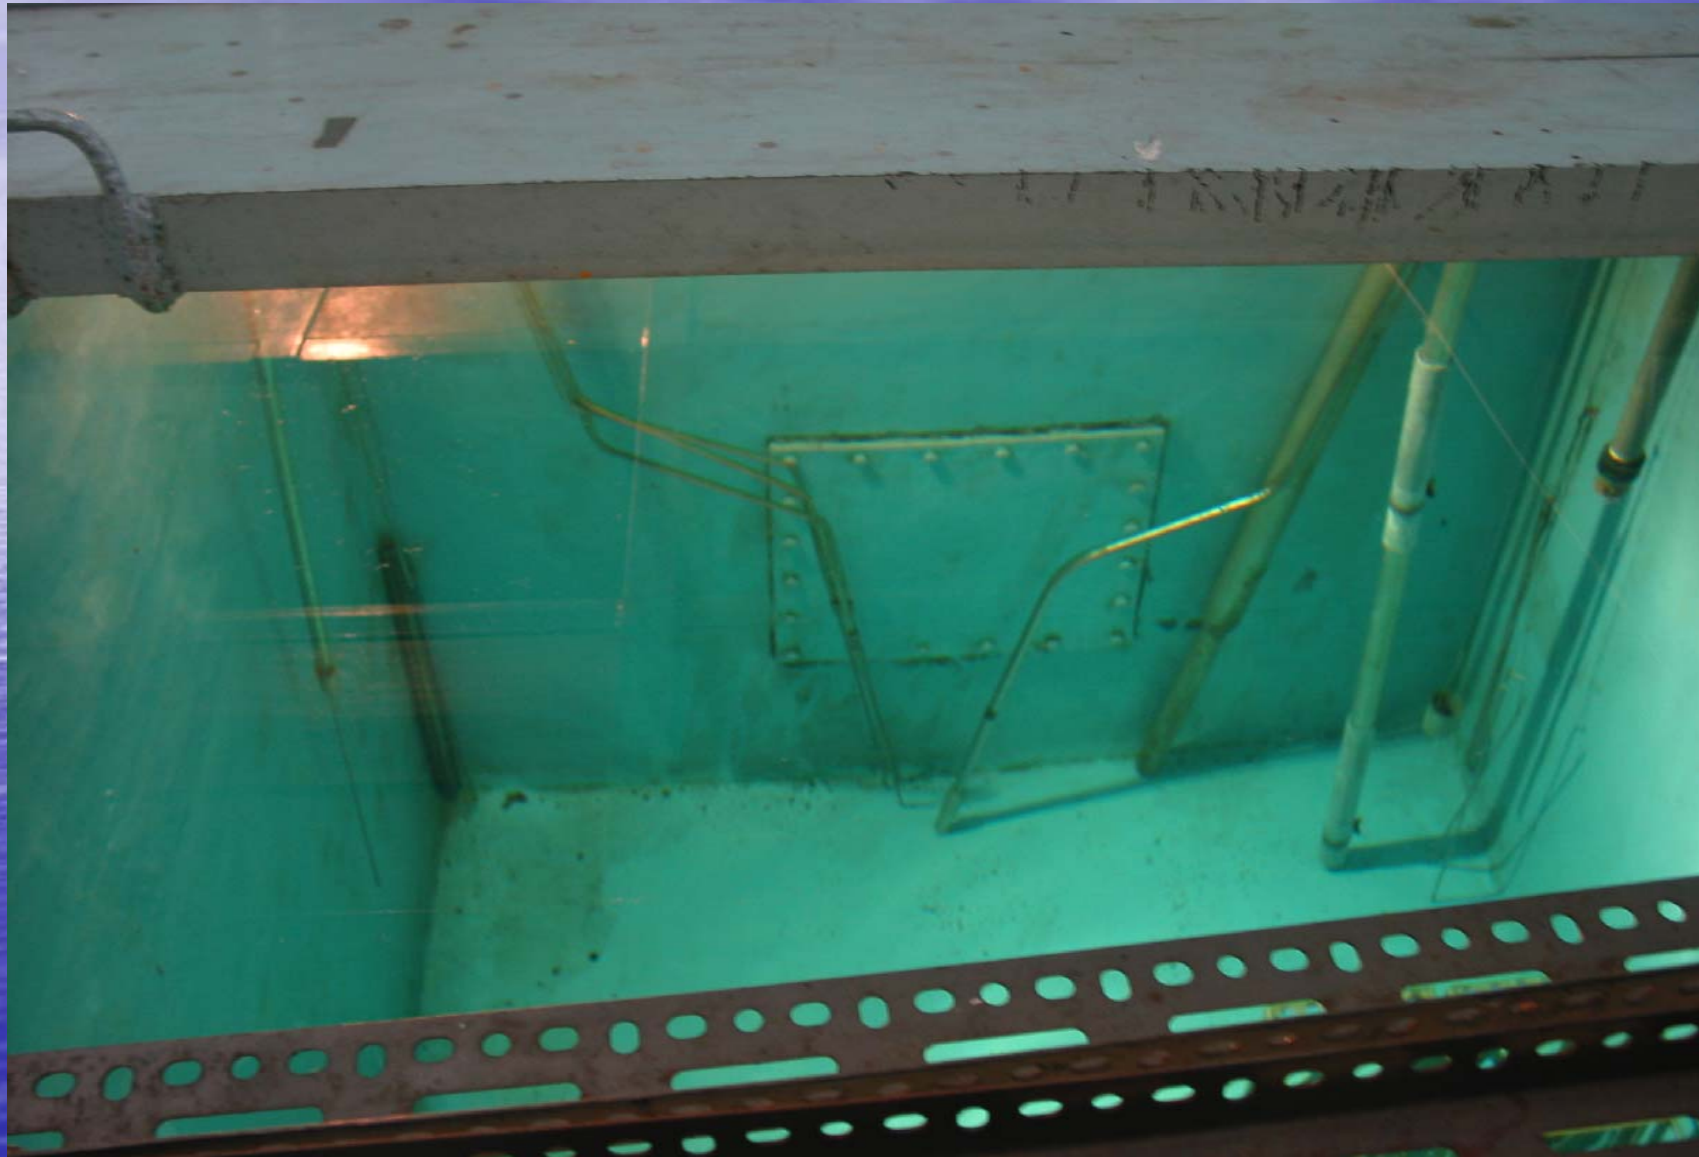
Bulk Shielding Facility (BSF-service pool)

The external surface of the bulk shielding facility (BSF) shows evidence of water leakage. The white deposits on the side of BSF shown in Figure 7, which were originally thought to be $\text{Ca}(\text{CO}_3)$, were analysed as Sodium carbonate.

- To dry the concrete block to attempt to remove the conditions that are causing the defects. The BSF would then be lined to prevent future water penetration of the concrete. If continued monitoring of the swelling indicates that some repair action should be taken the reactor pool will need to be emptied of fuel and control systems and the BSF would be required for storage.
- To maintain the program of periodic inspection to monitor the rate of progression and take action to repair to the areas involved.
