THE RADIOLOGICAL INCIDENT IN HUEYPOXTLA

INTERNATIONAL ATOMIC ENERGY AGENCY VIENNA, 2022

A radiological incident occurred in Mexico in December 2013. A vehicle transporting a teletherapy unit head with a Category 1 cobalt-60 radioactive source from a medical facility in Tijuana to a disposal facility in Santa Maria Maquixco, Mexico, was stolen by a group of armed individuals. A number of individuals who came into contact with the radioactive source received doses in excess of the effective dose limit specified in Mexican regulations.

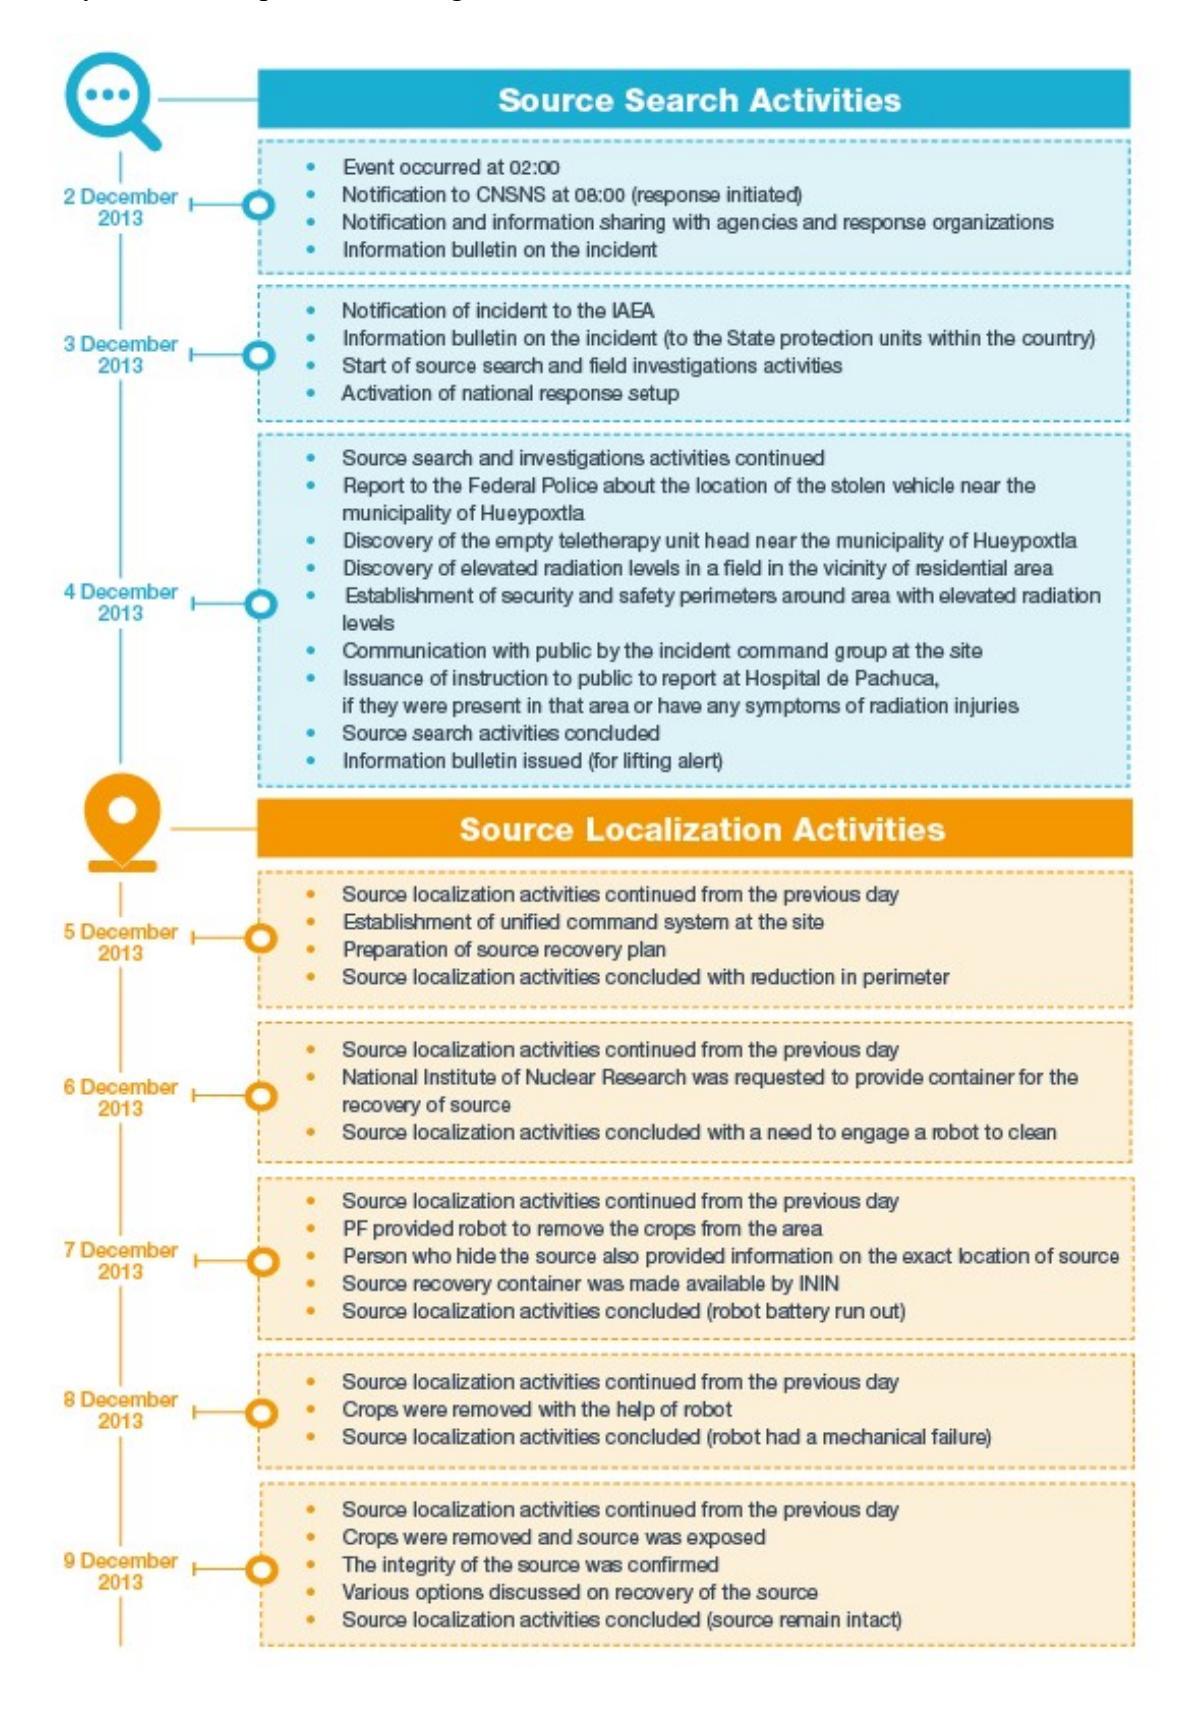
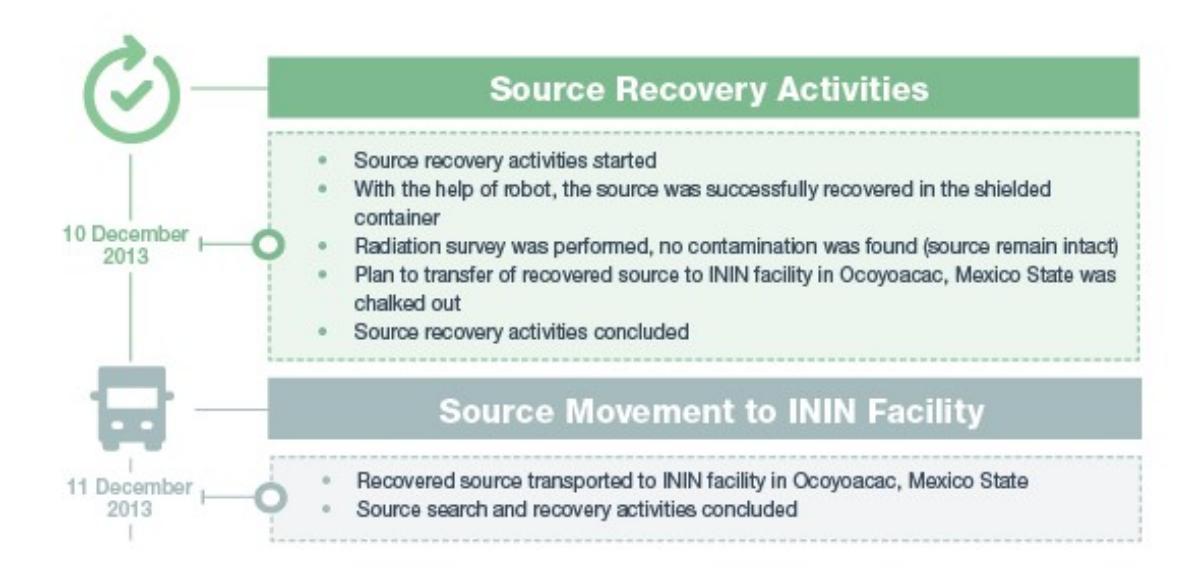
FIG. 4. Source search, localization and recovery activities.

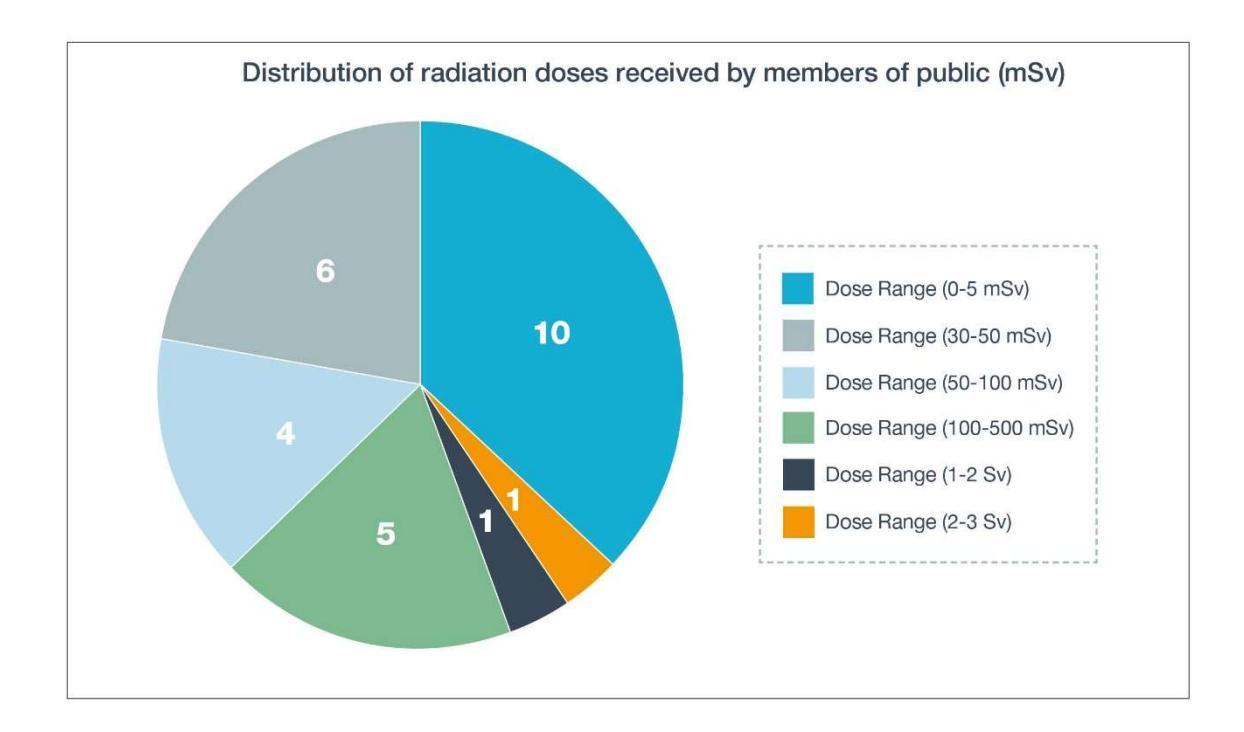
The Ministry of Health informed CNSNS about a second group of five persons, who had been allegedly involved in the dismantling of the teletherapy unit head and who had been exposed to the radioactive source. On request of CNSNS, ININ collected blood samples and conducted biological dosimetry studies of this second group of people. One person was identified as having received a dose in excess of the limit specified in the Mexican regulation to prevent non-stochastic effects among occupationally exposed personnel. In total, dosimetry studies were performed for twenty-seven individuals as presented in Fig. 8.

FIG. 8. Distribution of radiation doses received by members of public.

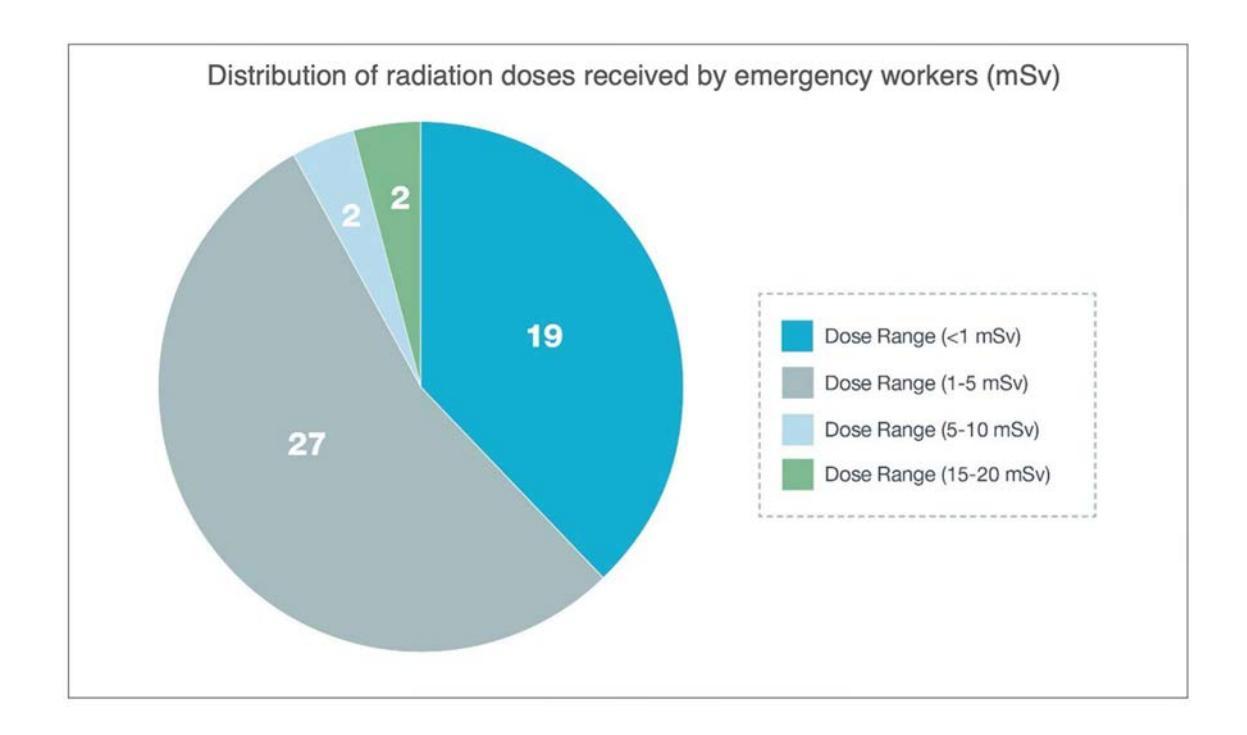
For the workers involved in the recovery process, a limit of 50 mSv effective dose was set. The average dose received by the emergency workers was less than 3 mSv, and the highest value was approximately 20 mSv.Figure 9 provides the details of the radiation doses received by the emergency workers in the source search and recovery operations.

FIG. 9. Distribution of radiation doses (mSv) received by the emergency workers.
