Life Extension of the Point Lepreau GS – Powering the Future

**Keith Stratton
New Brunswick - Canada**

October 27 – 30, 2009

International Conference on Opportunities
and Challenges for Water Cooled Reactors
in the 21st Century

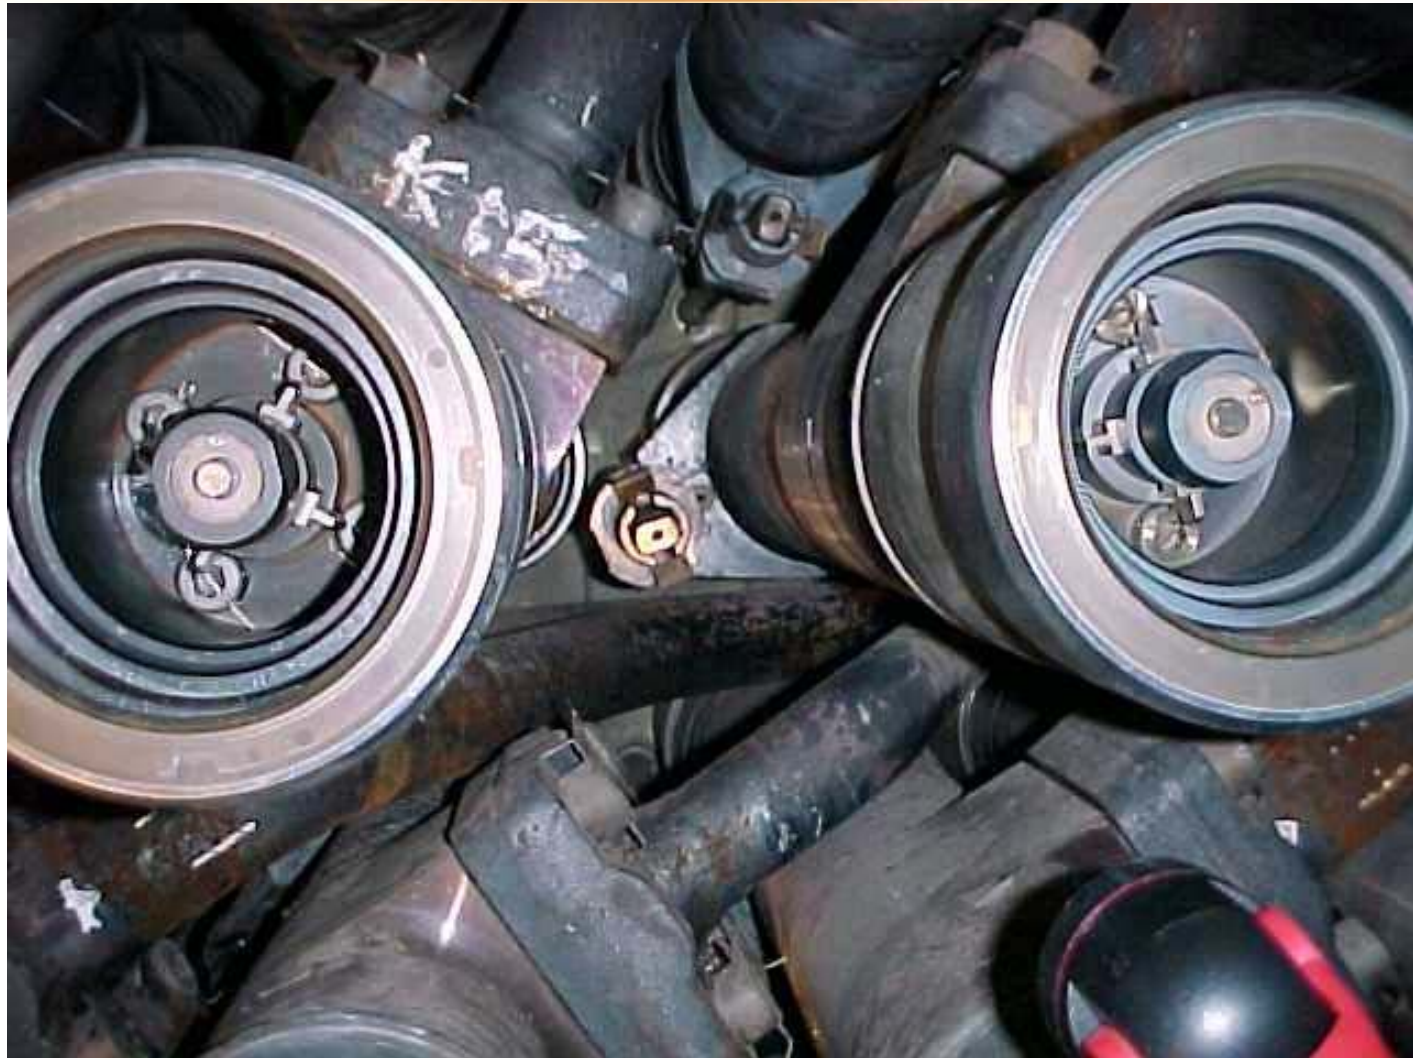
Feeders (continued)

- Unplanned outages in 1997 and 2001 because of leaks at bends
- Large annual inspection campaign initiated
- Cracks discovered on the ID on bend intrados
- Cracks discovered on the OD on bend extrados
- Cracks grew from undetectable to 75% through wall in one year
- Crack location unpredictable
- Stress corrosion cracking and low temperature creep cracking
- Eighteen bends replaced because of cracking
 - › two through wall
 - › ten partial through wall
 - › six falsely identified

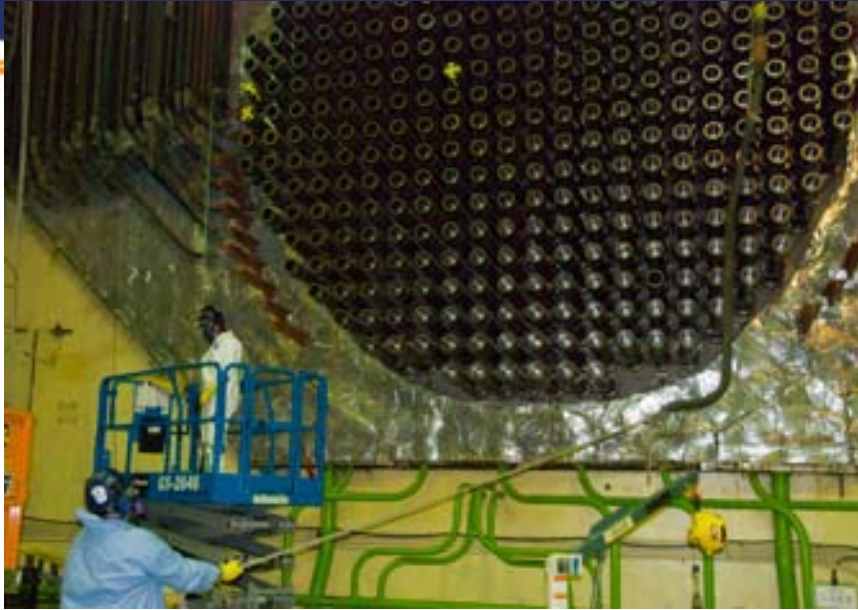
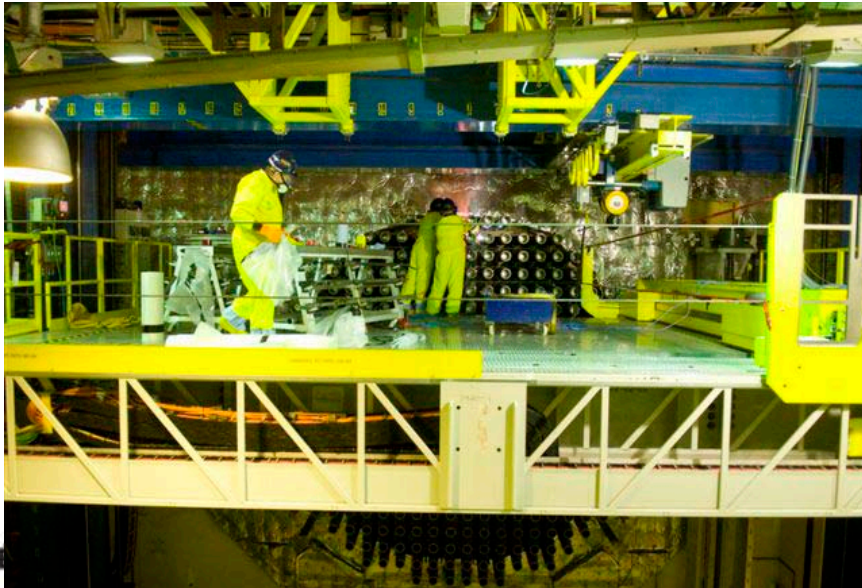
Retube status

- Disassembly complete
 - End fittings removed
 - Pressure tubes removed
 - Calandria tubes removed
 - Feeders removed
- Inspections in progress
- Installation of upper feeders begun

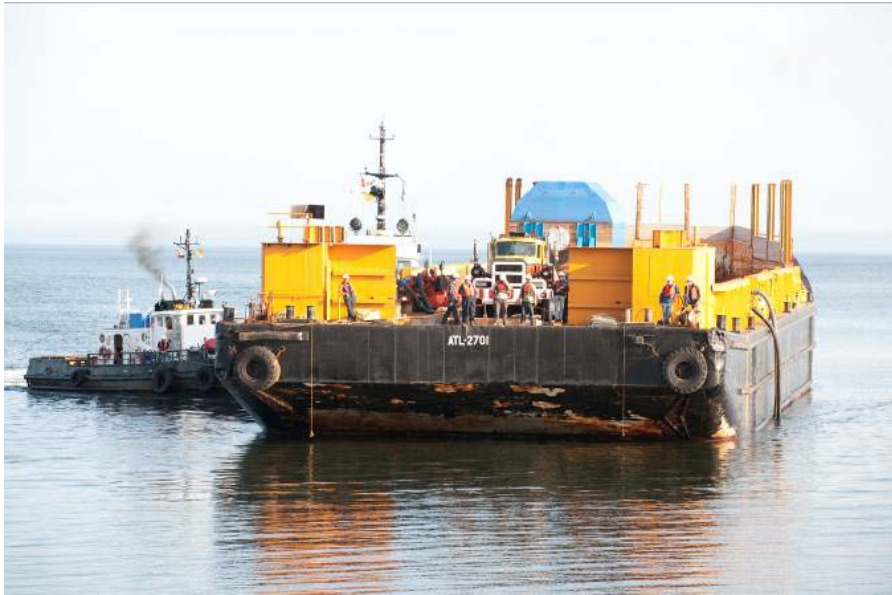
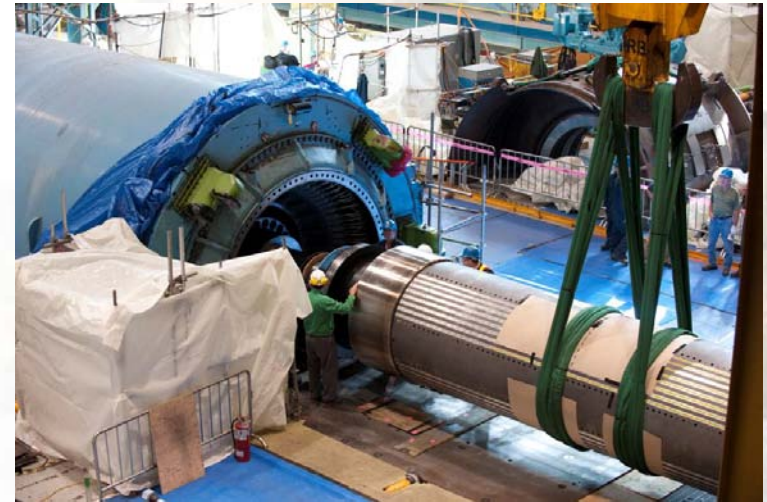
Main Generator and Turbine Rotors

- One of three turbine rotors safely delivered to the station and installed
- Two other turbines recovered, delivered and installed
- Alignment of turbines in-progress

- Main generator rotor rewind and reinstalled
- Main generator stator rewind and reinstalled
