# Degradation Monitoring of G.A. Siwabessy Research Reactor's Secondary Cooling Pipe

Roziq Himawan

Indonesian National Nuclear Energy Agency (BATAN)

International Conference on Research Reactor: Safe Management and  
Effective Utilization, 14-18 November 2011, Rabat, Morocco

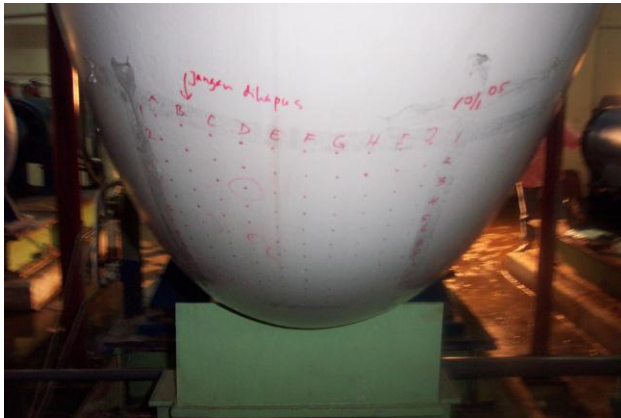
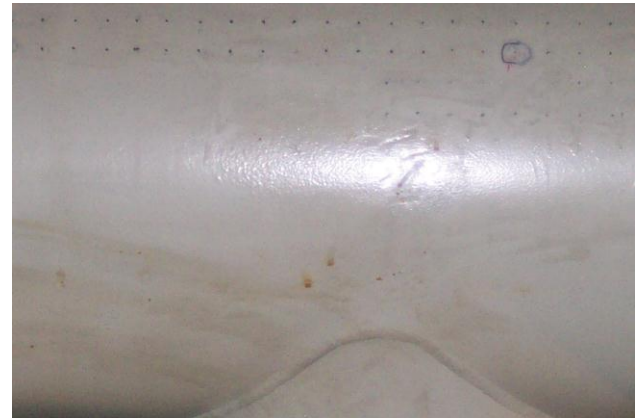
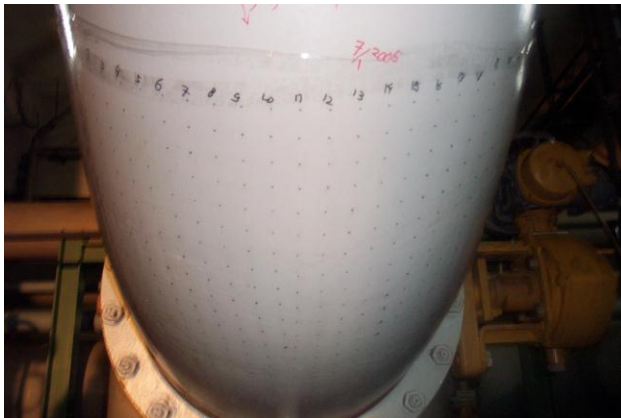
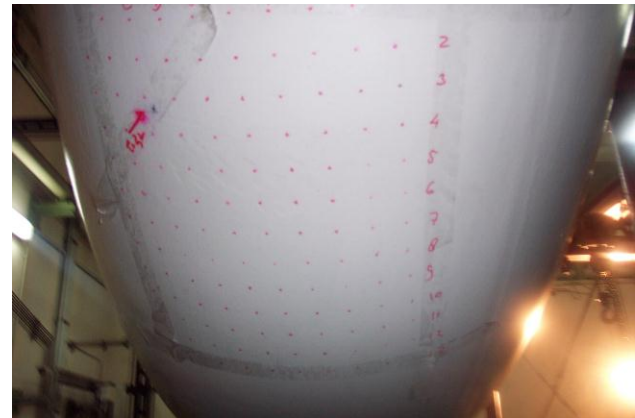
# Ultrasonic Thickness Measurement (2004)

Measurement results which larger than initial thickness are caused by

- Paint layer
- Corrosion (product)
- Sedimentation from cooling water (impurity of raw water, chemical agent)

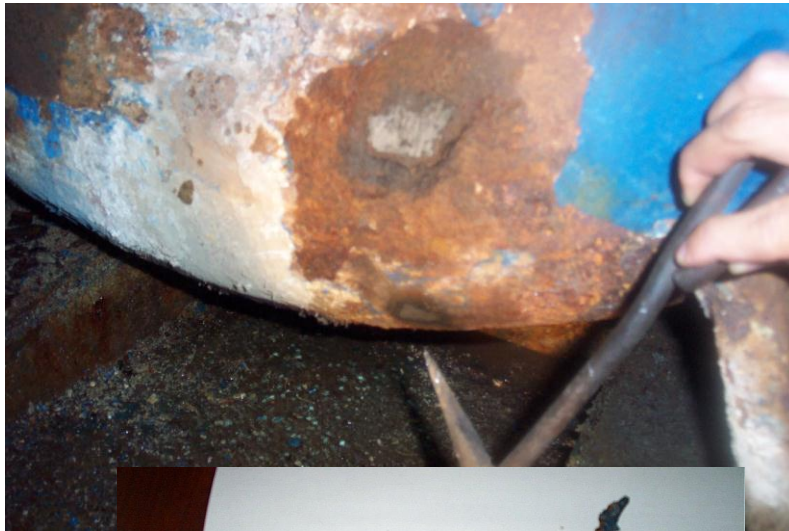
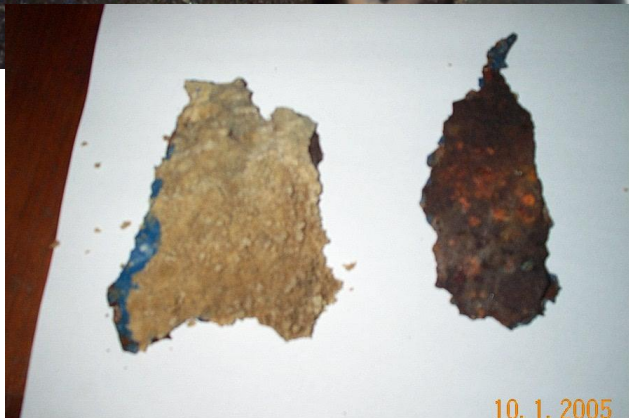
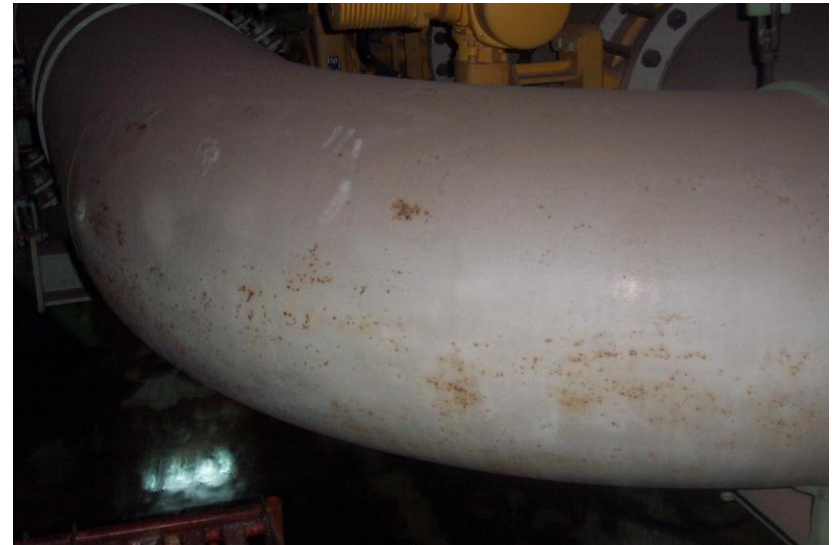
# Inspection Results

Thickness mapping : Indicated Pitting corrosion

- Degradation of pipe are due to homogenous and pitting corrosion rather than erosion-corrosion (flow accelerated corrosion)
- Improvement of water treatment are needed to suppress corrosion occurred in the internal surface
