# The Radiological Accident in Ventanilla

# THE RADIOLOGICAL ACCIDENT IN VENTANILLA

INTERNATIONAL ATOMIC ENERGY AGENCY VIENNA, 2019

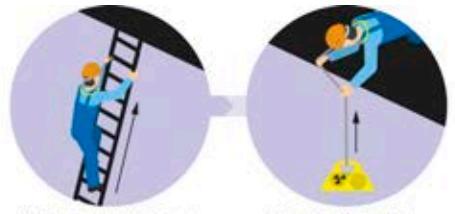
Worker 1 climbs up the ladder with guide tube around the neck with end in left pocket

Worker 1 hoists radiography equipment up to the platform

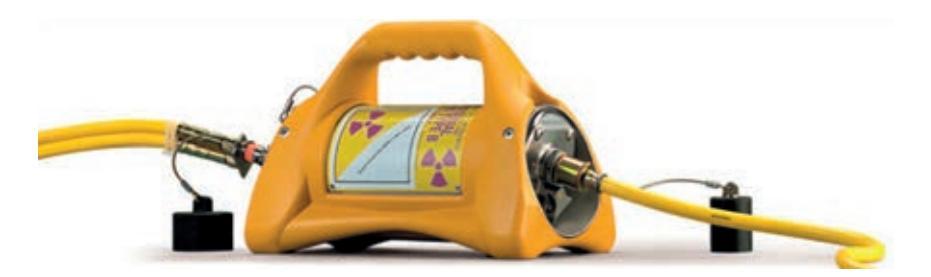
FIG. 3. The source projector (camera) model used in the accident [6].

The main factor contributing to the accident was the lack of safety and radiation protection procedures: specifically, the failure of the pigtail to return to the safety position in the radiography equipment. Other factors that contributed to the accident included the inadequate use of portable radiation detector survey meters and, possibly, inadequate use of personal alarm dosimeters.

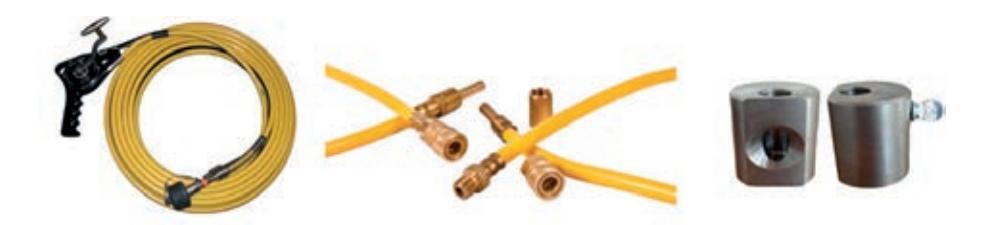
FIG. 4. Parts of the radiography equipment and associated tools: yellow guide tube (left); connectors (centre); and collimator (right)[6].

A collimator (see Fig. 4) is a radiation shield that is placed at the end of the guide tube to limit and direct the radiation beam to the dimensions required when the sealed source is moved into position for a radiographic exposure.

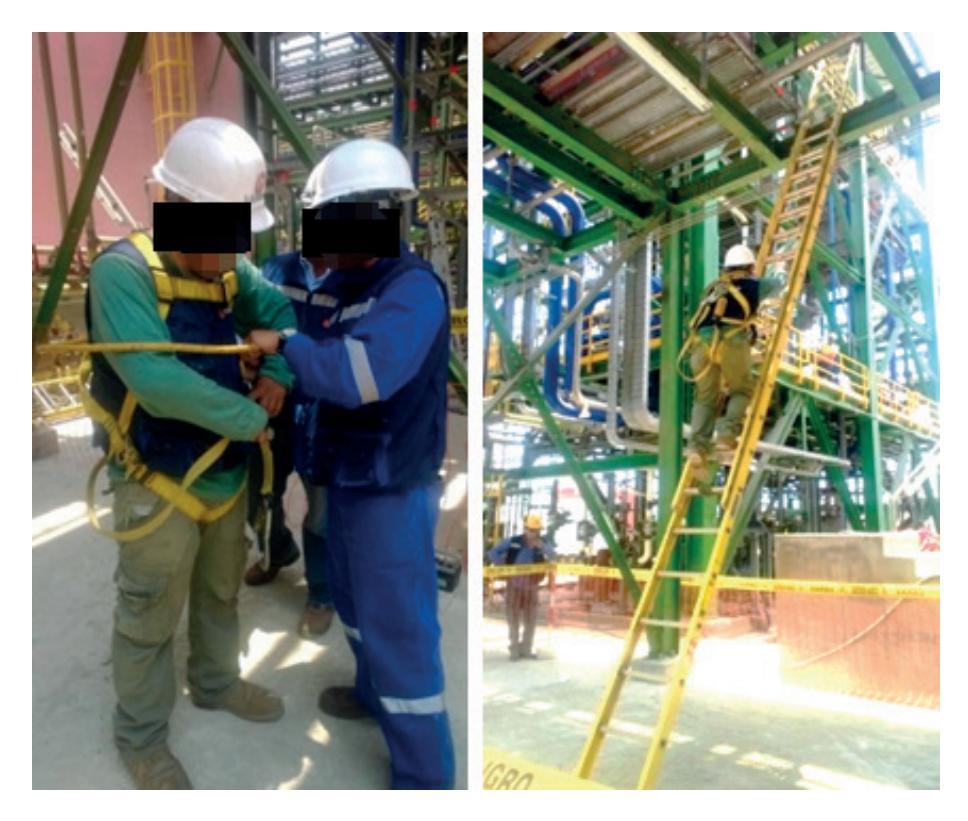
FIG. 5. Left: Worker 3 (blue overalls) adjusting the safety harness on the operator (green overalls). Right: The operator climbing up the ladder according to the instructions given by Worker 1 (photographs courtesy of IPEN [6]).

The time that Worker 1 would have needed to climb up and down the platform was measured as follows:

- Time taken to climb up the ladder: 52.7 s;
- Time taken to climb down the ladder: 47.5 s.

Considering the inclined position of the worker while climbing up and down the ladder, it was estimated that the distance between the radioactive source and the skin surface of the worker's body (left flank) was on average approximately 6 cm.

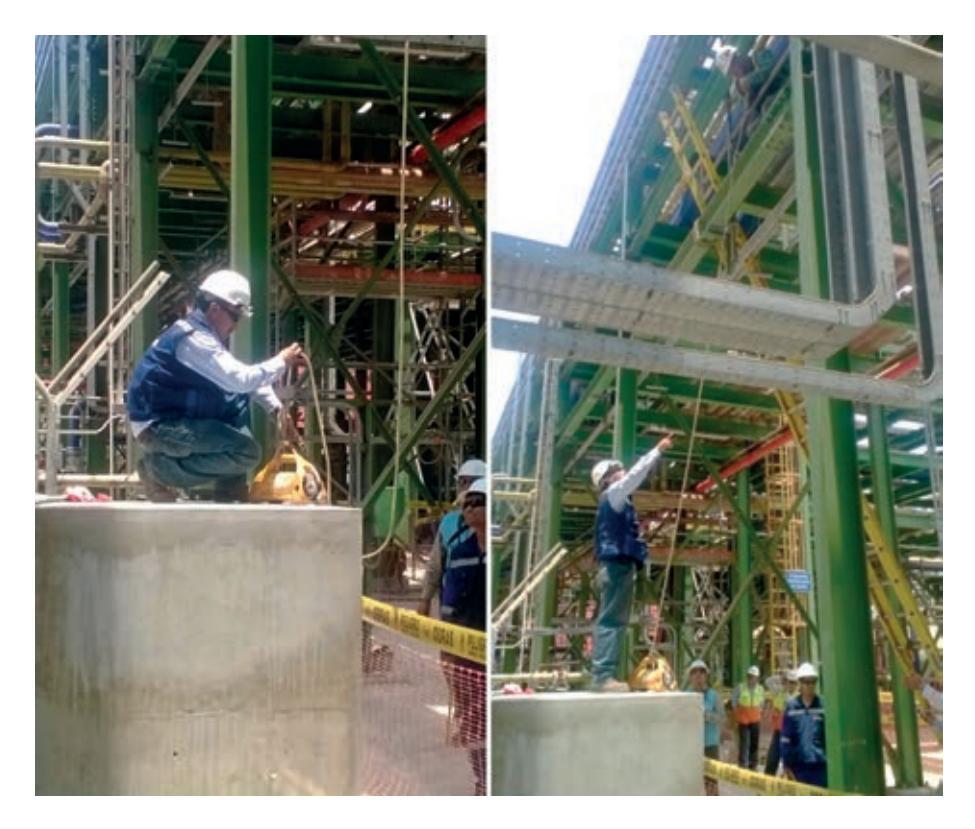
FIG. 6. Worker 3 performs manoeuvres to raise and lower the radiography equipment while Worker 1 stays on top of the platform (photographs courtesy of IPEN [6]).

To perform the radiography of a pipe joint, Worker 1 would hoist the radiography equipment to the platform using a rope prepared by Worker 3. Once the radiographs of that joint were finished, he would lower the radiography equipment. During these manoeuvres, Worker 1 would keep the guide tube in the position shown in Fig. 1. At the same time, Worker 3 would also carry out manoeuvres to raise and lower the radiography equipment to and from Worker 1, while Worker 1 stayed on the platform, as shown in Fig. 6.

As Worker 1 would adopt an inclined position to handle the rope with the equipment, it was estimated that the collimator would have been about 8 cm from the skin of Worker 1 (left flank). This assumption was based on direct measurements and considerations concerning the weight of the collimator.

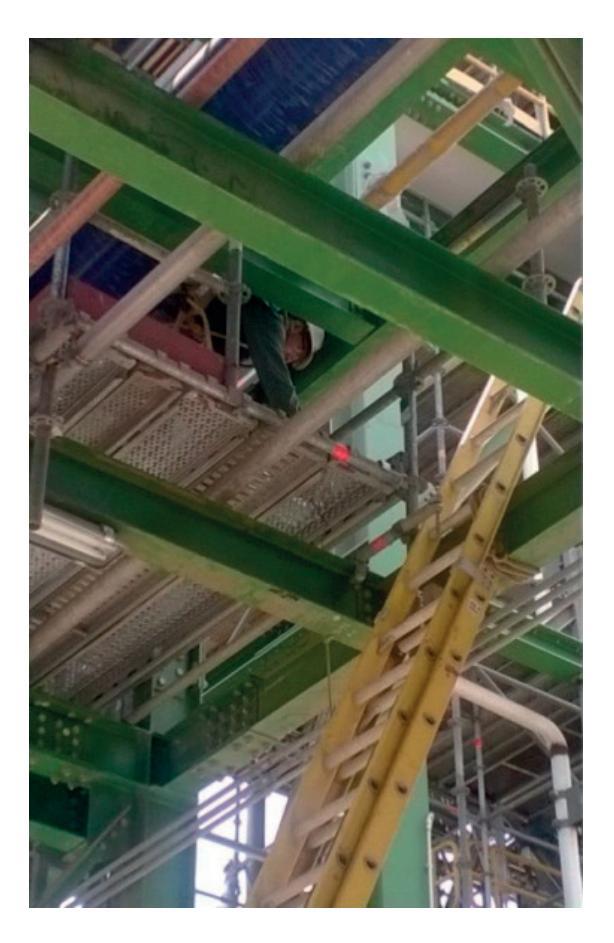
FIG. 7. Reconstruction of the manoeuvres on the platform: Connecting and disconnecting the guide tube, attaching and detaching the radiography equipment to raise or lower it (photograph courtesy of IPEN [6]).

Another action to be considered in the estimated duration of the exposure of Worker 1 was the time used to attach and detach the guide tubes from the radiography equipment so that the equipment could be raised and lowered (Fig. 7). Worker 1 performed this manoeuvre with the guide tube around his neck and the collimator in his left vest pocket. According to Worker 1, these manoeuvres were carried out within approximately 60 s. The estimated distance between the collimator and the skin of Worker 1 (left flank) was approximately 8 cm.

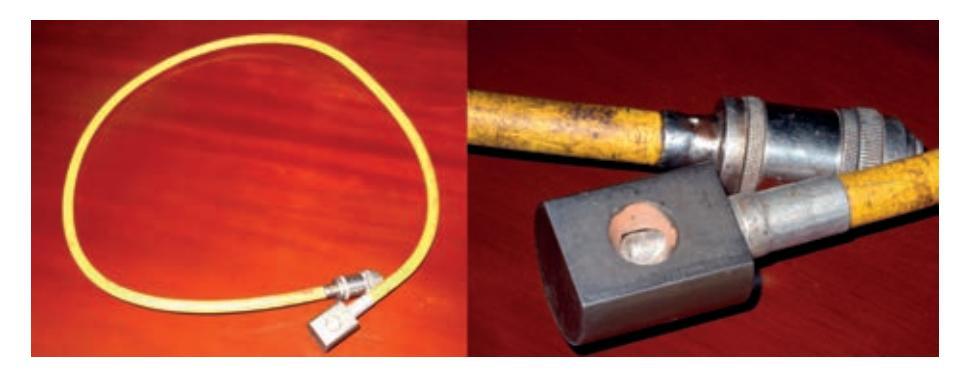
FIG. 10. Left: The guide tube used during the accident, with the collimator connected. Right: A closer image of both distal parts of the guide tube, with the collimator connected to the guide tube.

To facilitate understanding of the dosimetric calculation for the reader, it is necessary to describe the guide tube, the collimator and the pigtail, which are shown in Figs 10, 11 and 12.

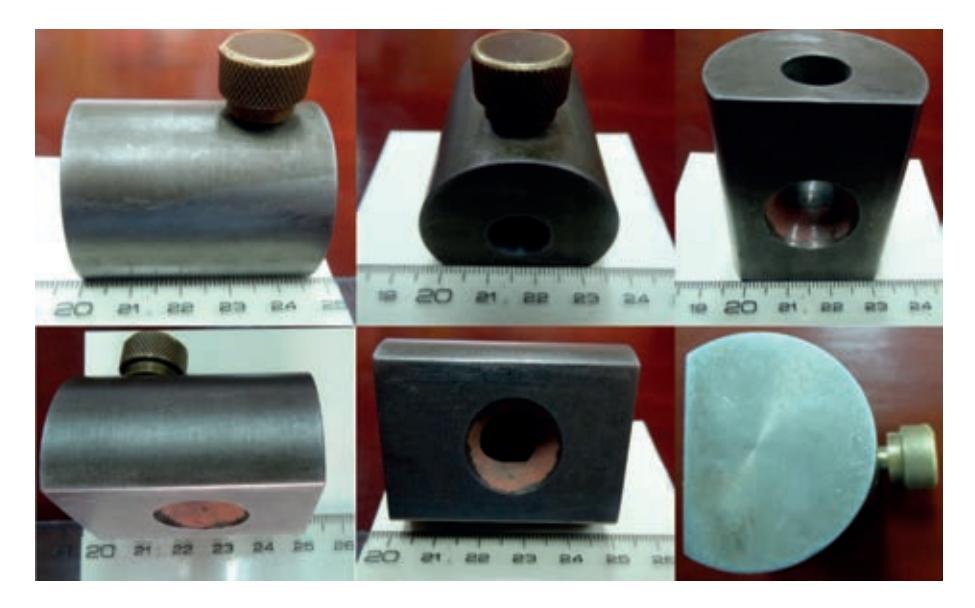
FIG. 11. Different sides and dimensions of the collimator used on the day of the accident. The centre photographs show the side for connecting the distal part of the guide tube to the collimator (top centre) and the side with the pinhole for the exposure of the source (bottom centre).

The dimensions of the collimator involved in the accident are shown in Fig. 11 (in cm). Note that there are two openings, one for connection with the guide tube and the other for exposure of the source (pinhole).

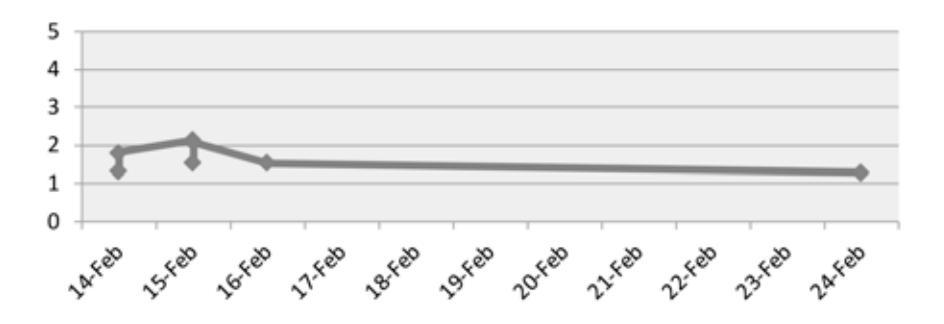
FIG. 16. Lymphocyte counts  $(10^3/\mu L)$  in the 10 days after exposure for Worker 1.

However, Worker 1 did not experience nausea, vomiting or any other possible prodromal manifestation of ARS. Also, the early haematological curve, especially the lymphocyte behaviour, made ARS unlikely (see Fig. 16). A mild transient leucocytosis was observed on the day of the exposure, which may be related to cytokine mediated inflammatory response due to the radiation exposure (see the white blood cell counts in Fig. 17).

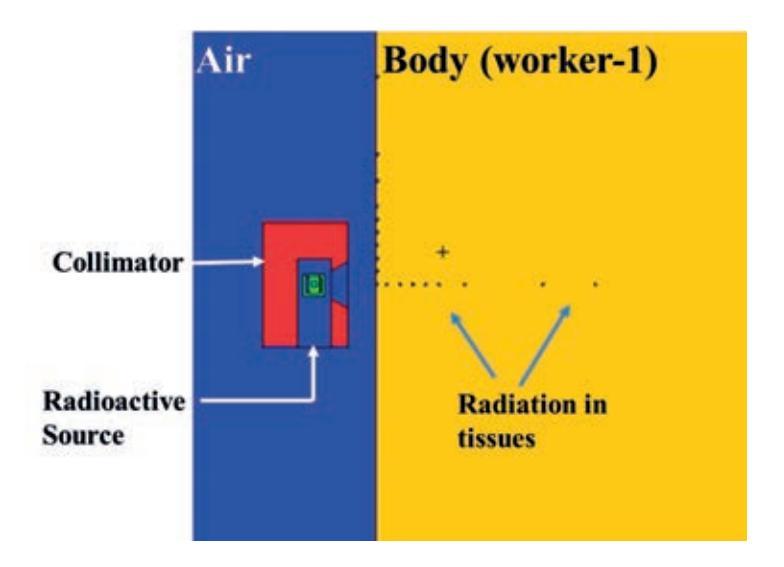
FIG. 18. Modelling of the thigh at 1 cm from the entrance of the collimator [22].

The estimated in-depth doses are given in Table 5. It can be seen that the local skin dose (at the centre of the necrosis area) is lower than that calculated by IPEN because of the different source–skin distances. The threshold dose for necrosis development (20–25 Gy) was estimated to be 2 cm in depth. The absorbed dose to the muscle next to the lesion was estimated to be between 25 Gy (entrance) and 13 Gy (posterior muscular border). The absorbed dose to the part of the femur located next to the lesion was estimated to be 5 Gy (see Fig. 19).

Depth in tissues (cm)	Absorbed dose (Gy)
0	81
0.5	60
1	43
1.5	32
2	25
2.5	19
3.5	13
6.5	5
8.5	3

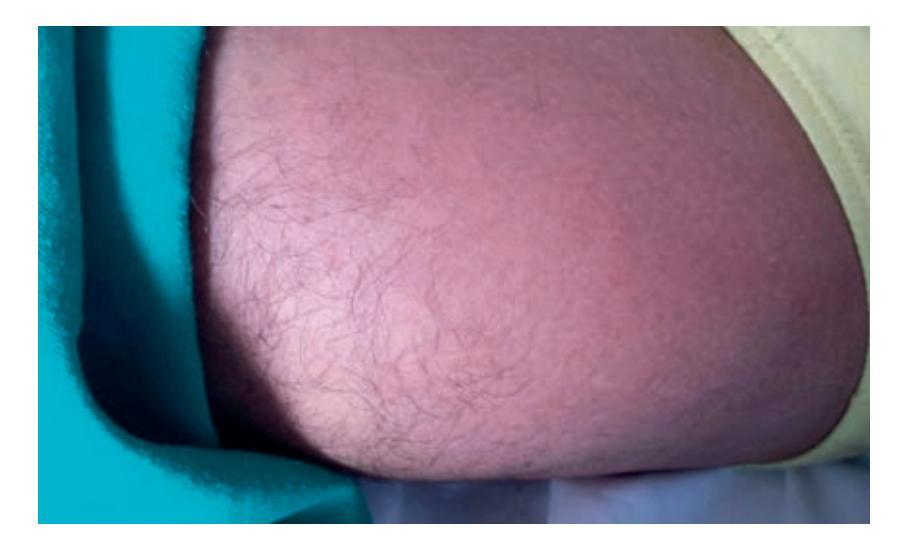
FIG. 20. Photograph from the day of the accident (14 February 2017) (photograph courtesy of A. Lachos, INEN [24]).

- At 13:00, an officer from OTAN interviewed Worker 1 to obtain further information related to the accident.
- At 17:00, medical staff from IPEN and INEN evaluated the patient. He had not shown any signs of nausea, vomiting or diarrhoea since the estimated time of the accident. The physicians observed an increased local temperature and a small erythema on his left hip/upper thigh area.

The medical staff from IPEN suggested that a serum amylase blood test and a sperm count (semen analysis) be performed. The medical staff from IPEN also advised the healthcare staff at the clinic on the management of irradiated patients. Figures 20 and 21 show the affected area of Worker 1 on the day of the accident and the first day after his exposure.

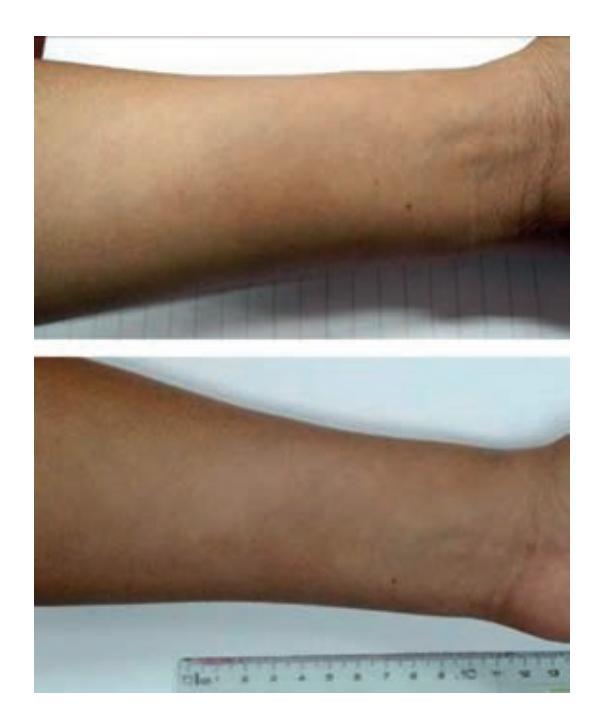
The patient mentioned, on 13 March 2014, the appearance of an erythema and pruritus and dyschromia on the left forearm and left flank on the abdomen, which were confirmed by the Assistance Mission experts on 30 April 2014 (see Figs 31 and 32).

FIG. 31. Left forearm of Worker 1 in two different photographs showing slight depigmentation (dyschromia). Initially, a dry desquamation was reported (30 April 2014) (photographs courtesy of INEN).

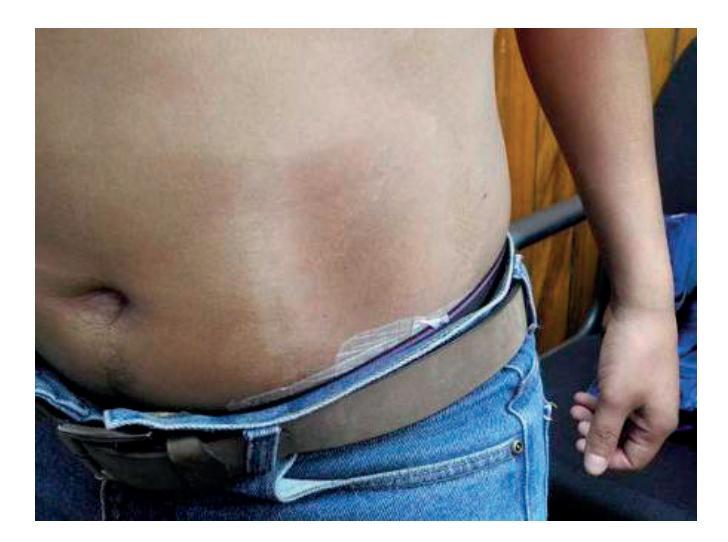
FIG. 32. Left abdominal area of Worker 1 showing depigmentation. Initially, a dry desquamation was reported (30 April 2014).

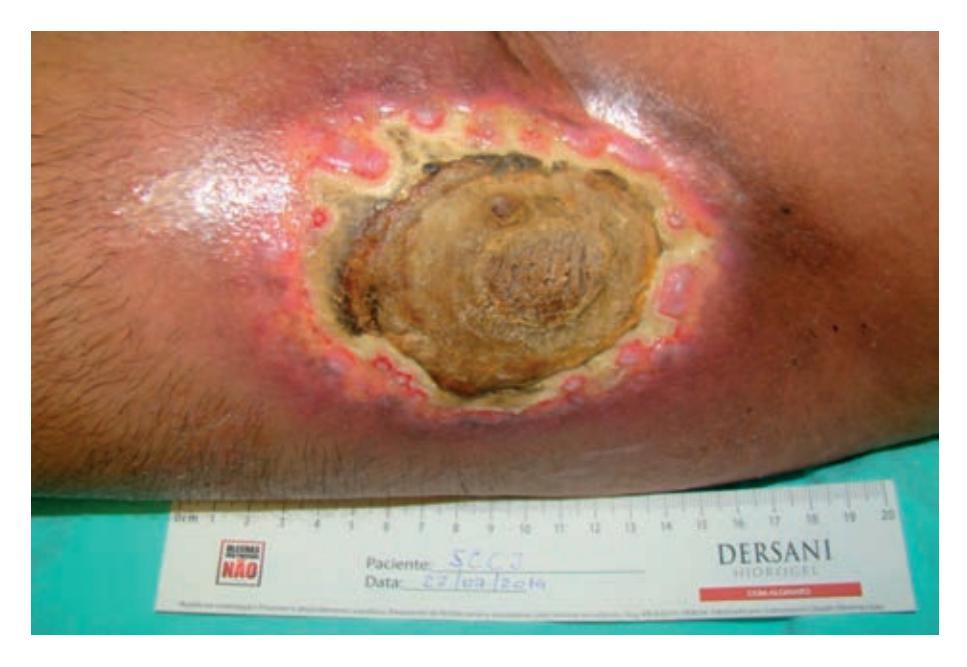
FIG. 35. View of the lesion on admission to the Marcilio Dias Naval Hospital (photograph courtesy of HNMD).

After extensive arrangements, the patient was admitted to the HNMD in Rio de Janeiro, Brazil, on 21 July 2014, 157 days after the accident. Figure 35 shows the condition of the lesion at that time.

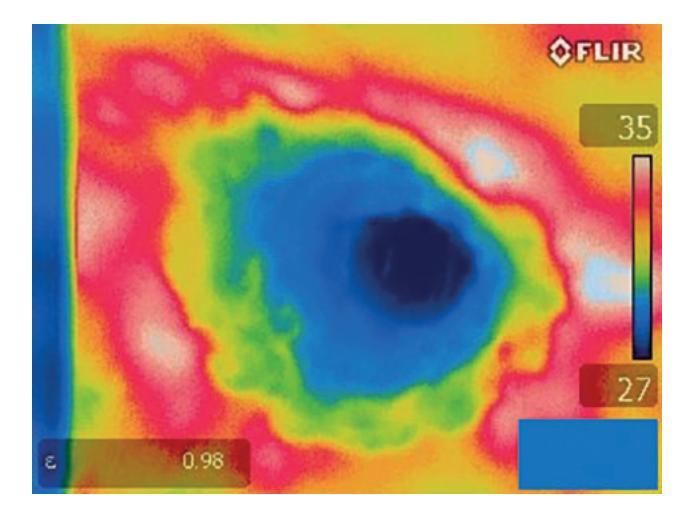
FIG. 36. Thermography of left thigh on admission to Marcilio Dias Naval Hospital (image courtesy of HNMD).

and psychology departments. A comprehensive evaluation was ordered, including biochemistry, bone scintigraphy, thermography and another MRI. The thermography of the left thigh and pelvis showed a large central area of necrosis (Fig. 36). The patient was also evaluated by the pain management clinic, and it was decided to begin treating with gabapentin and continue with the administration of tramadol (an opioid).

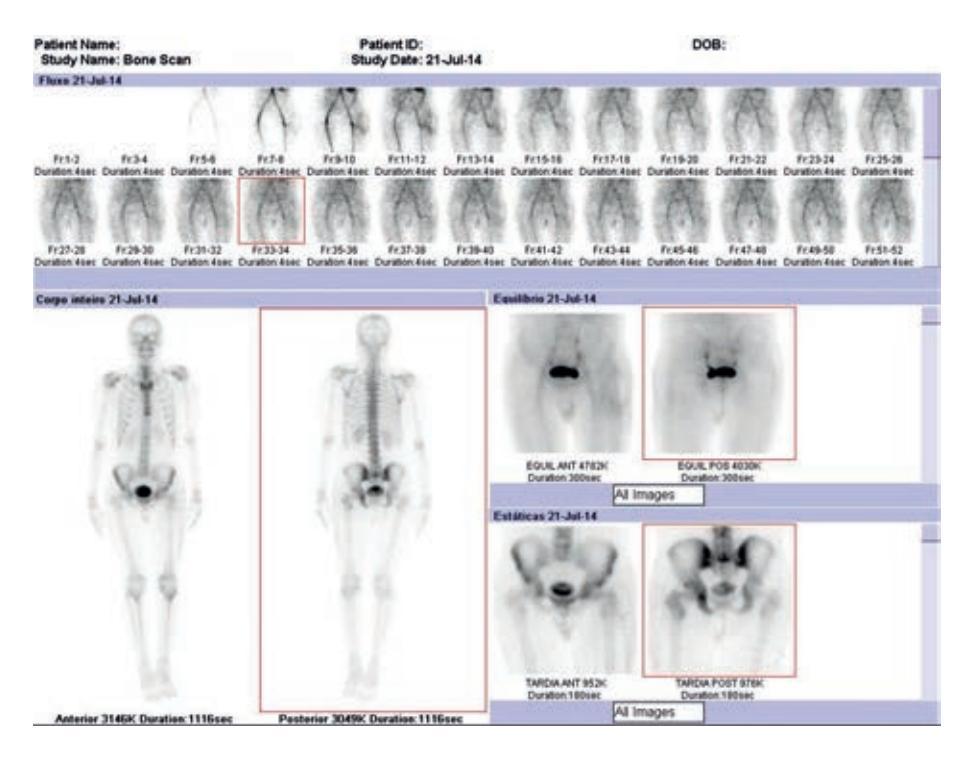
The bone scintigraphy (Fig. 37) showed no bone injury; the MRI identified an infiltration and oedema in the muscle and muscle interstitium of the proximal third of the thigh. The patient began physiotherapy, medical nutritional therapy and received psychological support, which continued throughout his stay at HNMD. To aid with psychological support, the hospital permitted the patient's spouse to stay with him during his hospitalization.

FIG. 37. Bone scintigraphy in three phases with no abnormalities (images courtesy of HNMD).

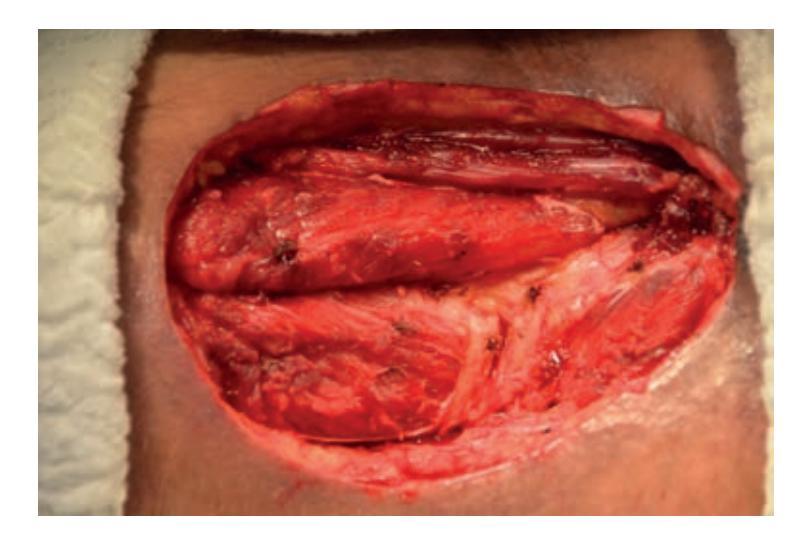
FIG. 40. Viable muscular layer underlying the necrotic area during the surgery (photograph courtesy of HNMD).

necrosis up to the muscular plane (see Fig. 40), the first injection of MSCs with the assessment of the IAEA Assistance Mission team (see Fig. 41) and a skin autograft (see Fig. 42). The next three MSC administrations were carried out once weekly, with the last one on 28 August 2014. A new thermography image and a comparison with the aspect of the lesion after the first surgery is shown in Fig. 43.

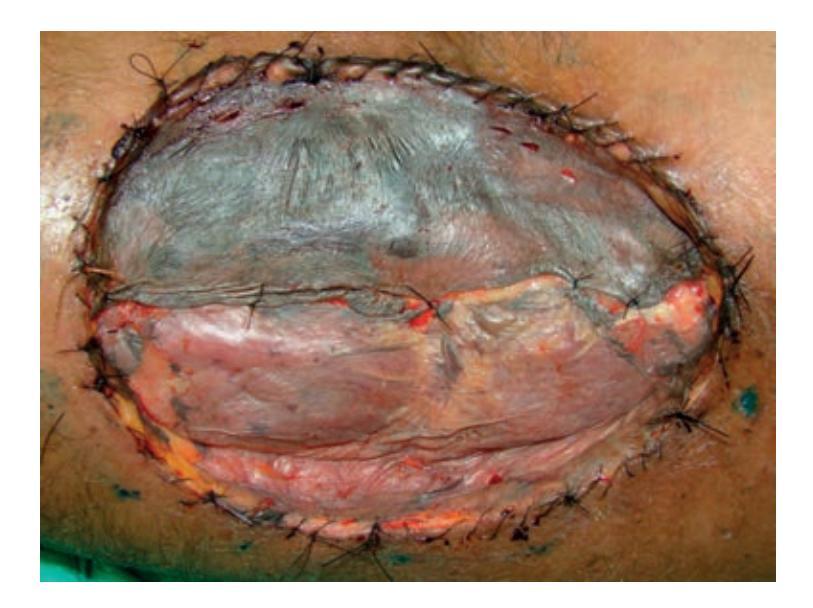
FIG. 42. Evolution of the LRI after the surgery (14 August 2014) (photograph courtesy of HNMD).

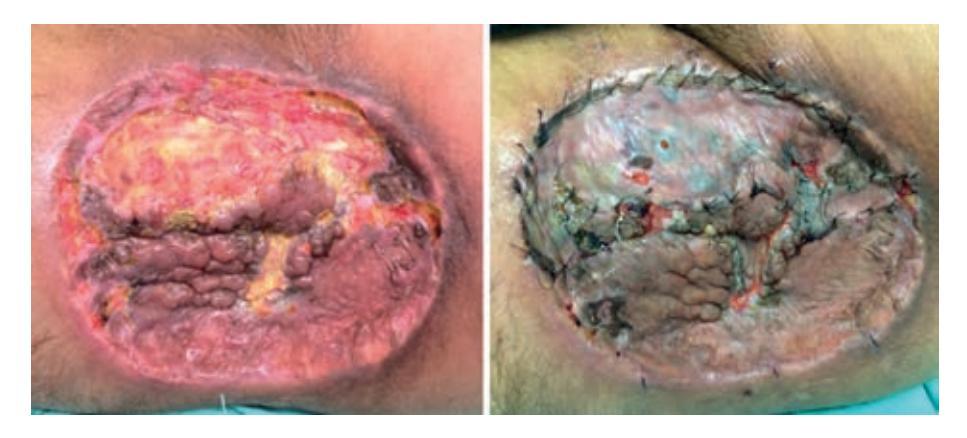
FIG. 44. Worker 1's local radiation injury before (left) and after (right) the second surgery (photographs courtesy of HNMD).

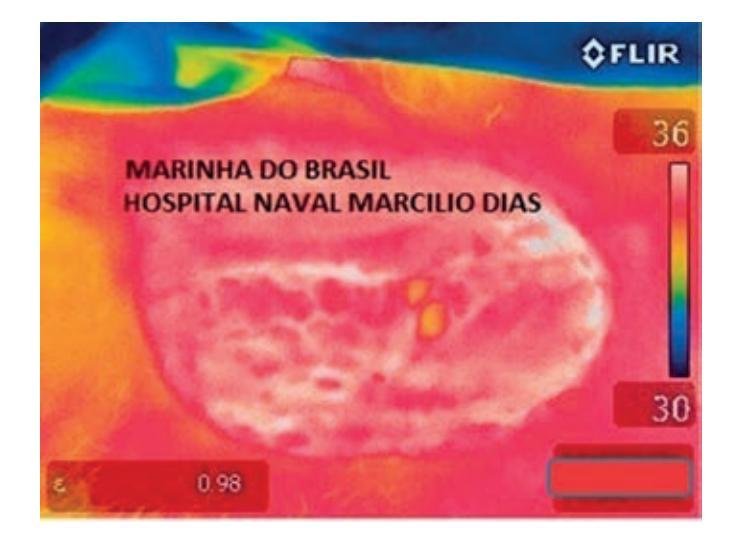
FIG. 45. Thermography image on discharge from Marcilio Dias Naval Hospital (photograph courtesy of HNMD).

On 4 November 2014, a new thermography was performed, which showed no ischemic area in the left thigh (see Fig. 45). The integration of the skin graft was complete, and the patient was discharged from HNMD in Brazil on 6 November 2014 in a good condition to continue follow-up in Peru (Fig. 46).

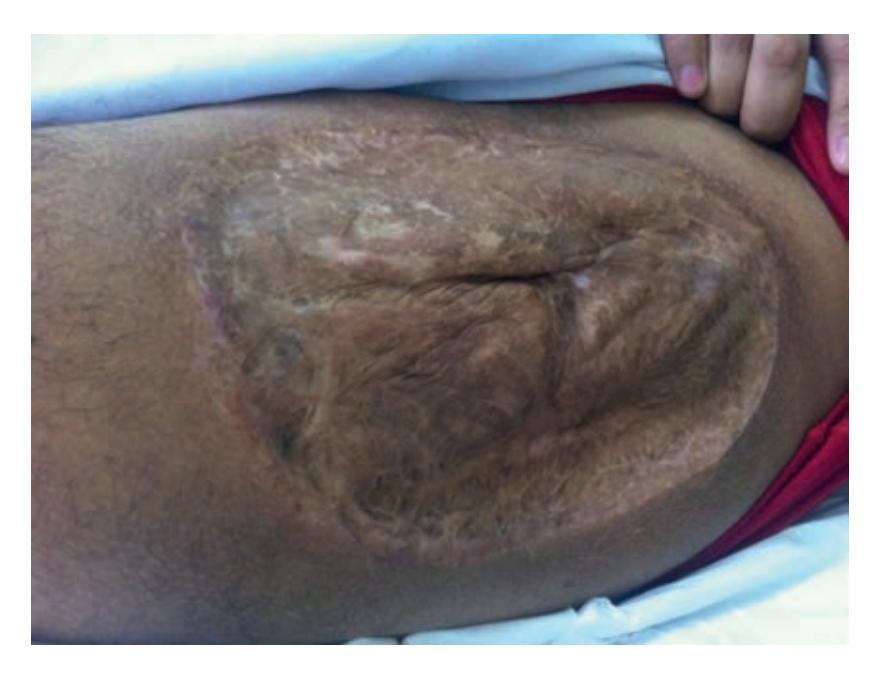
The patient continued with medical follow-up in Peru after his return from Brazil, and no new episodes of pain or ulceration of the skin occurred. He is in good medical condition, with no evidence of recurrences within the three years following the accident. The lesion as of March 2017 is shown in Fig. 47.

FIG. 47. View of the operated area during medical follow-up in Peru in March 2017 (photograph courtesy of A. Lachos, INEN).
