IAEA-TECDOC-611

***Use of plant specific PSA  
to evaluate incidents  
at nuclear power plants***

**USE OF PLANT SPECIFIC PSA  
TO EVALUATE INCIDENTS AT NUCLEAR POWER PLANTS  
IAEA, VIENNA, 1991  
IAEA-TECDOC-611  
ISSN 1011-4289**

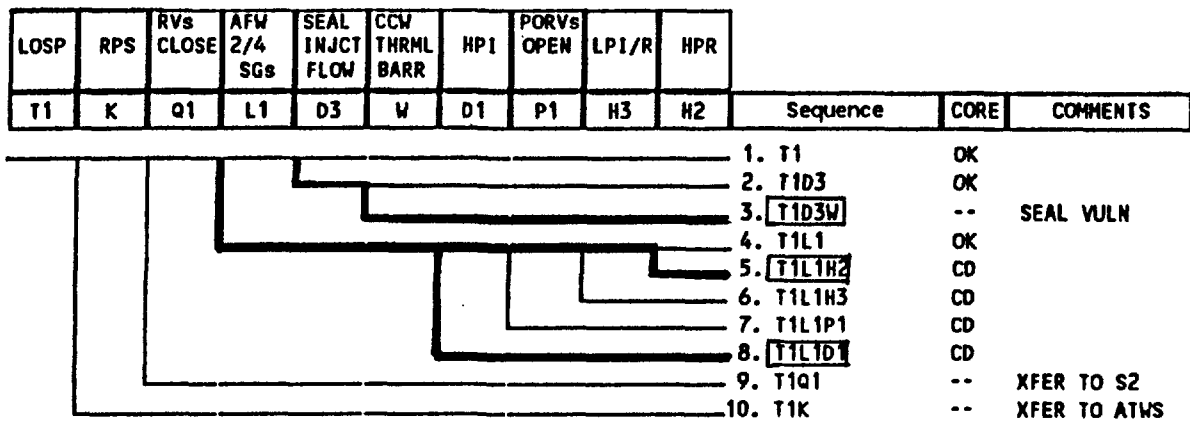
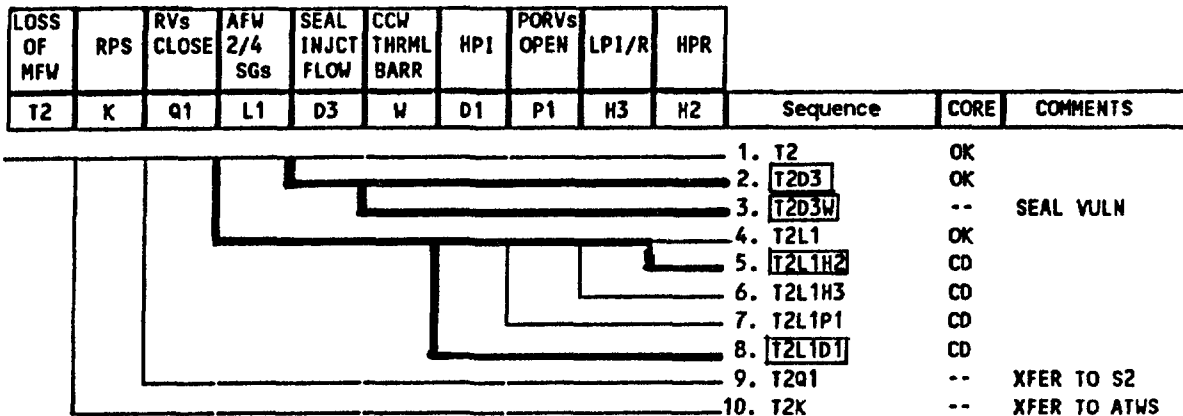
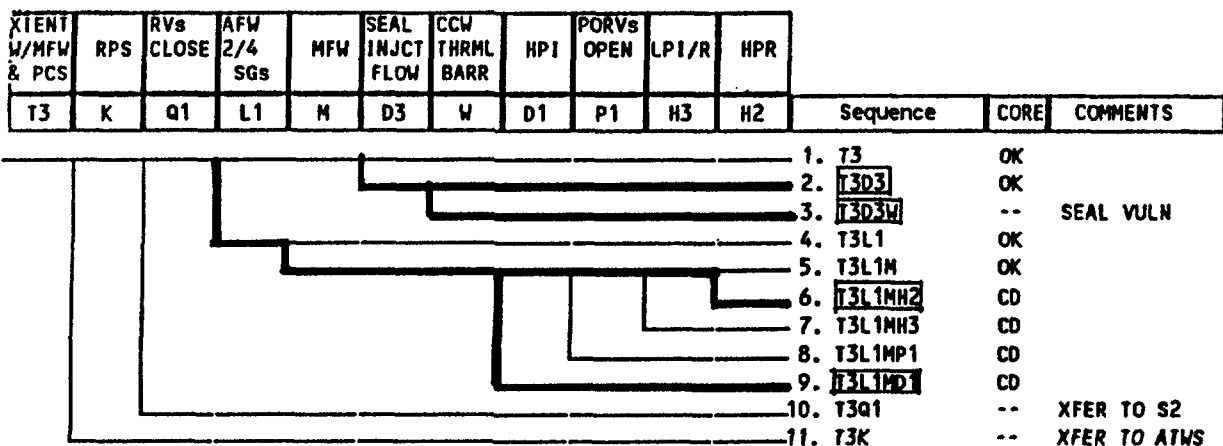
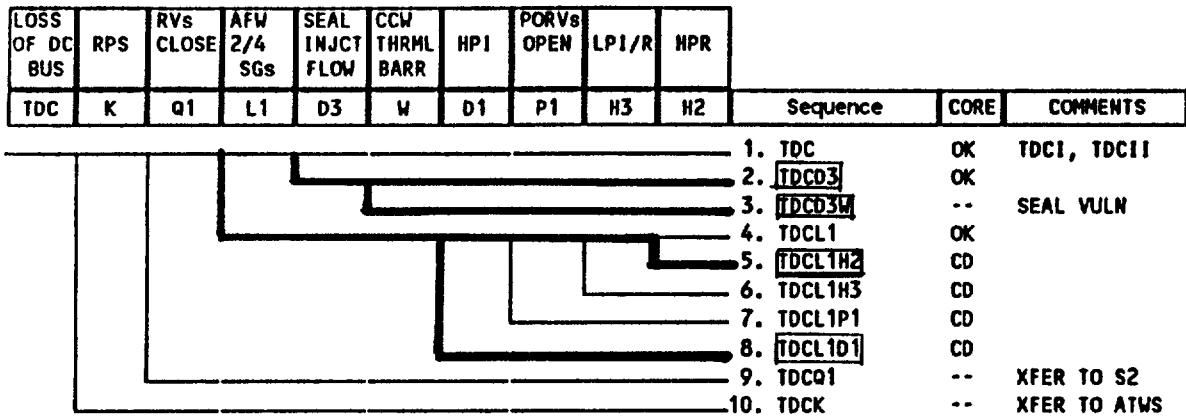
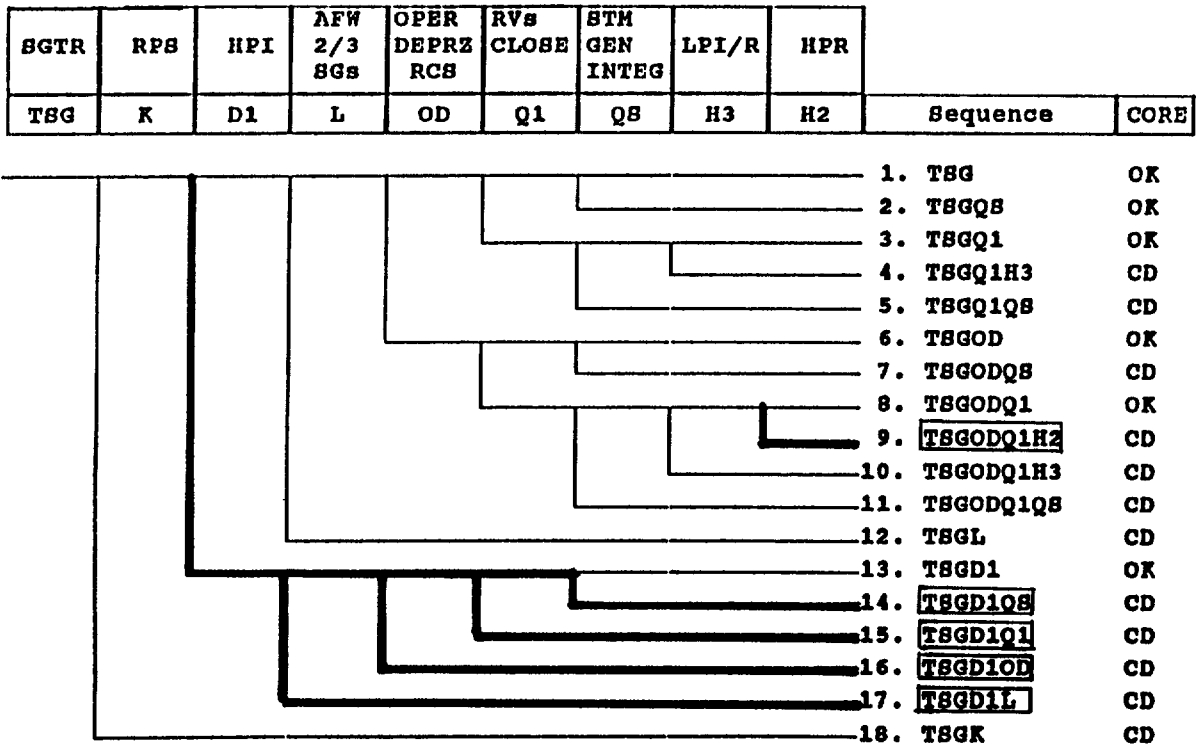
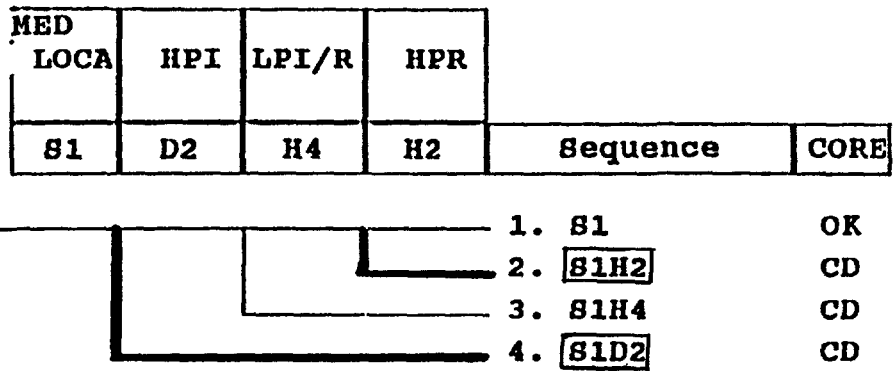
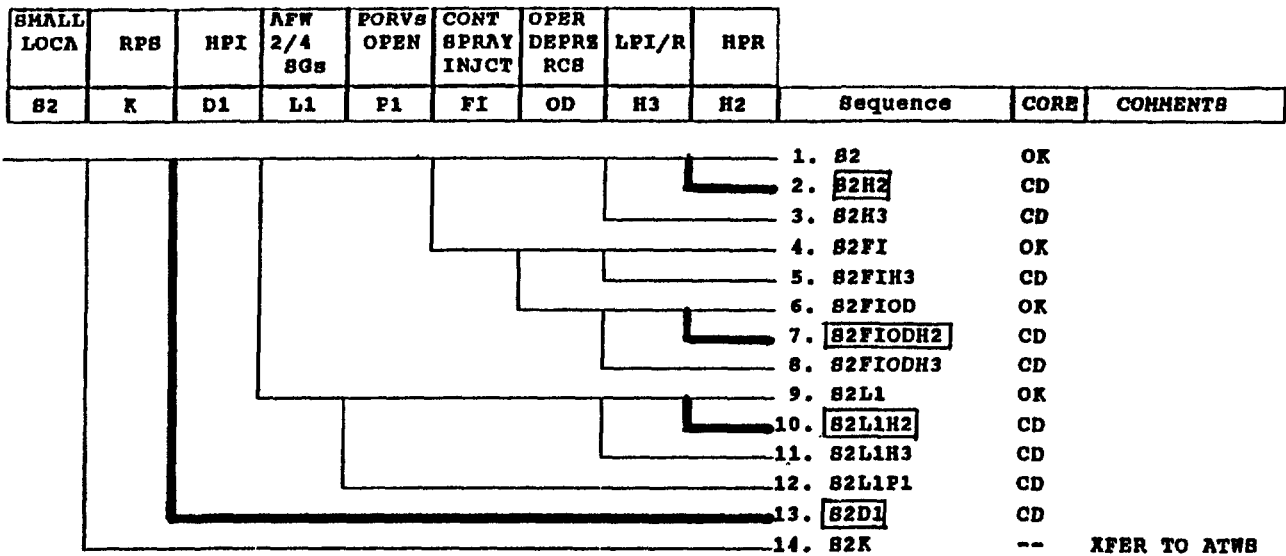
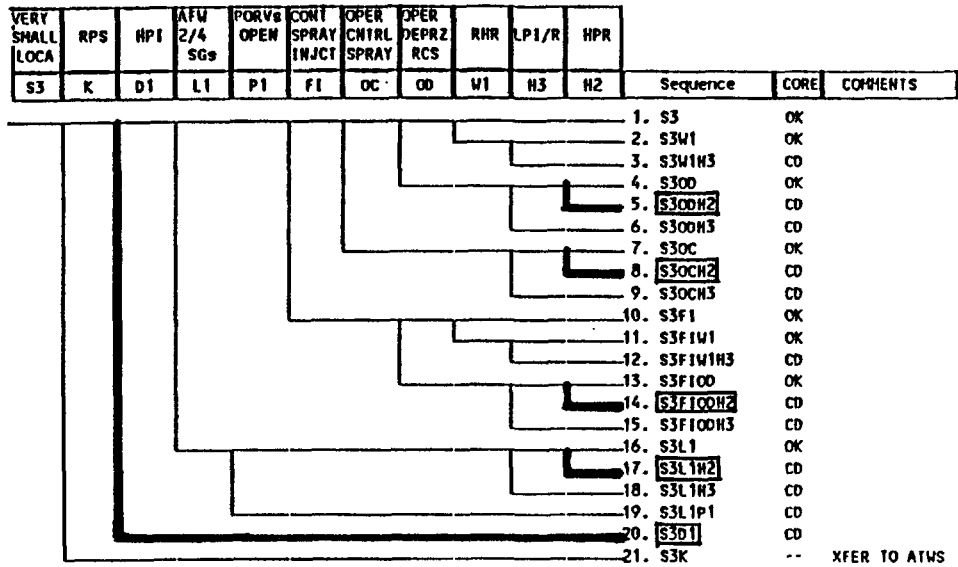
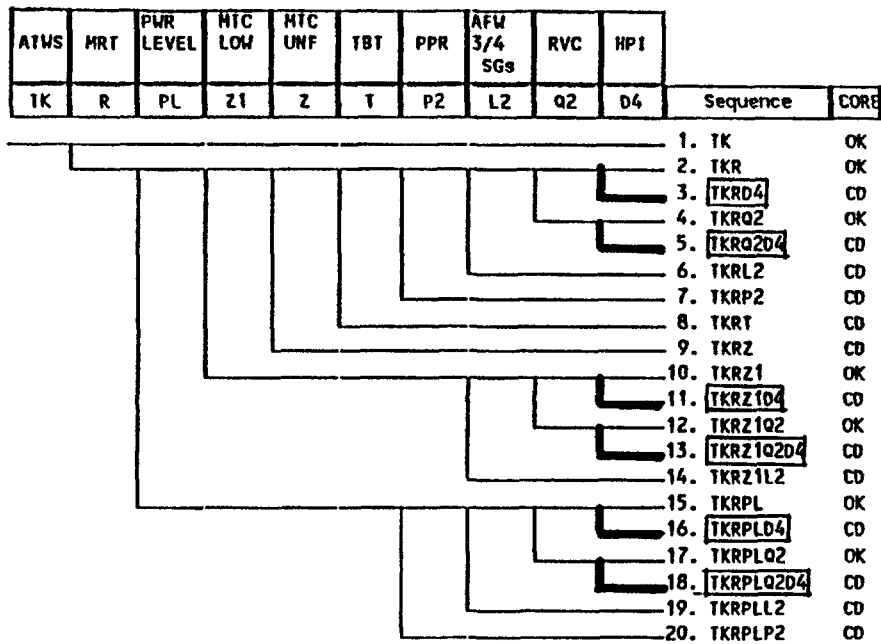
Both high pressure injection ( $D_1$ ,  $D_2$ ,  $D_3$ ,  $D_4$ ) and high pressure recirculation ( $H_2$ ) functions are potentially affected by the failure of CCPs. The potentially affected sequences have been identified in Figures A1-2 through A1-10. Because the CCPs were of limited importance in the original PSA, the dominate accident sequence results (cut sets) did not contain terms with basic events involving CCP failure to adequately cover the sequences with functions impacted by CCP failures. Therefore, the original system and function fault trees were reanalysed with high failure probabilities for the CCPs. A revised set of dominant accident sequences and associated cut sets were derived.

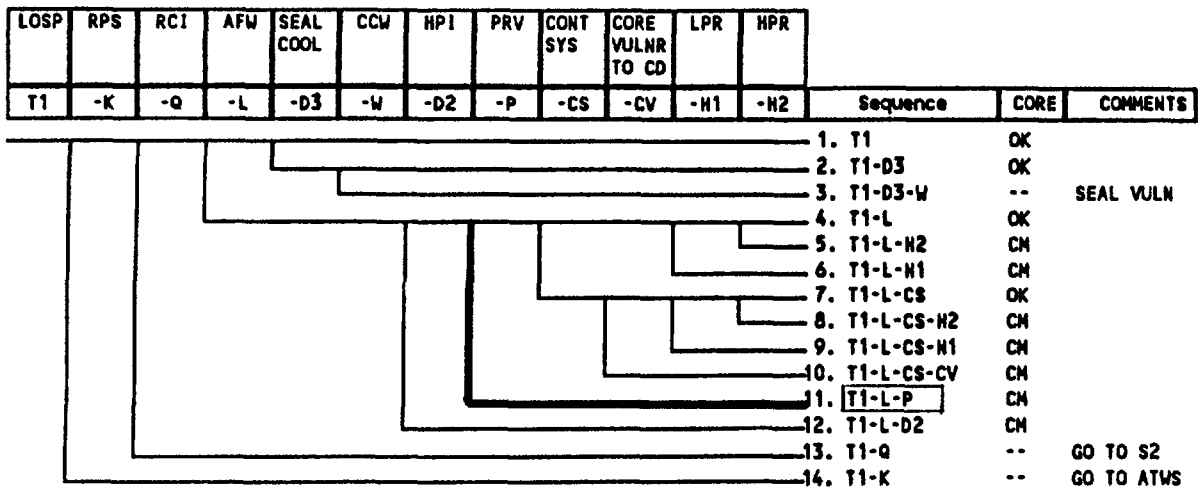
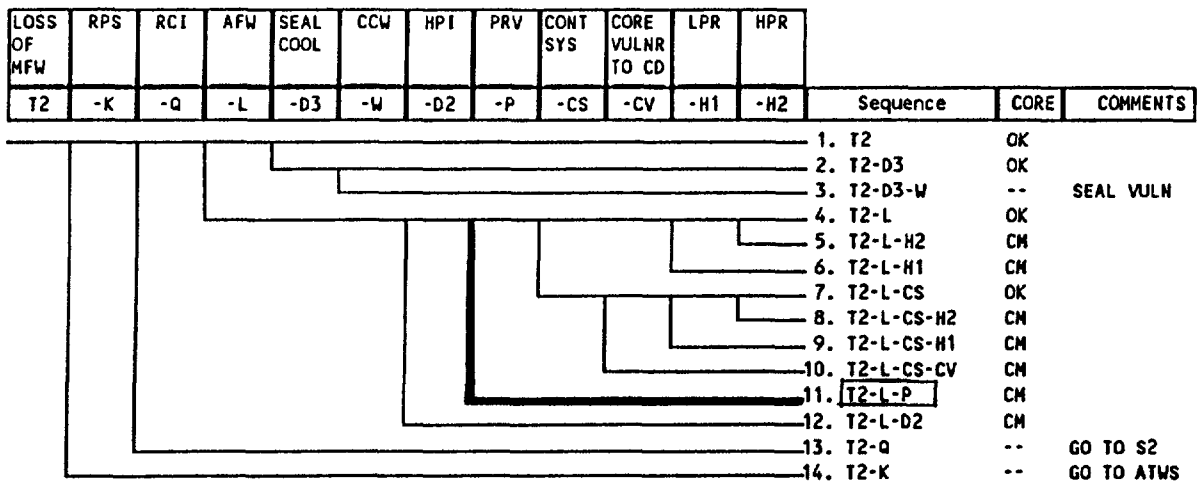
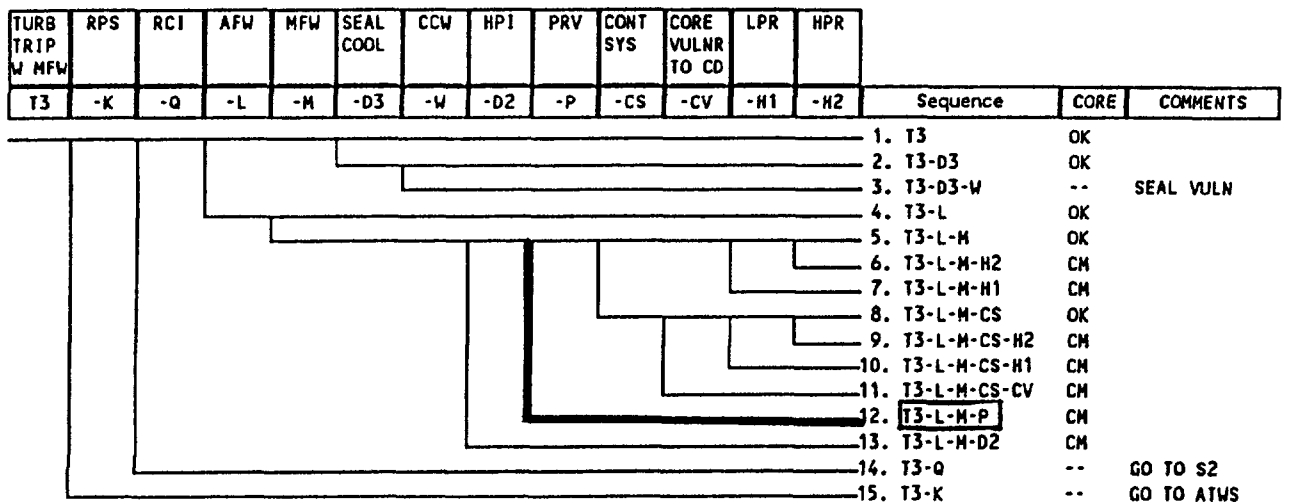
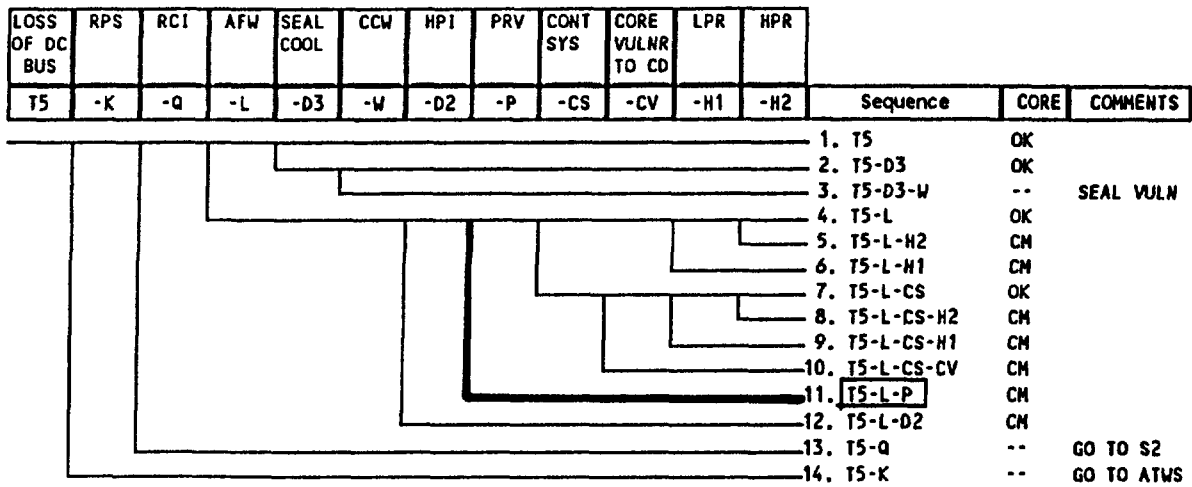
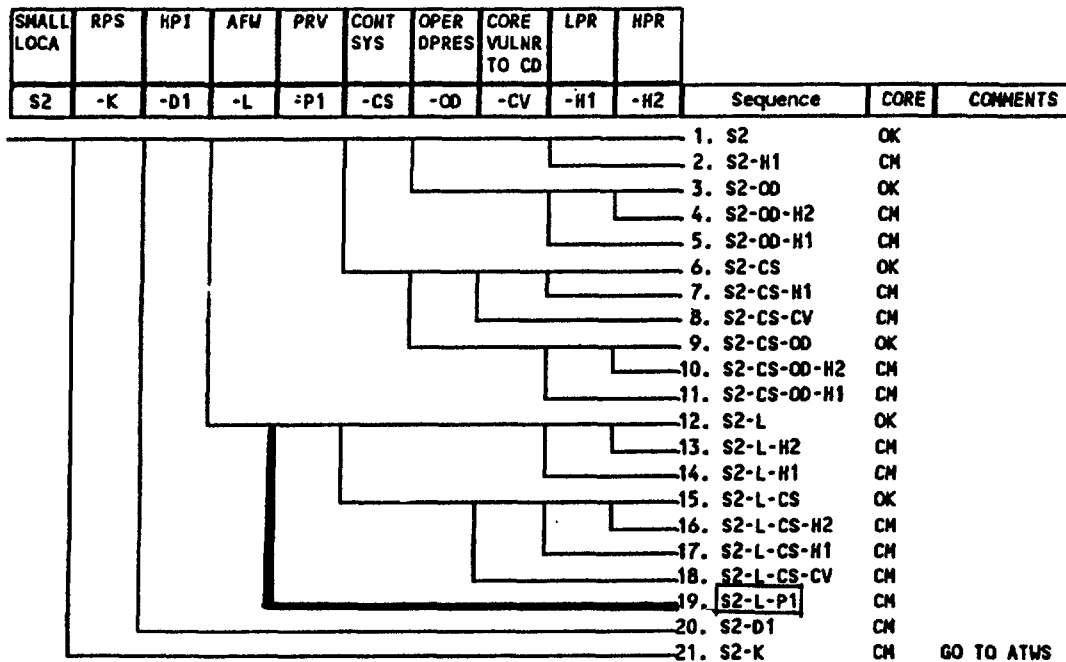
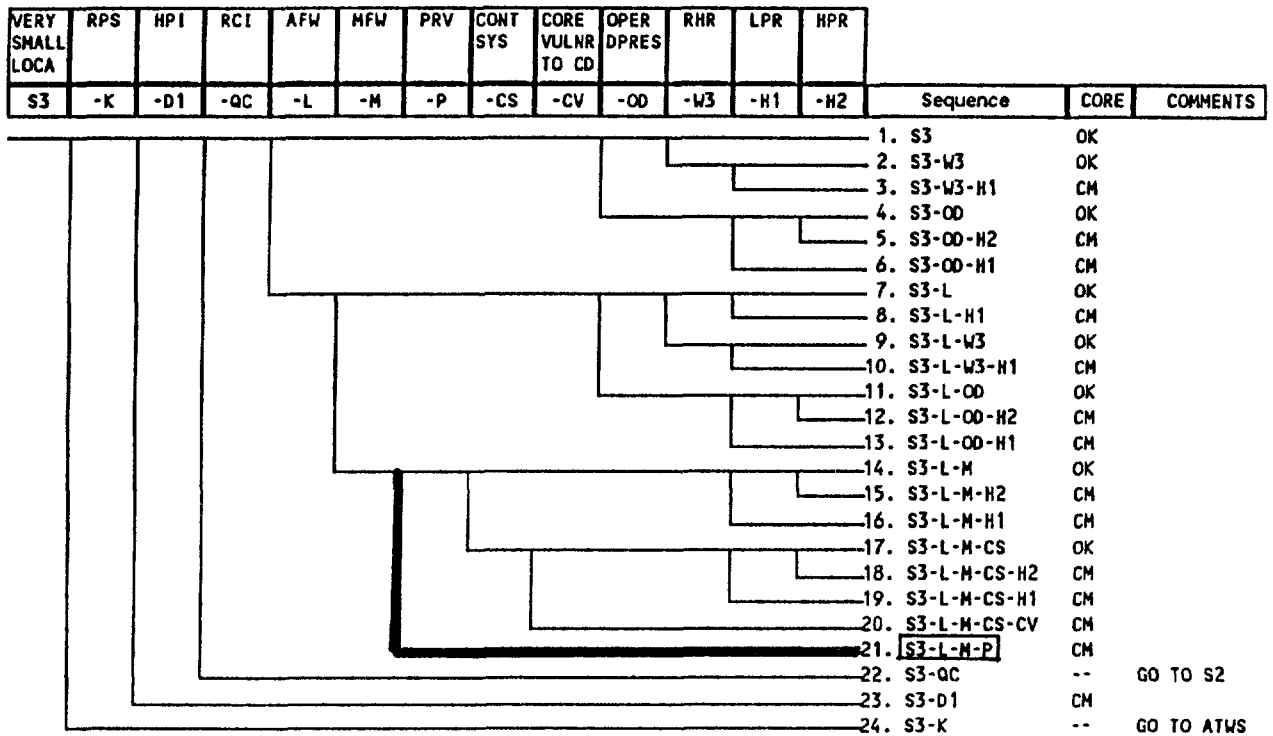
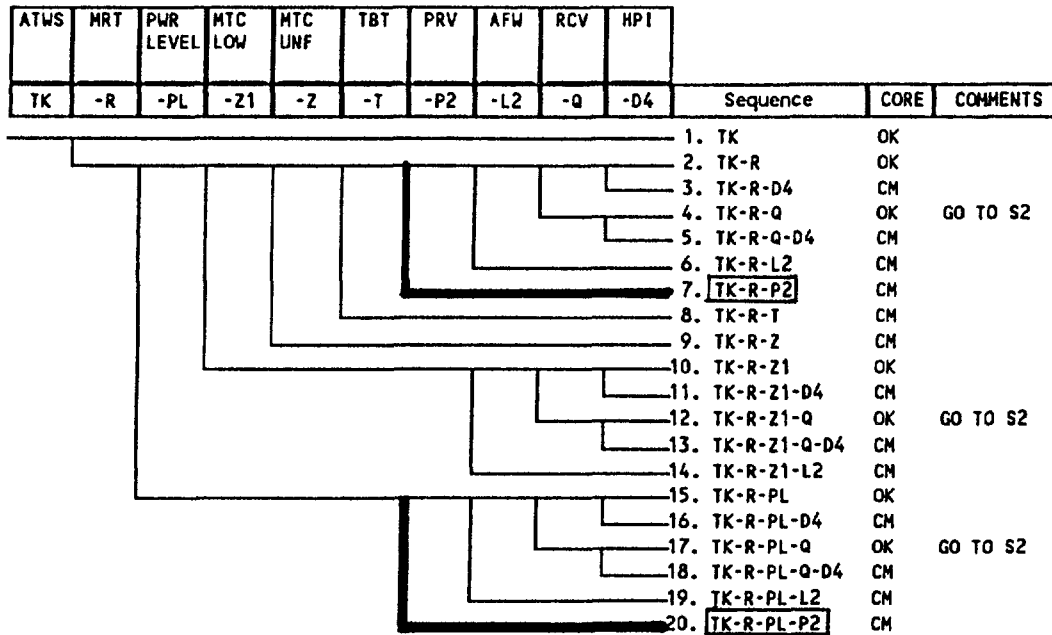
The potential accident sequences associated with this incident are found on each transient event tree (except station blackout), on the small and very small LOCA event trees, and on the ATWS event tree. Figures A3-2 through A3-8 show these sequences. The event tree top events of concern are P, P1 and P2. Top events P and P1 are associated with the establishment of feed and bleed cooling and contain only basic events pertaining to the PORVs and their block valves. This incident renders these top events failed. Top event P2 is associated with RCS pressure relief during ATWS and contains safety relief valves as well as PORVs. This top event is reduced in reliability by this incident since operator diagnosis and corrective action would be required given the conditions that existed with the PORVs.

Although the operators were able to eventually get the PORVs open in this instance, no information was provided on how long it took them to do so. It is presumed that some time lapsed. It is believed that such a recovery is possible with the plant at power during an incident requiring feed and bleed cooling. However, due to more severe timing constraints, stress levels, and harsh equipment environment, the likelihood of failing to make such a recovery seems high. For loss-of-coolant accidents and ATWS sequences no attempt was made to conduct the analysis needed to derive a meaningful recovery factor. Therefore, no recovery was applied to these sequences.
