Ageing Management of Reactor Internals for TEPCO

I. Impact to the Kashiwazaki-Kariwa NPS from the big earthquake on July 16th

II. Aging management of reactor internals considering seismic load

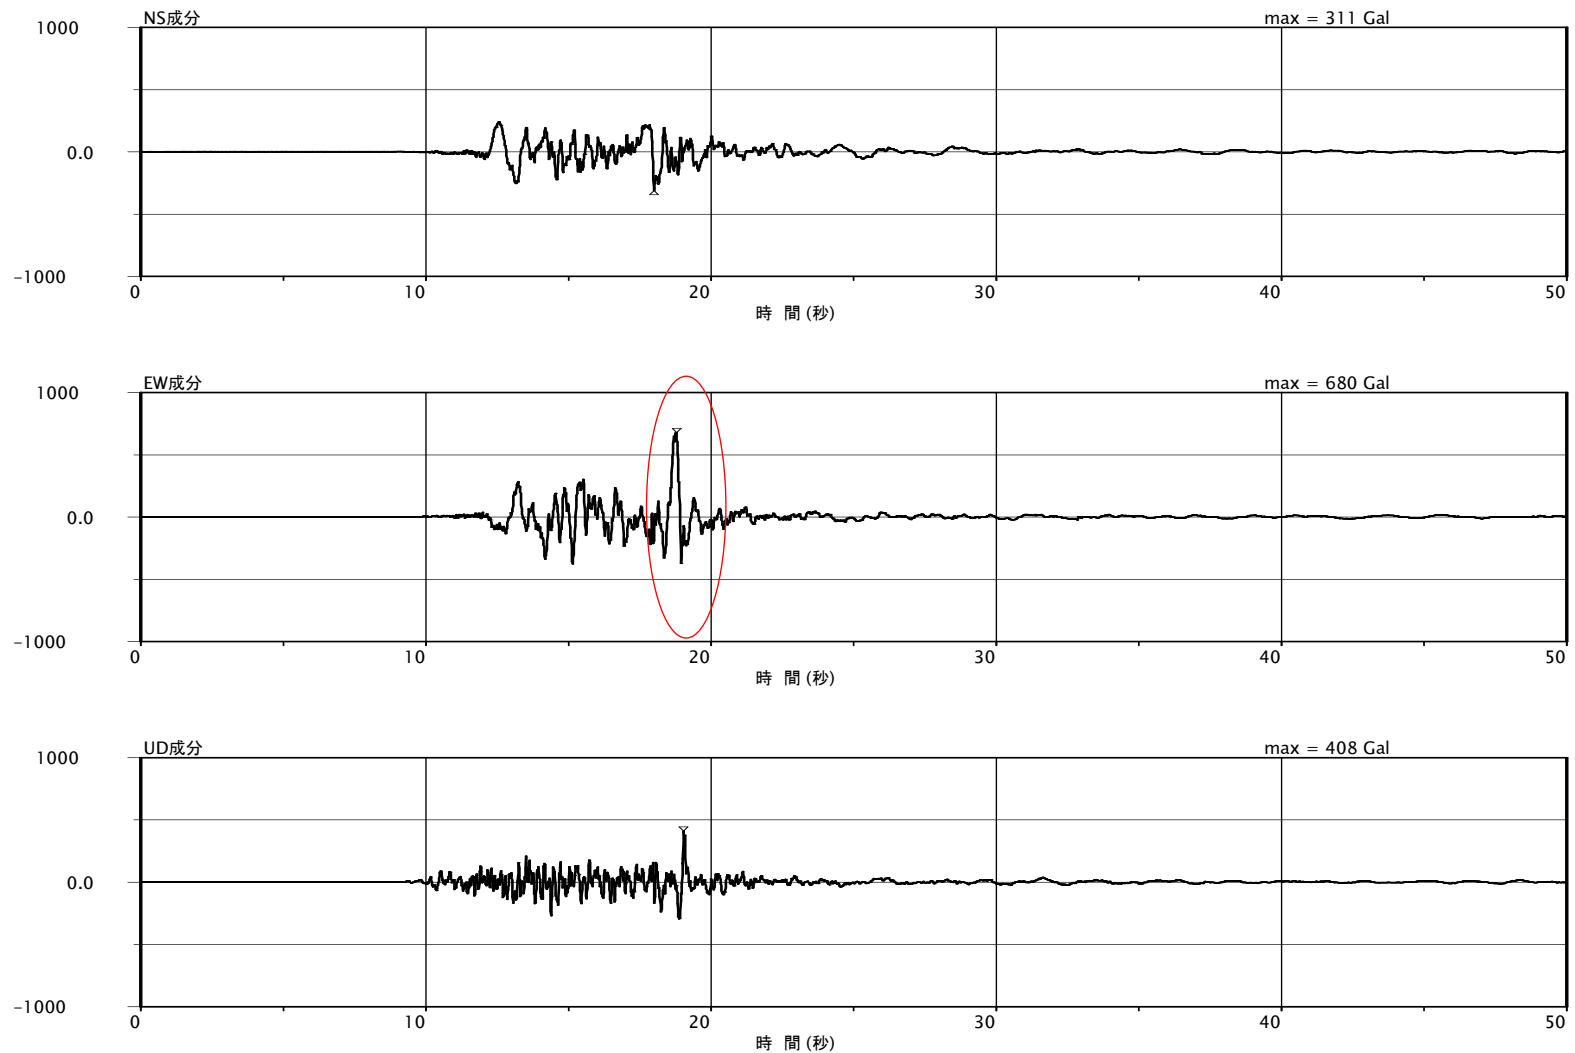
Time history (acc.) Base mat (B5F) R/B #1 1-R2

- The maximum acceleration at Unit 1 Rx/B mat: 680 gal against the design value of 273 gal.
- Units 1, 5 and 6 were not in operation for annual outage.
- Units 3, 4 and 7 were in operation, and Unit 2 was in the process of starting operation (soon after drywell inspection).

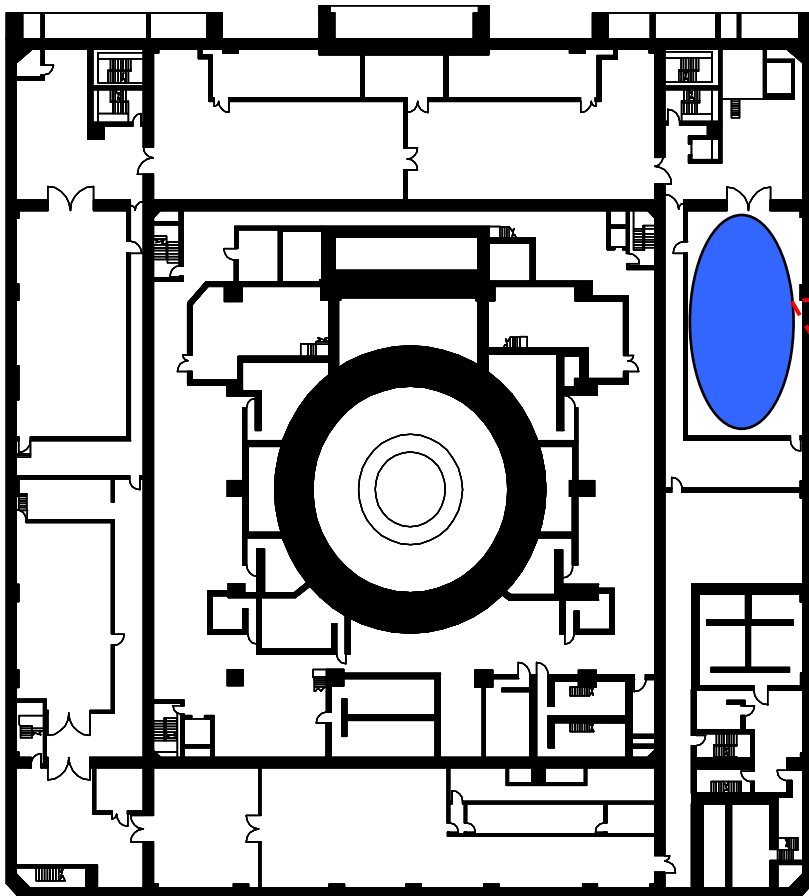
Emergency diesel generator at K-3

B1F in the annex of the reactor building.

The 20 emergency diesel generators at units 1 to 7 underwent a manual startup test from July 25 to 27 to confirm their availability.
