CORROSION INDUCED LEAKAGE IN THE RADIAL BEAM PORT OF THE 3 MW TRIGA MARK-II RESEARCH REACTOR OF BANGLADESH

Abstract

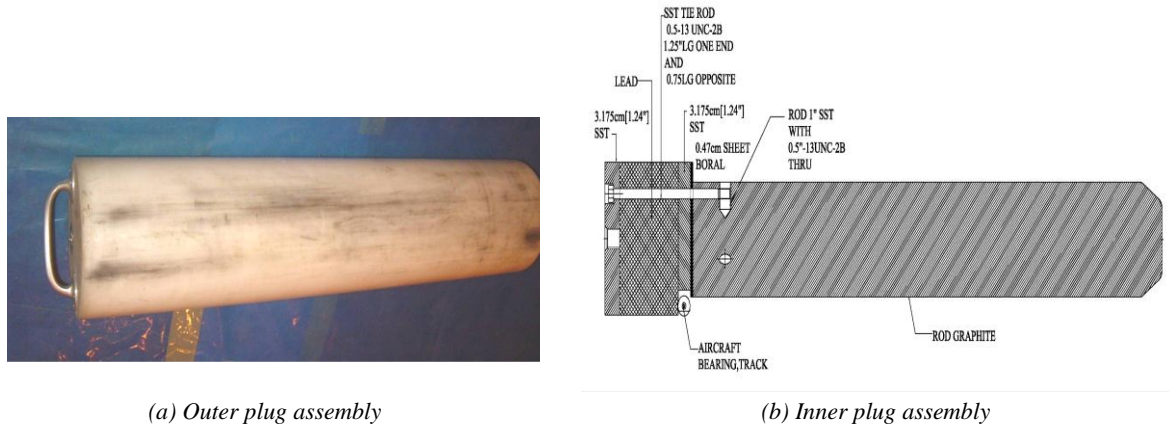
Fig. 3. Beam port plugs.

The HD polyethylene plug is a lightweight device (weight: 21.8 kg) and as such it was removed easily by hand. But for removing the inner plug, a special shielded handling equipment called, cask & carriage, and the over head crane of the reactor hall were used. While doing the removal operation, the graphite part of the inner BP plug got broken at the point where three punches, each 120° apart, were made for fixing the anchor bolts. With the approval of the local safety committee, efforts were made to take out the 93.98cm long broken

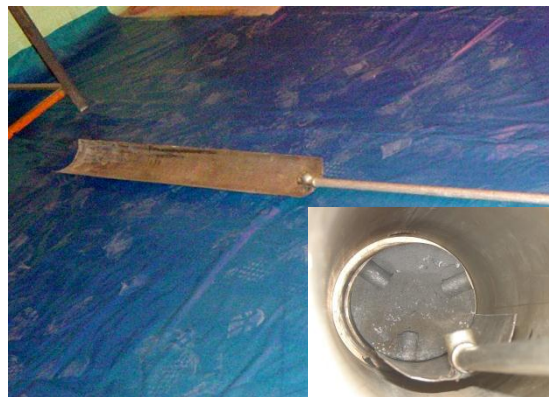
Fig. 4. Scoop used for graphite plug removal.

graphite plug. A scoop-like device (Figure 4) was used for this purpose. But unfortunately the plug got broken again into two parts. The outer part having a length of about 60.96cm could

be taken out easily with the help of the scoop mentioned above, but the inner part of the graphite plug (length 33.02cm; diameter: 14.94cm) remained stuck inside the aluminium section of BP tube. The plug was pulled by a mechanical tension application device after installing a rowel bolt on it (plug), but could not be moved. Then, with the approval of the regulatory authority, the sticking graphite plug was trimmed off by using an auger (circular-saw like cutting tool) and then taken out of the BP.

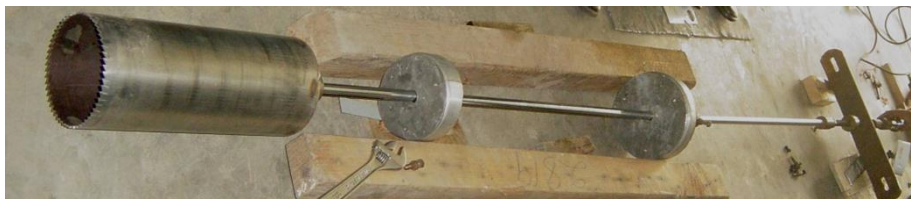
Fig. 5. The auger and associated fixtures.

Operations for removal of the 33.02 cm long broken part of the graphite plug was undertaken after getting formal approval of the regulatory authority. Before that Reactor Operation & Maintenance Unit (ROMU), the authorization holder of the reactor facility, had to submit to the regulatory authority detailed work plan, emergency response preparedness plan and QA program to be implemented in connection with plug removal work. While performing the removal operation, extreme care was taken such that the corroded aluminum BP pipe did not get damaged and also that the amount of graphite dust produced could be kept at minimum. The stainless steel auger, designed and fabricated mainly by ROMU personnel, was found to be very effective in this regard. A picture of the auger and associated fixtures used are shown in Figure 5. It is to be mentioned that the auger was operated manually so as to be sure that it was not cutting the wall of the aluminium BP tube. It took about 12 working days to complete the cutting operation. The picture of the last segment of the graphite plug is given in Figure 6. In this picture clear corrosion marks are seen on the surface of the graphite plug that was not trimmed off by the auger.
