## DEGRADATION MONITORING OF G.A. SIWABESSY RESEARCH REACTOR'S SECONDARY COOLING PIPE

R. HIMAWAN, SUWOTO, SRIYONO, A. TRIYADI  
National Nuclear Energy Agency (BATAN),  
Center for Reactor Technology and Nuclear Safety,  
Banten,  
INDONESIA

### Abstract

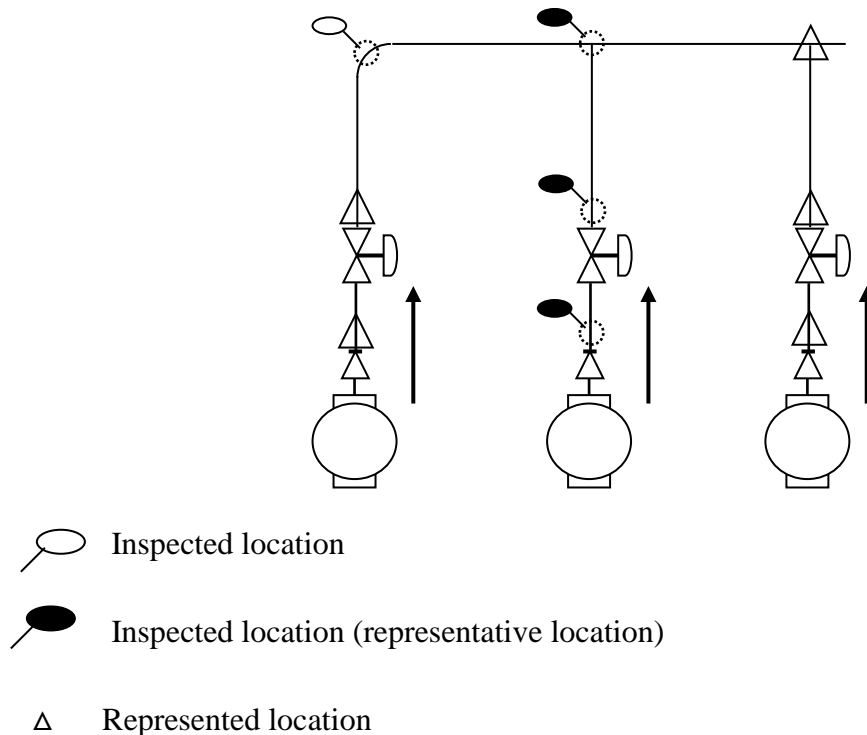
Fig. 1. Location selection method.

- Location close to the valves, orifices or other geometrical discontinuities were choosed;
- For the same configuration such as a redundant lines, just one line was selected as a representative;
- If in one line there are more than one geometrical discontinuities but has a same type, just one location was selected as a representative.

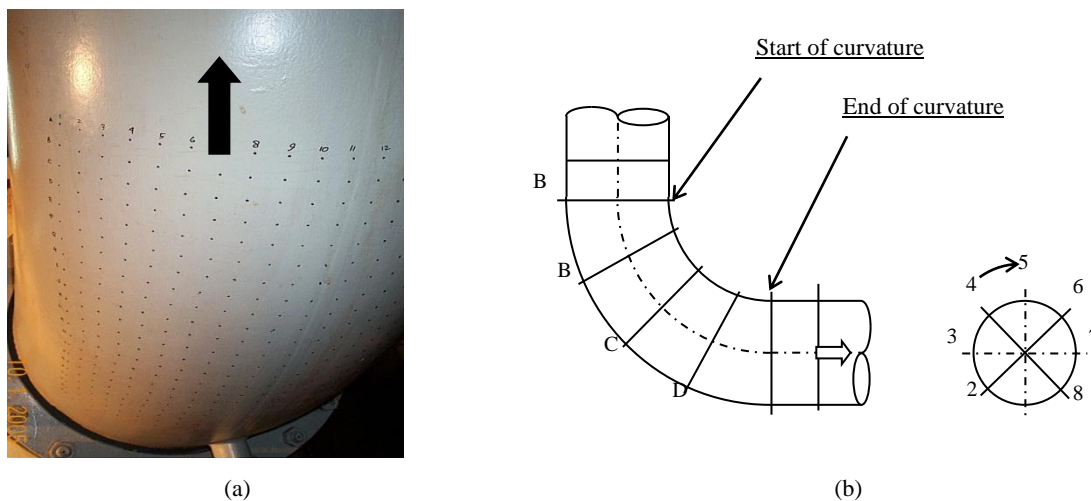
Fig. 2. Measurement point determination.

Figure 2.(a) shows point measurements which has 2 cm distance in horizontal and vertical. This method was applied in the first measurement in 2004 [3]. Due to the lack of measurement coverage in circumferential direction, in second measurement performed in 2009, the measurement point for T-joint section of pipe with diameter more than 5 inches, were determined as shown in Figure 2.(b). For another section such as orifice, elbow and others, the measurement points were determined in the similar way[2].
