## Decommissioning and Remediation after a Nuclear Accident, 3 Case Studies

# **Sellafield Ltd and INES**

# Caesium Extraction Plant Event INES Level 3 Event

Pile One Chimney INES Level 5 Event

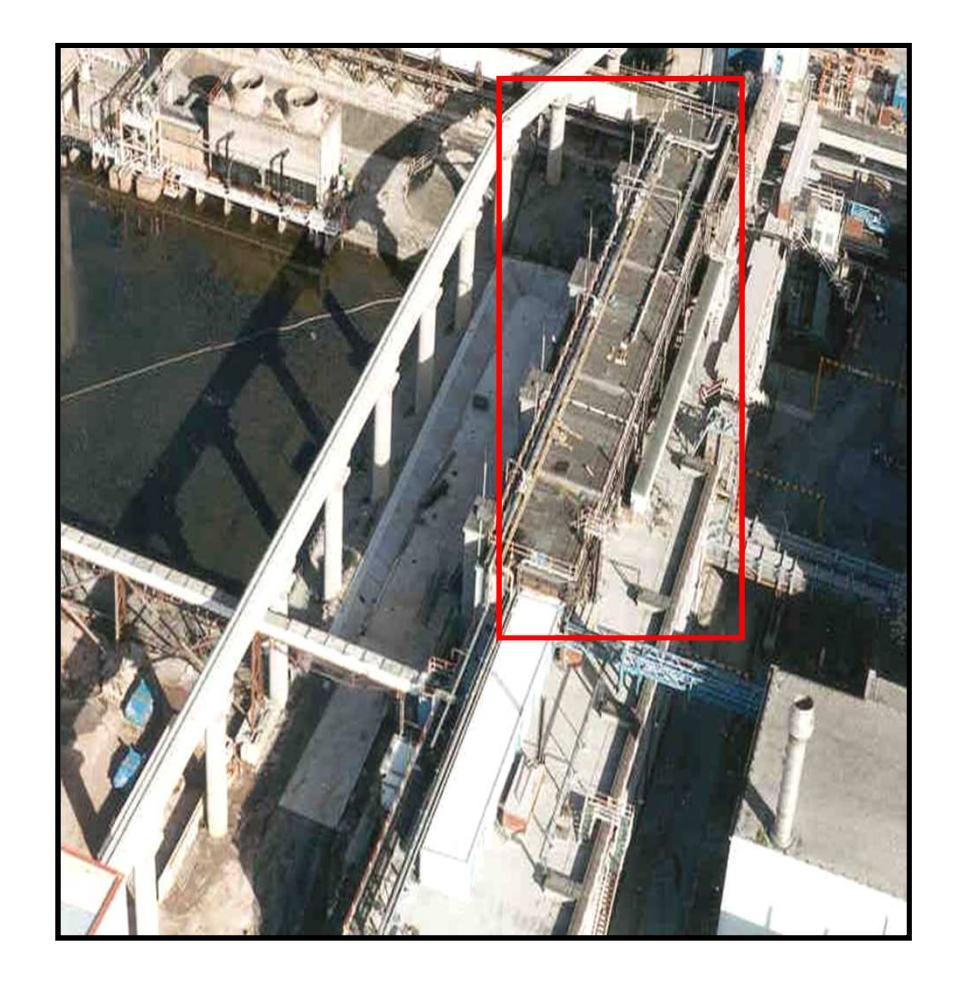
### **Caesium Extraction Plant**

The Caesium extraction plant was built in the mid 1950s to produce Kilo Currie sources for medical use.

It was built in 3 void areas above a Highly Active waste tank farm which housed 6 1000m3 highly active liquor tanks.

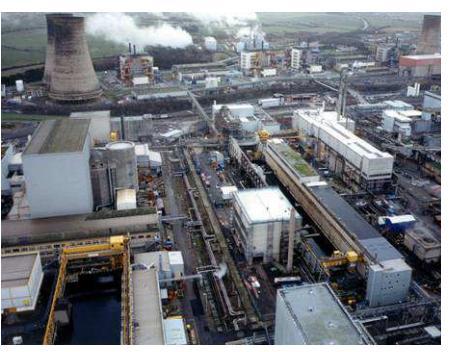
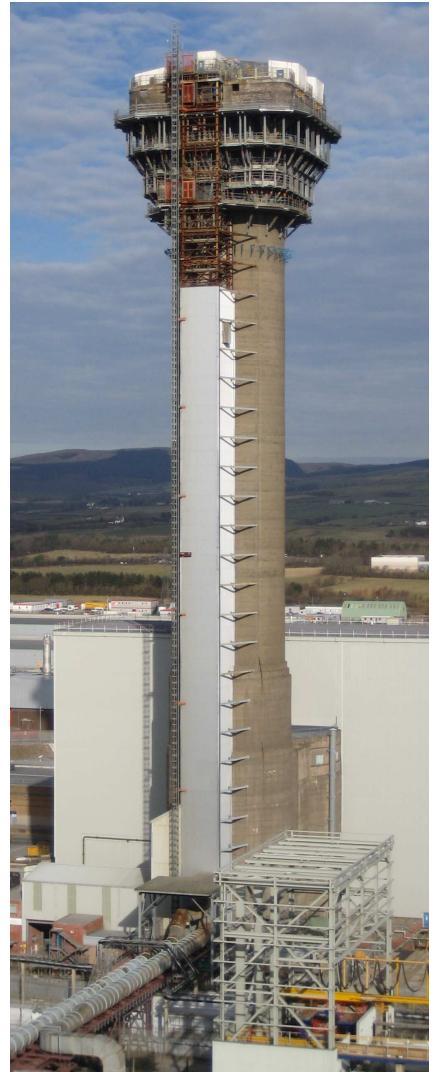
### **Pile One Chimney**

- B6 is Ventilation Stack for Pile 1 Reactor
  - 1957 Fire in Pile 1 Reactor led to significant contamination of chimney
  - 120 metre tall, 14 metre diameter concrete structure
  - Highly constrained site location
  - Decommissioning commenced 1988
    - Upper Concentrator
    - Filters and support structure
    - Insulation (fibrous & molar brick)
    - Lining Boxes and support steelwork
  - Decommissioning stopped in 2003 following fatal accident.
  - Decommissioning restarted 2007

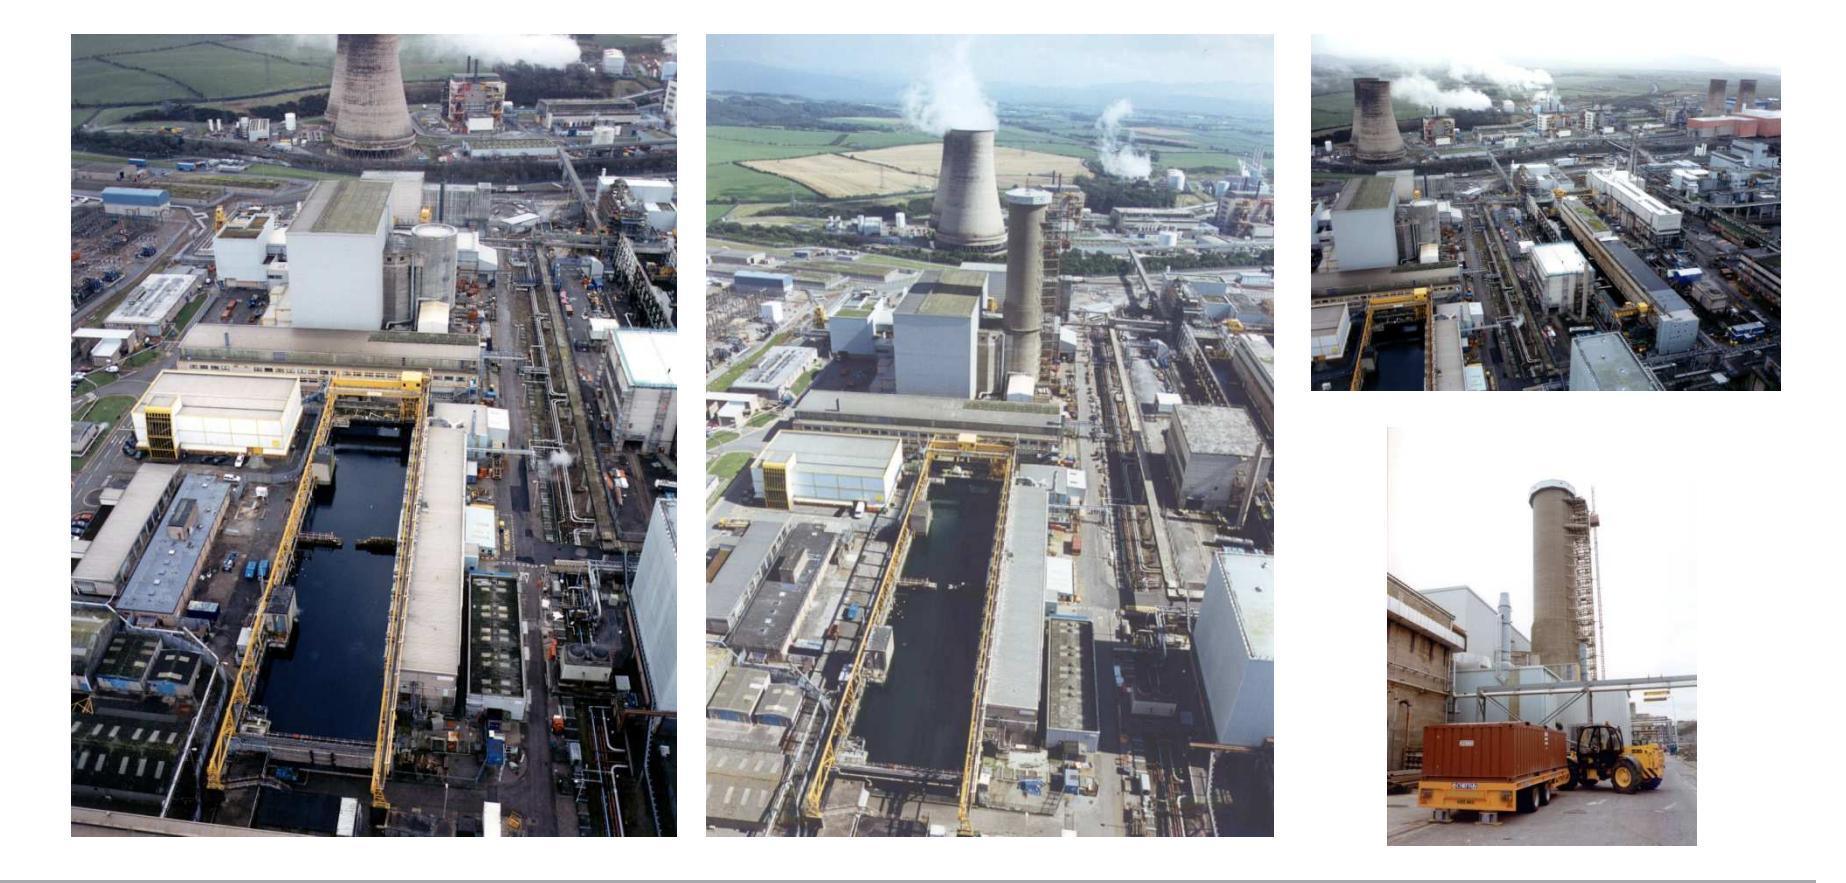
# **Practical Characteristics**

#### • Highly constrained site

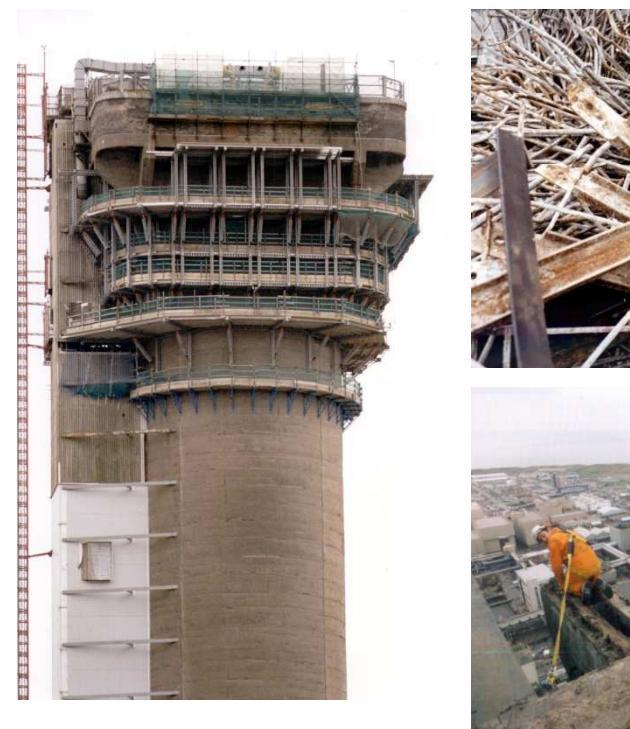
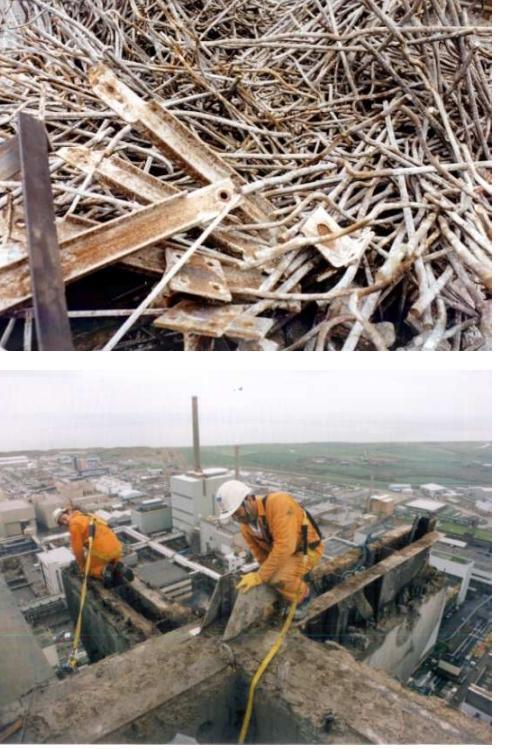
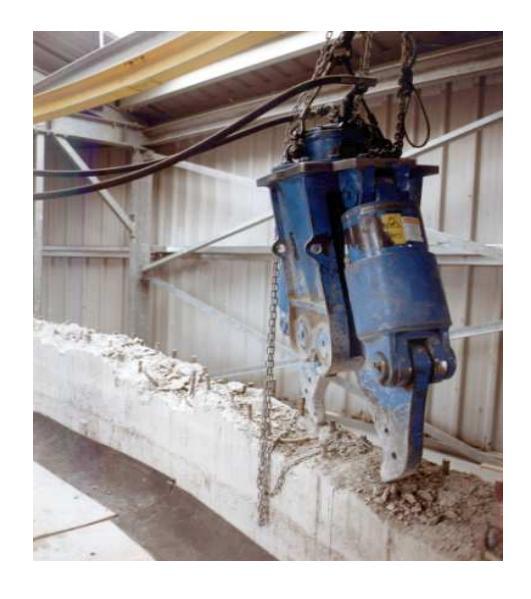
### **Practical Characteristics**

• Scale of decommissioning problem unique – 120m up in the air!

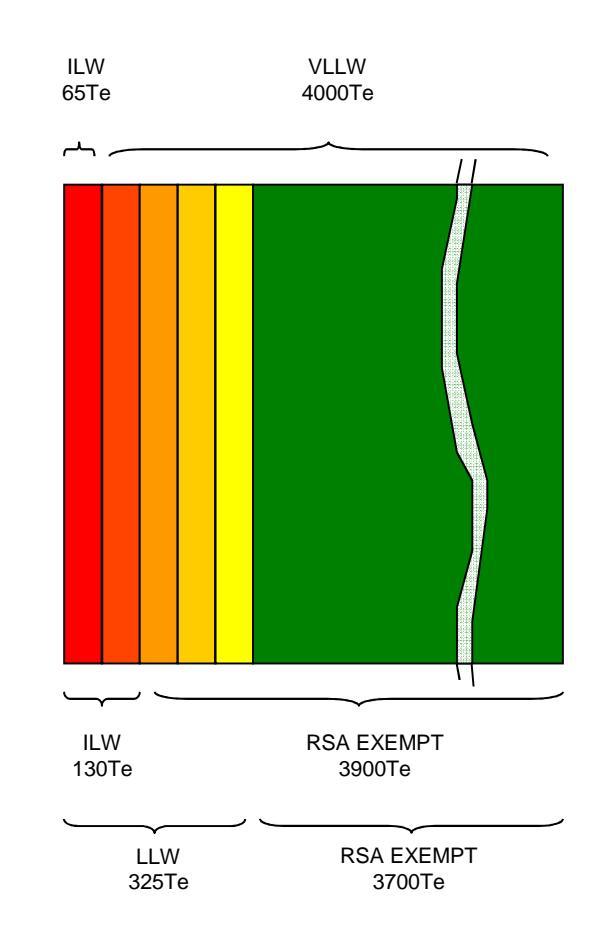
### **Radiological Challenge**

- Radiation & contamination problems from Pile fire in 1957
  - Average doserate in chimney base 433µSv/hr
  - Average doserate in chimney 250µSv/hr
- Whilst not significant doserates the durations of the work will result in significant individual doses.
- Problem is essentially a waste problem and the significant quantities of waste.

- Exterior levels of H-3 exceed current exemption limits.
- Therefore all material may have to be disposed of as radwaste.
- This has the potential of overwhelming the Low Level
  Waste Repository and cost will be significant
