**AGEING MANAGEMENT PROGRAM OF KARTINI REACTOR
FOR SAFE OPERATION**

**2nd International Conference on Research Reactors:
Safe Management and Effective Utilization
5 – 9 November 2007, Sydney - AUSTRALIA**

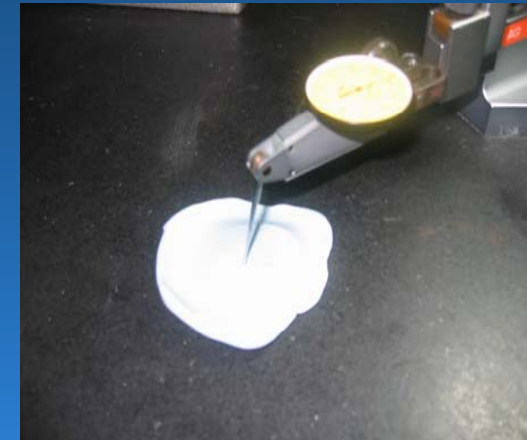
Fig.6. Measurement of swelling height

- Swelling height measurement conducted on the second impression (surface of pos.replica)
- The highest of swelling profiles for S1 in 3, S2 in 4
- Graph of S1 and S2 swelling areas and height as function of time shows in Fig.7.
