Microscopic Damage of Metals Exposed to the Helium Discharges in TRIAM-1M Tokamak and its Impact on Hydrogen Recycling Process

N. Yoshida, M. Miyamoto, K. Tokunaga, H. Iwakiri, H. Wakimoto, T. Fujiwara and the TRIAM group
Research Institute for Applied Mechanics, Kyushu University, Kasuga, Fukuoka 816-8580, Japan

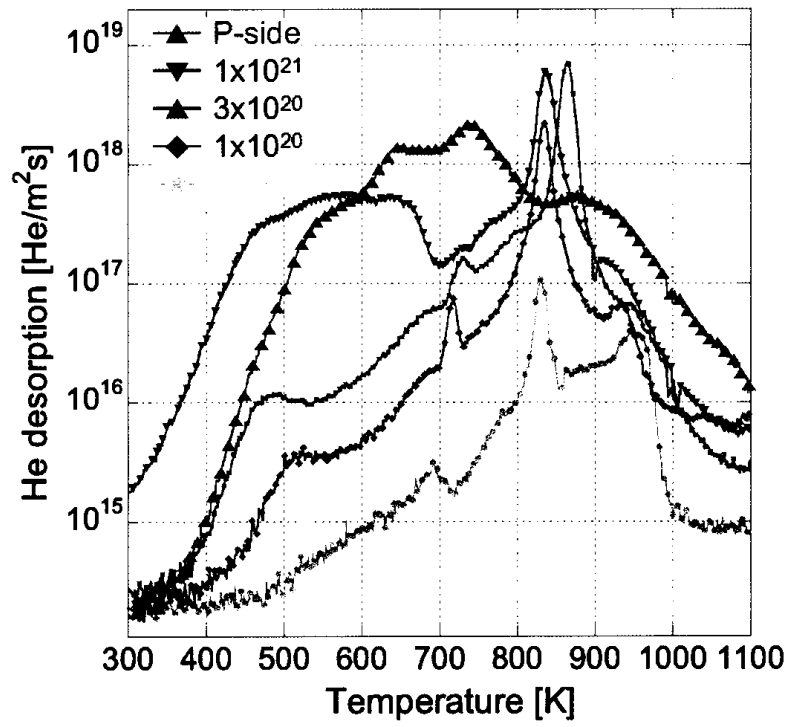
Fig. 5 Thermal desorption of helium from copper exposed to TRIAM-1M discharges and from copper irradiated by 1keV-helium ions. Fluence (ions/m²) of each data is denoted in the figure.

In order to estimate the amount of helium retained in the specimen, thermal desorption of helium from a copper plate placed on the P-side was measured and the result is plotted in Fig. 5 together with those for 1 keV-helium ion irradiation using ion gun. Though the detail of the spectrum is different from those of the ion-irradiated specimens, it showed typical feature of copper; termination of desorption below 1100K. The total of retained helium was, therefore, estimated to be 3.9×10^{20} He/m².
