Study of Radiation-Damaged Fusion Materials under High-Power Plasma Stream

Abstract. Plasma-facing materials (PFM's) of a fusion reactor will be affected by high heat flux, fast particles and 14 MeV-neutron irradiation. All these factors are crucial for the lifetime of the reactor components. This paper is devoted to the experimental studying the radiation damage effect on erosion of materials under plasma impact. To obtain a high level of radiation damage, we simulated an accumulation of radiation damage under fast neutron irradiation by fast ions with energies in the interval of 1-60 MeV accelerated on the cyclotron at Kurchatov Institute. Using this method we can accumulate the radiation damage at the level equivalent to fast neutron effect at the dose of up to 10^{22} neutron/cm² in a few days operation of the cyclotron. Both carbon materials and tungsten were taken for the study as the targets: MPG-8 (Russian graphite), SEP NB-31 (ITER PFM candidate) and W (99,95% wt). Irradiation on the cyclotron has been performed by 5 MeV carbon ions for carbon materials and 3-4 MeV alpha particles for tungsten. The plasma experiments have been performed on the materials having accumulated

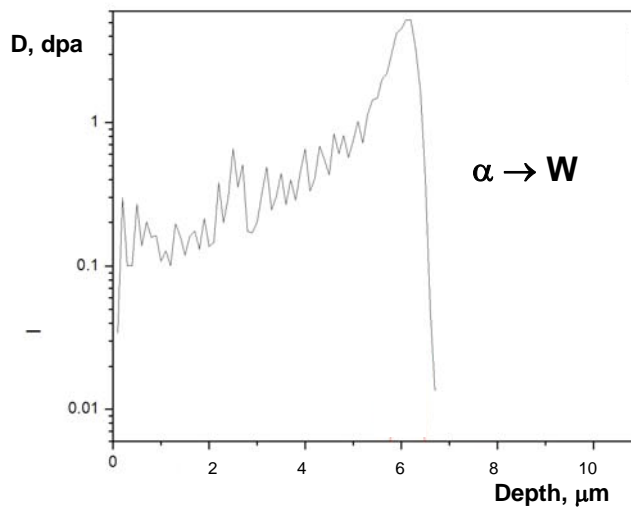
FIG. 6. Calculated profile of radiation defects produced in tungsten ($\rho=19.35$ g/cm³, 183.8 amu) irradiated by 4 MeV alpha-particles (He^{+2}) to dose $\Phi = 10^{17}$ α/cm^2 .

Irradiation by $^4\text{He}^{+2}$ ions. Tungsten samples W (99.95% wt) $10 \times 12 \times 1$ mm have been irradiated by α -particles ($^4\text{He}^{+2}$ ions) accelerated to 3.0-4.0 MeV. Three series of irradiations have been performed to reach high levels of radiation damage. α -particles fluence values collected on the samples were $5 \cdot 10^{17}$ ion/cm², 10^{18} ion/cm² [7] and $3 \cdot 10^{18}$ ion/cm². These values correspond to different levels of the obtained defects. Fig. 6 illustrates radiation defects production in tungsten by helium ions at energy of 4.0 MeV. The curve shown in the figure was obtained by calculation of the primary defect profile by the SRIM program [5] for 10^{17} ion/cm² of helium ion fluence. The distribution of the radiation defects has maximum ~ 5 dpa at about 6.2 μm characterizing the range of the high-energy α -particles in tungsten.
