Influence of Radiation Damage Obtained under Fast Charged Particle Irradiation on Plasma-Facing Erosion of Fusion Structural Materials

A.I. Ryazanov, V.S. Koidan, A.N. Bryukhanov, O.K. Chugunov, V.M. Gureev,
B.I. Khripunov, S.N. Kornienko, B.V. Kuteev, S.T. Latushkin, A.M. Muksunov, V.B. Petrov,
E.V. Semenov, V.P. Smirnov, V.G. Stolyarova, V.N. Unezhev

Russian Research Center” Kurchatov Institute”, Moscow , Russia

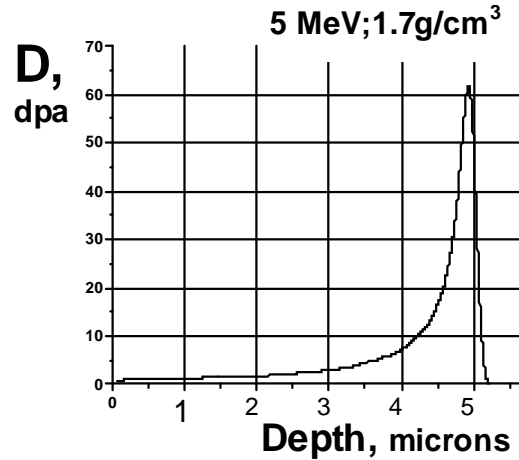
FIG. 1. Calculated profile of the primary radiation defects D (dpa) as a function of depth for a carbon material with density $\rho = 1.7 \text{ g/cm}^3$ after irradiation with 5 MeV carbon ions to the dose $5 \cdot 10^{17}$ ion/cm 2 ($D_{\text{max}} = 65 \text{ dpa}$ lies at $\sim 5 \mu\text{m}$, $\langle D \rangle = 9.7 \text{ dpa}$).

and 10 dpa in average over the damaged layer were obtained in the samples of each carbon material. The $^{12}\text{C}^+$ ion doses necessary to reach these values were 10^{17} ion/cm 2 , $5 \cdot 10^{17}$ ion/cm 2 and 10^{18} ion/cm 2 correspondingly. Distribution of the accumulated defects in the surface layer is given in *FIG. 1* where calculated curve of primary radiation defects produced in graphites by 5 MeV $^{12}\text{C}^+$ ions as a function of depth is shown (SRIM program [5]).

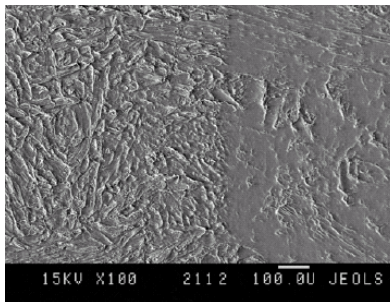
FIG. 2. Border of irradiated area on SEP NB-31 surface (10 dpa): damage zone is to the left (scale 100 μm).

Sputtering effect and radiation-induced deformation (swelling) took place on the materials along with the radiation damage produced by the ions. Modification of surface structure of the SEP NB-31 sample is shown in *FIG. 2* where the boundary between irradiated and non-irradiated areas is presented for the 10 dpa sample. The development of the surface is seen on the irradiated part (left).

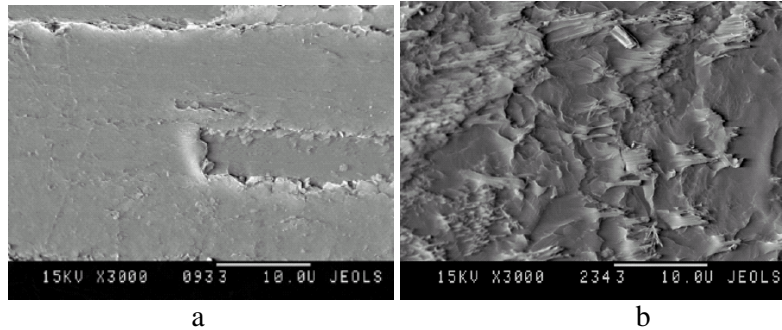
FIG. 3. Surface of the SEP NB-31 sample: a) in initial state and b) after irradiation to 10 dpa and plasma exposure (scale 10 μm).

Changes were found both after each plasma exposure. Example of the SEP NB -31 surface irradiated to 10 dpa after plasma bombardment is shown in *FIG. 3b*.

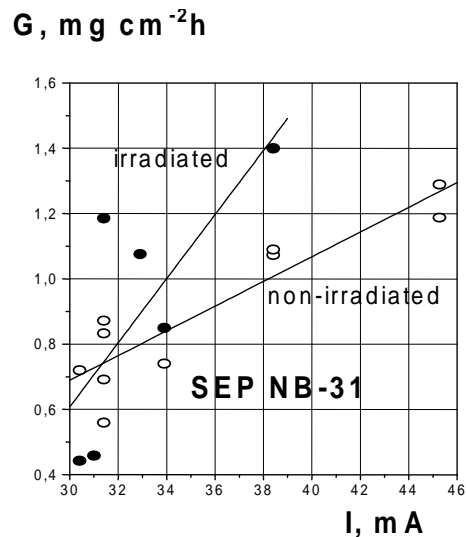
FIG. 4. Erosion rate of SEP NB-31 graphite vs plasma ion flux.

Weight loss due to the plasma bombardment was registered and erosion rate G was measured. Taking into account deuterium ion current to the surface erosion yield was evaluated. *FIG. 4* shows erosion rate of the SEP NB-31 composite in plasma as a function of plasma current to material sample irradiated with high-energy ions and for comparison to the non-irradiated one. Erosion yield Y was deduced from these measurements as the slope of the curves presented on the picture. Though scattered data (for CFC), the result gives evidence that erosion rate is higher for irradiated (damaged) material. Enhancement factor of the erosion yield given by appropriate ratio of Y values for irradiated to non-irradiated materials. It was $Y_{\text{SEP irradiated}}/Y_{\text{SEP}} = 2.6 \pm 0.6$ for SEP NB-31 and even larger $Y_{\text{pyro irradiated}}/Y_{\text{pyro}} = 4.8 \pm 0.4$ for pyrographite while the lower value $Y_{\text{MPG irradiated}}/Y_{\text{MPG}} = 1.6 \pm 0.4$ was found for MPG-8.

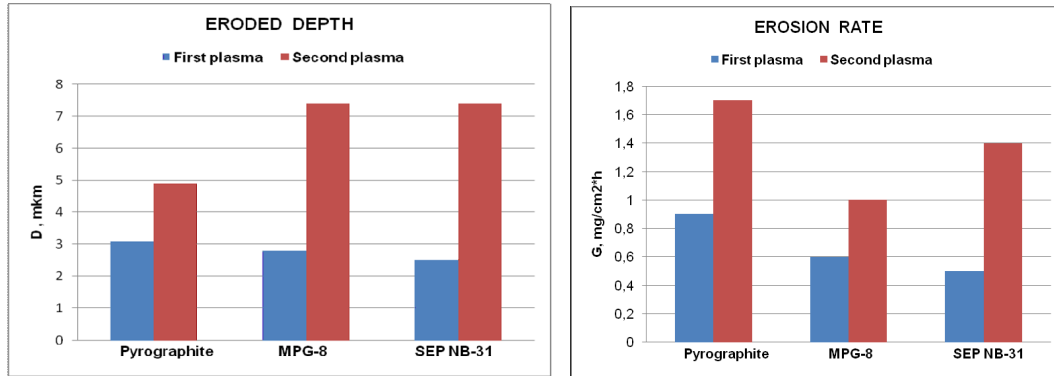
FIG 5. Erosion depth and erosion rate in double plasma experiment for 1 dpa samples of SEP NB-31, MPG-8 and pyrographite.

The results of double successive plasma exposure of carbon materials is illustrated in *FIG. 5* showing erosion depth and erosion rate of three types of graphite under study after the first and after the second plasma exposures. All materials exhibit increase of erosion rate in the second plasma corresponding to the layer of maximal defect density involved in the erosion.

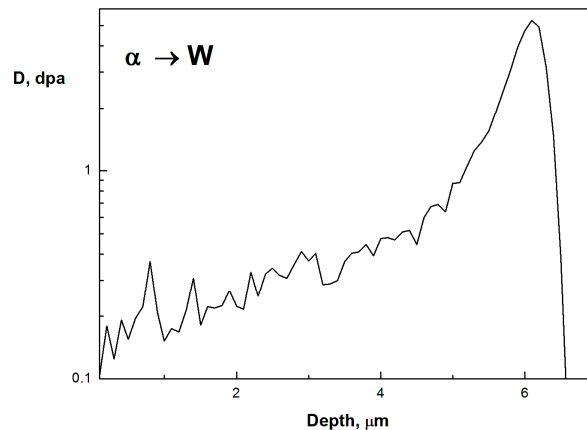
FIG. 6. Calculated profile of radiation defects produced in tungsten ($\rho = 19.35$ g/cm³, 183.8 amu) irradiated by 4 MeV alpha-particles (He^{+2}) to dose $= 10^{17}$ /cm².

Irradiation by $^4\text{He}^{+2}$ ions. Tungsten samples W (99.95% wt) $10 \times 12 \times 1$ mm have been irradiated by α -particles ($^4\text{He}^{+2}$ ions) accelerated to 3.0-4.0 MeV. Three series of irradiations have been performed to reach high levels of radiation damage. α -particles fluence values collected on the samples were $5 \cdot 10^{17}$ ion/cm², 10^{18} ion/cm² [7] and $3 \cdot 10^{18}$ ion/cm². These values correspond to different levels of the obtained defects. *FIG. 6* illustrates radiation defects production in tungsten by helium ions at energy of 4.0 MeV. The curve shown in the figure was obtained by calculation of the primary defect profile by the SRIM program [5] for 10^{17} ion/cm² of helium ion fluence. The distribution of the radiation defects has maximum ~ 5 dpa at about 6.2 μm characterizing the range of the high-energy α -particles in tungsten.

The successive plasma experiments were pursued till the depth of maximal defect concentration was reached. We have made 5 successive exposure tests of the sample having taken the $^4\text{He}^{+2}$ fluence of $5 \cdot 10^{17}$ ion/cm². Total deuterium ion fluence on the surface from the plasma accumulated during this series was $2 \cdot 10^{22}$ D⁺/cm²; and the surface layer eroded after 5 experiments was 7 μm thick (see FIG. 6). Considerable changes in the structure were

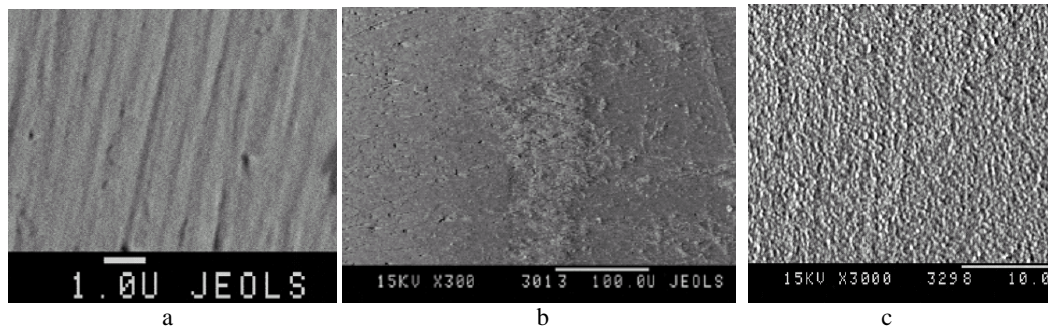
FIG. 7. Tungsten surface modification by high-energy α -particles; a) the surface as prepared, b) the border of irradiation area on tungsten sample with the received ion fluence 10^{18} ion/cm²: the left part was not irradiated; c) as irradiated with $^4\text{He}^{+2}$ ions to fluence $3 \cdot 10^{18}$ ion/cm² (scale bars in microns).

The study of the surface in the vicinity of irradiation area border on the tungsten samples has not shown as important deformation as on graphites. It was not detected with our profilometer on the first sample at $5 \cdot 10^{17}$ ion/cm², the two other samples have shown linear deformation effect of 0.1-0.3 μm or 2-5% as compared with 6 μm thickness of the damaged layer. On the third sample ($3 \cdot 10^{18}$ ion/cm²) we observed a large area $\sim 1/4$ cm² having experienced a very large deformation about 140 μm but it was not due to swelling but splitting of the surface layer from the tungsten bulk took place. The surface of the sample after irradiation to 10^{18} ion/cm² is given in FIG 7b. The picture was taken in the vicinity of irradiation border, which is well seen in the photo. Example of the sample irradiated with α -particles to $3 \cdot 10^{18}$ ion/cm² is shown in FIG. 7c.

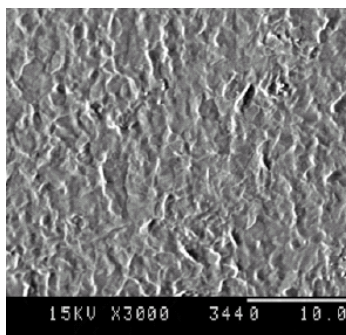
FIG. 8. Tungsten irradiated to 10^{18} $^4\text{He}^{+2}$ /cm² after plasma exposure to $3.7 \cdot 10^{21}$ D⁺/cm² (at 250 eV) (scale 10 microns).

Plasma effect on radiation damaged tungsten. Plasma exposure of irradiated tungsten samples has been fulfilled also step-by-step in order to determine erosion characteristics in the near surface layers. Deuterium ion flux on the surface was $j=30-55$ mA/cm² in these experiments, energy of ions was 250 eV (bias). Temperature of the samples during exposure was not higher than 40 C. Surface changes have been found after plasma bombardment of irradiated tungsten. An example of the radiation-damaged tungsten at 10^{18} of $^4\text{He}^{+2}$ /cm² after plasma exposure to fluence $3.7 \cdot 10^{21}$ D⁺/cm² is shown in FIG. 8.

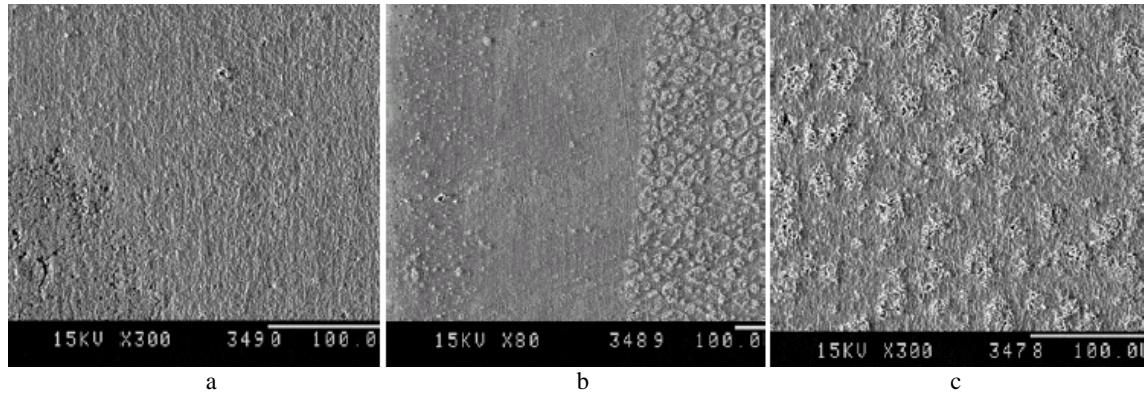
FIG. 9. Tungsten surface after plasma exposure to $2 \cdot 10^{22} D^+ / \text{cm}^2$: a) area subjected only to plasma, b) the border between the irradiated ($^4\text{He}^{+2}$ fluence of $5 \cdot 10^{17}$, to the right) and non-irradiated zone, c) damage (irradiated) zone (scale 100 microns).

observed when the sputtering process came to the layer of maximal defect concentration. Three parts of this sample are shown in *FIG. 9*: a) the no-damage zone subjected only to 5 plasma exposures, b) the border of irradiated zone (to the right), c) damage (irradiated) area. The defect structure is distinctly seen on the irradiated side.
