Russian Research Center “Kurchatov Institute”

# Influence of Radiation Damage obtained under Fast Charged Particle Irradiation on Plasma-Facing Erosion of Fusion Structural Materials

*International Topical Meeting on Nuclear Research  
Applications and Utilization of Accelerators,  
Vienna, 4-8 May, 2009*

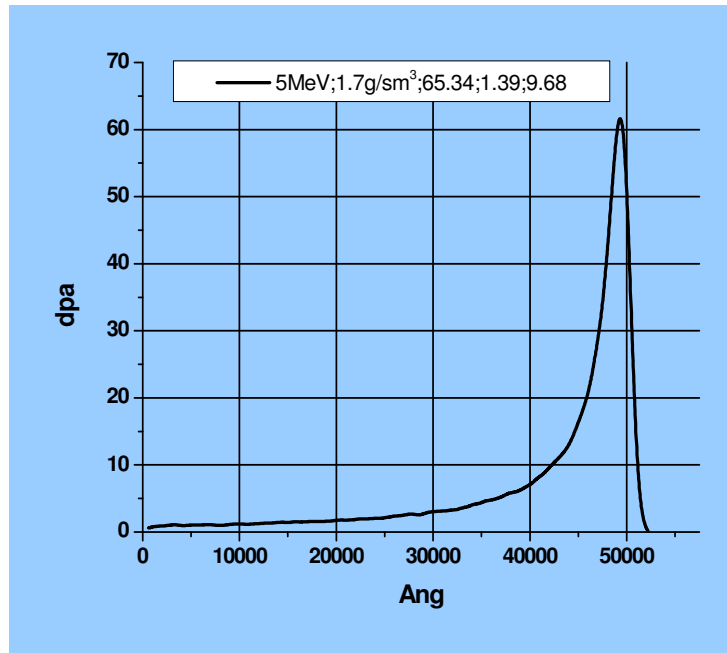
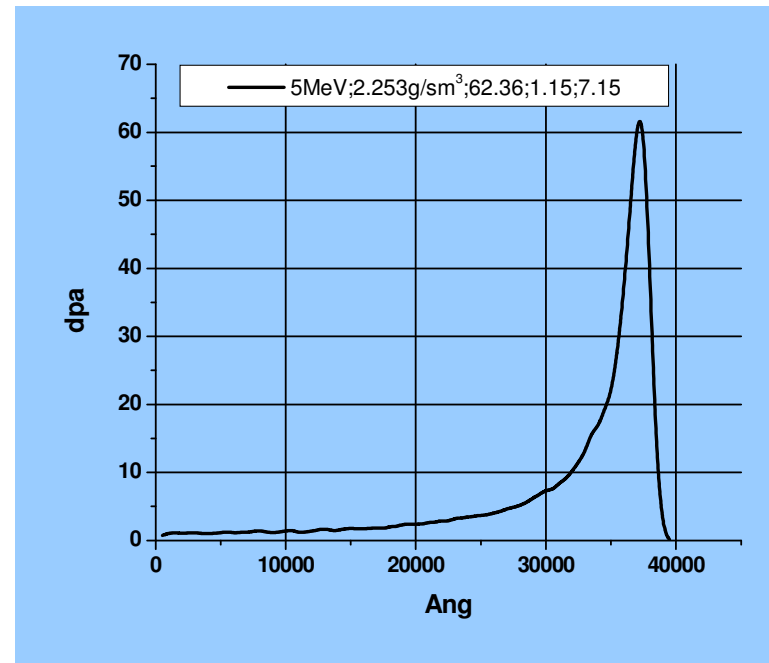
$$\rho = 1.7 \text{ g/cm}^3 \quad \langle D \rangle = 9.68 \text{ dpa}$$

$$\rho = 2.253 \text{ g/cm}^3 \quad \langle D \rangle = 7.15 \text{ dpa}$$

**Primary radiation defects D (dpa) vs 5 MeV  $^{12}\text{C}^+$  ion penetration depth in carbon material for the total ion dose  $10^{18} \text{ ion/cm}^2$**

damage profile calculated by SRIM code

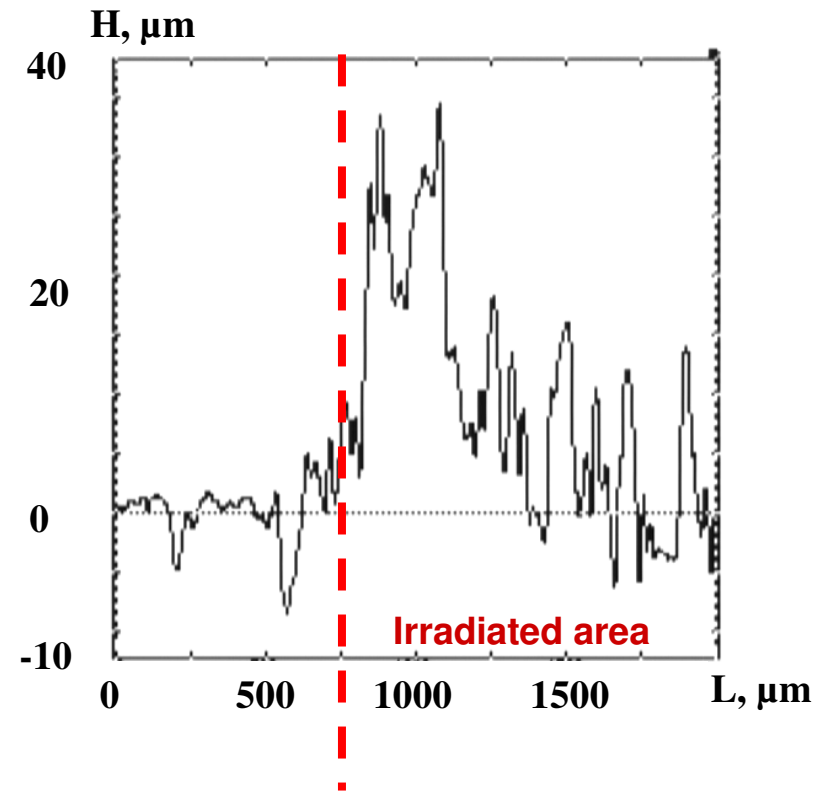
**CFC SEP NB 31**  
**10 dpa**

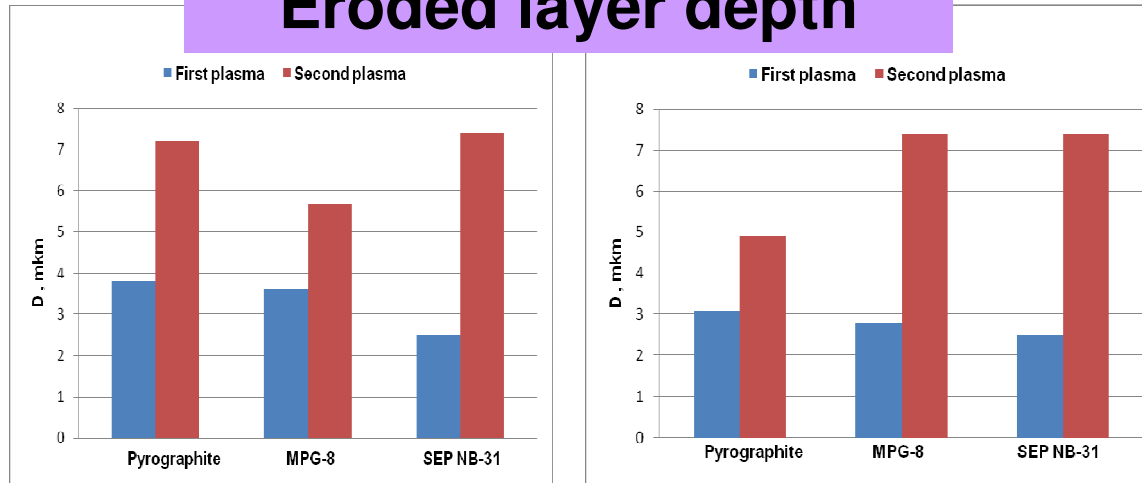
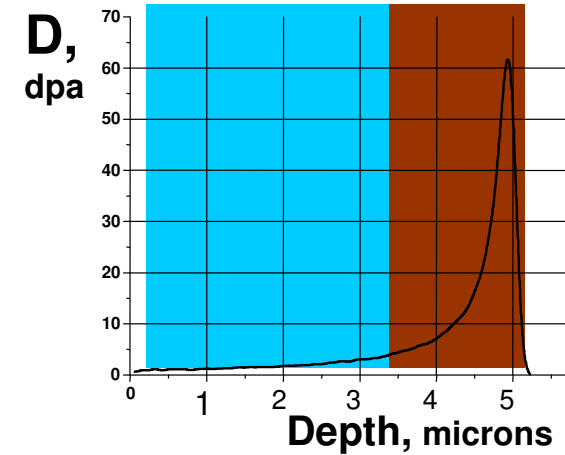
## Eroded layer depth

1 dpa

5 dpa

Double plasma exposure experiment:

Damage distribution maximum reached in the second plasma exposure

Increase of erosion rate in the layer of maximal defect density

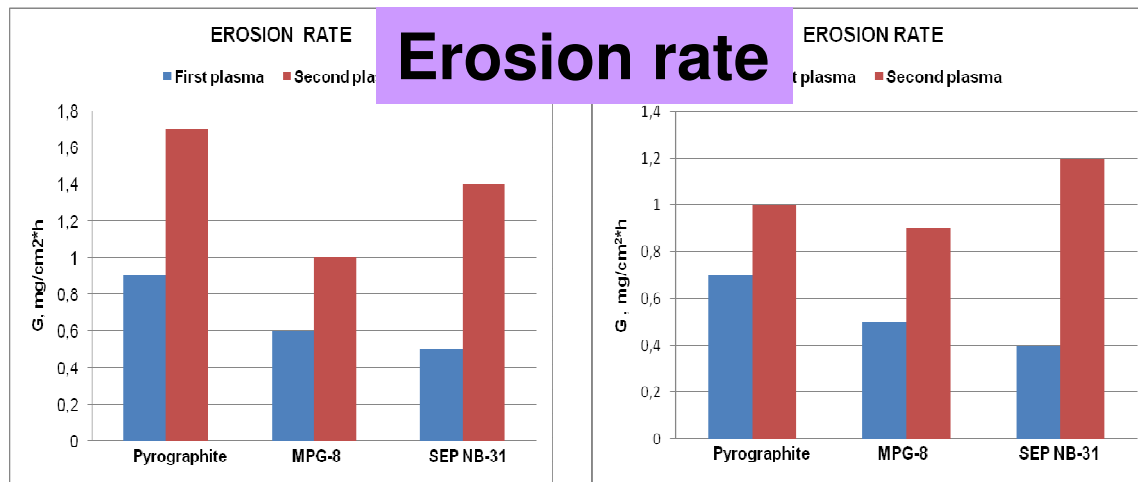
## Erosion rate

Pyro MPG SEP

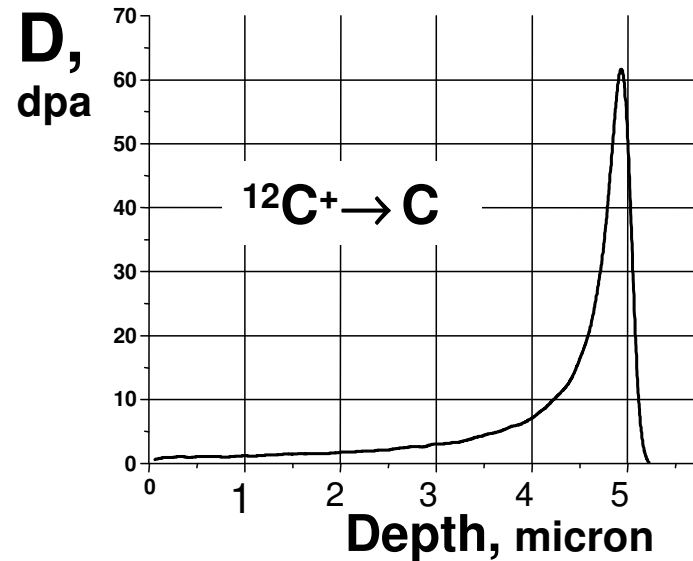
$$\langle D \rangle = 9.68 \text{ dpa}$$

Calculated profile of primary radiation defects D (dpa) produced in carbon material ( $\rho=1.7 \text{ g/cm}^3$ ) irradiated by **5 MeV** carbon ions to  **$10^{18} \text{ ion/cm}^2$** .

Damage profile calculated by SRIM code

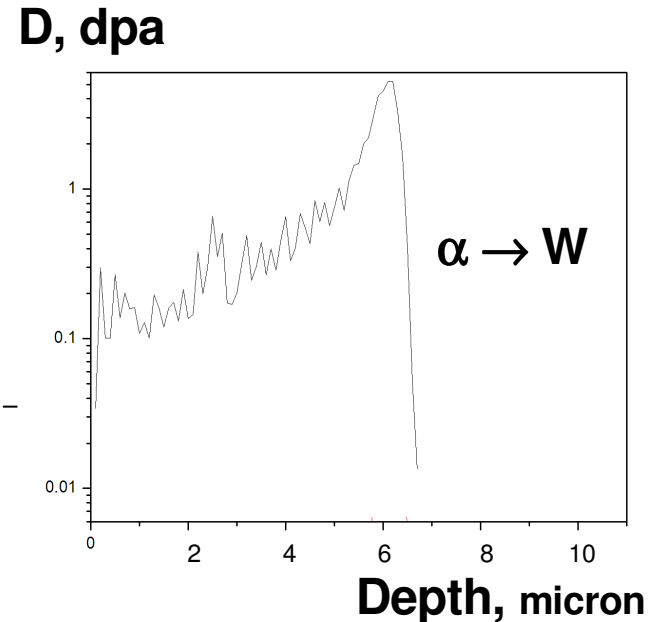
$$\langle D \rangle = 0.3 \text{ dpa}$$

Calculated profile of radiation defects produced in tungsten ( $\rho=19.35 \text{ g/cm}^3$ , 183.8 amu) irradiated by **4 MeV** alpha-particles ( $\text{He}^{+2}$ ) to dose  $\Phi = 10^{17} \alpha/\text{cm}^2$ .

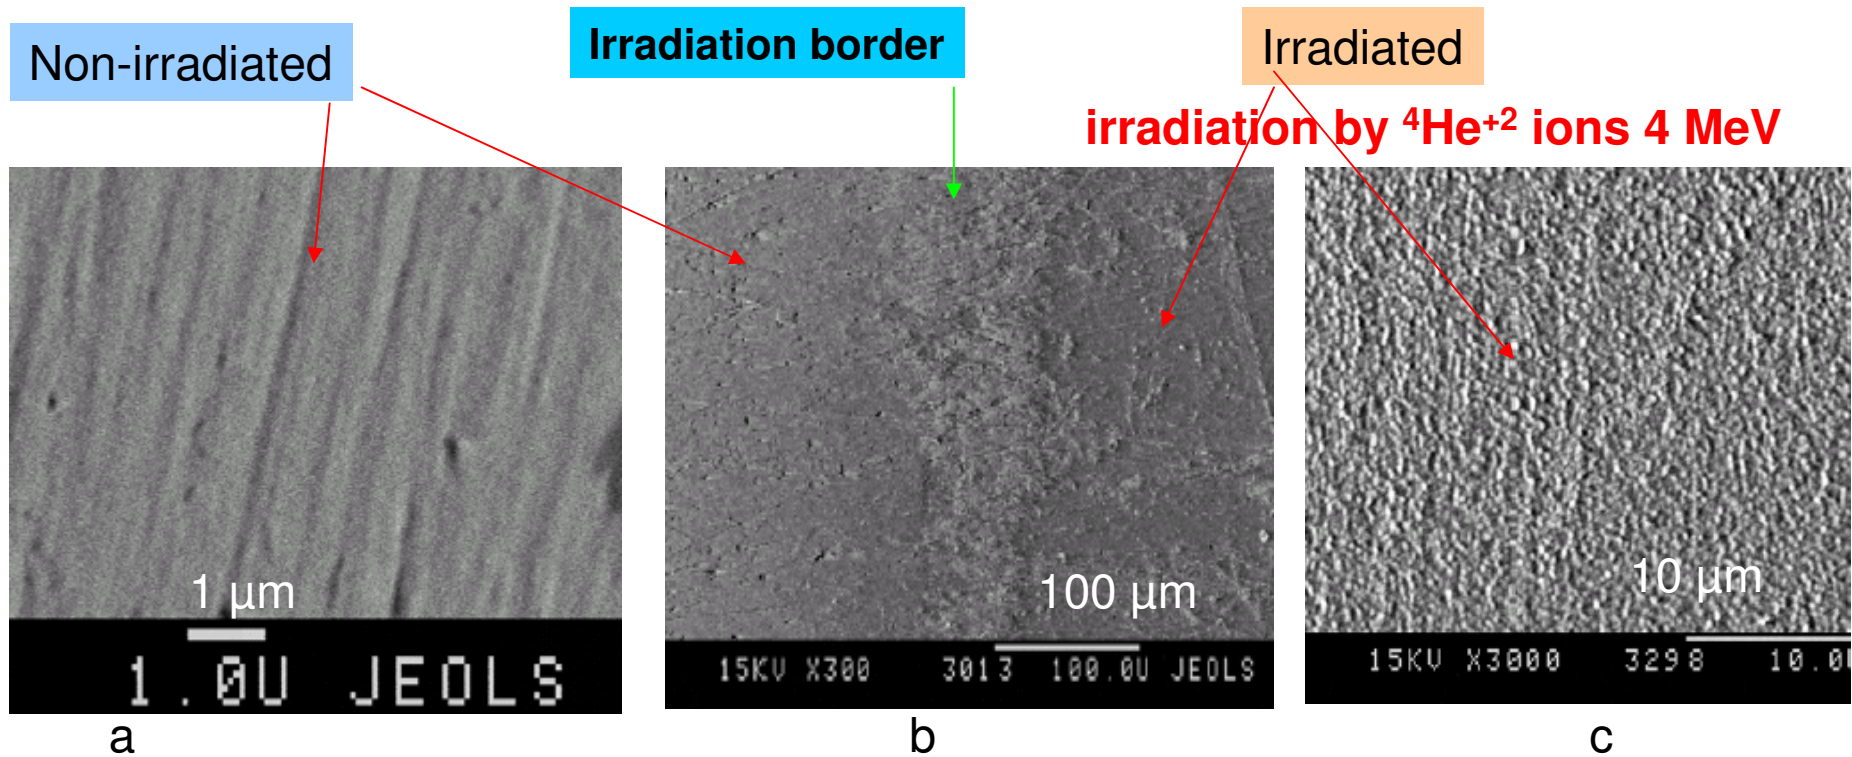
# Tungsten surface modification by high-energy $\alpha$ -particles

*surface as prepared*

*border of irradiation area  
on tungsten sample  
having received ion  
fluence  $10^{18}$  ion/cm<sup>2</sup>*

*tungsten irradiated with  
 $^4\text{He}^{+2}$  ions to fluence  
 $3 \cdot 10^{18}$  ion/cm<sup>2</sup> (scale  
bars in microns)*
