IAEA-TECDOC-1421

***Experience gained from fires in
nuclear power plants:
Lessons learned***

November 2004

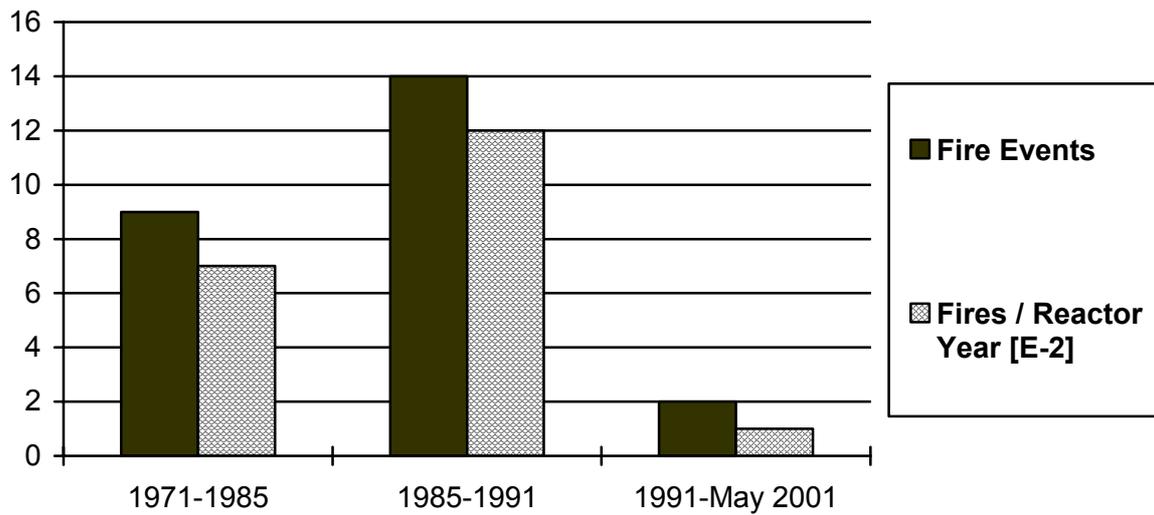
FIG. 1. Reportable fire events from NPP in Germany.

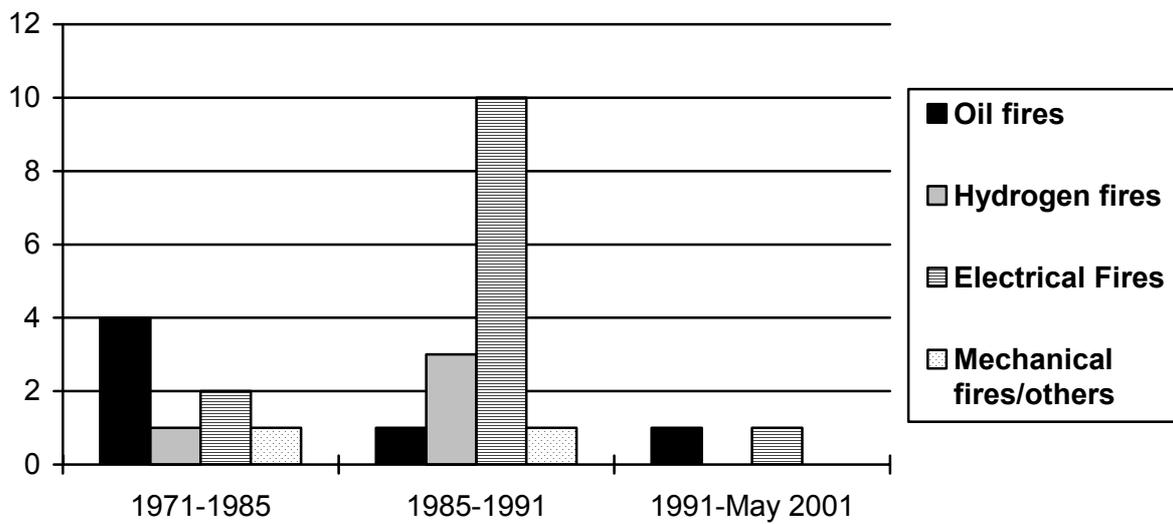
FIG. 2. Different types of reportable fire events from NPP in Germany.

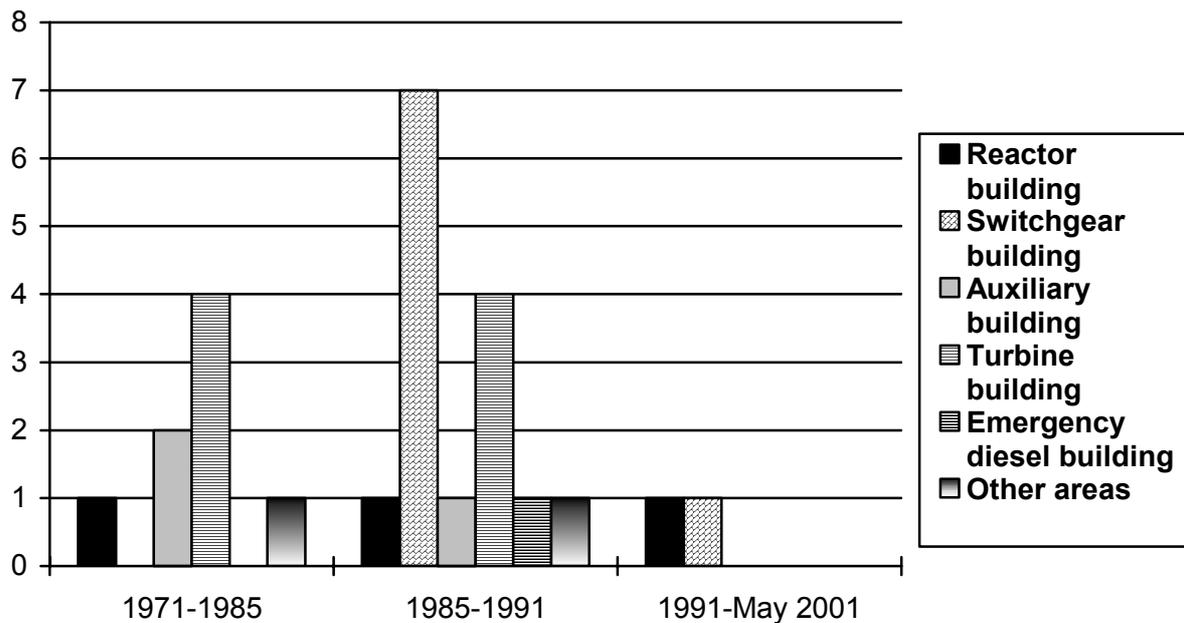
FIG. 3. Reportable fire events from NPP in Germany binned to different areas.

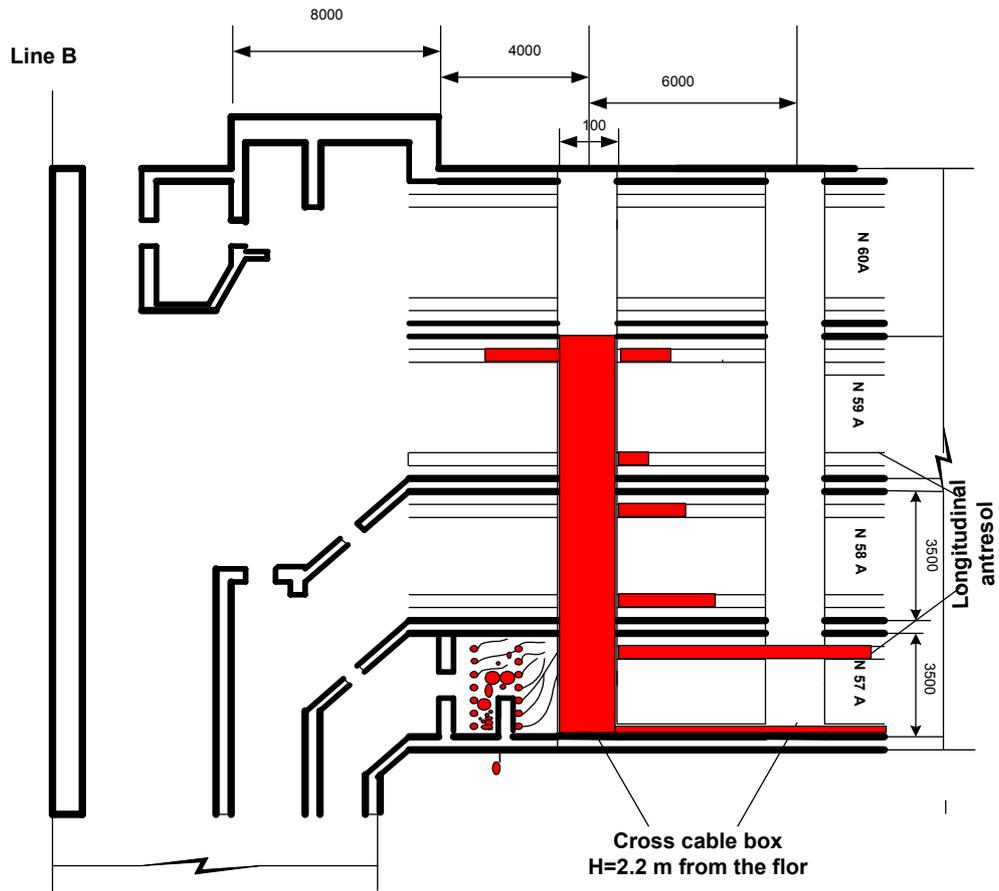
FIG.2.
Armenian NPP Layout
Level - 3.6 m
The red color indicated
fire propagation

The long-term short circuit current along the cable 2NTV-4 led to its overheating and ignition on the places of rupture. This caused ignition of adjacent cables and fire in the cable compartments 59a and 60a, and also to ignition of a bunch control cables laid on metallic box and cable shaft 2 in Main Control Room -1 (look at Fig. 2, 3).

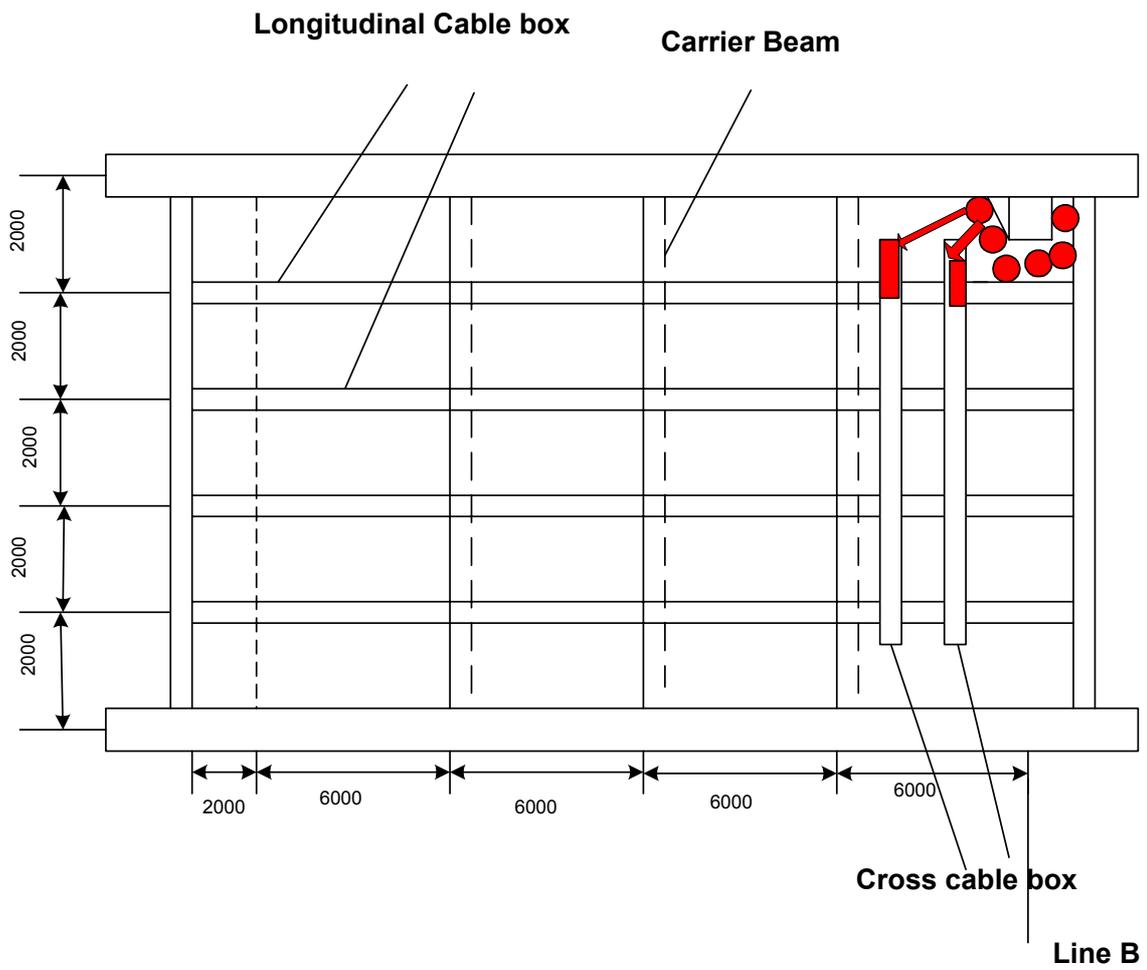
**Fig.3. Armenian NPP
Layout
Level 5.4 m
The red color indicated
fire propagation**

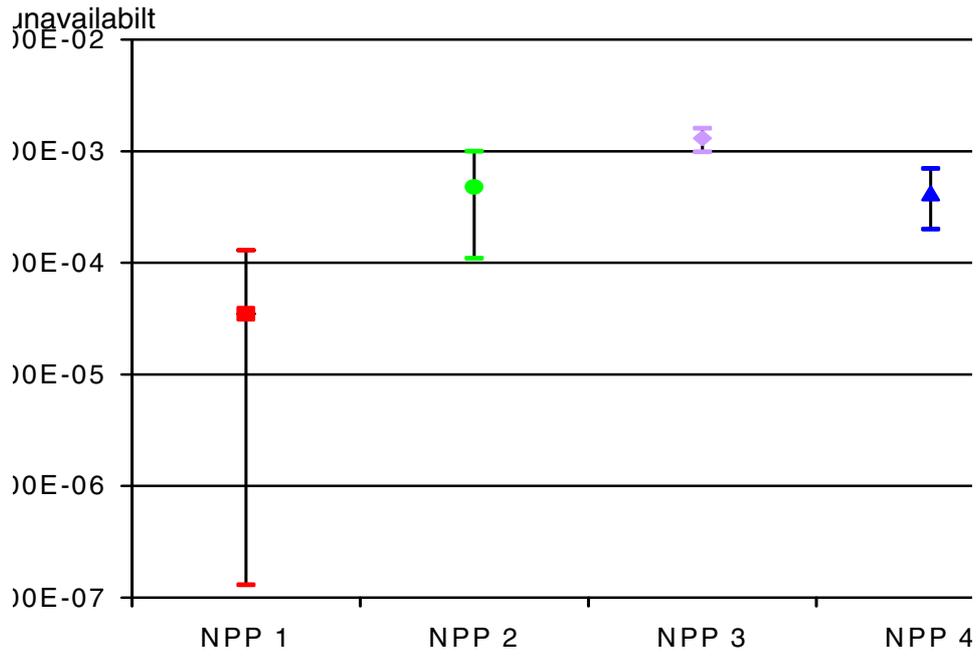
FIG. 1. Plant Specific Unavailabilities per Demand for Automatically Actuated Fire Detectors from Four German Nuclear Power Plants [9].

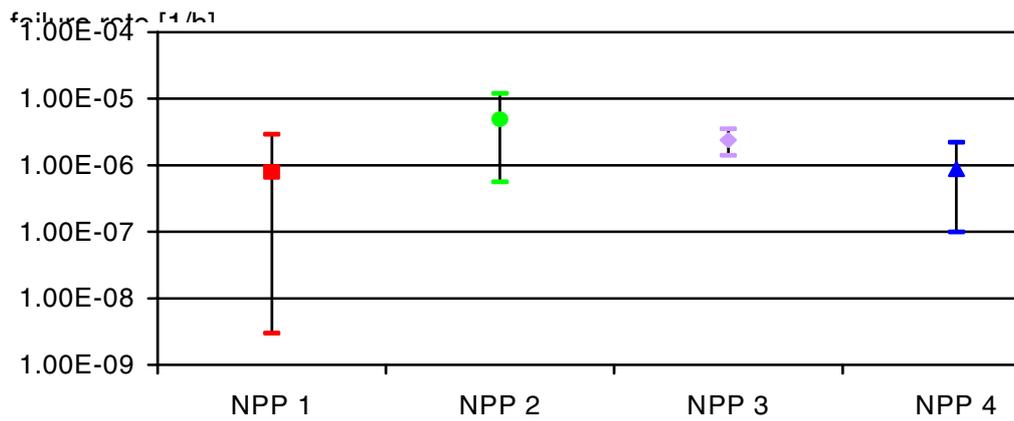
FIG. 2. Plant Specific Failure Rates λ [1/h] for Smoke & Heat Removal Dampers from Four German Nuclear Power Plants [9].

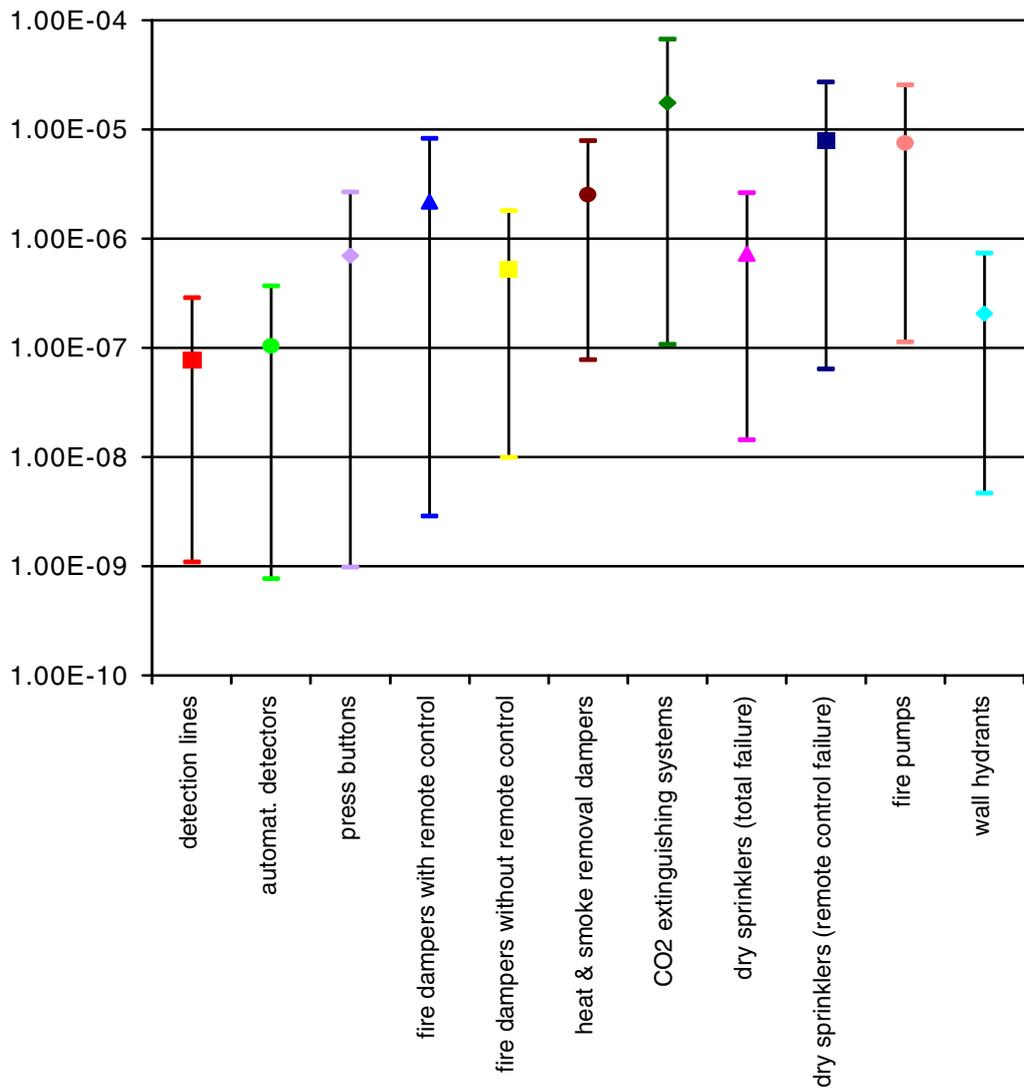
FIG. 3. Generic Failure Rates λ [1/h] for Active fire Protection Features from Four German Nuclear Power Plants [9].

Table 1 gives an overview of the generic failure rates for active fire protection equipment from four German nuclear power plants as estimated in [9]. Figure 3 outlines a uniform behaviour for a majority of active fire protection features with failure rates in the range of 10–6/h. The reliability of the fire detection features is slightly higher. The highest value estimated for CO₂ gas extinguishing systems can only be seen as a first rough estimate not applicable as verified input data in a fire PSA because of the still much too small database from only few operating hours in two reference NPP.

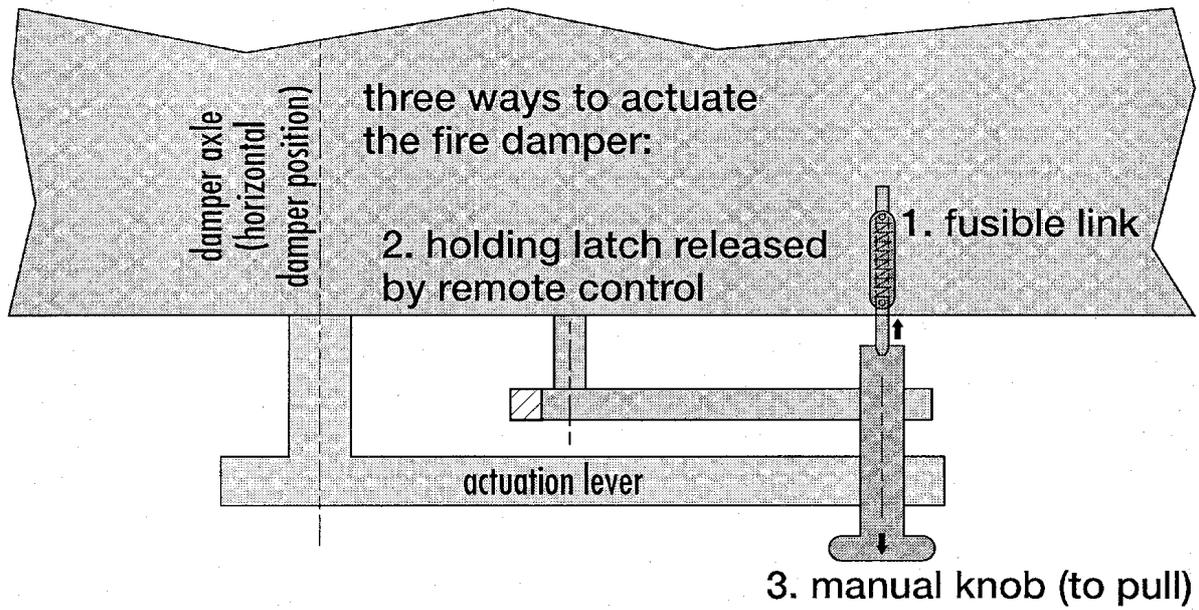
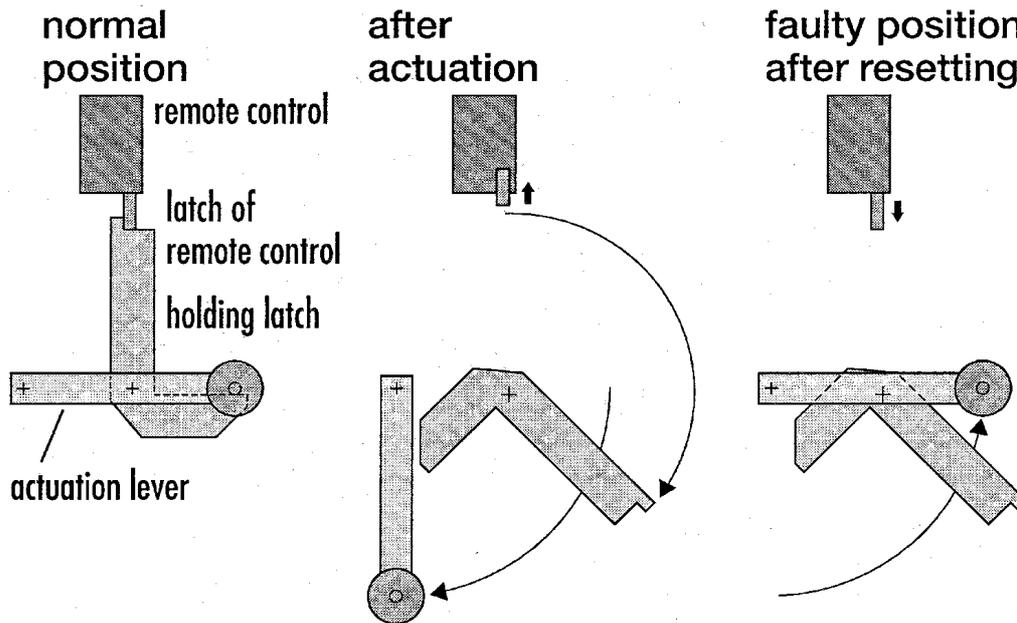
Ventilation Channel (plan view)

Position of the Actuation Mechanism (elevation)

FIG. 4. Schematic drawing of the actuation mechanism positions of fire dampers with findings.

Figure 4 shows schematically the typical function of the fire damper actuation mechanism: On electrical actuation, the latch is released. It moves downward and releases the manual lever, thus enabling the damper to fall into “closed” position. On thermal actuation, the pin moves out of the casing of the damper on actuation. It thereby removes the knob of the manual lever from the latch, thus also releasing the manual lever and closing the damper.

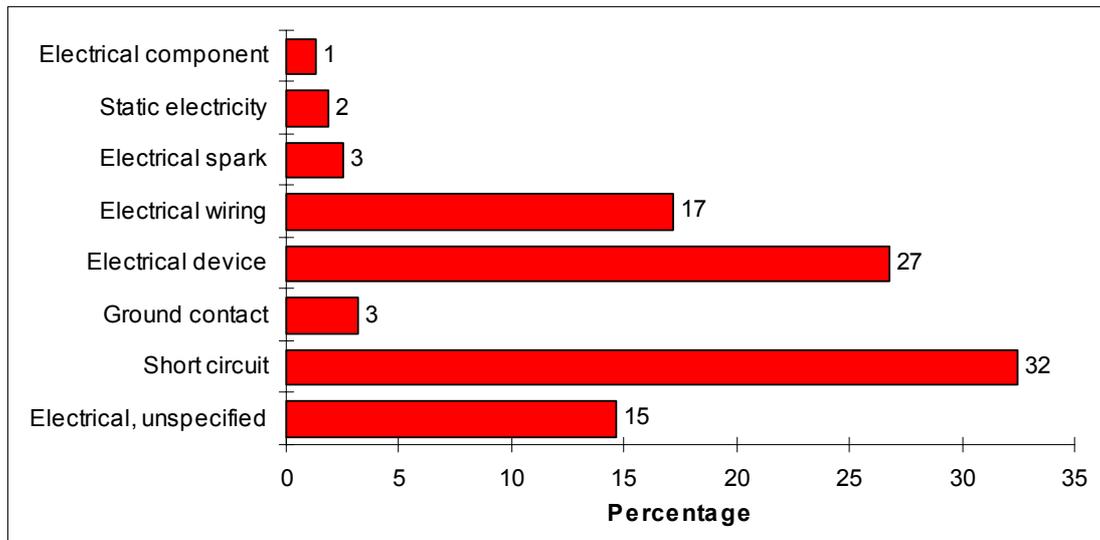
FIG. 1. Electrical fire causes recorded from large accidents in Finland 1980–1993. Total number of accidents in this figure is 157.

Fires recorded as electrically induced were collected from statistics on large fire accidents in Finland 1980–1993 based on unpublished material from the Federation of Finnish Insurance Companies. A fire accident was recorded as large, if the value of the material loss exceeded 100 ... 250 k€ (due to inflation and changes of definitions during the period the limit fell within these limits in prices of year 2000). Ignition mechanism as well as failed component was used without distinction in these statistics to express fire cause and the results are presented in Figure 1. Fire causes denoted as “electrical device” or “electrical” without further

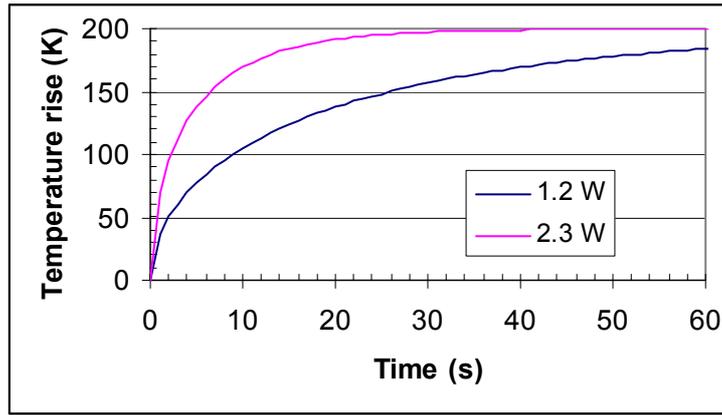
FIG. 2. Heating of a cold junction in a 1 mm² copper wire.

In Figure 2 two limiting curves are calculated using Equation (1) to demonstrate temporal behaviour of a cold junction of a 1 mm² copper wire. For a total temperature rise of 200 K (Equation (1')) 2.3 W is needed if $h = 100$ W/m²K. The final state is reached in about 30 s. Only 1.2 W is needed for the same temperature rise, if $h = 25$ W/m²K, but now more than a minute is needed to reach the final temperature. Generally only 1 ... 12 W is needed to heat a cold junction of a wire of 0.5 ... 4 mm² cross section used in electronics to a temperature able to ignite combustible material nearby. Time constants τ were in the range 5 ... 160 s, respectively.

As shown from Figure 2, the steady temperature is the real indicator of the potential ignition. Therefore, different boundary conditions, like cable insulation, do not change drastically the rate determining factors given in Equation (1'). For that reason no more complicated boundary conditions are attempted for this linear configuration. Two-dimensional configurations with analog dissipating boundary conditions would be interesting, but they were not studied in this project. Of a special interest would be a loose joint between two layers of conductors on different sides of a printed circuit card, where the point like source is imbedded in resin. Since this material of the printed card is combustible and conducts heat badly as compared to metals, it might create a dangerous local hot spot, a potential ignition source. This is in principle the problem of constriction resistance treated widely in old electrotechnical literature.

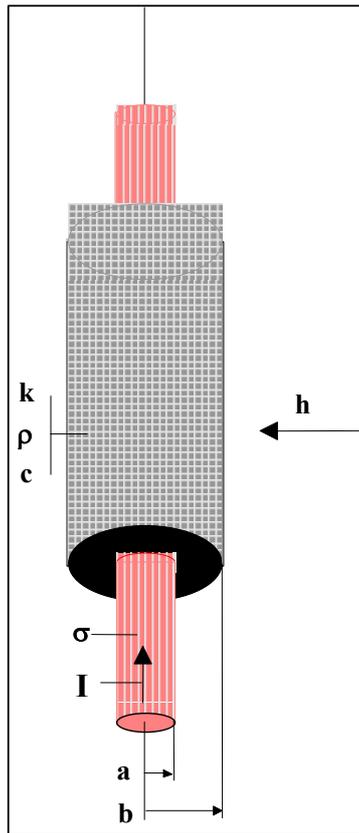
FIG. 3. Geometry and notations of an insulated cable heated by electrical current. a radius of conductor, b radius of cable, k thermal conductivity of cable insulation material, h effective heat transfer coefficient from the surface of cable, ρ density, c specific heat capacity, I electrical current and σ electrical conductivity.

Consider an insulated cylindrical cable carrying a current in a metal conductor with geometry and notations as shown in Figure 3. If the cable is carrying an overload of current, the final temperature T_2 is given by [1]

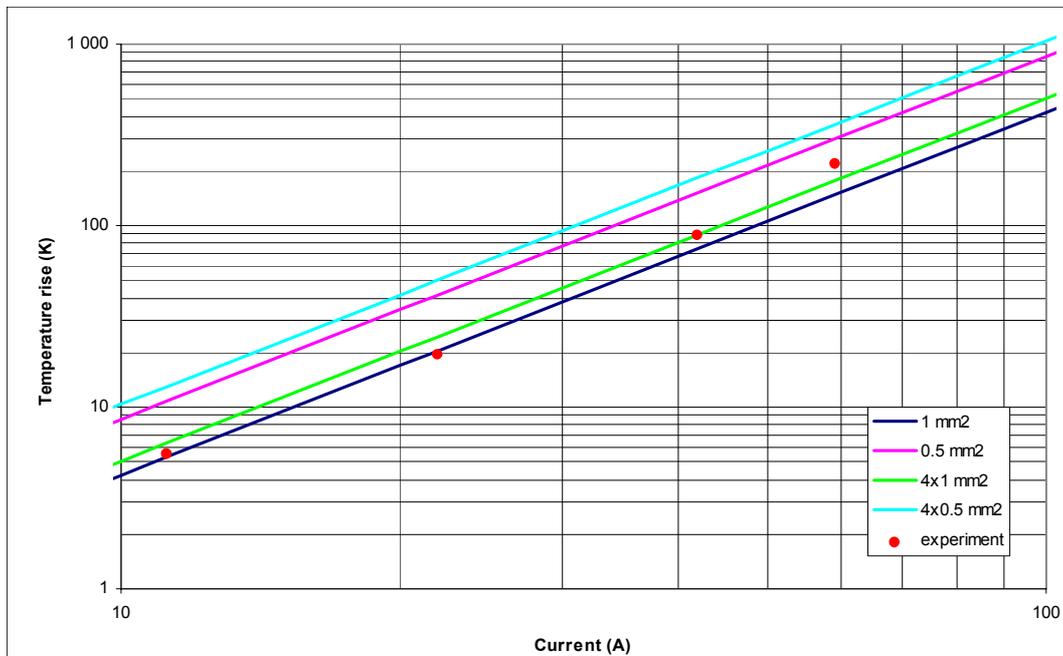
FIG. 4. Heating of cables from overcurrent. Full lines are theoretically calculated maximum temperatures for different types of cables, and the dots experimentally measured data from tests using a $4 \times 1 \text{ mm}^2$ cable [1].

In contrast to cold junctions rather high currents are needed to produce temperatures likely to lead to ignition of combustible insulation material as is shown in Figure 4.

Comparison of theoretical plots with measured points shows rather good agreement. The outcome from these series of experiments was that it is an unlikely mode of ignition. To produce an increase of temperature in excess of 200 K currents of the order of 60 ... 100 A are needed. Since most of the electrical instruments are protected for overcurrents using fuses, they are likely to trip, before high enough heating is obtained.

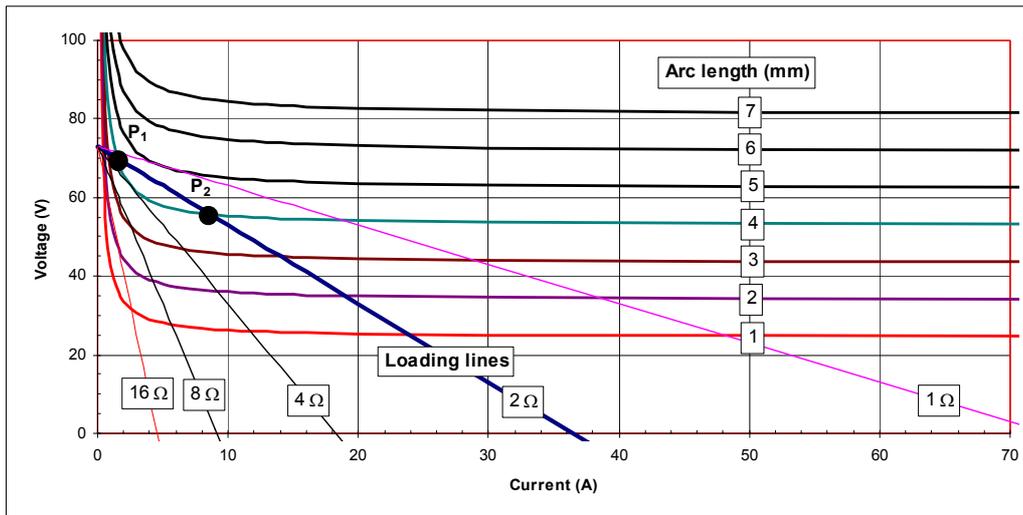
FIG. 5. The voltage of an electric discharge over copper electrode arc gap as a function of current. Crossing points with loading line indicate operating points, where only P₂ is stable [9].

Since the load outside the arc is mainly resistive, the stable points of the arc are determined by plotting a loading line on Figure 5. For zero current the voltage is the battery voltage E , and for zero voltage the current is a short circuit current

In Figure 5 the voltage of the arc is plotted as a function of current for some gap widths of copper electrodes, and indicating some loading lines with given output resistance R_s .

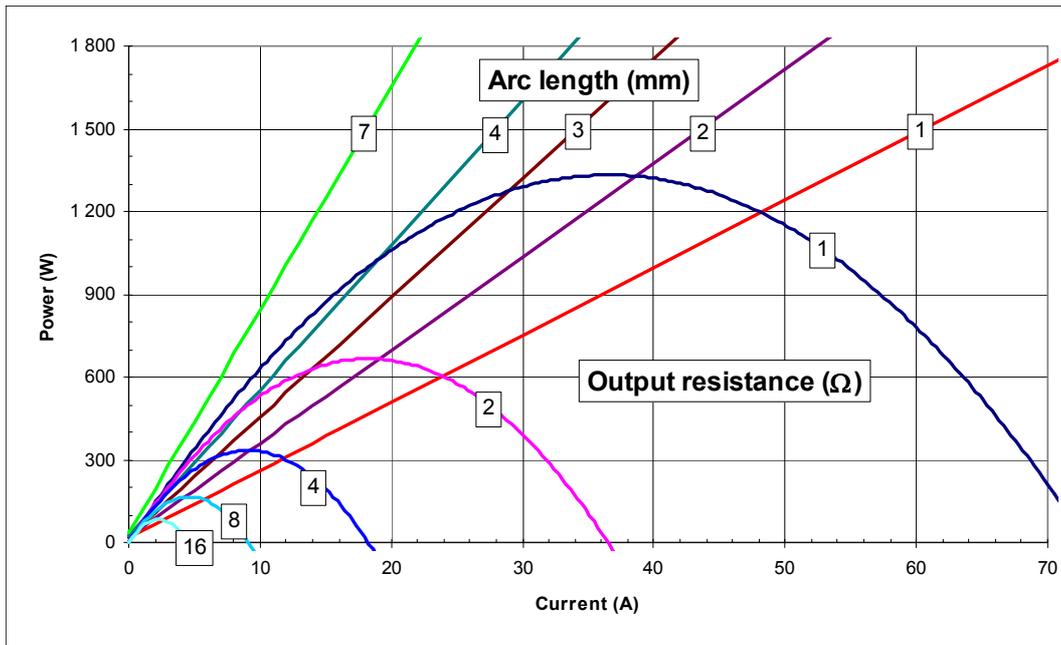
FIG. 6. The power dissipated by an electric discharge over copper electrode arc gap as a function of current for different output resistance of the energy source [1].

In Figure 6 the output power is plotted as a function of spark current using two parameters determined from outside: the spark length l , and power source output impedance (mostly resistive) R_s . The stable operating point (P2 of Figure 5) of an arc of a given length is the crossing point of the arc length line, and output resistance parabola. For example for a 2Ω resistance and 1 mm spark gap the power is 600 W.

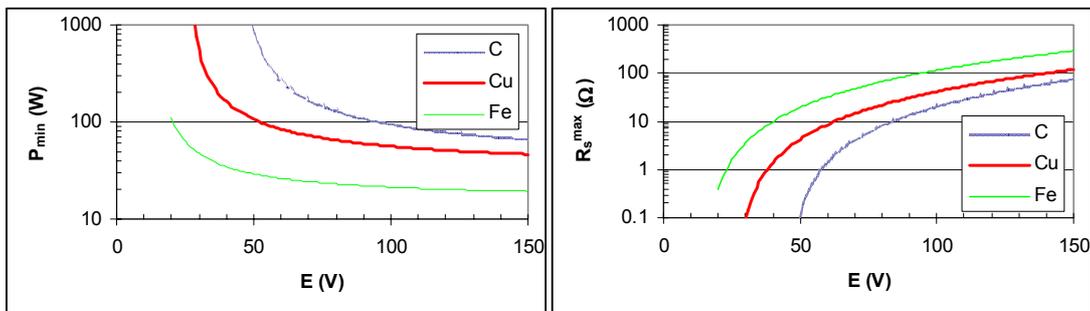
FIG. 7. Dissipated minimum power P_{min} (left), and maximum source impedance R_{smax} (right) as a function of battery voltage E for three different electrode materials.

In Figure 7 minimum power P_{min} (left) and maximum source impedance R_{smax} (right) are plotted as a function of battery voltage E for three different electrode materials. One sees for Figures 6 and 7, that arcs produce intensively heat in a small volume and act as point source ignitors. However, the amount of produced heat might be so big, that a flame is blown off, and no sustained ignition is obtained. This might happen for example in a faulty cable, where the first ignited fuel is the cable insulation. If the output resistance of the power source is properly chosen, the dissipated power reduces so much that favourable conditions for ignition might be created. Figure 7 indicates, that for low battery voltage E , the minimum power tends to be rather high, and is likely to blow off the flame from flammable material surface. For higher battery voltages the power decreases if the source impedance is properly high as given by the right hand plot of Fig. 7. The ultimate minimum value of the dissipated power under any circumstances is the numerical value of Ayrton's parameter γ given in Table 5. Thus the minimum power for a stable spark between copper electrodes is about 32 W. The spark length in millimetre region has practically no effect on the dissipated minimum power.
