Effects of Plasma Interaction with Radiation-Damaged Tungsten

Abstract. 14 MeV-neutrons from DT fusion reaction present a serious concern for materials of the first wall and divertor in a tokamak fusion reactor operating in steady state because of the damage produced in material structure. However, there is lack of information on radiation damage of plasma facing materials and their behavior under plasma impact. This paper is devoted to experimental investigation of tungsten at high level of radiation damage under steady state deuterium plasma. Tungsten is one of the important candidates as plasma facing material for application in ITER and, probably, beyond. The displacement damage of 1-80 dpa was produced in tungsten samples W (99,95% wt) by high-energy alpha particles $^4\text{He}^{2+}$ (3-4 MeV) from accelerator at Kurchatov Institute (cyclotron). The irradiated samples were then studied in deuterium plasma on the LENTA linear divertor simulator. Plasma exposures were made at 250 eV of ion energy and fluence 10^{21} - 10^{22} ion/cm². Erosion dynamics of the damaged surface layer (~6 μm) as well as deuterium retention were studied. Surface modifications have been observed in t

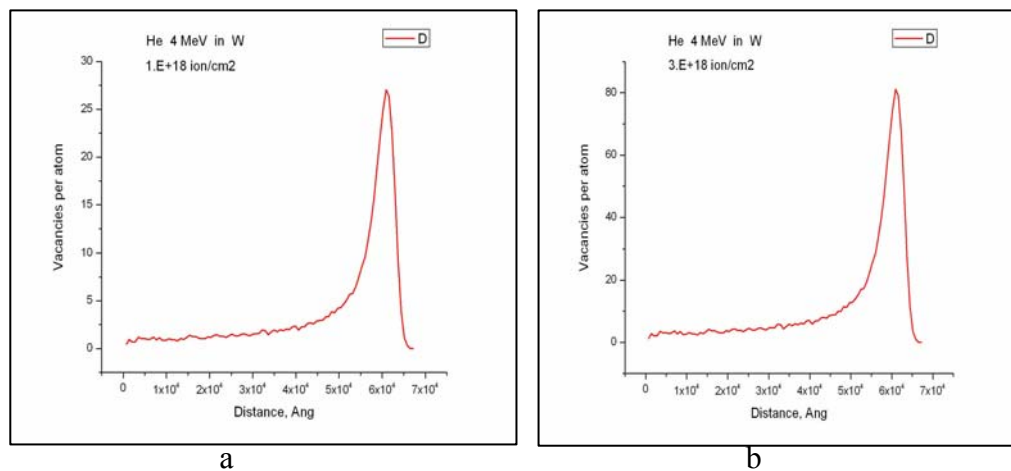
FIG. 1. Primary radiation defects in tungsten produced by 4 MeV alpha particles (${}^4\text{He}^{+2}$) at fluence $\Phi = 10^{18}$ He⁺⁺/cm² (a) and $3 \cdot 10^{18}$ He⁺⁺/cm² (b).

The damages produced so far are concentrated in the surface layer, the depth of the damaged layer being about ion range. In our case, the thickness of the damaged layer was about 6 μm corresponding to accelerated alpha-particles stopping range in tungsten. Distribution of the defects was highly non-uniform. Fig. 1 shows the result of calculation by SRIM program [7] of primary defects distribution in tungsten irradiated by alpha particles at 4 MeV to doses $\Phi = 10^{18}$ He⁺⁺/cm² and $\Phi = 3 \cdot 10^{18}$ He⁺⁺/cm². In the latter case, the average concentration of the produced defects in the damaged layer exceeded 10 dpa.

The following primary defect values were characteristic of the three radiation doses given above $\Phi = 5 \cdot 10^{17}$, 10^{18} and $3 \cdot 10^{18}$ He⁺⁺/cm². The maximal values were 13.5 dpa, 27 dpa, 81 dpa, correspondingly, while average levels over damaged layers were 2 dpa, 4 dpa and 12 dpa. The damage minima were near the surface and these were 0.5 dpa, 0.9 dpa and 2.8 dpa.

The presented data shows that undamaged tungsten has the minimal areal density of the trapped deuterium ($1,6 \cdot 10^{16}$ D/cm²). At the same time two other damaged samples have higher deuterium content. The largest integral deuterium retention $1,7 \cdot 10^{17}$ D/cm² was detected on the sample W-2 ($1 \cdot 10^{18}$ He⁺⁺/cm²), and this value exceeded the retention for the undamaged case by an order. This measurement was made at the erosion depth of about 5 μ m, i.e. close to or in the peak of displacement distribution. The W3 sample had also higher area D content ($(2-2,4) \cdot 10^{16}$ D/cm²) than the non-irradiated W1 but lower than W2. The measurement on W3 was made close to the initial surface of the sample after erosion was stopped at the region where the displacement damage was at a few dpa level (see Fig. 1).

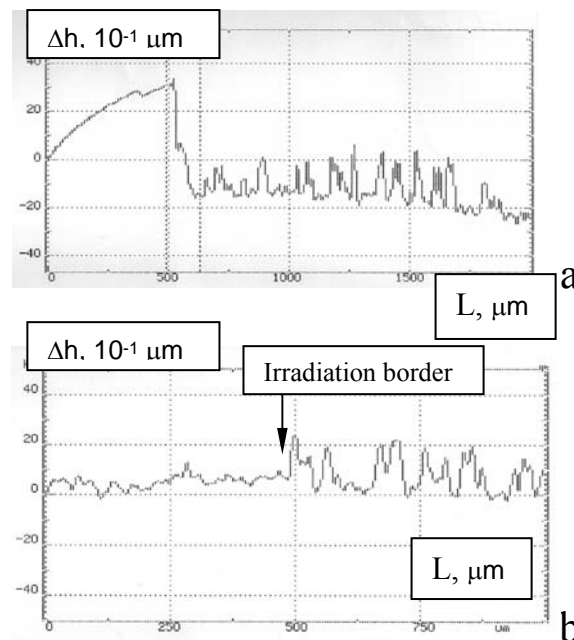
FIG. 4. Surface profile of irradiated tungsten ($10^{18} \text{ a}/\text{cm}^2$) after plasma erosion to depth of the peak damage ($\sim 5 \mu\text{m}$): a – profile at the sample edge (0-500 μm interval was masked from the plasma); b – the region around the border of irradiation; left - undamaged part, right - damaged part.

These observations were further clarified by the measurements of the surface profiles. An example of the profiles taken with profilometer is presented in Fig. 4. These profiles were registered on the sample described above ($1 \cdot 10^{18} \text{ He}^{++}/\text{cm}^2$) on the fourth step of plasma exposure, i.e. approximately at the position of damage maximum when the plasma has eroded about 5-6 μm . A rough structure of spot groups is developed on the surface when erosion comes to the depth of the peak damage (ion range) (Fig. 4a, the part of the curve at 500-2000 μm ; the edge part 0-500 μm was shadowed from irradiation and from the plasma). The plasma exposed part shows the developed profile with the structure elements of about $\Delta h \sim 2 \mu\text{m}$ in height. Fig. 4b shows the same case around the border of irradiated area after 4th exposure to the plasma. Irradiated part of the surface is to the right; undamaged one is to the left. The development of the structure of $\Delta h \sim 2 \mu\text{m}$ high is detected only on the irradiated side of the tungsten.

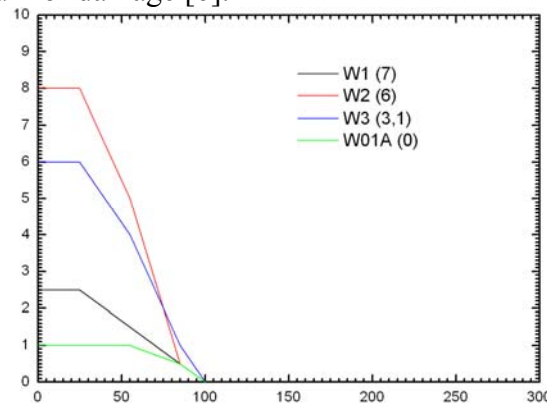
FIG.5. Deuterium concentration in tungsten in four samples: W1 - $\Phi = 5 \cdot 10^{17} \text{He}^{++}/\text{cm}^2$, α +plasma; W2 - $\Phi = 1 \cdot 10^{18} \text{He}^{++}/\text{cm}^2$, α +plasma; W3 - $\Phi = 3 \cdot 10^{18} \text{He}^{++}/\text{cm}^2$, α +plasma; W01A - $\Phi = 1.1 \cdot 10^{18} \text{He}^{++}/\text{cm}^2$, no plasma.

Depth distributions of the trapped deuterium in four damaged tungsten samples are shown in Fig. 5. The fourth sample labeled as W01A was taken for comparison at the state after alpha irradiation to $1,1 \cdot 10^{18}$ He⁺⁺/cm² without plasma processing. The three other samples were subjected to irradiations mentioned in the first section and to the plasma processing. It follows from this graph that deuterium penetration from the plasma into tungsten is about 100 nm in all cases for different damages of the material. On the other hand, the quantity of the retained deuterium depends on the damage level and on the erosion progress stage in plasma exposure

series (erosion depth stage is given in Fig. 5 in brackets in microns). Maximal deuterium uptake was detected on the W2 sample at the stage when erosion came close to the zone of maximal damage (27 dpa) and it was about 8% at. More deep penetration of deuterium was registered around the maximum of damage [6].
