IAEA-CN-155/049

Results of German Investigations on Damage Due to Material Ageing and Corrosion

PLIM, Shanghai, 15 - 18 October 2007

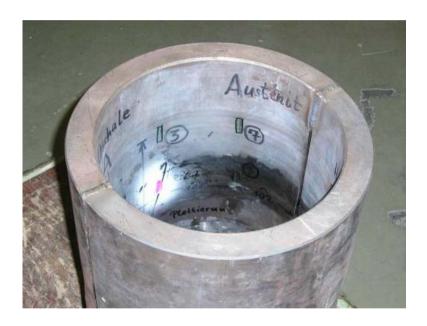
Fig. 4 shows the bi-metallic test specimen, re-welded from half pipes A and B to original pipe shape. The flaw is a crack of about 6 mm depth, generated by genuine intergranular stress corrosion cracking (IGSCC), similar to the well-known SUMMER crack.

FIG. 4. Bi-metallic test specimen (OD 332 mm / 32 mm wall thickness)

The flaw was generated by loading of a half pipe after saw cutting of the test specimen (3-point bending specimen, load 60 tons = 600 kN) with corrosive chemistry on stressed inner surface.
