Life Extension at the Point Lepreau Generating Station - Powering the Future

K. P. Stratton

New Brunswick Power Nuclear Corporation (NBPN)

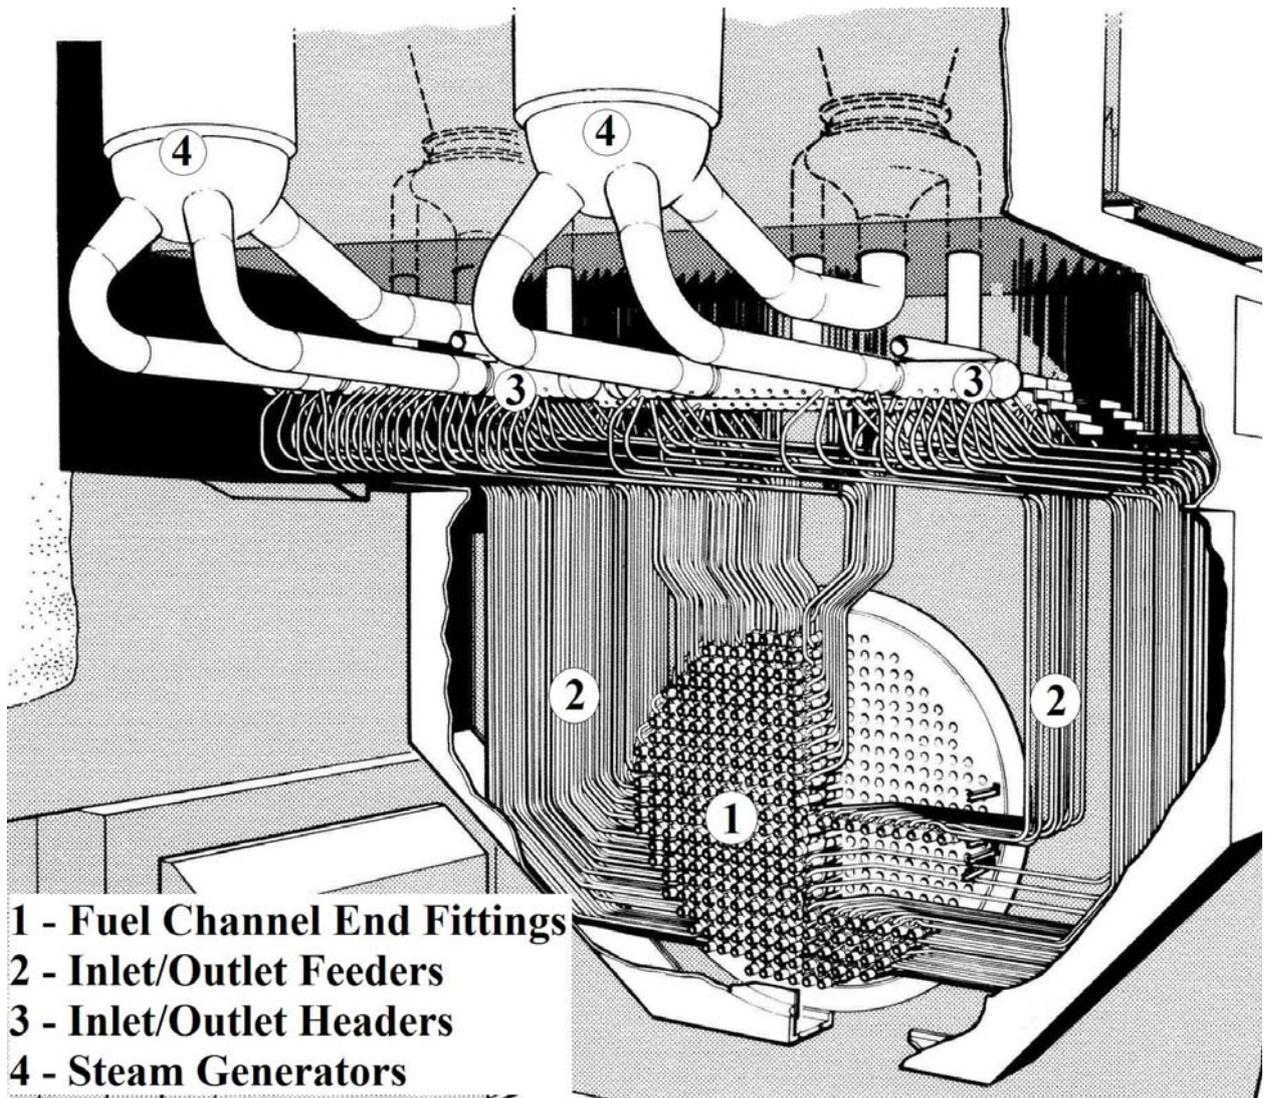
Fig. 1. Layout of the CANDU[®] Reactor Coolant System.

The CANDU 6 is a pressurized heavy water design with 380 individual fuel channel assemblies running horizontally through the reactor core's cylindrical calandria vessel. Each fuel channel is comprised of two concentric zirconium alloy tubes. An inner pressure tube carries the fuel bundles and pressurized reactor coolant and an outer calandria tube separates the heavy water moderator in the calandria vessel from the pressure tube. Four loose spacer springs in the annulus maintain separation between the two tubes in each channel. PLGS has four recirculating steam generators with alloy 800 tubing. Primary reactor coolant is carried between the fuel channels and the steam generating system by 380 SA 106B carbon steel feeder pipes and four headers, each for inlet and outlet flow. Figure 1 shows a schematic view of one reactor face and the general feeder piping system layout, with the insulation cabinet removed. Figure 2 is a schematic of the reactor assembly showing the fuel channel configuration. The current steam generators will remain in service for a total expected operating life of about 55 years.

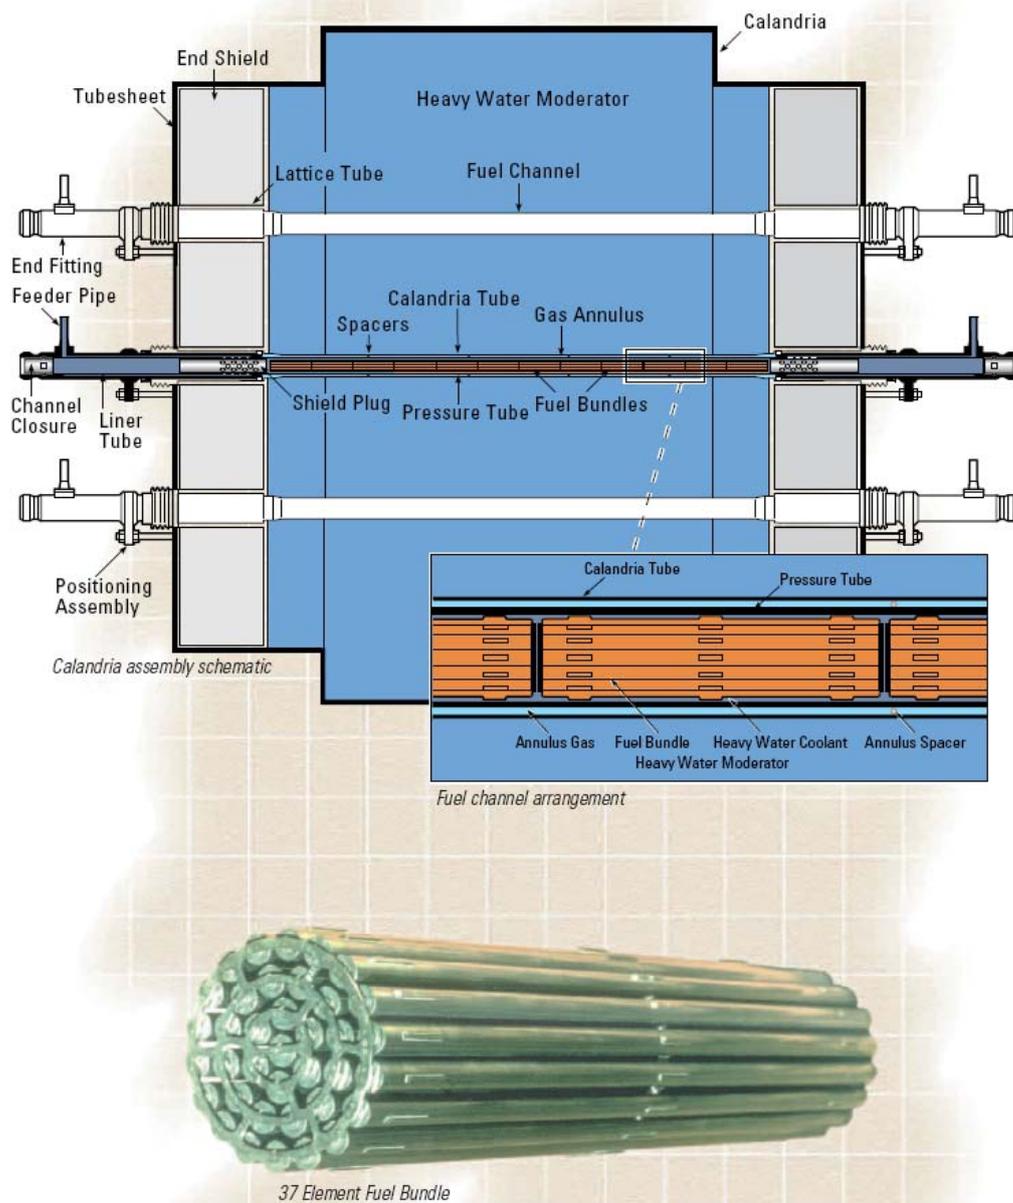
Fig. 2. CANDU[®] Reactor assembly
