IAEA-TECDOC-1762/Rev. 1

Operating Experience from Events Reported to the IAEA Incident Reporting System for Research Reactors

International Atomic Energy Agency

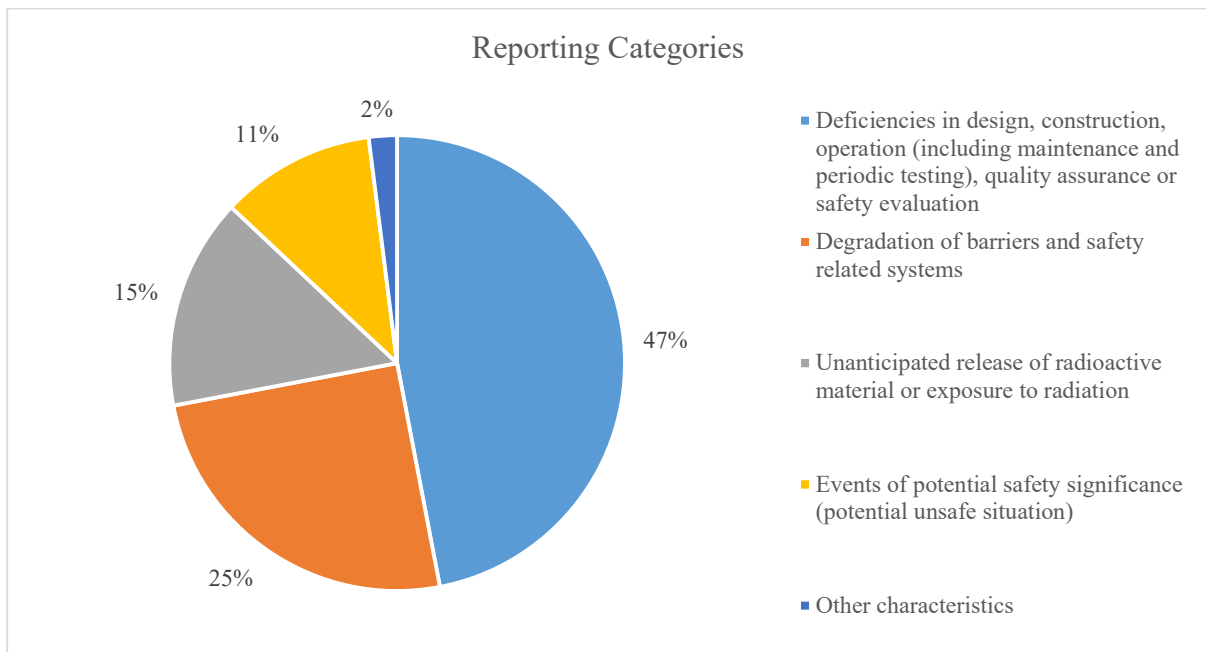
Among the events analysed, the largest number of events (47%) were reported in the reporting category of ‘deficiencies in design, construction, operation (including maintenance and periodic testing), quality assurance or safety evaluation, including experimental devices and isotope production facilities’, followed by ‘degradation of barriers and safety related systems (including experimental devices and isotope production facilities important to safety)’ (25%). About 15% of the events were reported in the category of ‘unanticipated releases of radioactive material or exposure to radiation’, 11% of the events were reported in the category of ‘potential safety significance (potential unsafe situation)’, and 2% of the events were reported in other categories, which includes ‘generic problems of safety interest’, and ‘effects of unusual external or internal events’. Figure 2 shows the distribution of events based on the reporting category.

FIG. 2. Distribution of the analysed events among reporting categories.

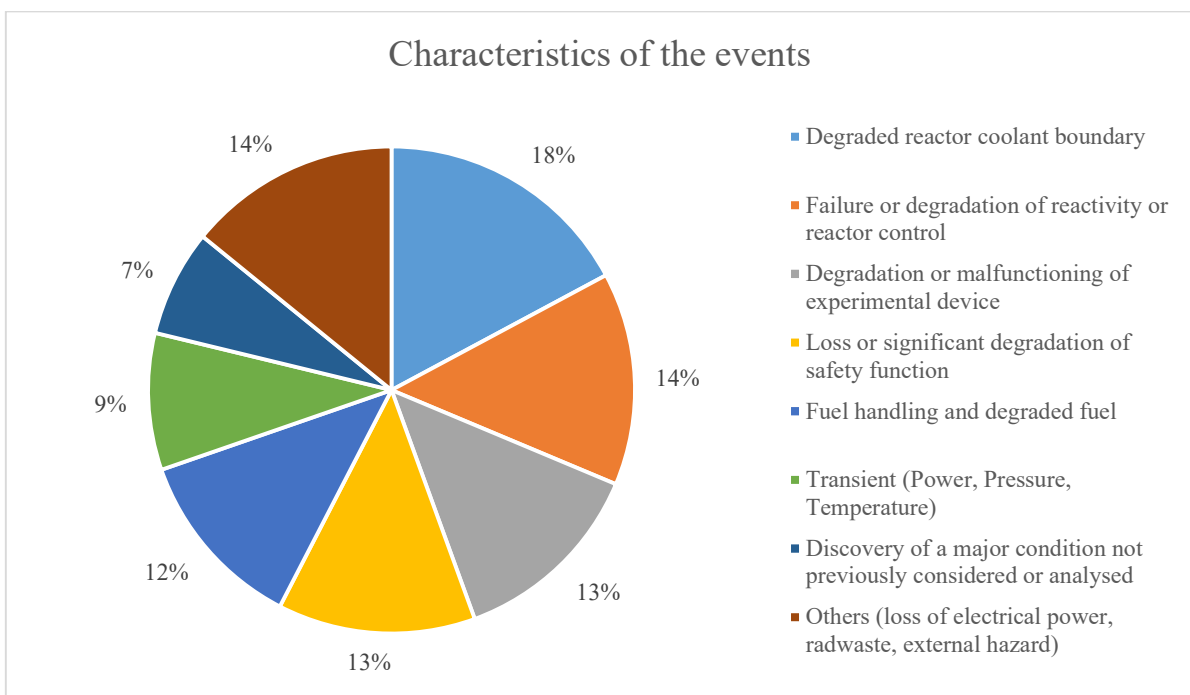
- b) The analysis of the event reports showed the following grouping according to the characteristic of events: The largest number of events resulted in ‘degradation of the reactor coolant boundary’ (18%), followed by failure or degradation of reactivity or reactor control (14%), ‘other characteristics’, which include events related to radioactive waste, loss of electrical power, and external hazards (14%), degradation or malfunctioning of experimental device (13%), loss or significant degradation of safety function, which includes degradation of reactor containment or confinement, and failure or significant degradation of heat removal capability (13%), fuel handling and degraded fuel (12%), ‘transient’, which includes reactor power, pressure, or temperature transients (9%), and finally, ‘discovery of a major condition not previously considered or analysed’ (7%). Figure 3 shows the distribution based on the characteristics of the events.

FIG. 3. Distribution of the analysed events based on the characteristics of the event.

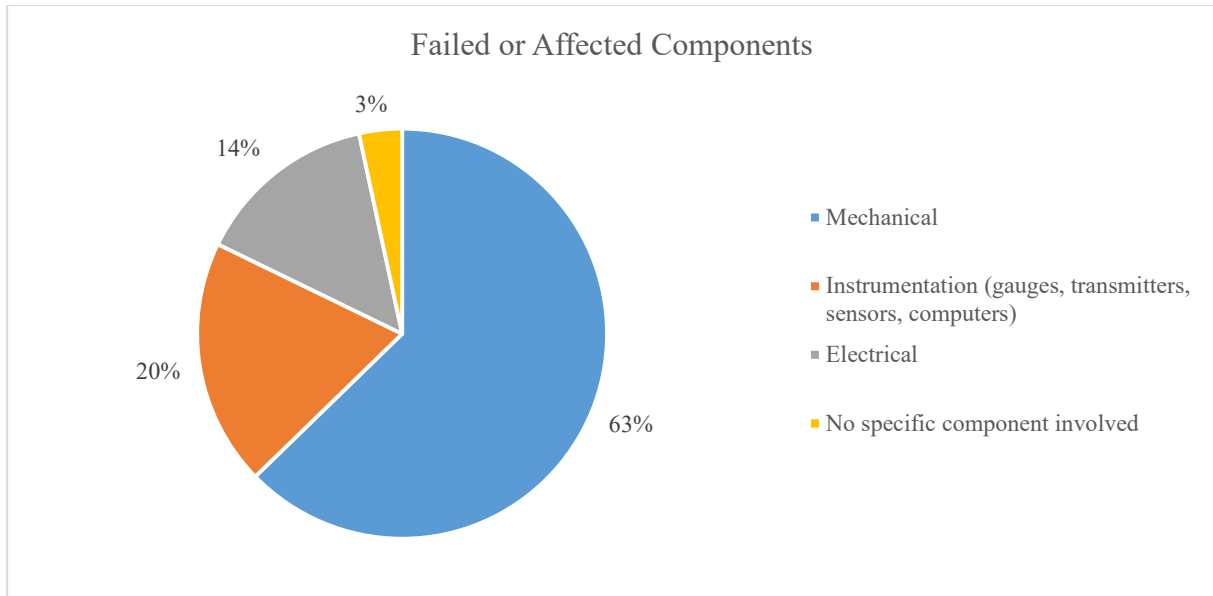
- c) The analysis of the events showed that mechanical components (63%) were the most affected components of research reactors, followed by instrumentation (gauges, transmitters, sensors, and computers) (20%) and electrical components (14%). In (3%) of events, no specific component was involved. Figure 4 shows the distribution of failed or affected components.

FIG. 4. Distribution of the analysed events among failed or affected components.

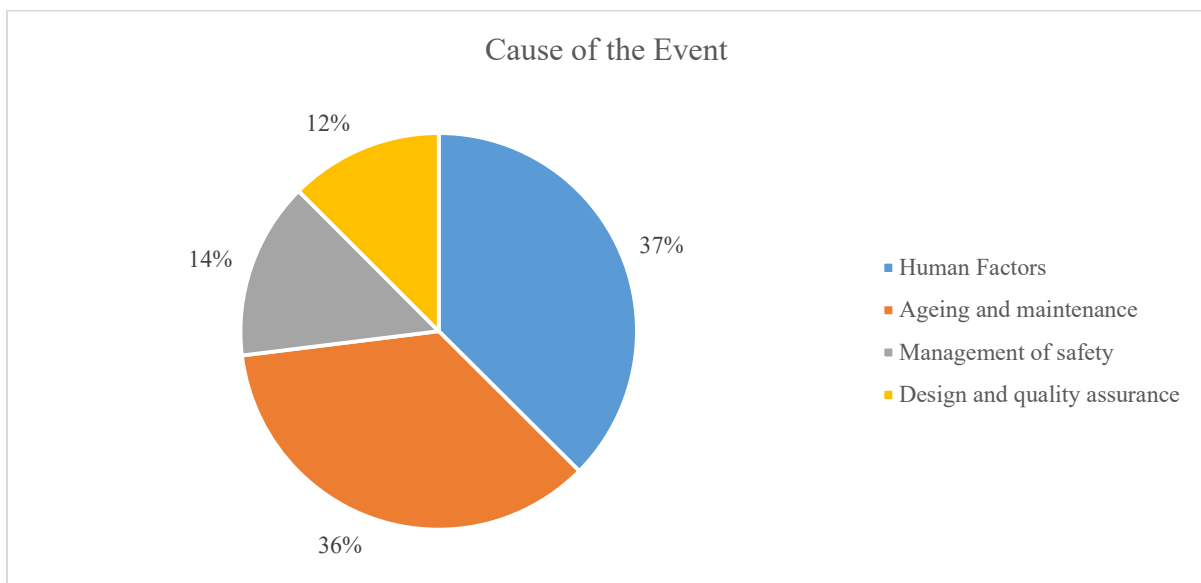
- d) The analysis of the causes of events showed that the leading root causes of events were 'human factors', including inadequate or ineffective use of procedures, inadequate training, and errors of omission and commission (37%), and 'ageing of structures, systems and components (SSCs) due to corrosion, fatigue, crack, vibrations, and obsolescence, or deficiencies in maintenance' (36%). Other important contributors were related to deficiencies in 'management of safety' including lack of safety culture and inadequate management system (14%), and inadequate 'design and quality assurance', including control of modifications and utilization projects (12%). Figure 5 shows the distribution of root causes for the analysed events.

FIG. 5. Distribution of the analysed events based on the cause of events.
