# Defueling TMI-2

Russ Green

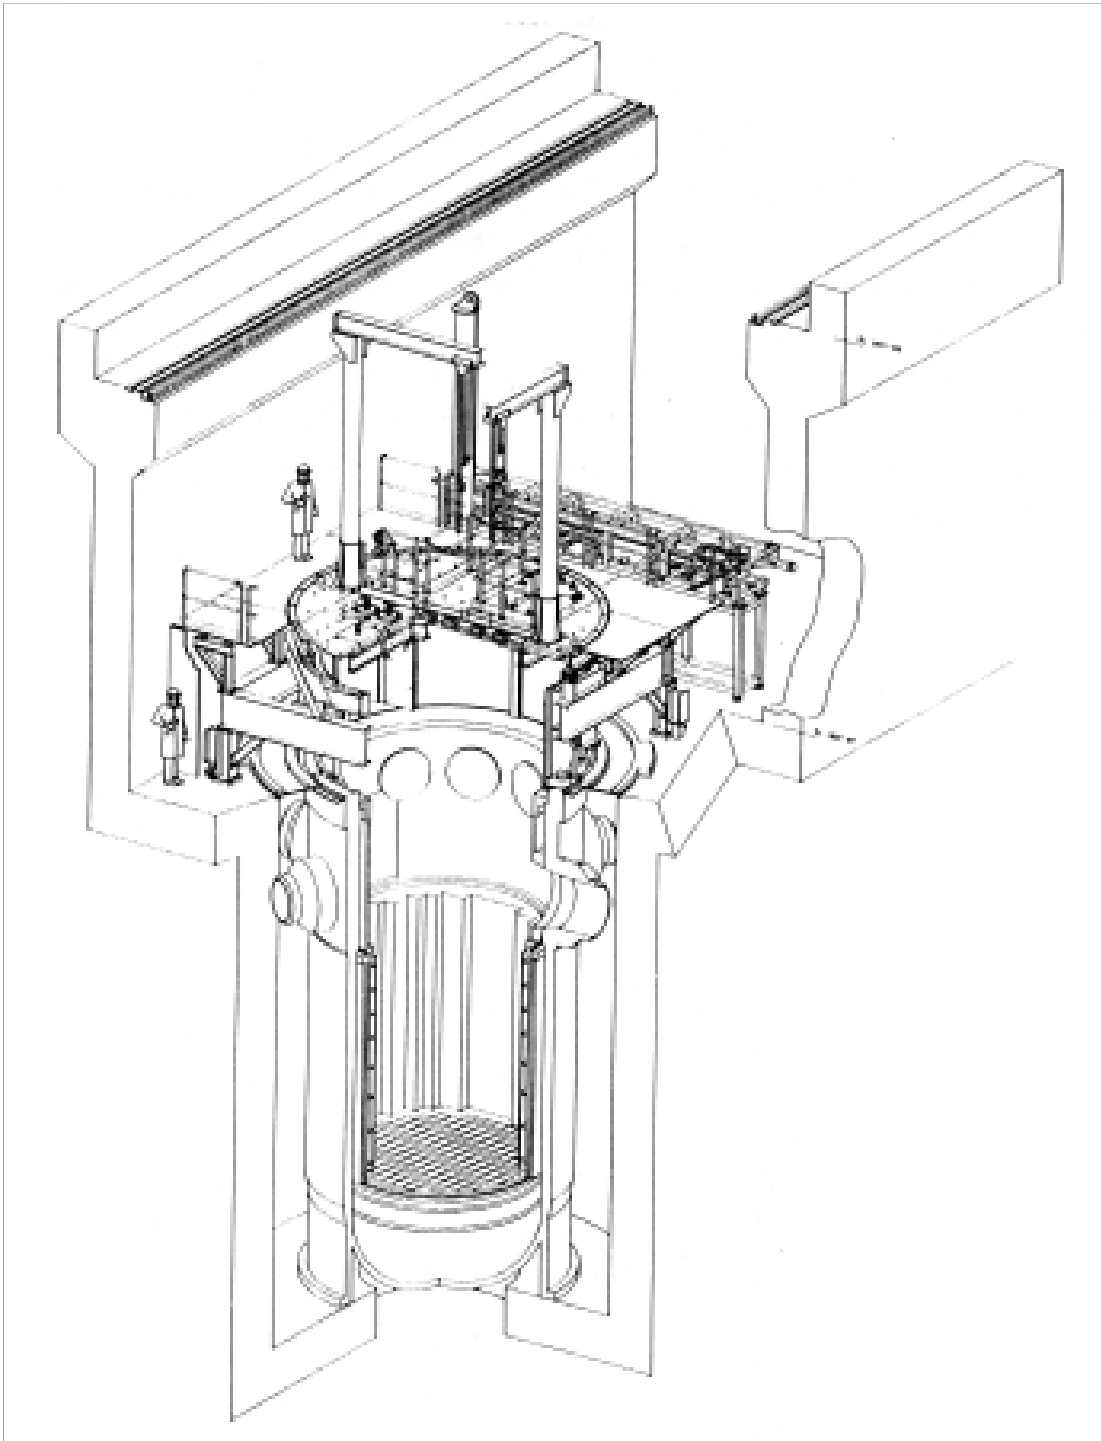
# Work Platform

Internals Indexing Fixture  
Rotating Work Platform  
Rotating Service Platform

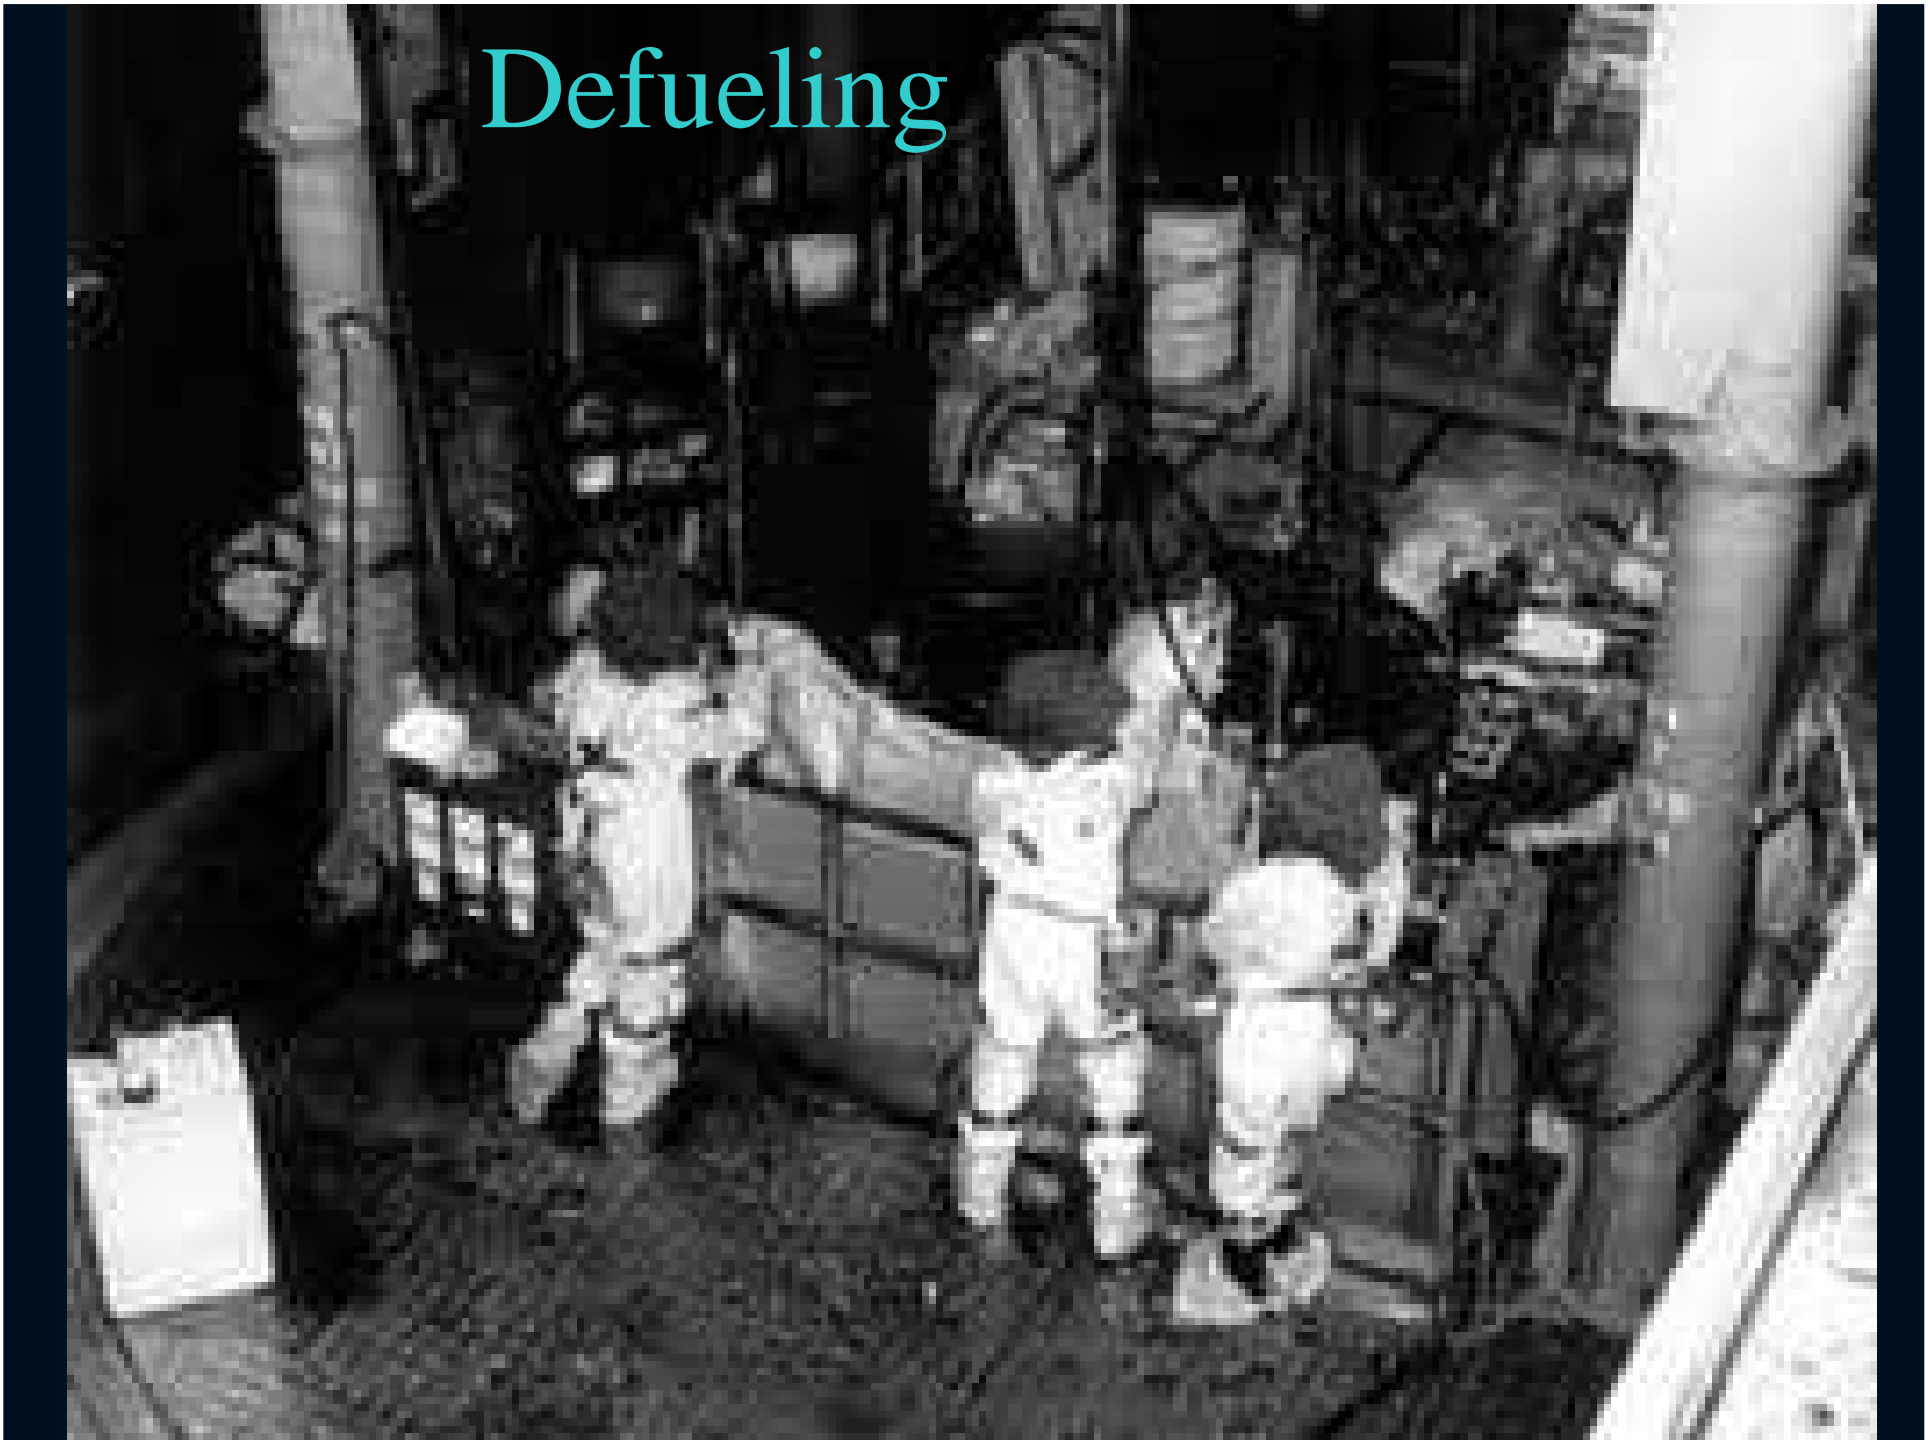
# Defueling

Key:

A: Camera Operator

B: Tool Operator

C: Crane Operator

D: Probably the Camera Controller acting as an assistant to the Tool Operator

E: Radiation Control Technician

F: Step Stool for disconnecting tools from the jib crane when tied off in the slot

G: Hydraulic control skid used to power long handled tools.

H: Long Handled tool tied off in the slot

I: Step off pad to the Defueling Water Cleanup equipment.

J: Small Long Handled tools tied off in the slot

K: Long Handled tools tied off along the fuel canal wall

L: Monitor console

M: Rack containing disposable booties and gloves

N: Unknown but may be a container of discarded booties and gloves awaiting transfer

O: Camera control console and radio repeater equipment

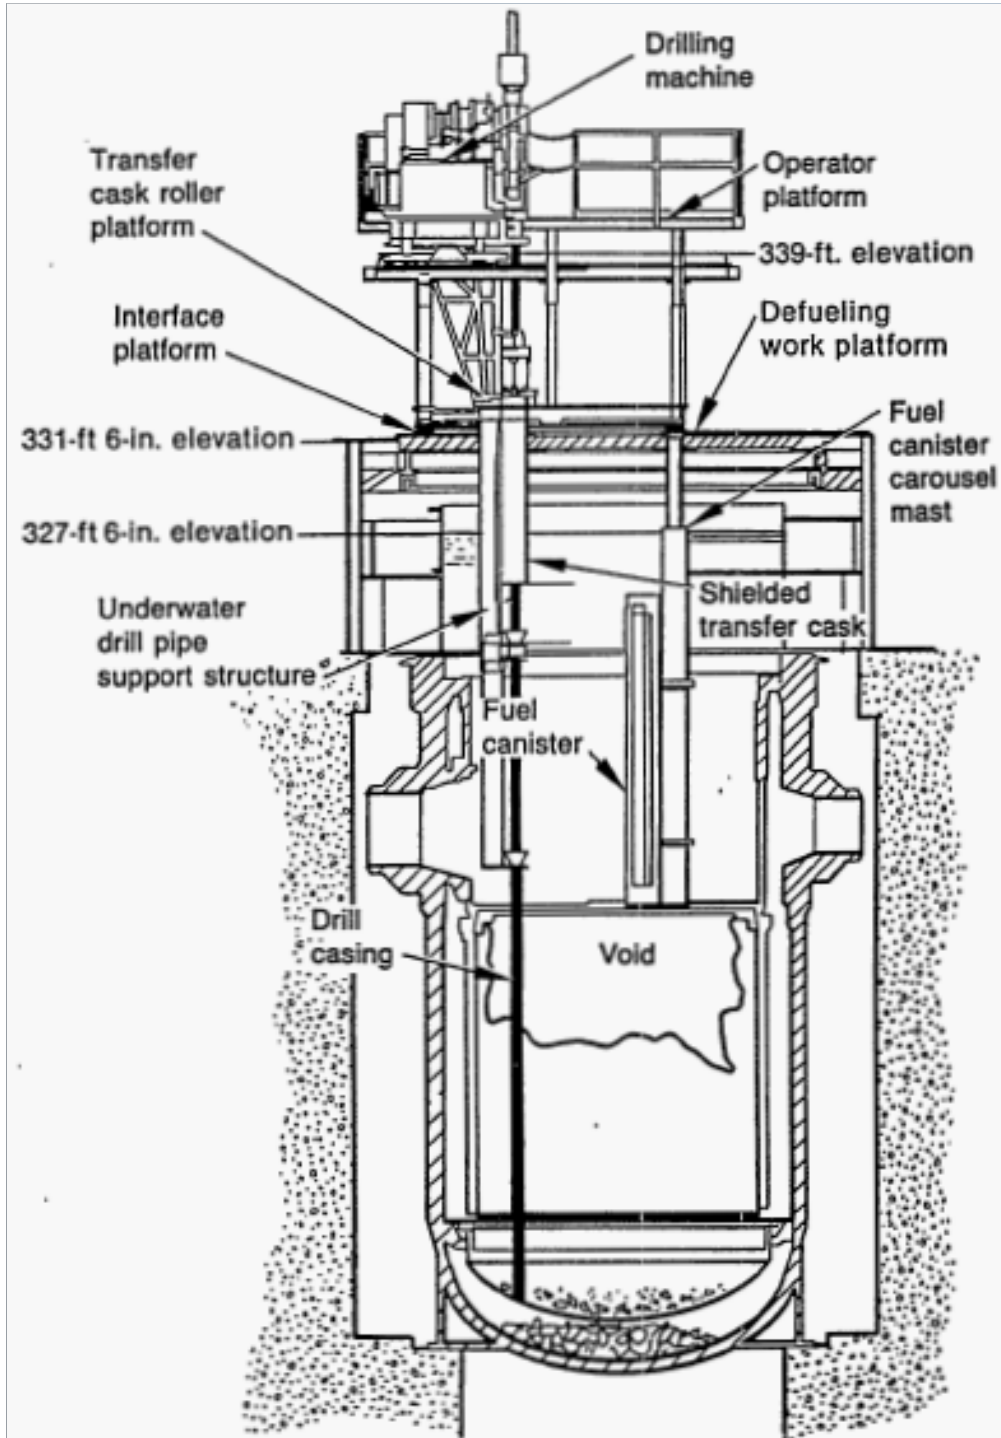
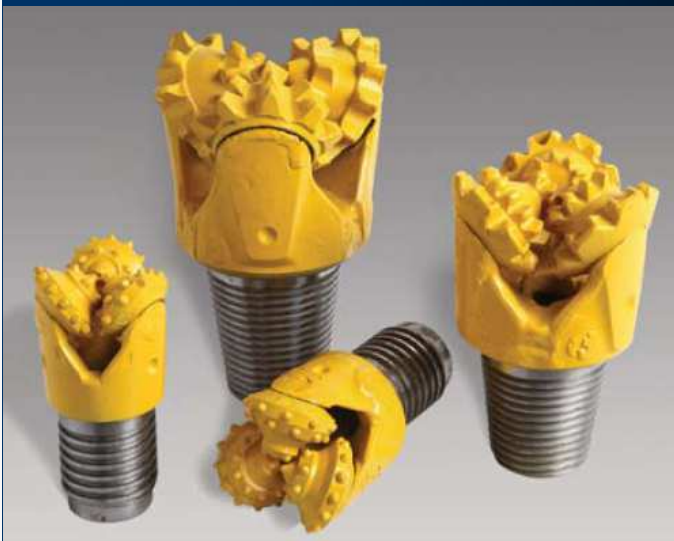
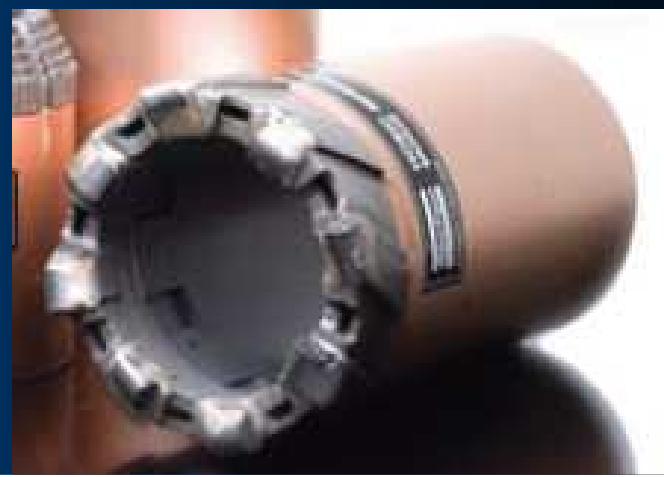
# Core Bore

Data for Accident Analysis

Monolith Break up

Tungsten Carbide Teeth with Synthetic Diamond

- Adapted from commercial mining drilling equipment
- One of the most important machines for the project
- First use with hollow core bits: 10 samples 1.8 m long x 6.4 cm diameter (figure below)
- Second use with solid face bits to chew through the hard once-molten mass in the core region
- Third use was assisting lower grid and instrument tubes by grinding metal (next viewgraph)

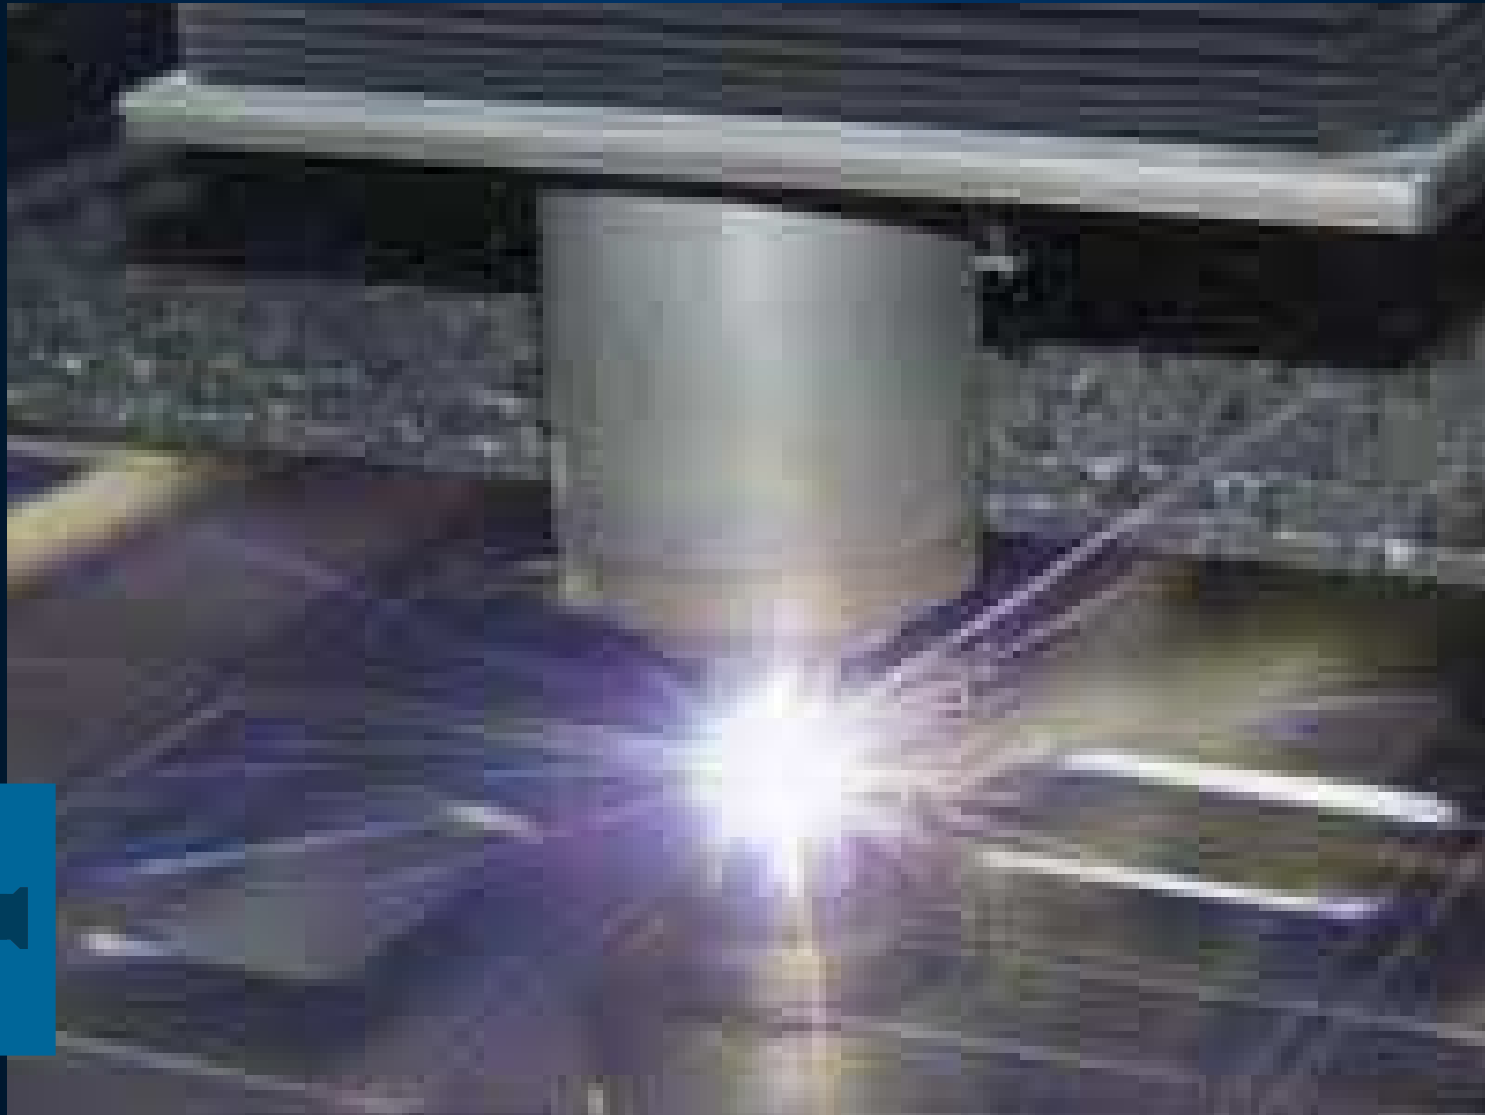
## Underwater Plasma Arc Cutter

# Internals Cut Out
