## Comprehensive First Mirror Test for ITER at JET with Carbon Walls

**Abstract.** Metallic mirrors will be essential components of all optical spectroscopy and imaging systems for plasma diagnosis that will be used on the next-step magnetic fusion experiment, ITER. Any change of the mirror performance, in particular reflectivity, will influence the quality and reliability of detected signals. On the request of the ITER Design Team, a First Mirror Test (FMT) has been carried out at JET during campaigns in 2005-2007 and 2008-2009. To date, it has been the most comprehensive test performed with a large number of test mirrors exposed in an environment containing both carbon and beryllium; the total plasma time (in 2005-2007 period) over 35 h including 27 h of X-point operation. 32 stainless steel and polycrystalline molybdenum flat-front and 45° angled mirrors were installed in separate channels of cassettes on the outer wall and in the Mk-II HD divertor: inner leg, outer leg and base plate under the load bearing tile. Post exposure studies comprised reflectivity measurements and surface analyses with microscopy, secondary ion mass spectrometry, ion beam analysis and energy dispersiv

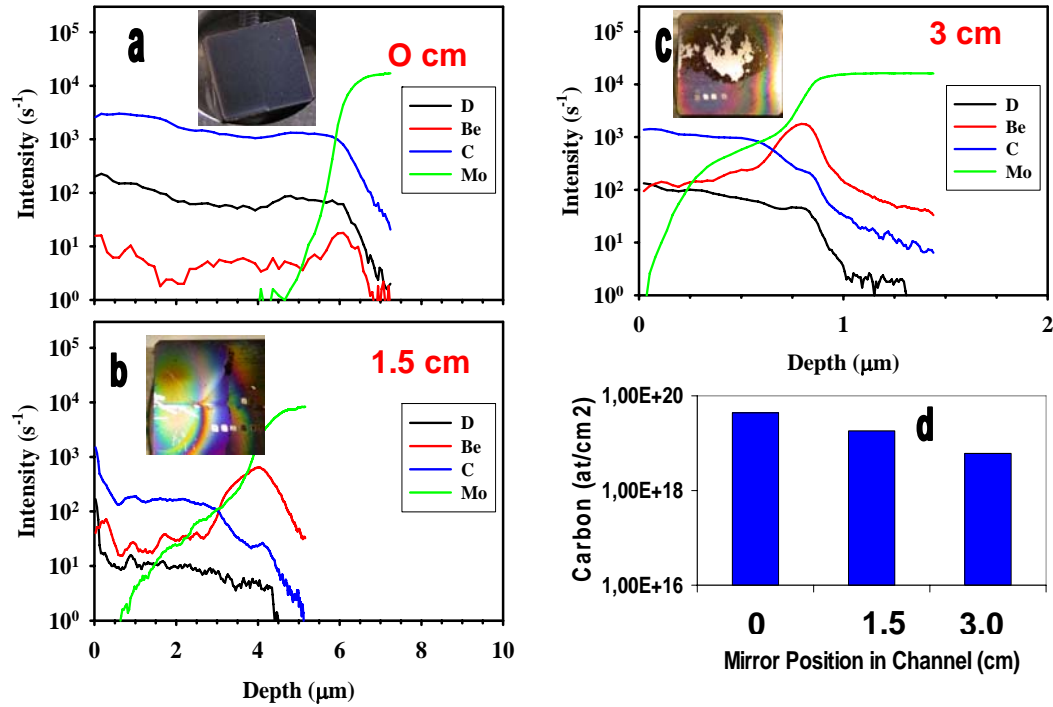
FIG. 3. Surface composition and thickness of deposits on Mo mirrors from the outer divertor: SIMS depth profiles and total carbon content in films measured with EPS.

SIMS and IBA results are shown in graphs on Fig. 3 (a-c) and (d), respectively for Mo mirrors from the outer divertor leg. From the SIMS plots one infers the qualitative composition of the films (carbon, deuterium and beryllium) and the layer thickness of approximately 6.5, 4 and 0.85  $\mu\text{m}$  on mirrors located 0; 1.5 and 3 cm from the front of the channel, respectively. The interface between the Mo substrate and the layer is not perfectly sharp especially in the case of thinner films, i.e. on the mirrors located at 1.5 and 3 cm in the channels. It is an indicator of material mixing during the layer formation. One may assume that the arriving flux of neutral carbon and small quantities of beryllium atoms caused sputter

erosion of the Mo surface. As a result, these erosion products and the arriving species were deposited together on the mirror surface. The formation of carbides on the interface cannot also be excluded but SIMS and IBA do not permit conclusive statements on that matter. Quantitative EPS measurements plotted in Fig. 3 (d) show that the carbon films contain  $4.3 \times 10^{19}$ ,  $1.8 \times 10^{19}$  and  $0.6 \times 10^{19}$  C at  $\text{cm}^{-2}$ , thus corresponding to 6.6, 3.0 and 1.0  $\mu\text{m}^3$ , respectively. Assuming the deposit density of about  $1.3 \text{ g cm}^{-3}$  equal to  $6.5 \times 10^{22}$  C at  $\text{cm}^{-3}$  [12] the agreement between SIMS and IBA results is nearly perfect; some discrepancies may be attributed to the non-uniformity of the layer thickness especially due to flaking of the deposits, as can be seen in the image inserted in Fig. 3 (c). The beryllium content in these films is in the level from  $5 \times 10^{17}$  to  $1 \times 10^{18} \text{ cm}^{-2}$ , i.e. a few atomic per cent.

The results in Fig. 3 are representative for all divertor samples: deposition decreases with the depth in the channel. An opposite trend is characteristic for mirrors from the main chamber wall, where very small amount of deposited species is detected on the mirrors located near the channel mouth (e.g. only  $1.3\text{-}1.5 \times 10^{17}$  C at  $\text{cm}^{-2}$  on the three front sample at 0 and 1.5 cm), but thicker deposits are found deeper in the channel at 3 and 4.5 mm. Thus, IBA and SIMS data confirm the general observation from the visual inspection. Moreover, the data obtained for the front mirrors (i.e. located at 0 cm) in the divertor agree qualitatively with the deposition pattern observed on the sensors of quartz microbalance (QMB) devices installed in the vicinity of the mirrors: most significant deposition in the inner divertor, less deposition in the outer leg [13]. Only limited comparison can be made because the QMB crystals were exposed to selected discharges, whereas the mirrors were facing plasma continuously during all operation scenarios.
