IAEA-TECDOC-1316

Effects of radiation and environmental factors on the durability of materials in spent fuel storage and disposal

INTERNATIONAL ATOMIC ENERGY AGENCY

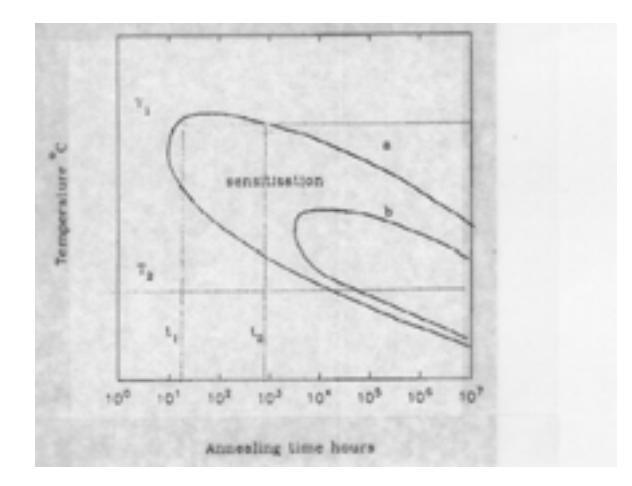
Figure A1 Sensitisation fields in both high (a) and low (b) C+N stainless steel.

Considering the sensitization field for the high carbon and nitrogen steel, shown in Fig. A1, an isothermal exposure to time t, at temperature T, leads to chromium-rich precipitate formation and chromium depletion at grain boundaries. This metallurgical condition persists

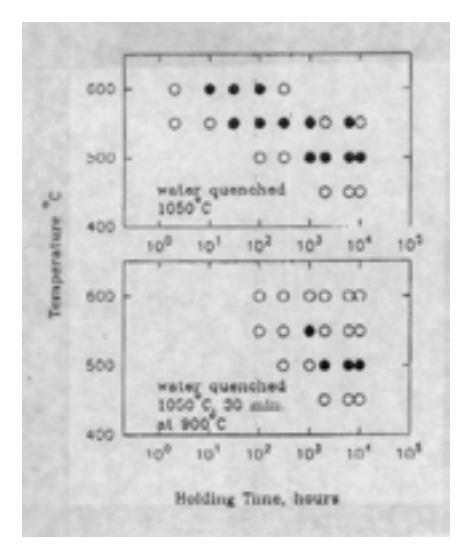
Figure A2 Influence of heat treatment on sensitisation of 18/8 stabilized stainless steel containing 0.059C and 0.32Ti.

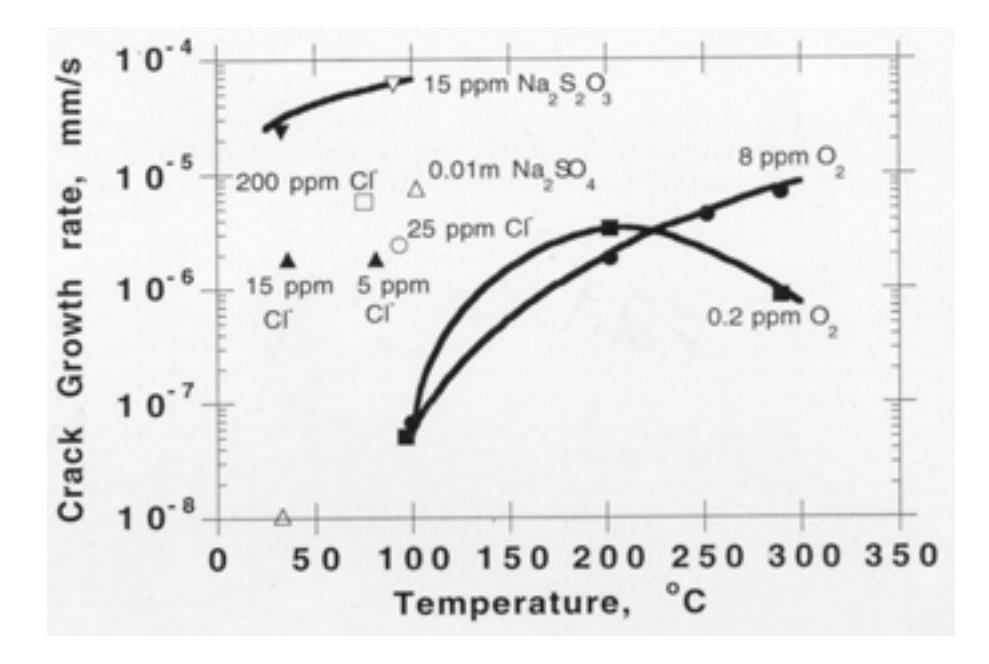
Figure 1. The temperature dependence of crack growth rate as compiled by Jones and Henager [13] for sensitized steel. The curves labelled for oxygen content are obtained in deionized water. The addition of sulfates and chlorides is seen to increase the rates.

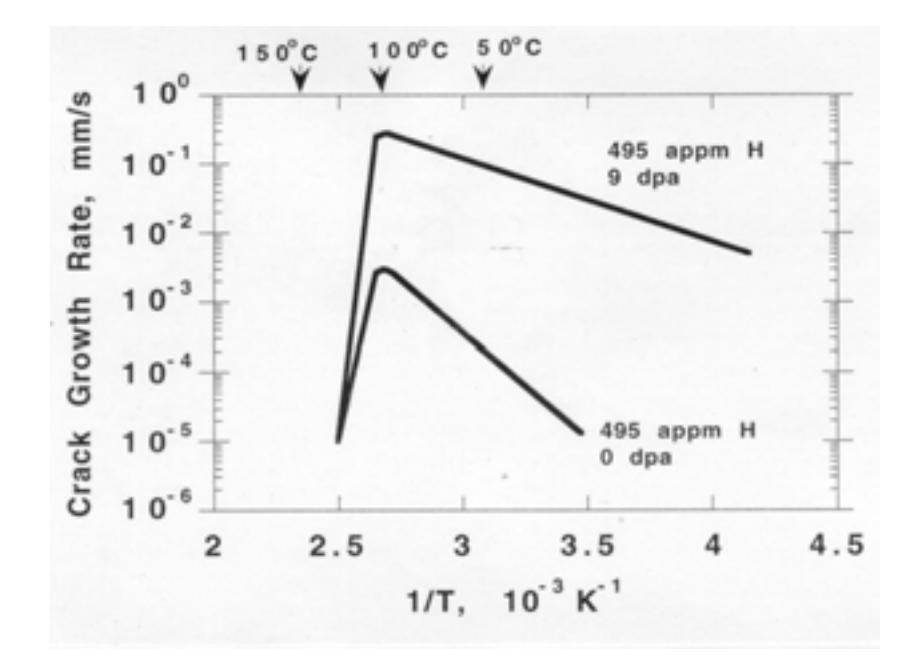
Figure 2. Temperature dependence of predicted hydrogen-induced crack growth [17].

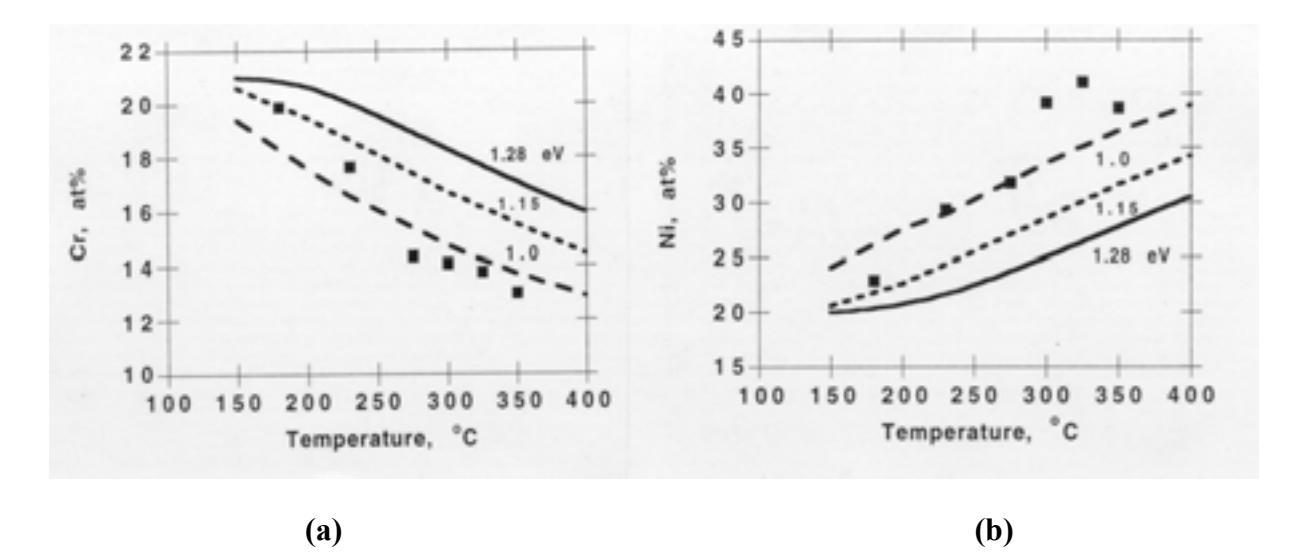
Figure 3. The temperature dependence of measured and predicted grain boundary concentrations of (a) chromium and (b) nickel, induced by ion irradiation at 10 dpa.

Temperature dependencies of the measured grain boundary chromium and nickel concentrations are illustrated in Fig. 3. RIS is not effectively suppressed at 10 dpa until temperatures are lowered below 300°C. Model predictions of grain-boundary chromium and nickel concentrations are also shown in Fig. 3. The effect of the assumed vacancy migration energy is demonstrated. A value of 1.28 eV [26] is commonly assumed for austenitic alloys,

although annealing measurements on SSs indicate 1.17 eV [27]. In the present analysis, 1.15 eV is considered a reasonable estimate based on defect physics experiments [27]. A value of 1.0 eV is included to illustrate sensitivity to lower values of the vacancy migration energy and indicate the value for a better empirical fit to the RIS measurements. The damage efficiency for producing freely migrating defects by nickel ions is expected to be a few percent [28], and 3% is used in Fig. 3.

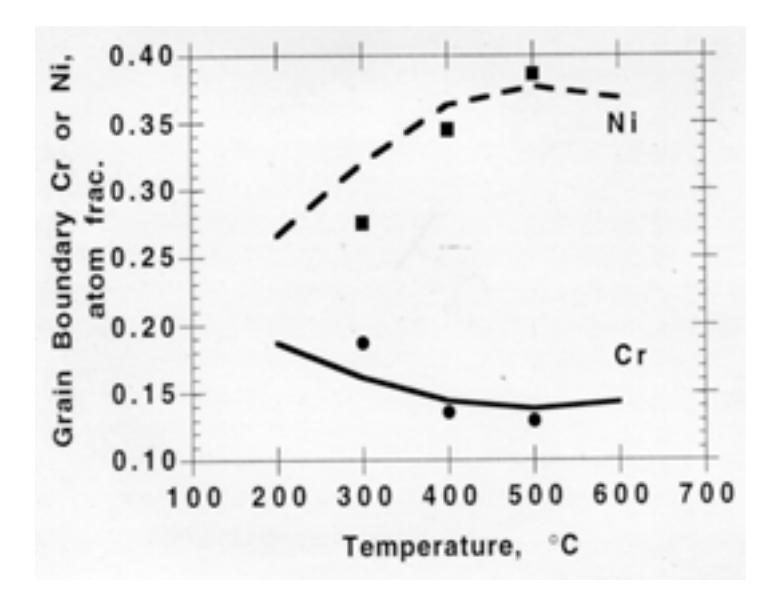
Figure 4. The temperature dependence of grain boundary concentrations of chromium and nickel induced by proton irradiation at 0.5 dpa.

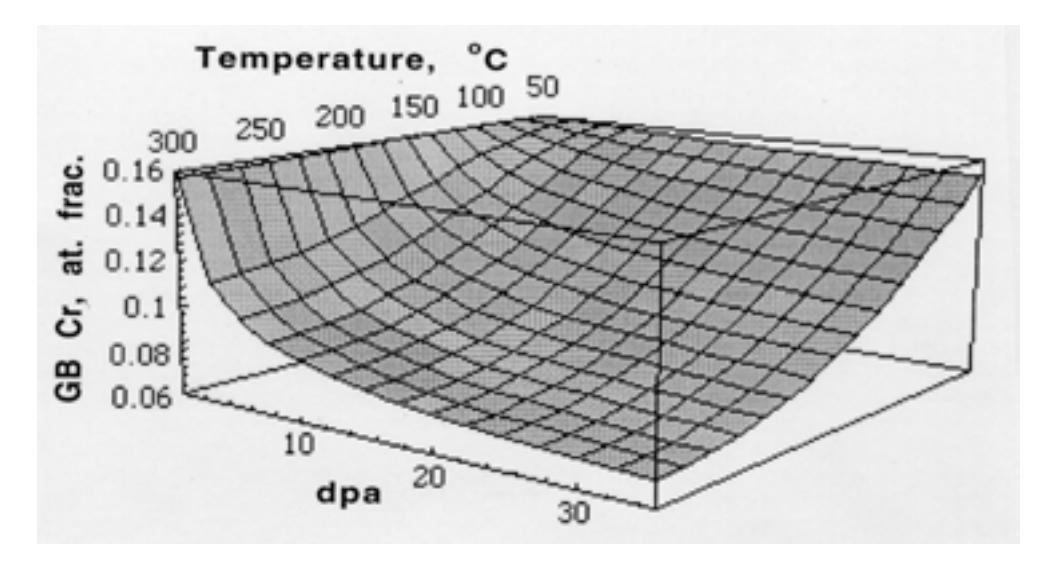
Figure 5. Predicted grain boundary concentrations of chromium for neutron irradiation for a damage rate of 3×10^{-7} dpa/s.

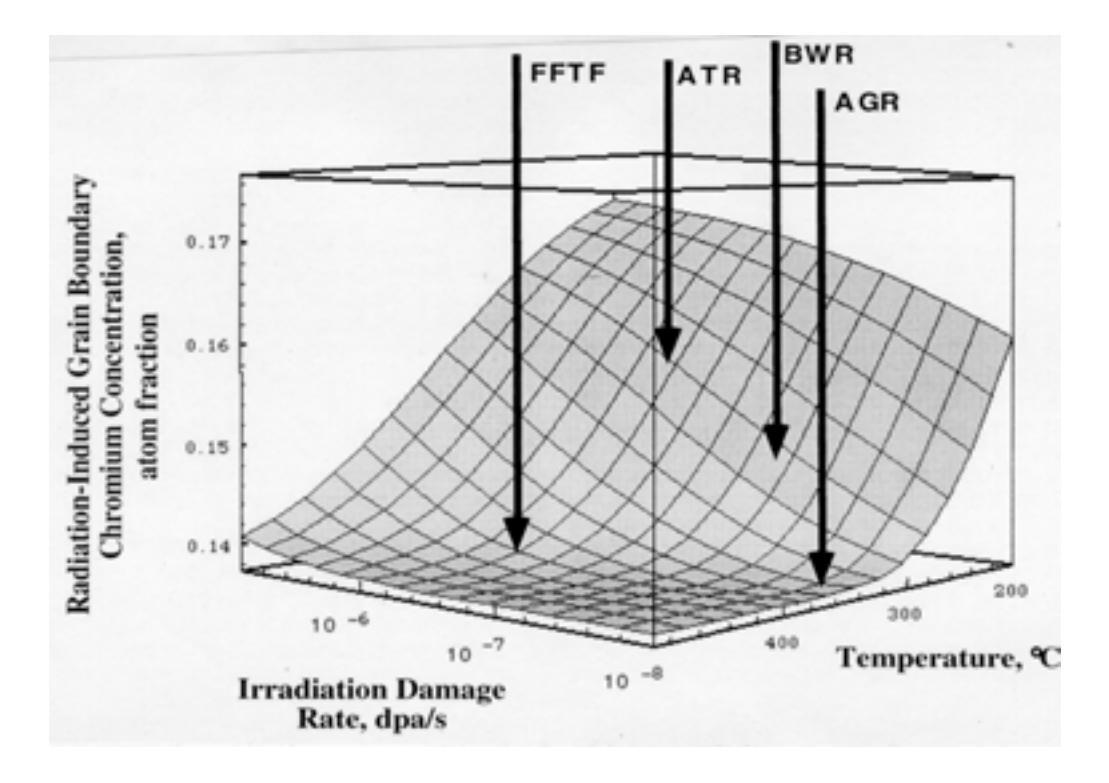
Figure 6. Effect of damage rate and temperature on predicted grain boundary concentrations of chromium at 1 dpa.

The effect of radiation from different reactors is shown in Fig. 6 for the Fast Flux Test Facility (FFTF) reactor, advanced test reactor (ATR), BWR, and AGR. RIS induced during LMR exposure such as in FFTF is more than that for the BWR exposure because of a higher irradiation temperature. Similarly, the AGR exposure produces more RIS because of a higher temperature and a lower damage rate compared to the BWR condition. The ATR produces the least RIS because of the high damage rate and low irradiation temperature.

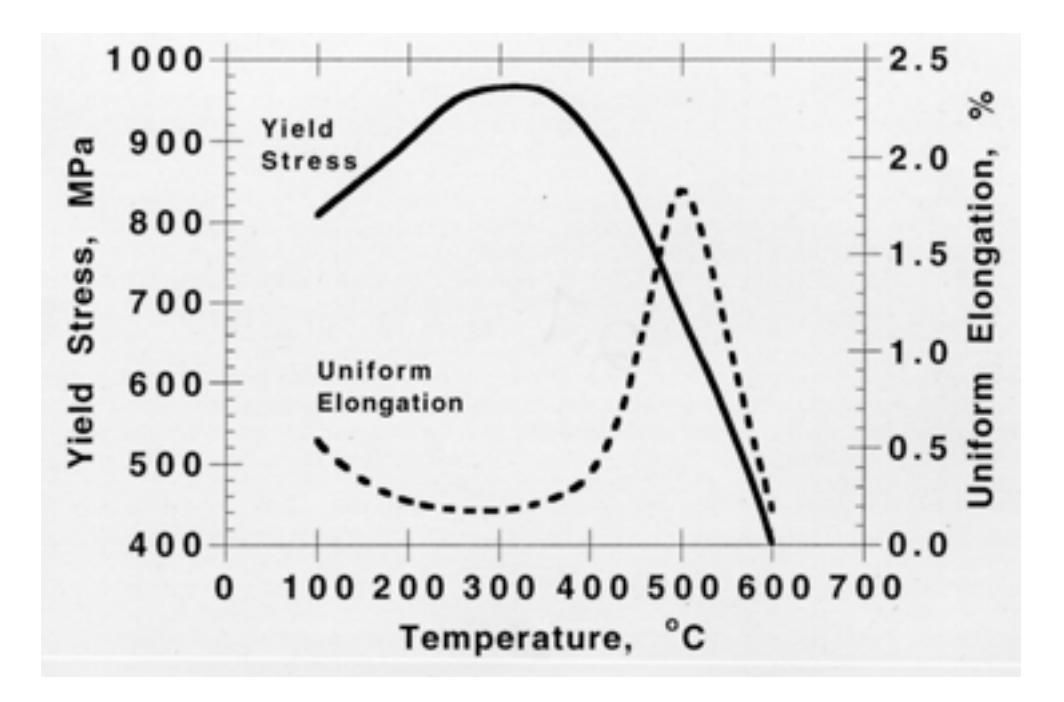
Figure 7. The trend for yield strength and uniform elongation of irradiated stainless steels [31].

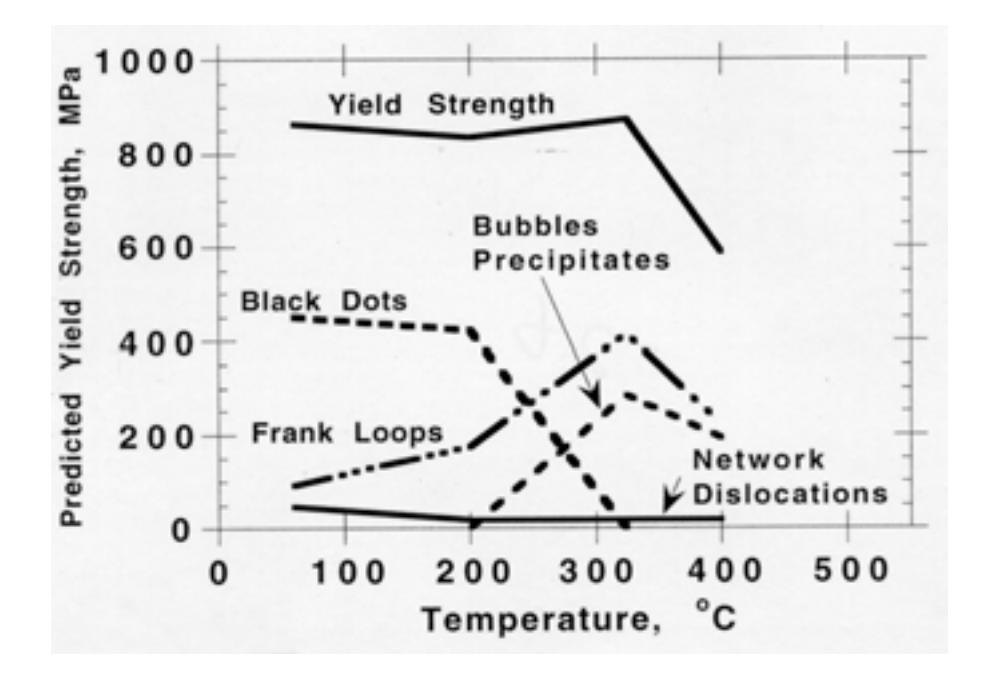
Figure 8. Predicted yield strength contributions from measured components of irradiated microstructure at 7 dpa [32].

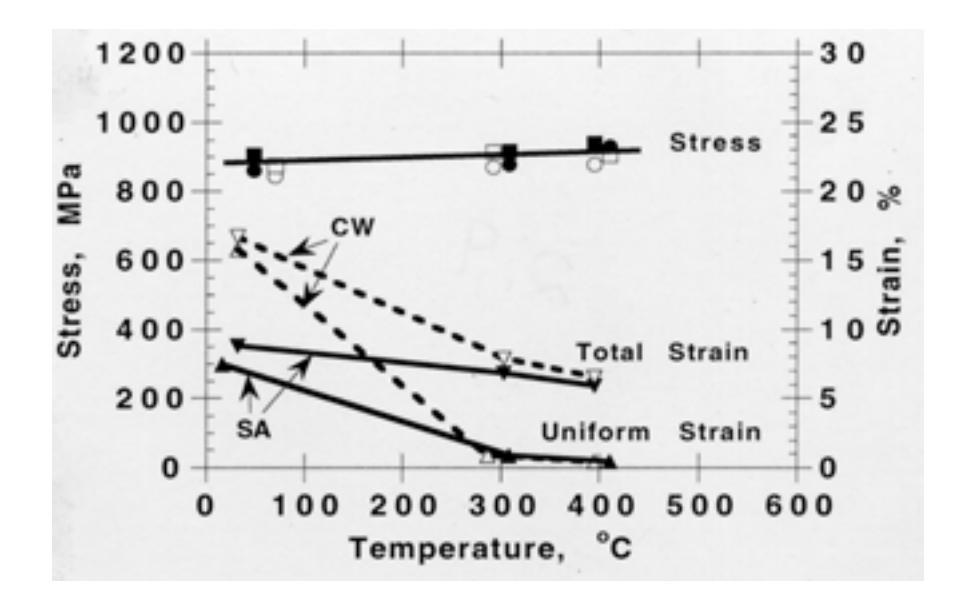
Figure 9. Tensile properties of an irradiated austenitic stainless steel. Open and closed symbols represent solution annealed and cold-worked conditions, respectively. Circles indicate yield stress, and squares represent ultimate tensile strength [33].

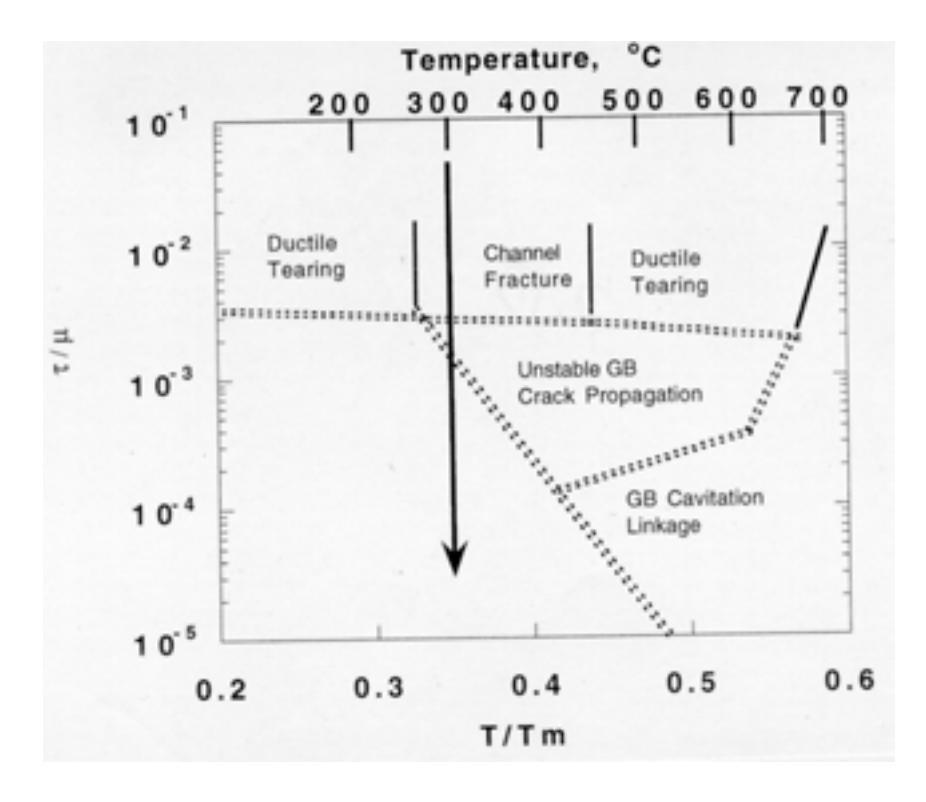
Figure 10. Fracture map as proposed by Bloom [40]. At $300 \,^{\circ}$ C, the fracture mode is expected to change from channel fracture to grain boundary fracture as the stress and strain rate are decreased. The mechanism transitions are shown as a function of normalized shear stress and normalized temperature.

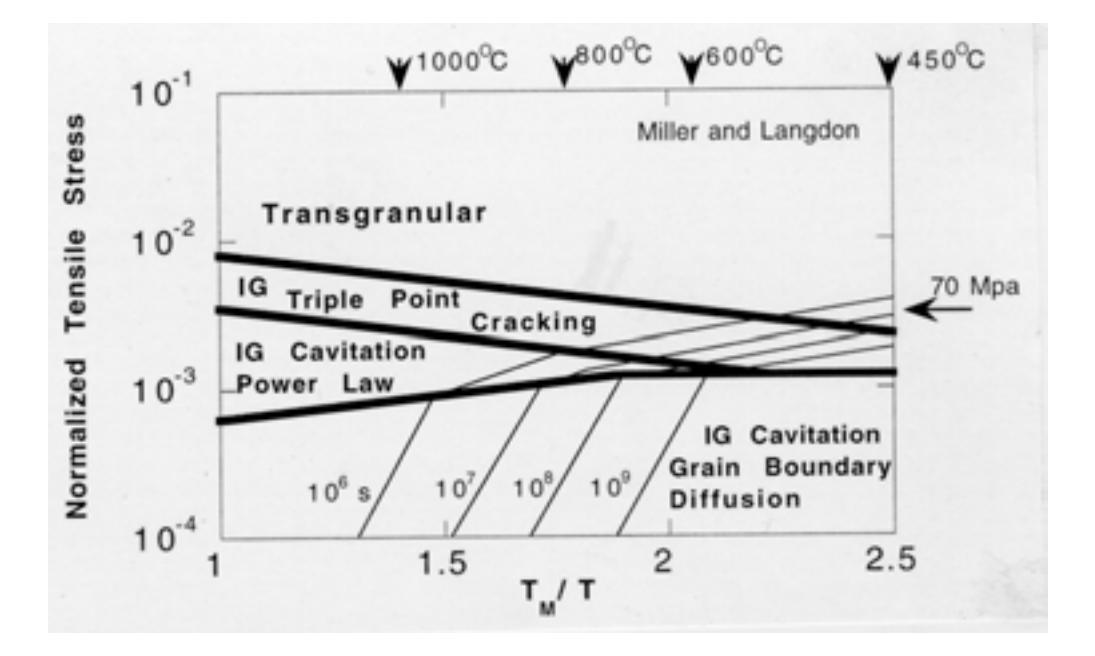
Figure 11. Unirradiated fracture behaviour of Type 316 stainless steel as a function of stress and temperature [42].

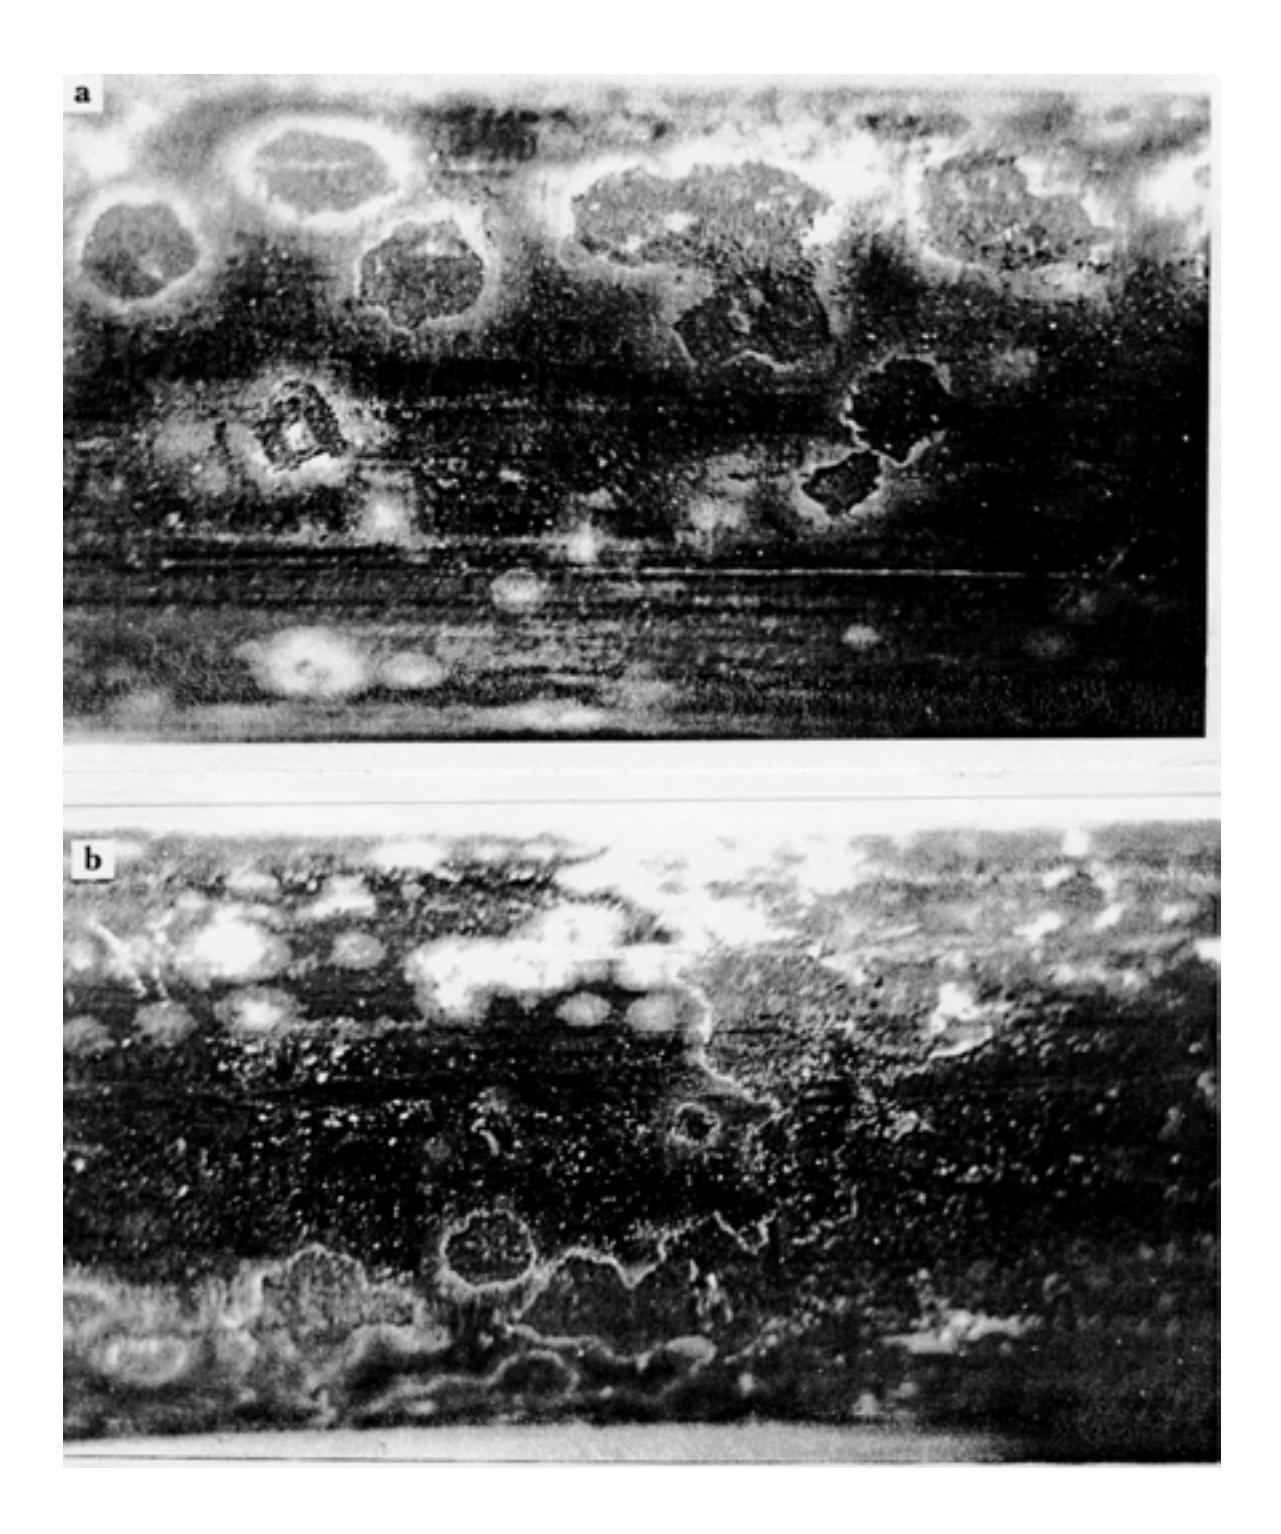
Figure 1. Oxidation of RBMK-1000 fuel rod 6 claddings after 5 years in cooling pond and 3 years in dry storage—a) between spacer grids and b) under spacer grids.

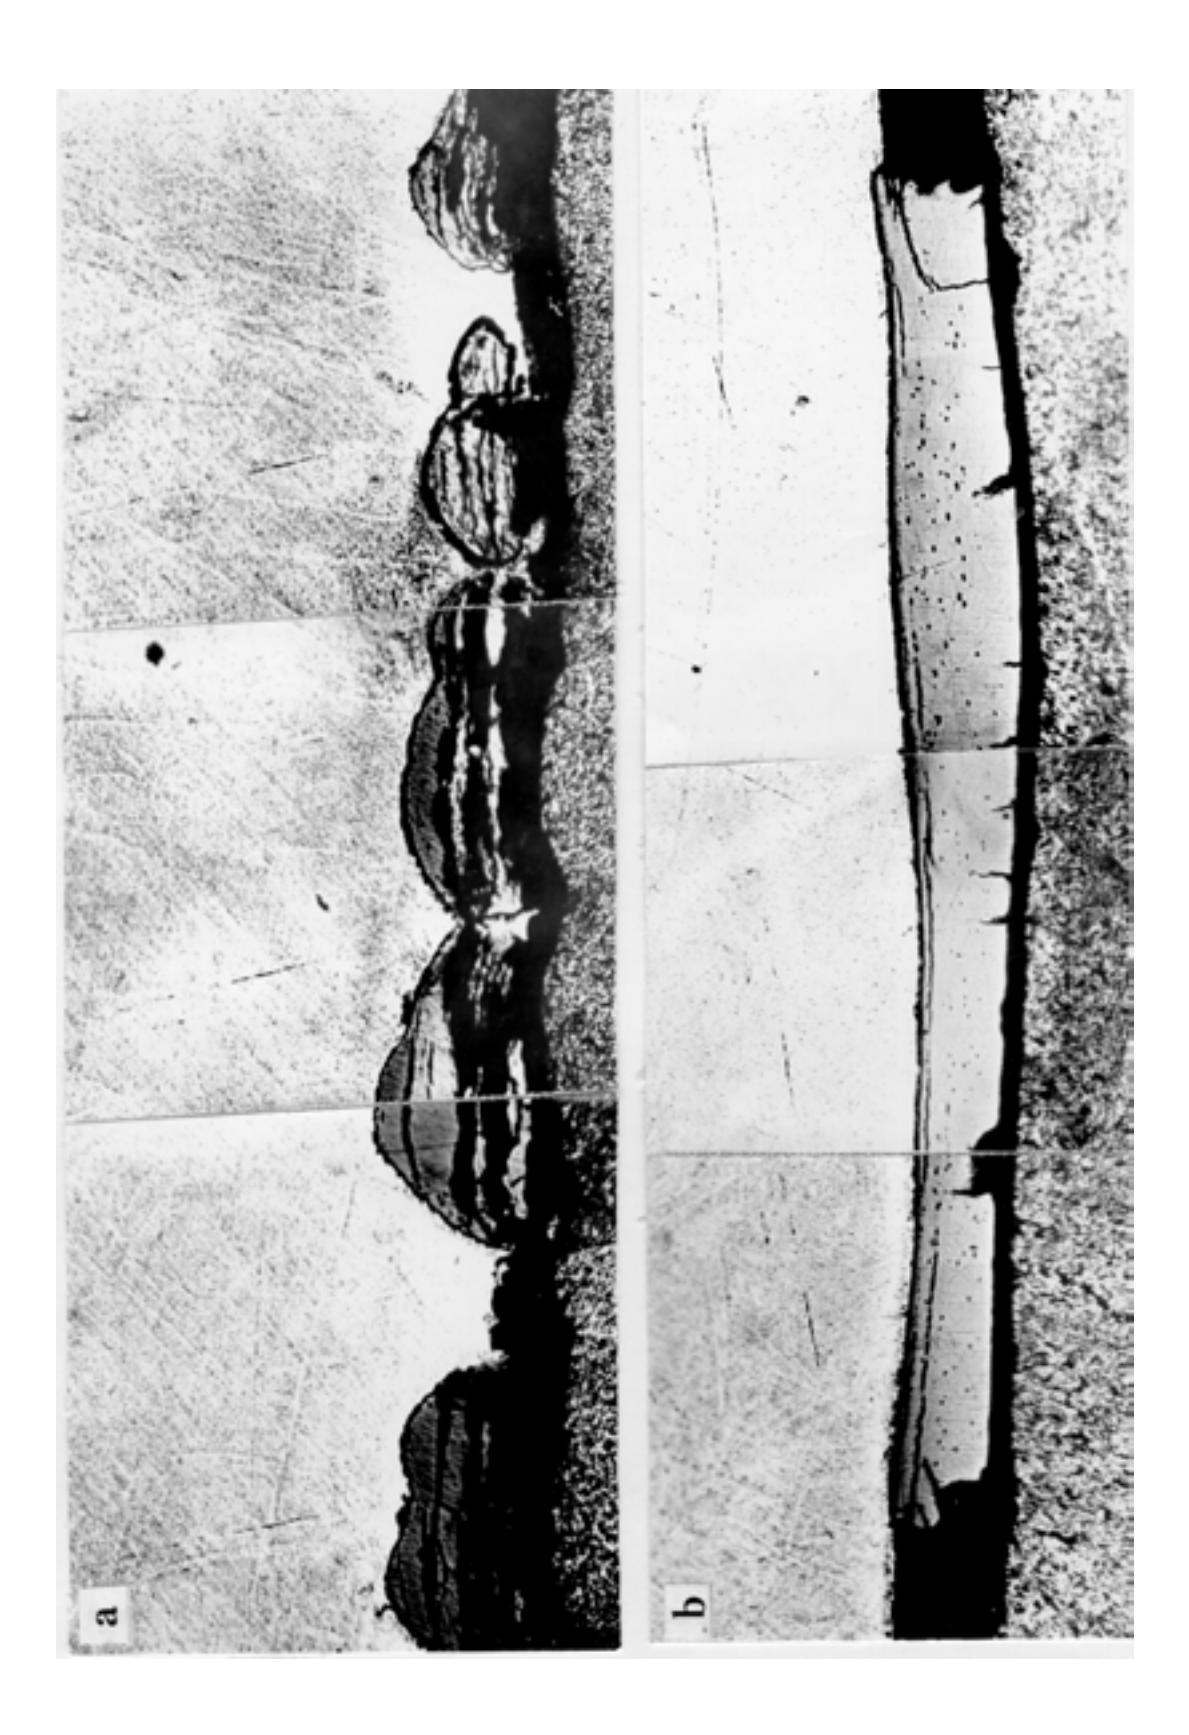
Figure 2. Microstructure of longitudinal section of RBMK-1000 fuel rod 4 cladding after 16 years in cooling pond—a) nodular corrosion under spacer grid and b) extended corrosion nodule at a plug.

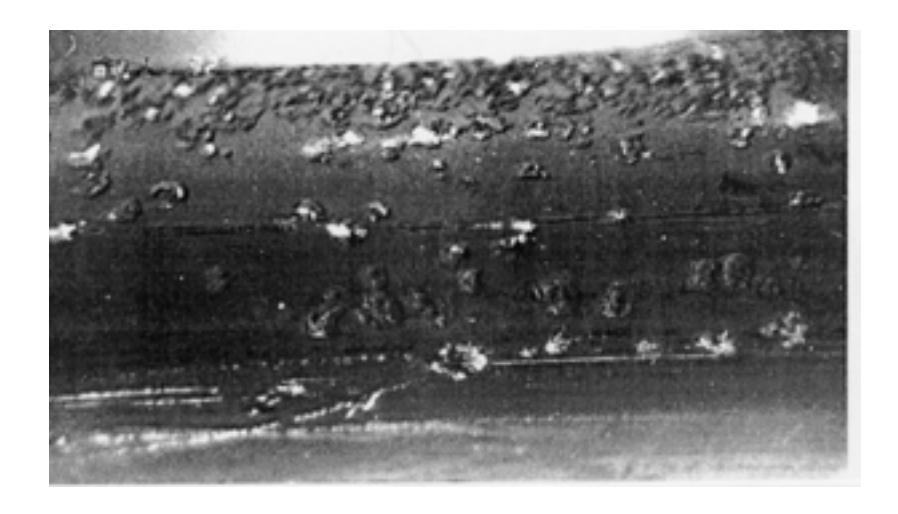
Figure 4. Surface of RBMK-1000 fuel rod 5 cladding (between spacer grids) after cooling pond storage.

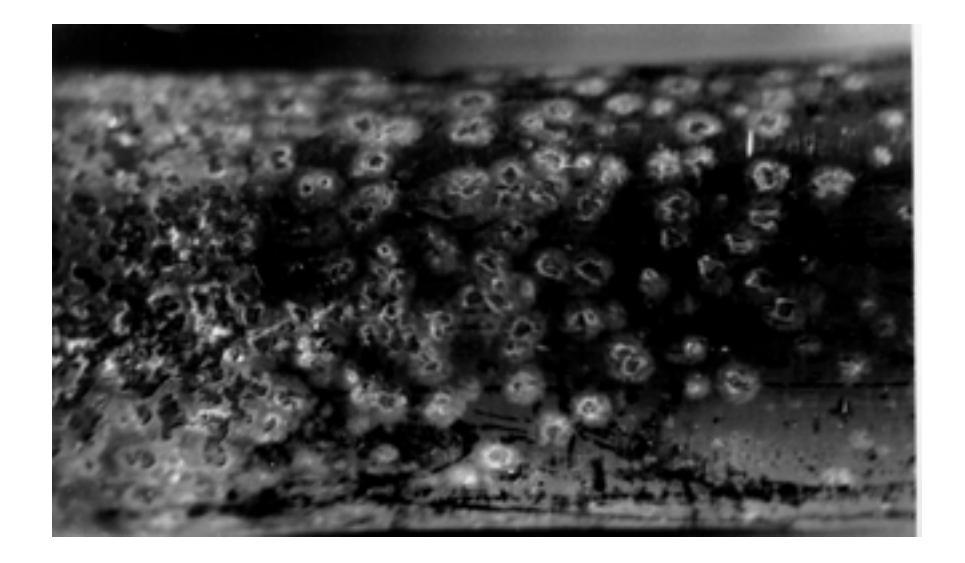
Figure 6. Transition from nodular oxidation in the form of a bond between spacer grids to annual oxidation under spacer grid in RBMK-1000 fuel rod 4 after 16 years in cooling pond.

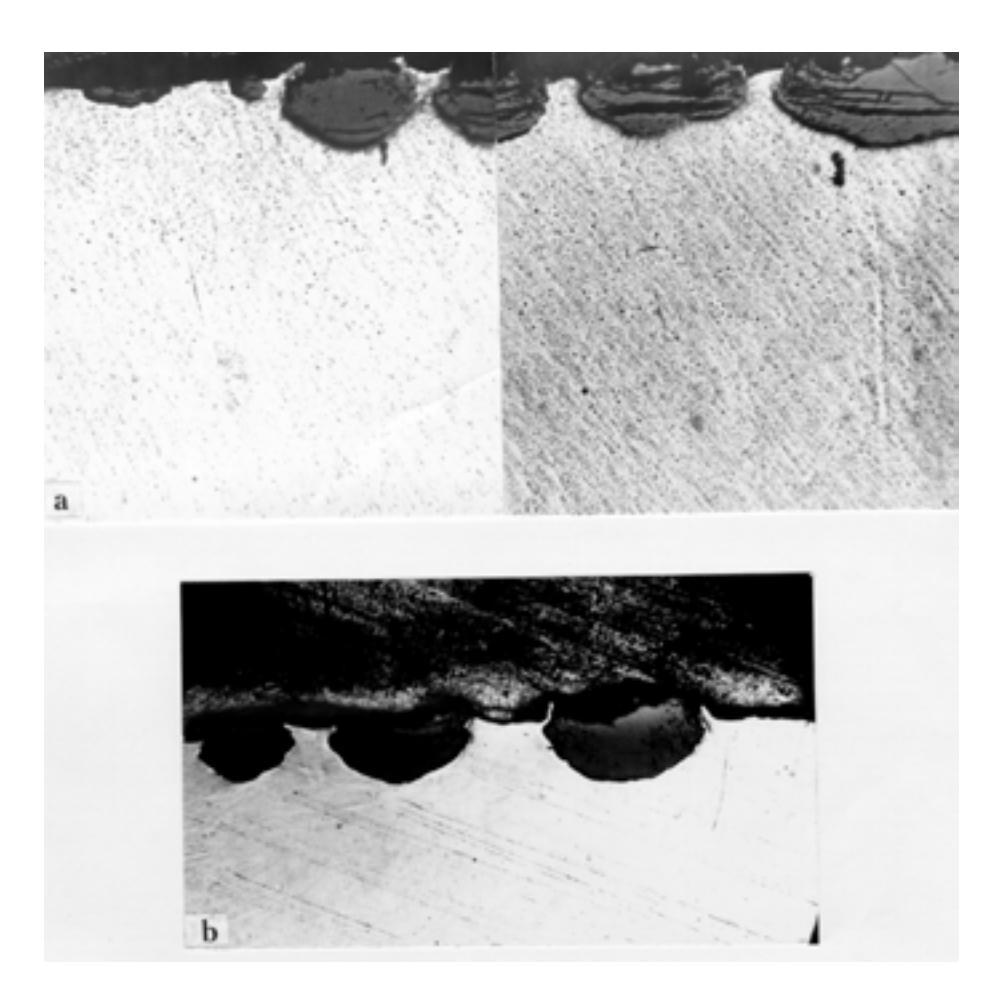
Figure 7. Microstructure of cross-section of RBMK-1000 fuel rod 4 cladding after 16 years in cooling pond—a) corrosion under spacer grid and b) corrosion between spacer grids.

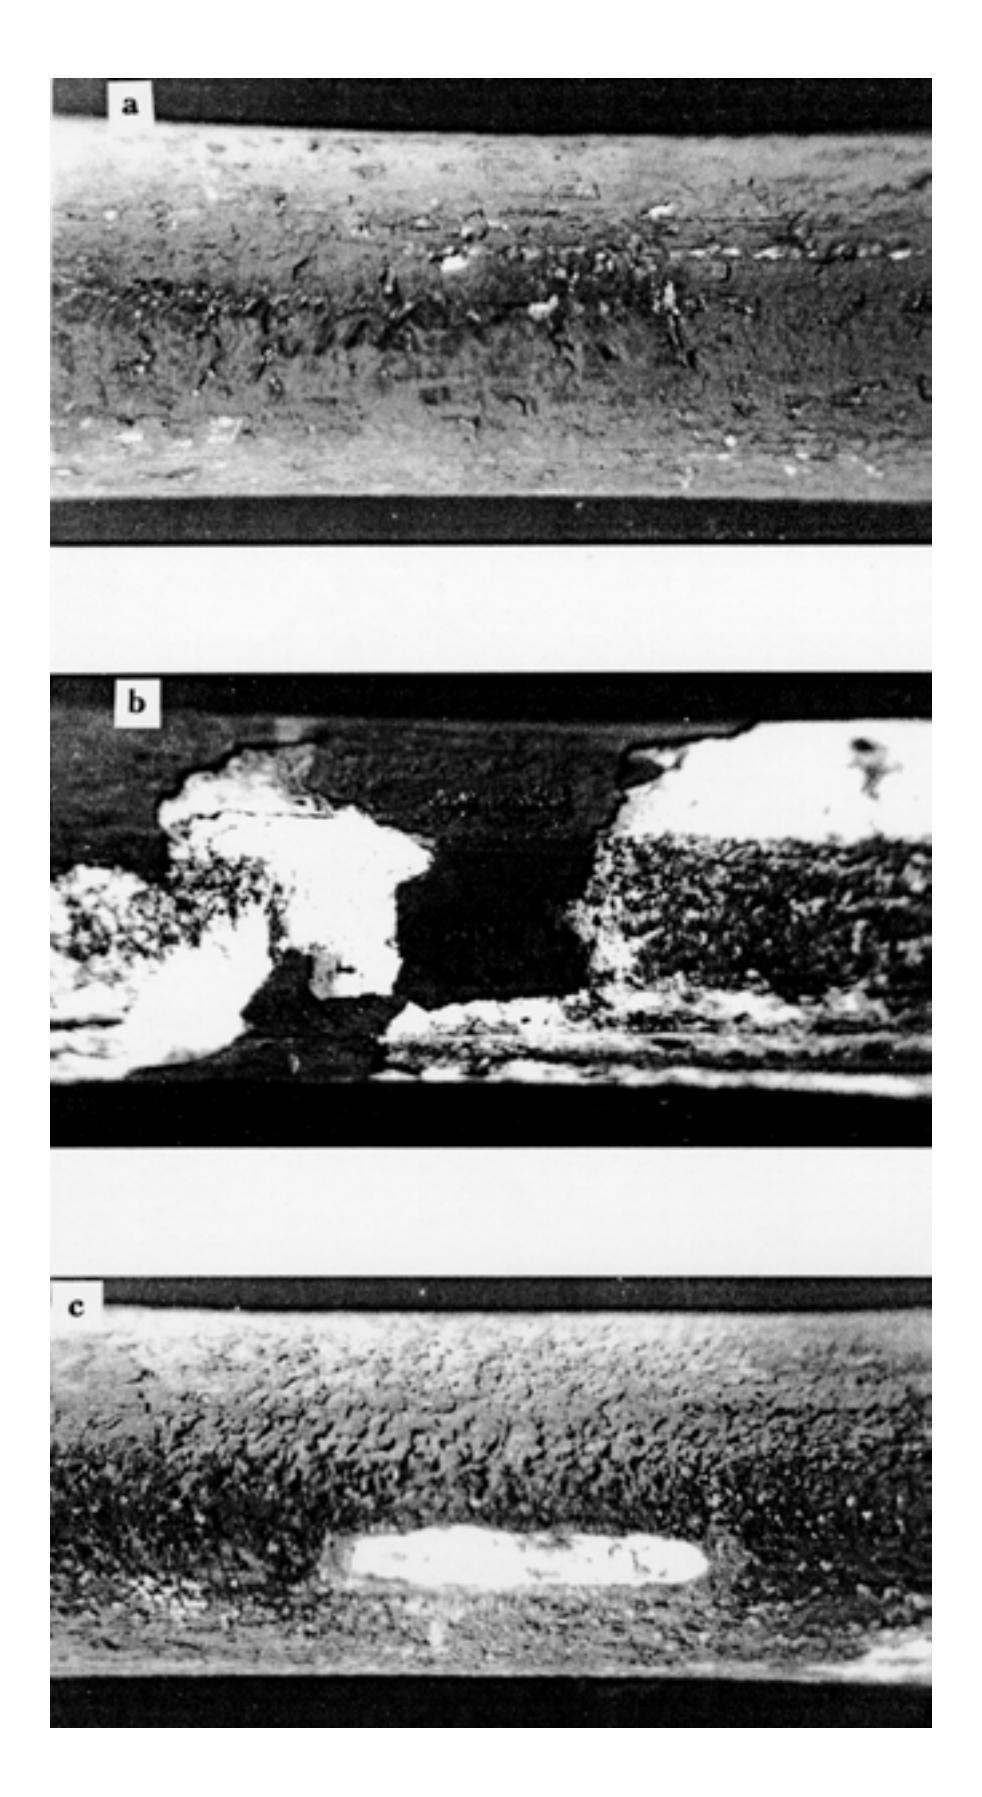
Figure 8. Cladding surface of VK-50 fuel rod 9 after 11 years storage—a) bottom, b) middle, and c) under spacer grid.

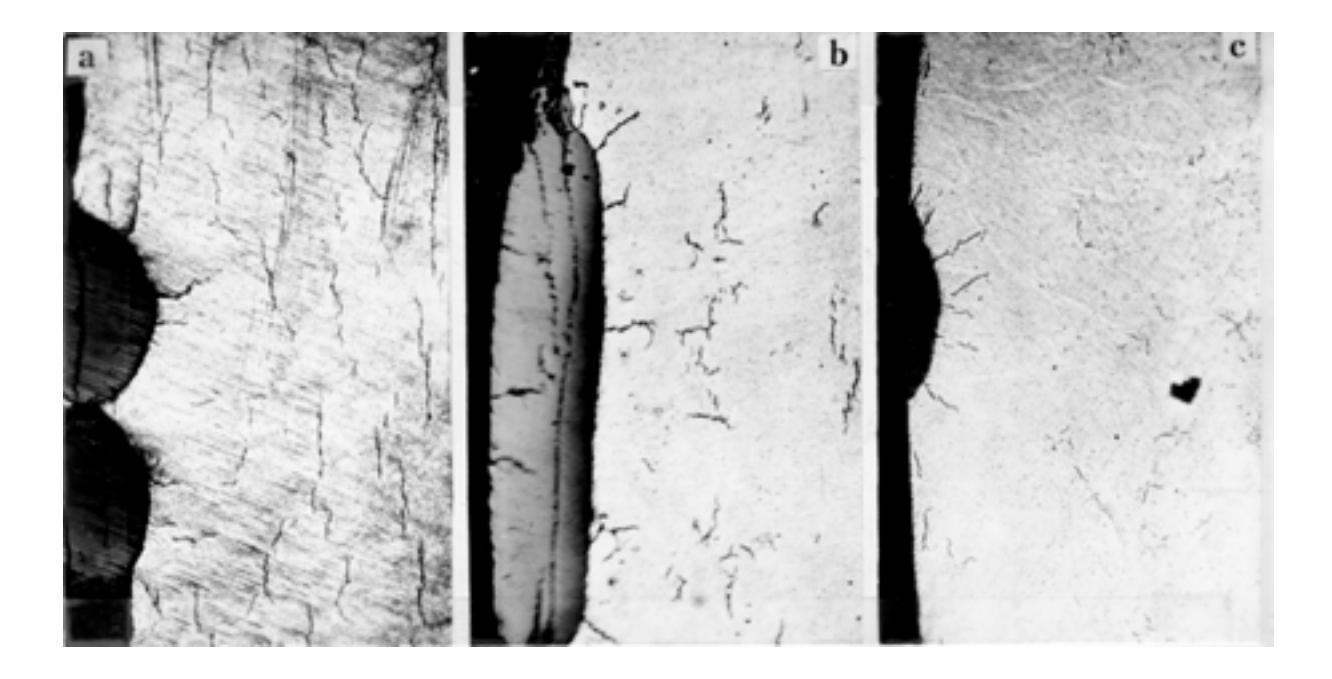
Figure 9. Microstructure of cross-section of VK-50 fuel rod cladding (8 years operation) with differently oriented hydrides—a) tangential, b) chaotic, and c) radial.

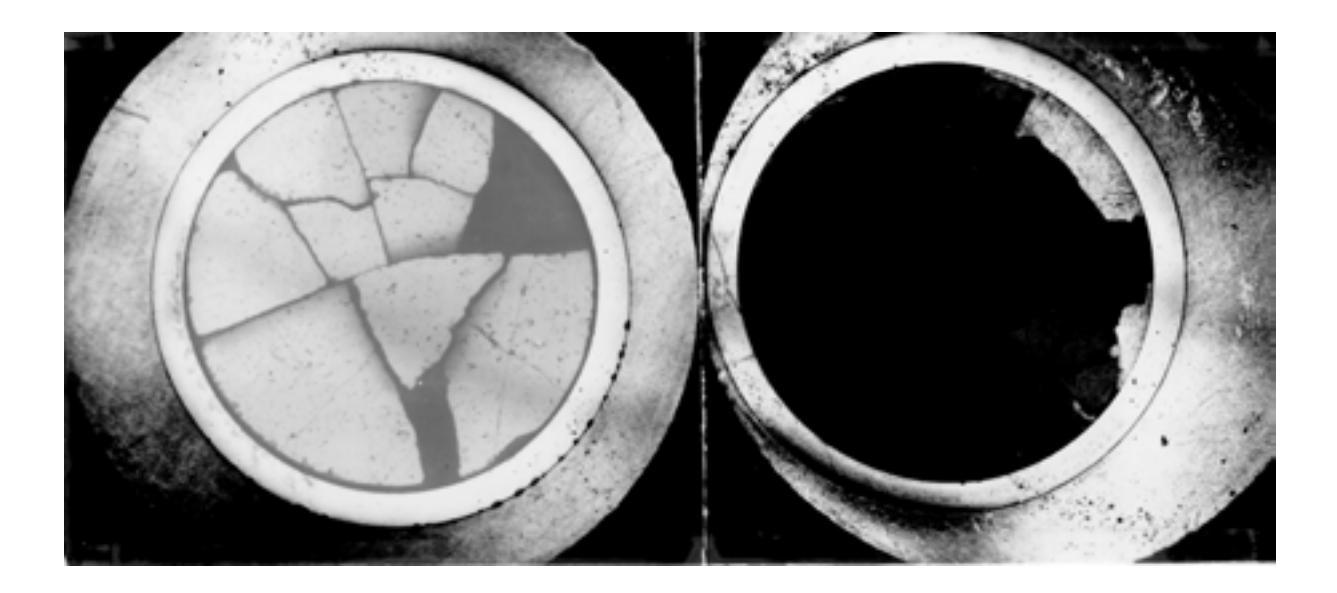
Figure 10. Cross-section of RBMK-1000 fuel rod 5 cladding.

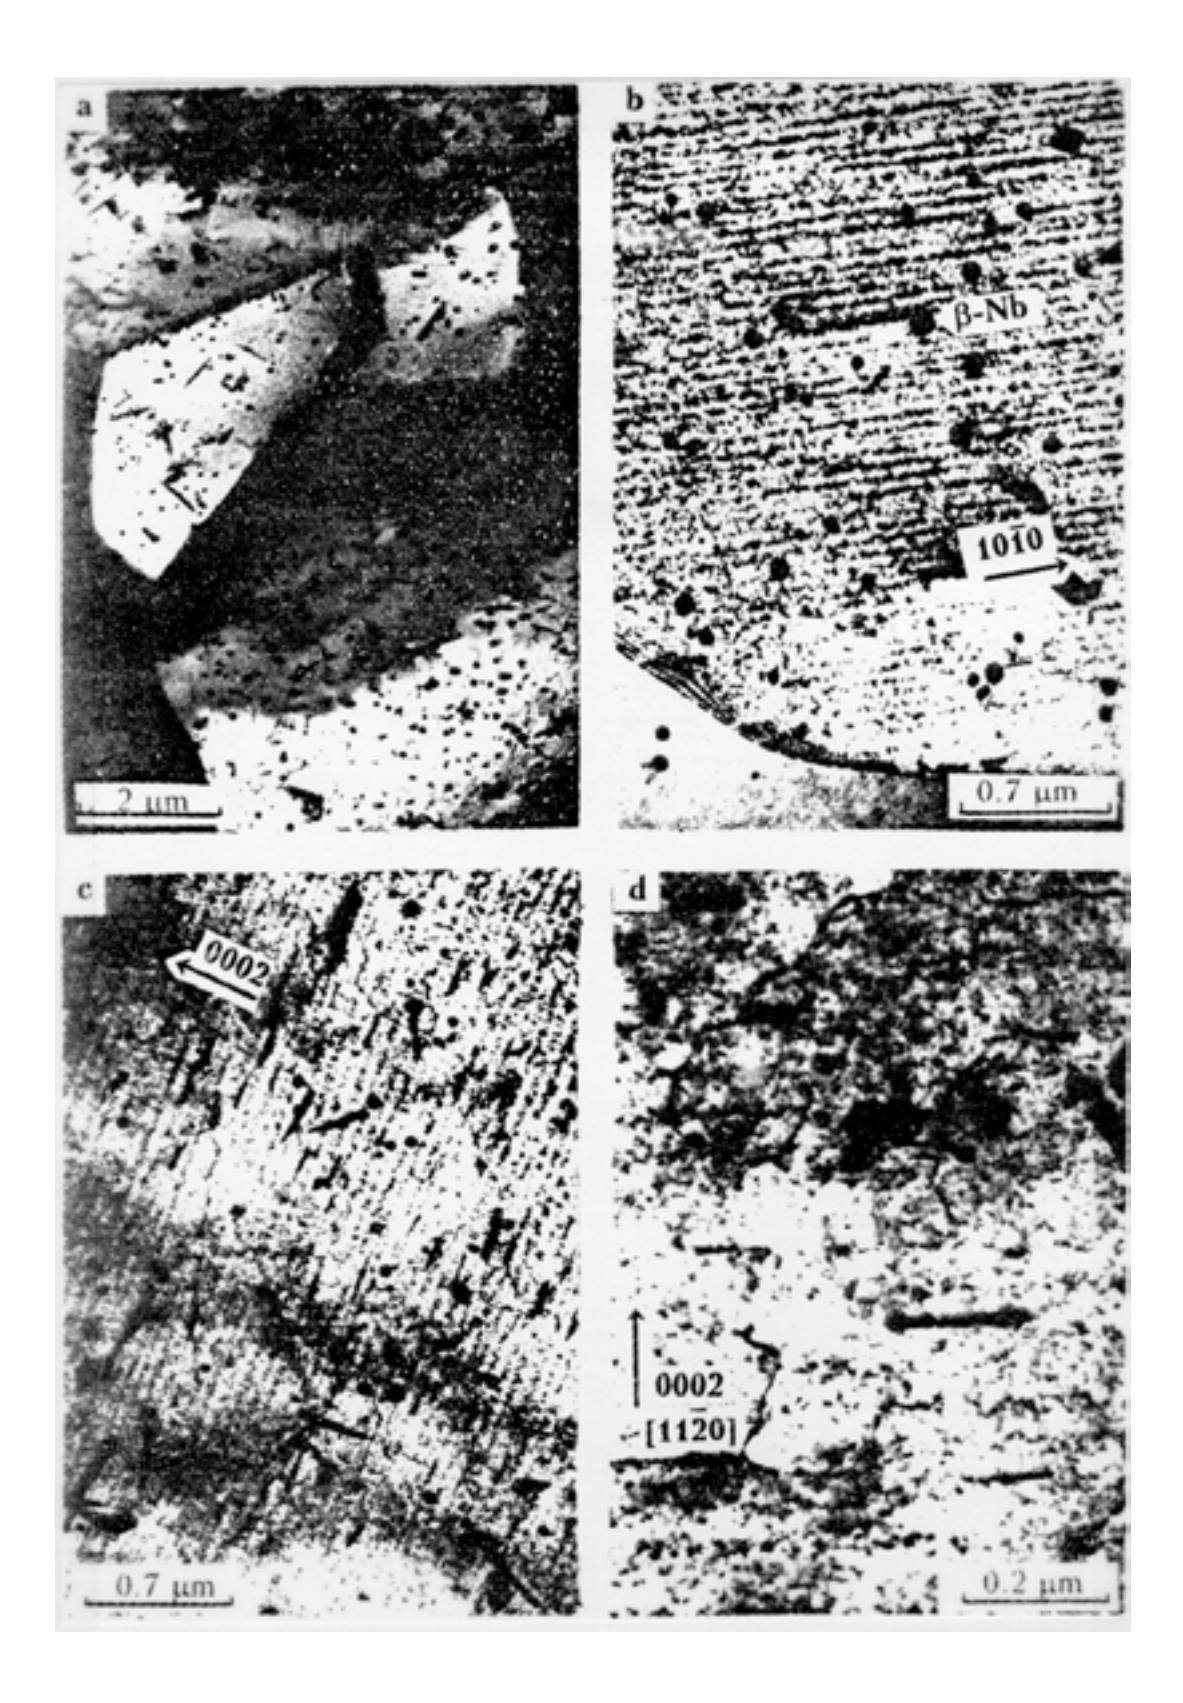
Figure 11. Microstructure of recrystallized Zr-1Nb alloy—a) initial and b) irradiated to fluence of 5×10^{25} nm⁻² at 350 °C: grain structure, β -Nb precipitates, (a) dislocation loop ordering; c) (c) dislocations, climbing onto basal planes; and d) fine defects, possibly (c) dislocations loops.

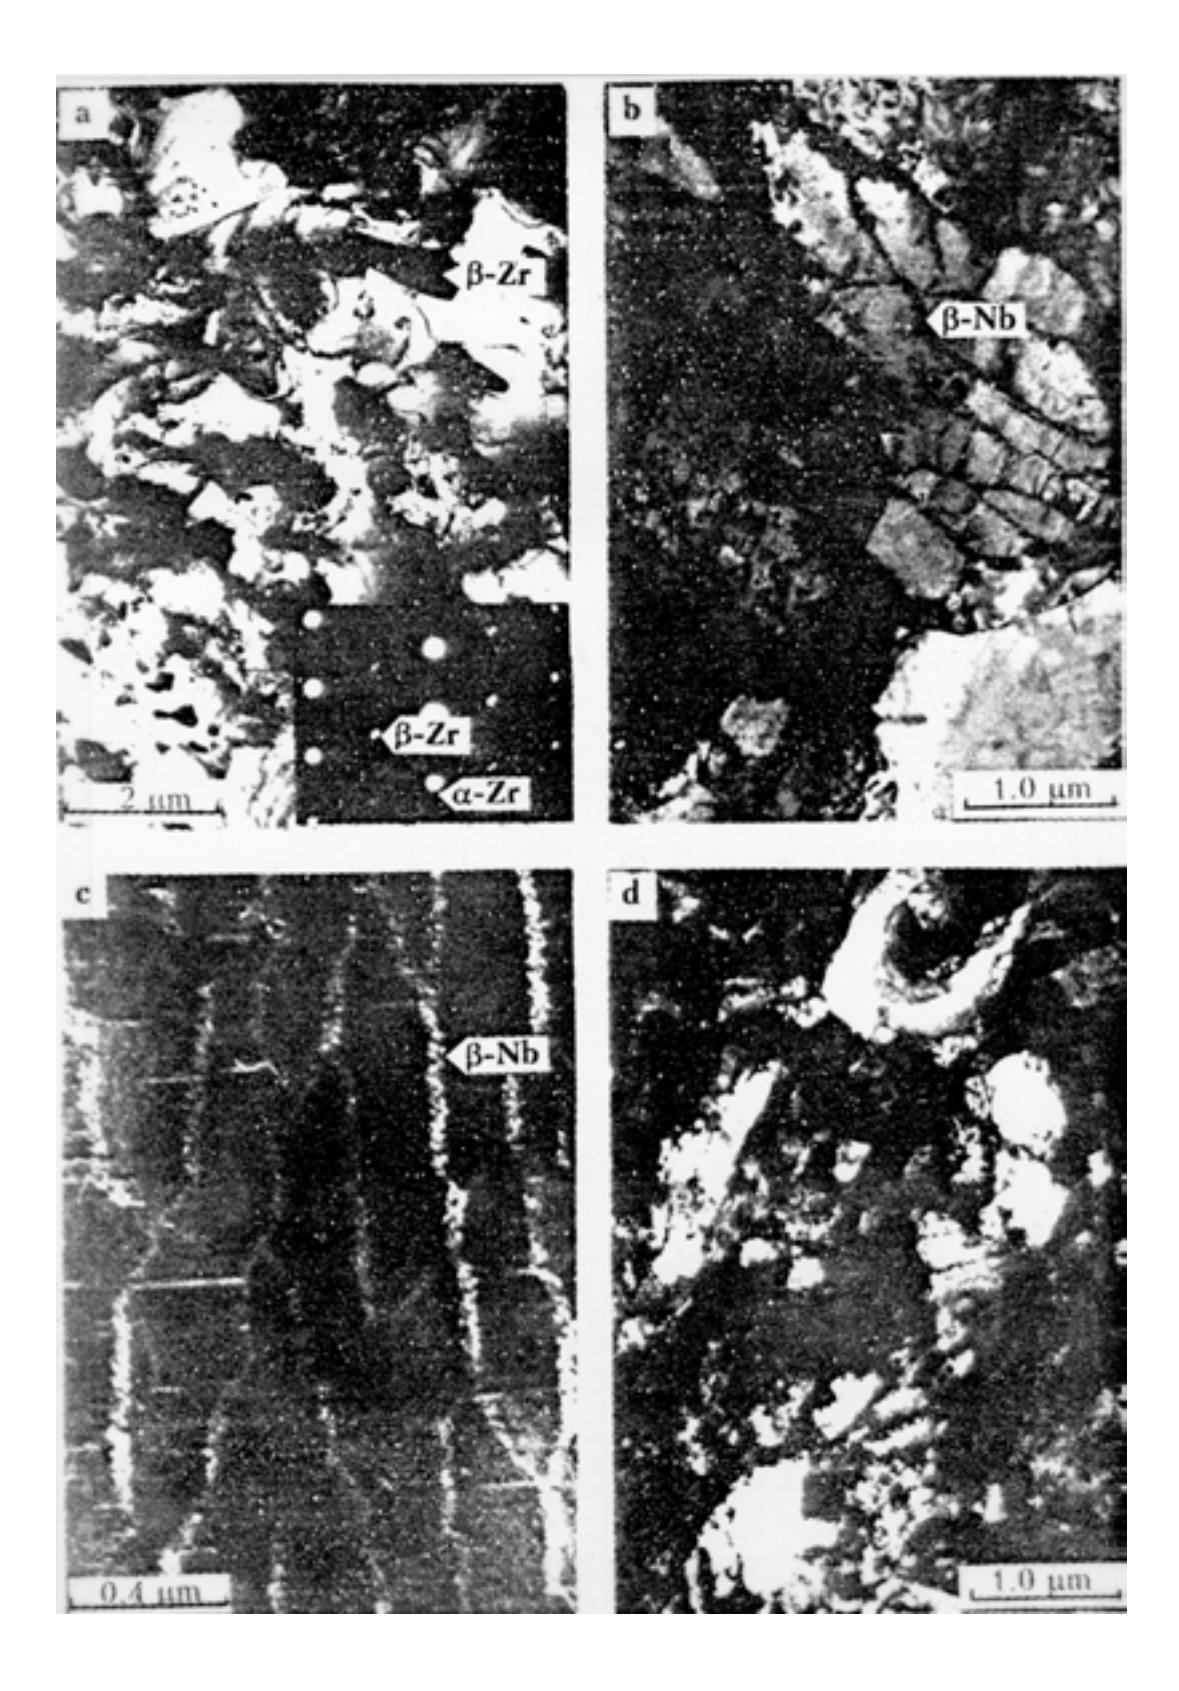
Figure 12. Microstructure of partially recrystallized unirradiation Zr-2.5Nb alloys—a) coldworked and annealed (state A), β -Nb, and β -Zr precipitates; b) distribution of fine dispersive β -Nb precipitates along non-recrystallized grains; c) distribution of β -Nb precipitates, dark field; and d) quenched and stress-relieved condition (state B).
