IAEA-TECDOC-1316

Effects of radiation and environmental factors on the durability of materials in spent fuel storage and disposal

INTERNATIONAL ATOMIC ENERGY AGENCY

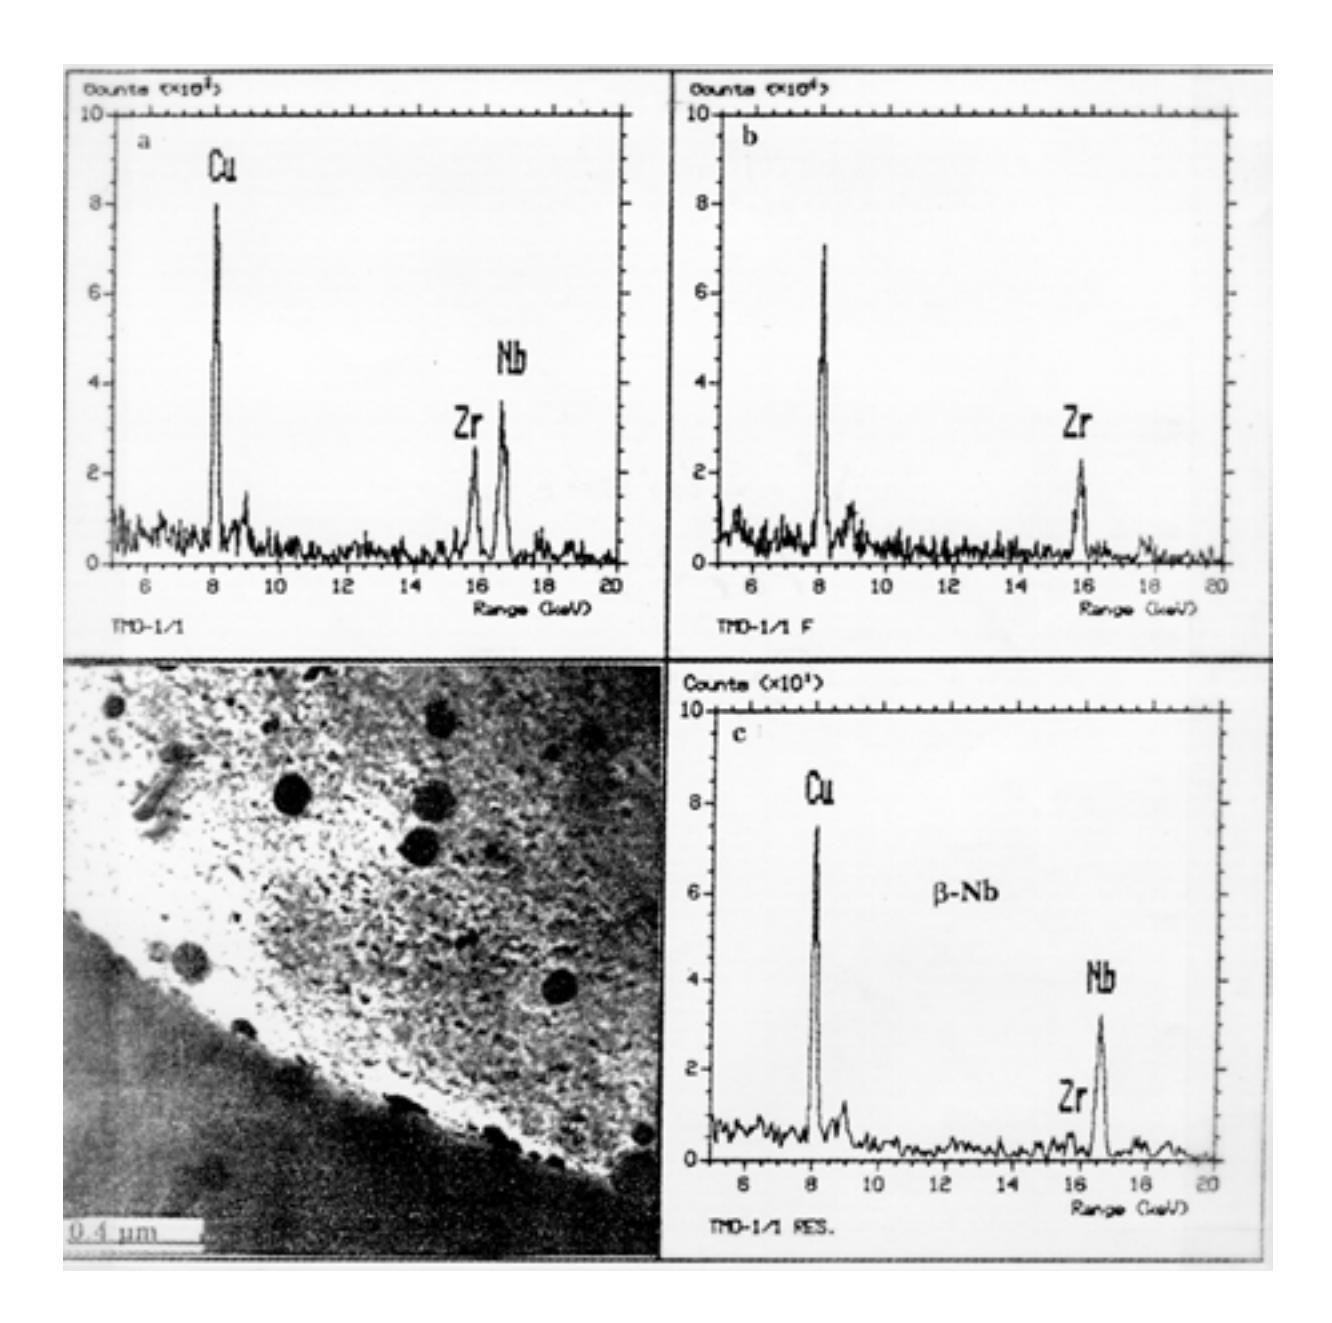
Figure 13. X ray microanalysis spectra of β -Nb precipitates in unirradiated Zr-2.5Nb alloy. Particles extracted on a carbon replica: a) not processed spectrum, b) background spectrum, and c) processed spectrum.

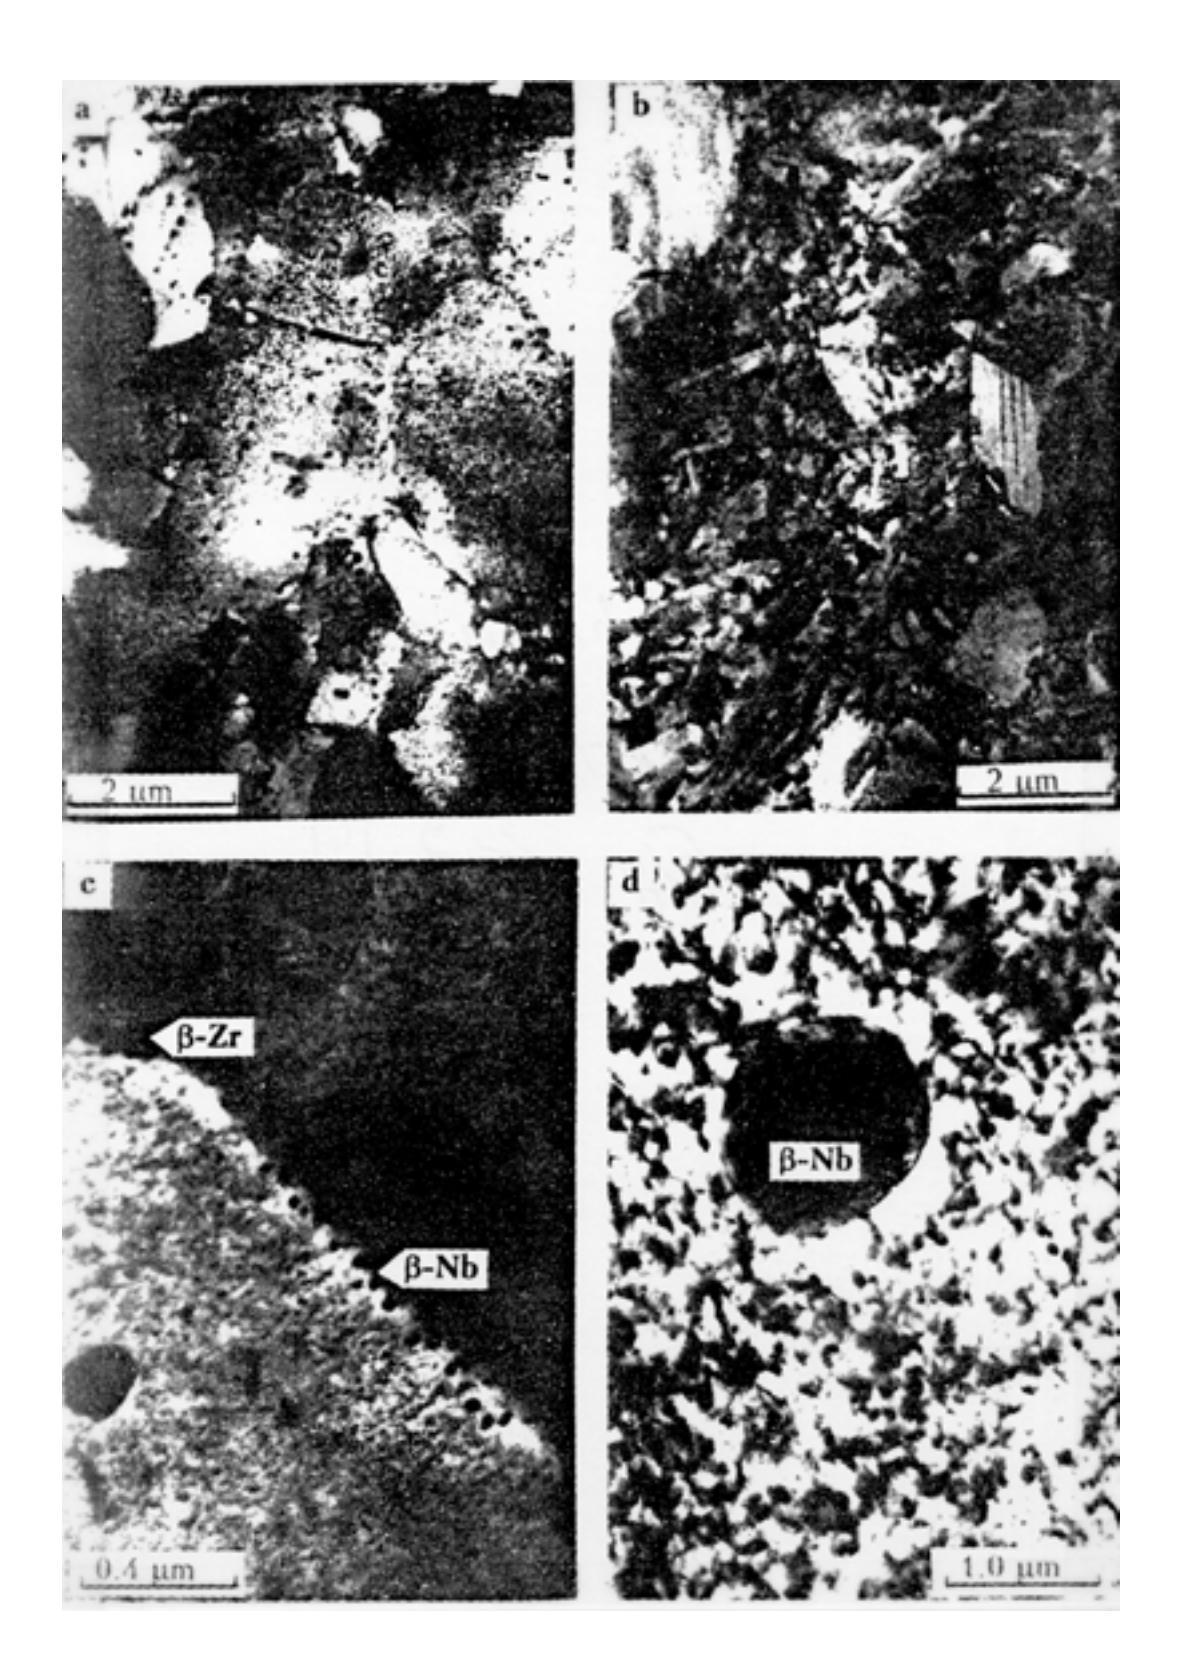
Figure 14. Microstructure of irradiation Zr-2.5Nb alloy: a) at 305 °C (RBMK-1000), state A; b) at 315 °C (RBMK-1500), state B; c) at 350 °C (5 x 10^{25} nm⁻², MIR), state A, β -Zr decomposition into β -Nb chains; and d) β -Nb precipitation in alloys.
