How did Individual and Organizational Use of Probability and Risk Assessment at TEPCO Contribute to the Fukushima Accident?

Hank Drumhiller
Senior Corporate Team Leader
World Association of Nuclear Operators, Atlanta USA
May 22, 2013

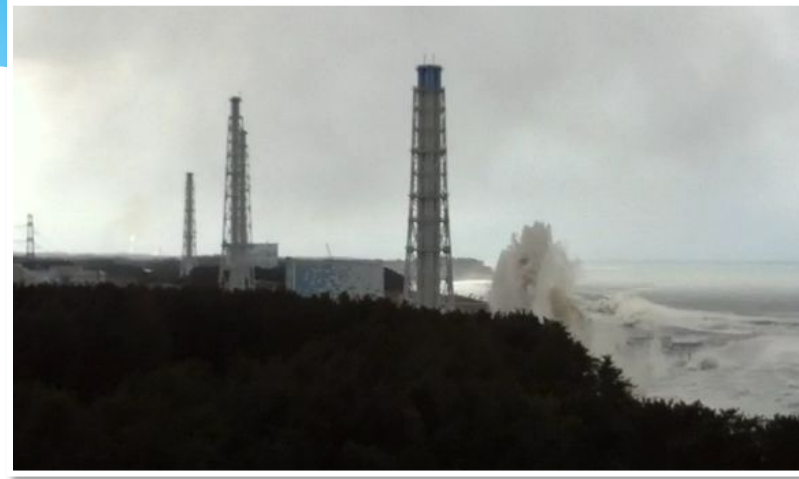
Background

- * Tsunami design basis was reevaluated at least five times
- * Actions were taken twice to modify the plant

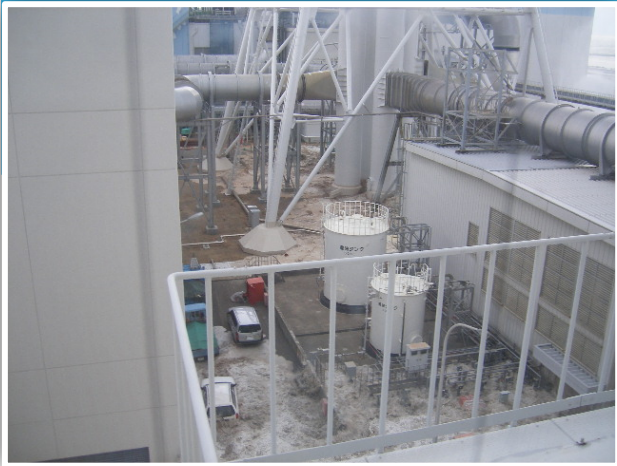
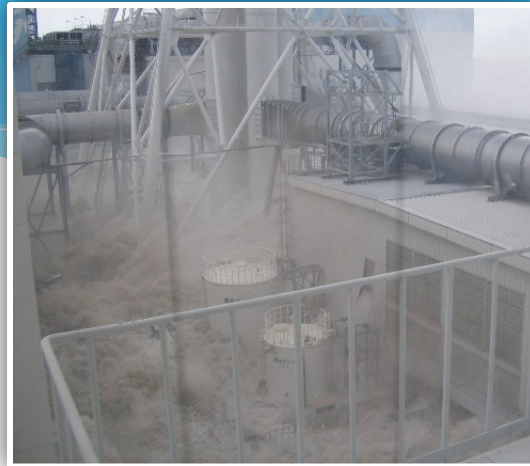
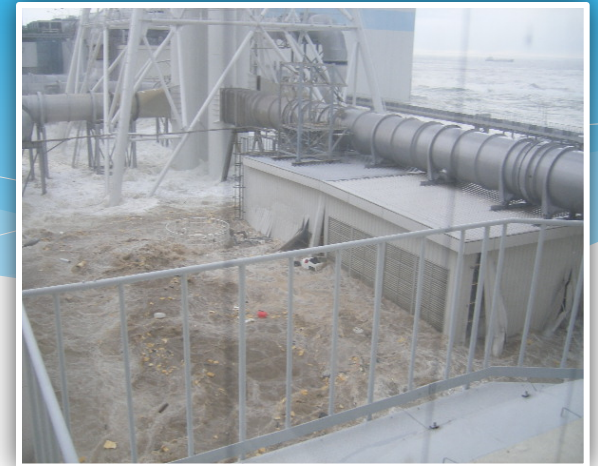
Tsunami Design Basis

- * Initial design basis was sea level + 3.1M – 1960 Chilean earthquake and tsunami
- * In 2002, increased to sea level + 5.7M
- * In 2009, increased to sea level + 6.1M
- * Seawater pumps were raised in response to both increases
- * Note: Units 1 – 4 site grade is sea level + 10M

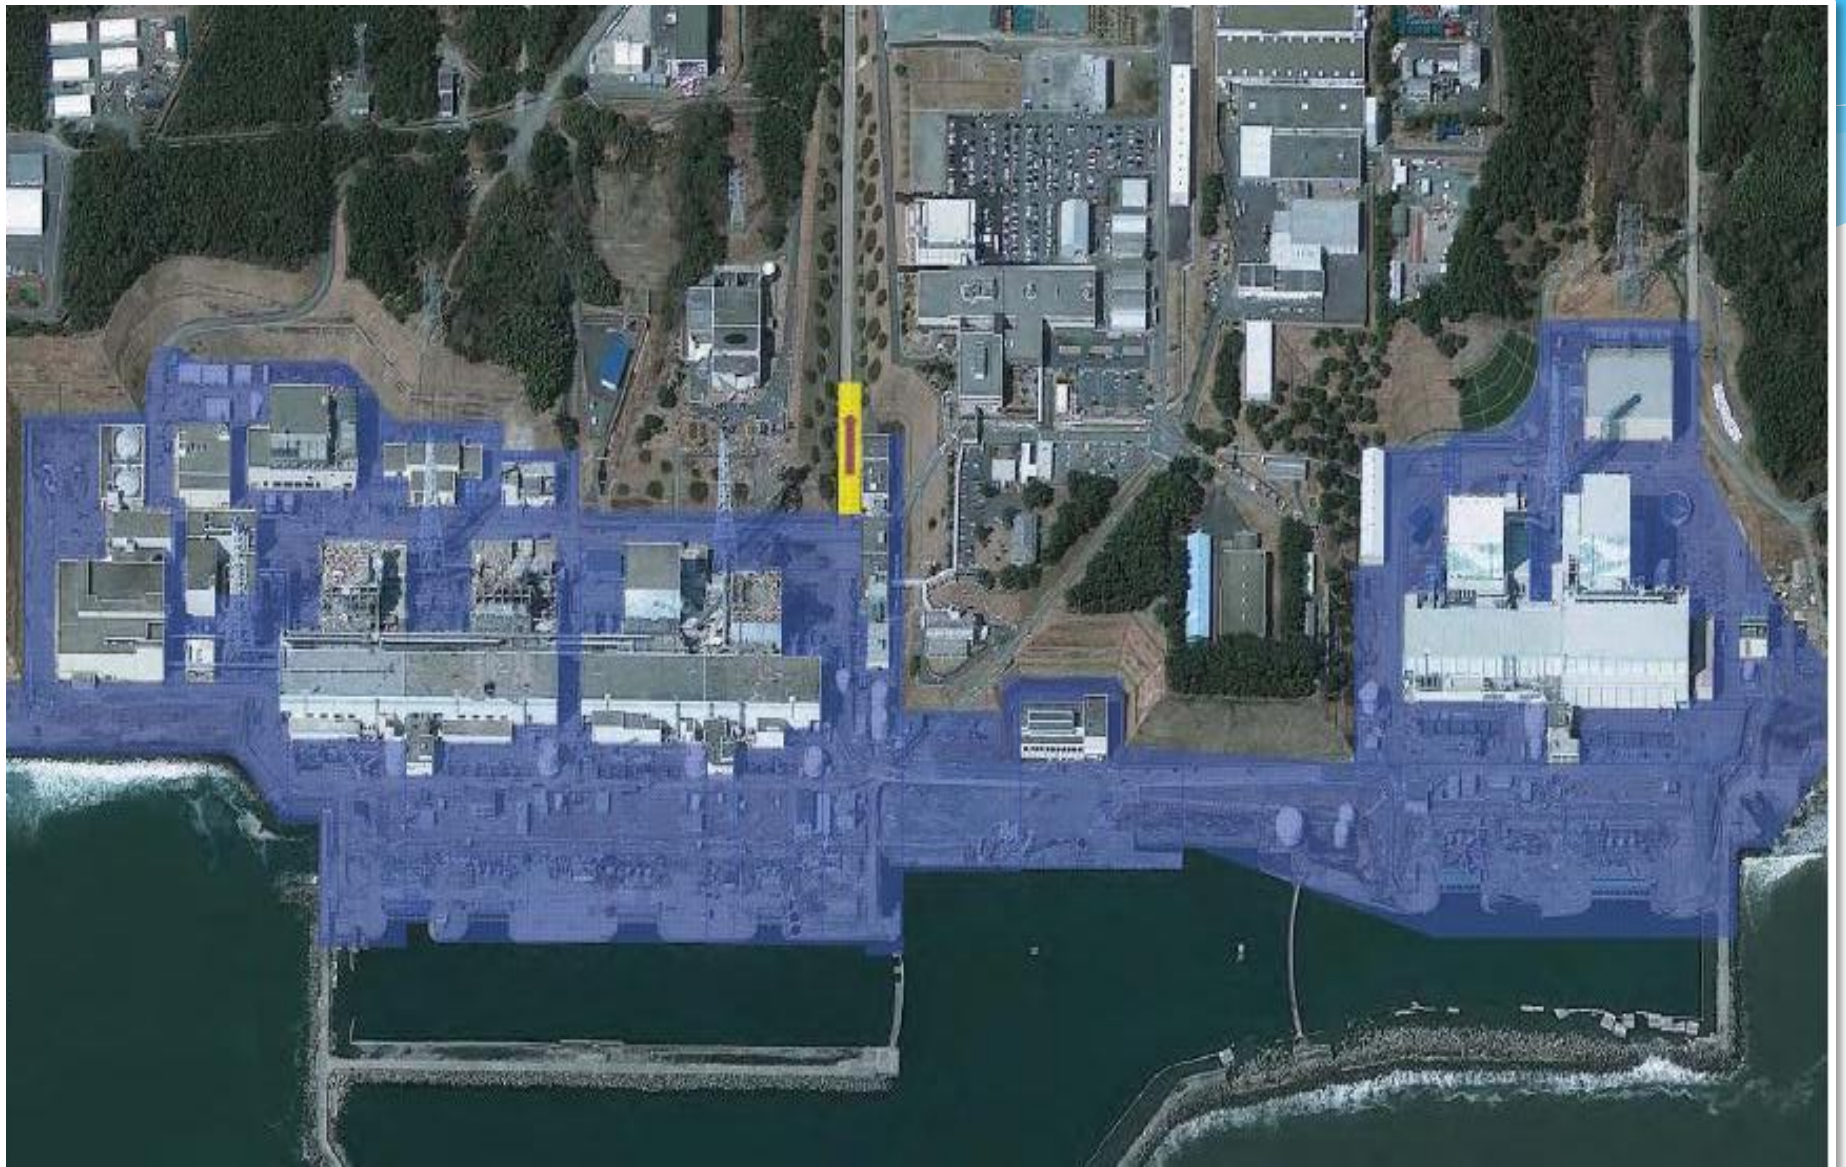
Tsunami Inundation

- * Larger magnitude, 9.0, and more fault lines and source area, and difference location than assumed in calculations
- * Forty-one minutes later, a series of tsunamis approximately 15M high
- * Destroyed sea water pumps, various tanks & facilities, and flooded reactor & turbine buildings thru open doors & ventilation louvers
- * Total loss of AC and DC power to units 1-5 (unit 3 retained limited DC)

- * Accepts an extreme external event can occur and rigorous preparations must be made
- * Promptly assess current capabilities to mitigate an event when new information is received that challenges current design assumptions
- * Reviews risk and possible consequences of changes in design bases assumptions
